**RE: Camden Water Utilities Inspections (Ouachita Co)**  
**AFIN: 52-00073**                      **NPDES Permit No.: AR0022365**  
**ARR000962**

<p><b>A R K A N S A S</b> Department of Environmental Quality</p>	<b>WATER DIVISION INSPECTION REPORT</b>				
	AFIN: <b>52-00073</b>	PERMIT #: <b>AR0022365</b>	DATE: <b>10/30/2019</b>		
	COUNTY: <b>52 Ouachita</b>	PDS #: <b>110284</b>	MEDIA: <b>WN</b>		
	GPS LAT: <b>33.563409</b> LONG: <b>-92.816980</b> LOCATION: <b>Entrance</b>				
<b>FACILITY INFORMATION</b>		<b>INSPECTION INFORMATION</b>			
NAME: <b>Camden Water Utilities</b> LOCATION: <b>101 Ouachita 197</b> CITY: <b>Camden, AR 71701</b>		FACILITY TYPE: <b>1 - Municipal</b> INSPECTOR ID#: <b>101531 S - State</b> FACILITY EVALUATION RATING: <b>2 - Marginal</b> INSPECTION TYPE: <b>Compliance Evaluation</b>			
<b>RESPONSIBLE OFFICIAL</b>		DATE(S): <b>10/30/2019</b> ENTRY TIME: <b>09:40</b> EXIT TIME: <b>12:52</b> PERMIT EFFECTIVE DATE: <b>9/1/2018</b> PERMIT EXPIRATION DATE: <b>8/31/2023</b>			
NAME / TITLE: <b>David Richardson / Manager</b> COMPANY: <b>Camden Water Utilities</b> MAILING ADDRESS: <b>P.O. Drawer J</b> CITY, STATE, ZIP: <b>Camden AR 71711</b> PHONE & EXT: / FAX: <b>870-8

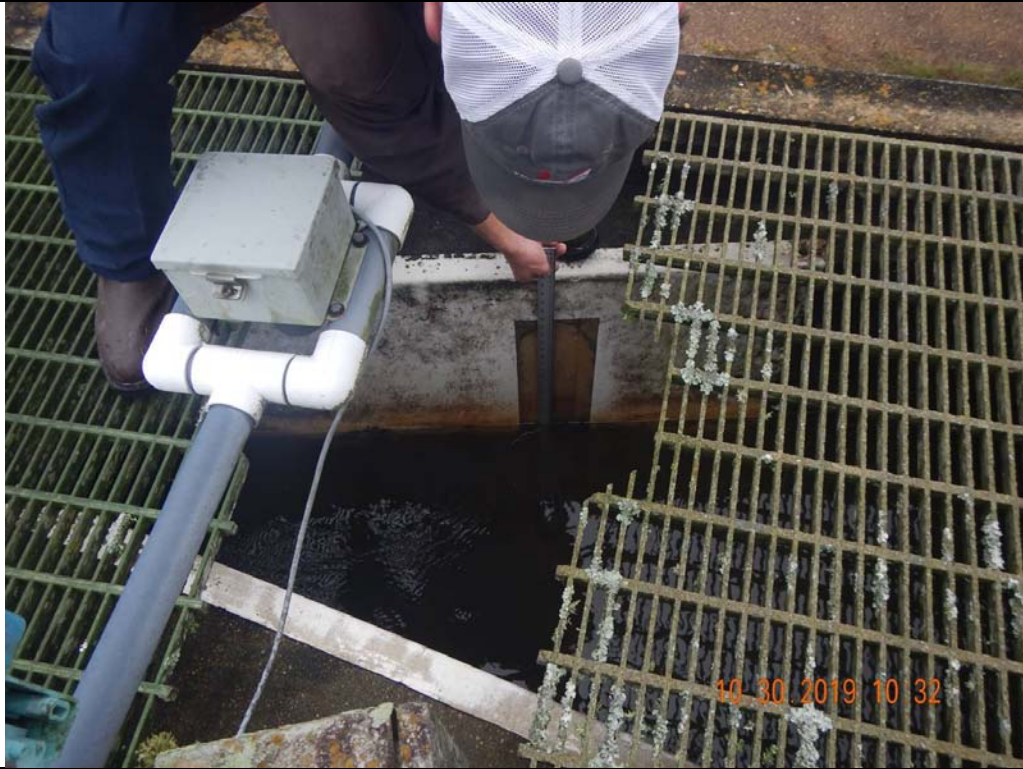
Location:	<b>Camden Water Utilities</b>		
Photographer:	<b>Michael Young</b>	Date:	<b>10/30/2019</b>
Time:	<b>10:32</b>	Witness:	
Photo #:	<b>29</b>

Description: **Staff gage is assisted with metal ruler.**

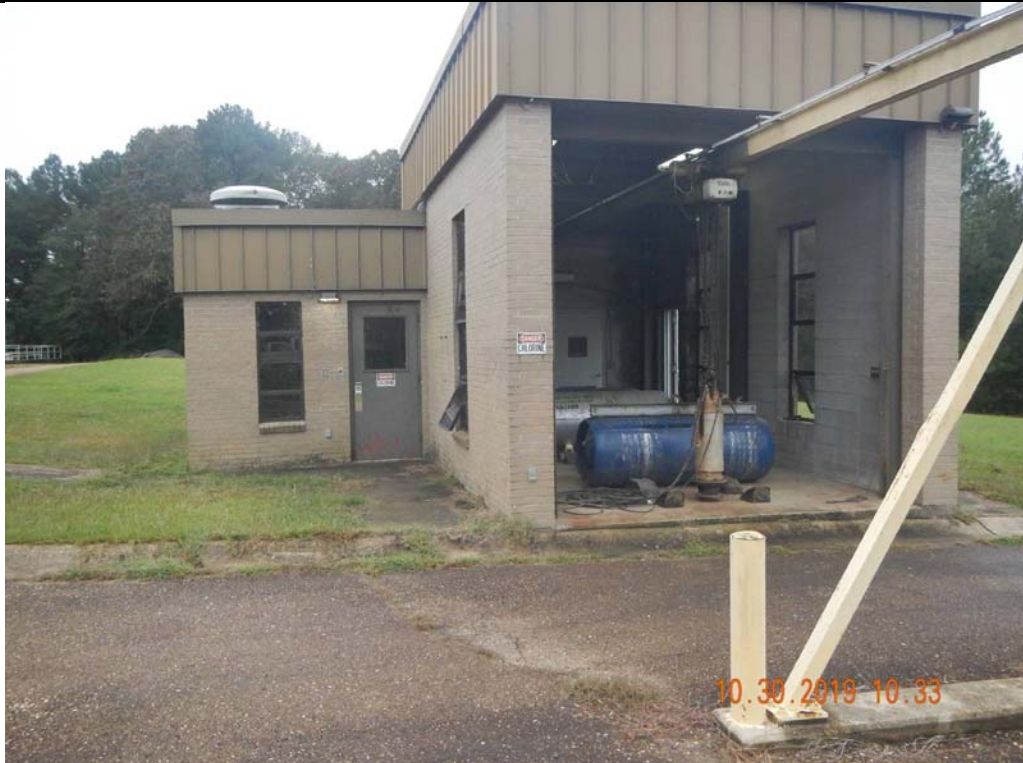
Photographer:	<b>Michael Young</b>	Date:	<b>10/30/2019</b>
Time:	<b>10:33</b>	Witness:	
Photo #:	<b>30</b>

Description: **Chlorine storage building.**

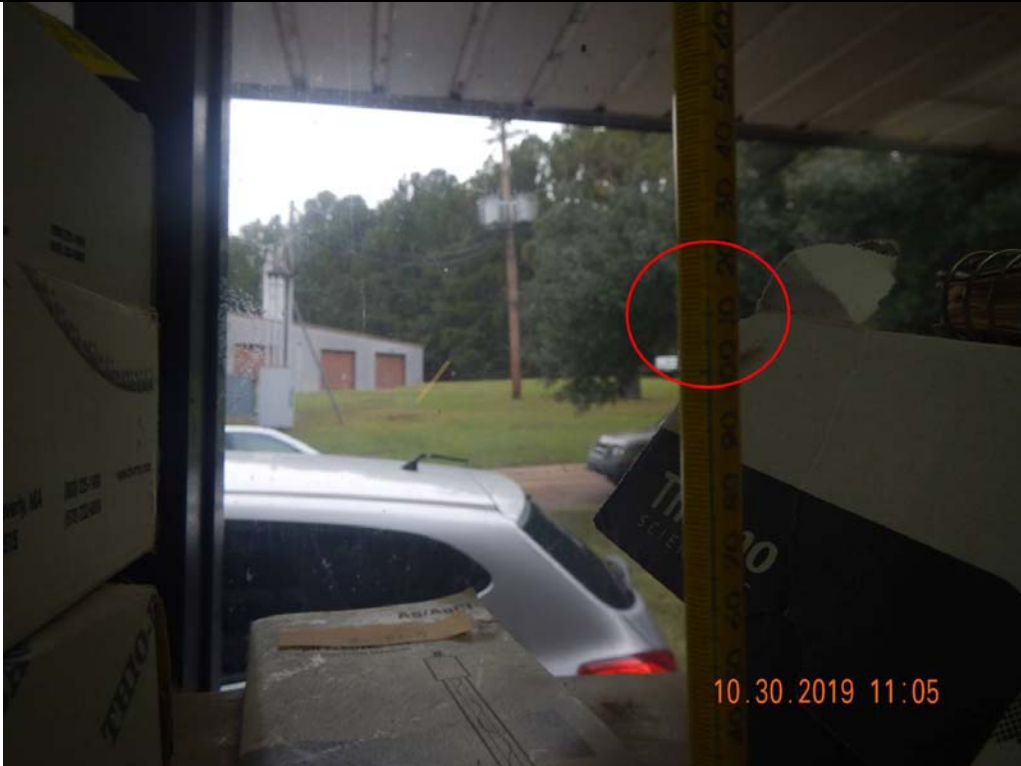
Location:	<b>Camden Water Utilities</b>		
Photographer:	<b>Michael Young</b>	Date:	<b>10/30/2019</b>
Time:	<b>11:05</b>	Witness:	
Photo #:	<b>31</b>	Description:	<b>Temperature of oven for TSS filters was 114° C at time of inspection.</b>

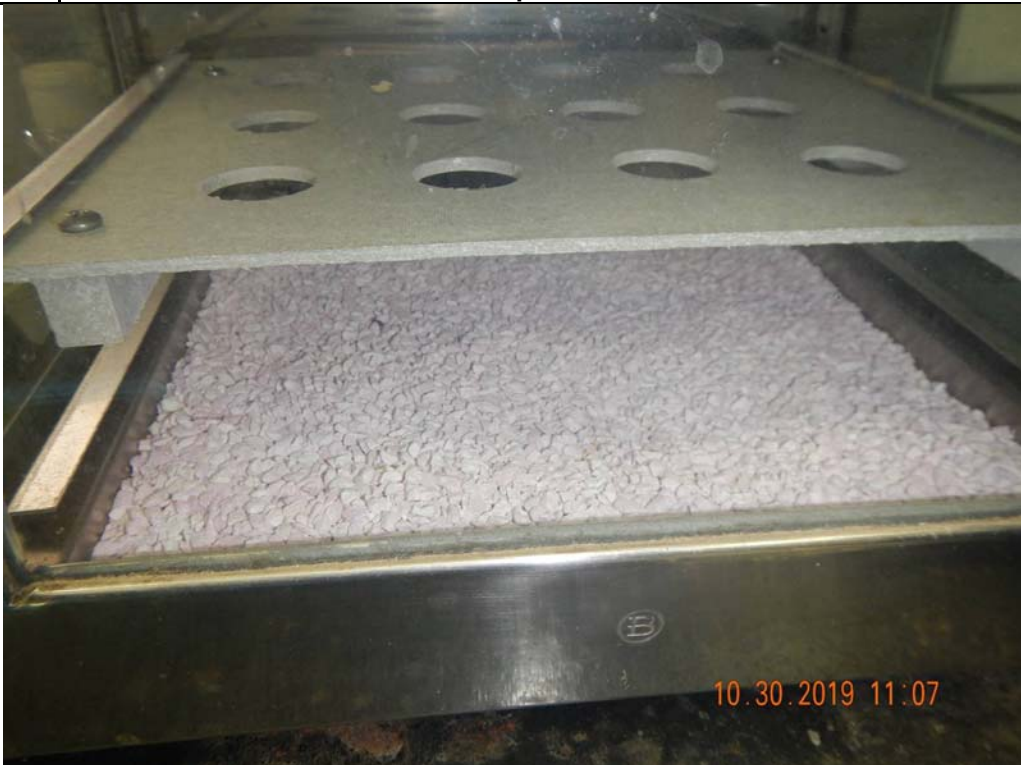
3. SATISFACTORY CALIBRATION AND MAINTENANCE OF INSTRUMENTS AND EQUIPMENT: <u>DO chamber not saturated; desiccant old</u>	<input type="checkbox"/> Y <input checked="" type="checkbox"/> N <input type="checkbox"/> NA <input type="checkbox"/> NE

Photographer:	<b>Michael Young</b>	Date:	<b>10/30/2019</b>
Time:	<b>11:07</b>	Witness:	
Photo #:	<b>32</b>	Description:	<b>Desiccant in the filter desiccator is pink/white.</b>

During Mr. Young's inspection of the WWTP Lab the desiccant in the desiccator was white and needed changing. Mrs. Strickland order new desiccant and replaced the old desiccant with new desiccant and noted to change the desiccant when it starts to turn colors.
