RE: Heber Springs WWTP Inspections (Cleburne Co)

AFIN: 12-00029 NPDES Permit No.: AR0022381

<u>'</u>	_						
^	RKANSAS ENVIRONMENTAL QUALITY	OFFICE OF WATER QUALITY INSPECTION REPORT						
		AFIN: 12-00029 PERMIT #: AR002238		2381		DATE:	7/7/2020	
		CC	DUNTY: 12 Clebu	rne	PDS:	#: 112973	•	MEDIA: WN
		GF	GPS LAT: 35.485717 LONG: -91.995			OCATION:	General	Area
	FACILITY INFORMAT	IN	SPEC	TION INFO	RMATIO	N		
	ber Springs WWTP			facility type: 1 - Municipal		ror id#: 89 S - State)	
	≀⊓on: 74 Bypass Road	FACILITY EVALUATION RATING 2 - Marginal		Co	CTION TYPE: mpliance	Evaluation		
He	ber Springs, AR 72543			· '	TRY TIME: 9:30	12:30		FFECTIVE DATE:
	RESPONSIBLE OFFIC	CIAL	-	17172020	3.00	12.00	1/1/2 PERMIT E	U19 EXPIRATION DATE:
	E: / TITLE							/2023
Paul Graham / General Manager				FAYETTEVILLE SHALE RELATED: N				
	ber Springs Water and Sewer Co	mmi	ission	FAYETTEVILLE SHALE VIOLATIONS: N				
MAILI	NG ADDRESS:			INSPECTION PARTICIPANTS				
	08 West Front Street			NAME/TITLE/PHONE/FAX/EMAIL/ETC.:

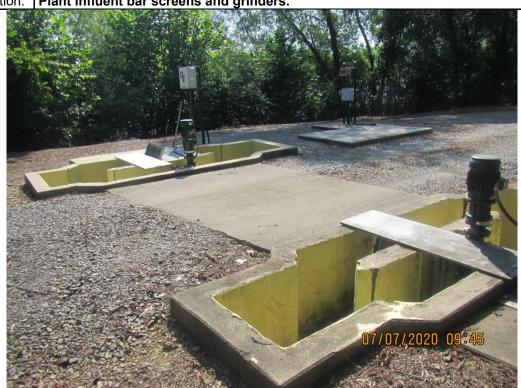
Office of Water Quality Photographic Evidence Sheet Location: Heber Springs WWTP Photographer: Travis Harmon Date: 7/7/2020 Time: 0945 Witness: None; no other regulatory personnel Photo #: 1 Description: Plant influent bar screens and grinders.

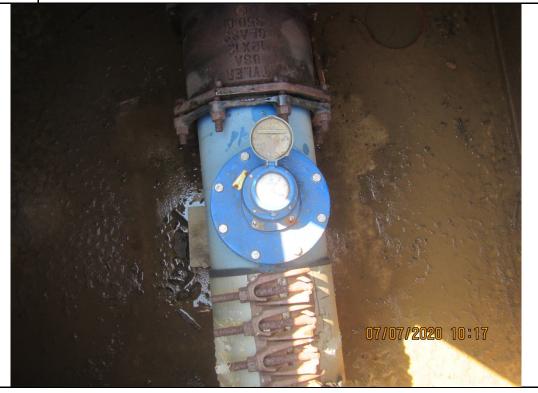
Photograp	her:	Travis Harmon	Date:	7/7/2020	Time:	1017
Witness:	None				Photo 7	# : 8

Description: In-line flowmeter.

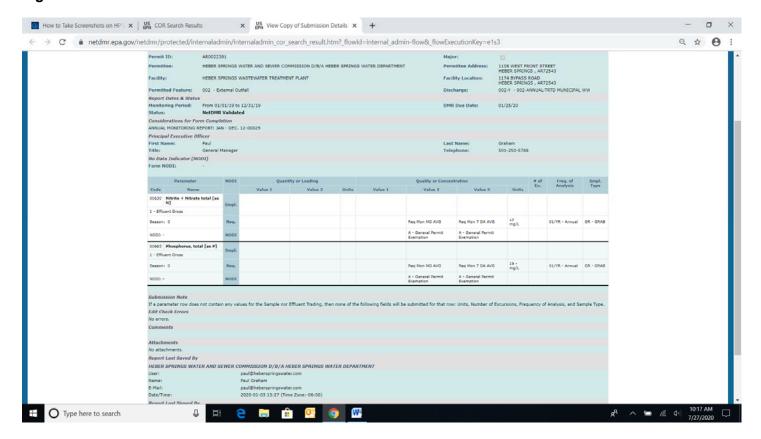
- 1. The 2019 annual DMR for TP/NO3+NO2-N does not include analysis results. This information is required in DMR per Part I.A1 of the permit. The facility provided TP/NO3+NO2-N analysis results for 2019 during the inspection. The facility must resubmit the 2019 DMR (002-Y) with the analysis results entered. TP/NO3+NO2-N do not have limits, but the results are required to be reported (see screenshot on Page 15 of 16 of this report).
- 2. At the time of inspection, an airline had a leak. This is a violation of Part III.B.1.A of the permit. The leak should be repaired when conditions allow. Also, some vegetation is established along the 3-cell lagoon. Please see Photos #3-4.

Figure 1. Screenshot of Outfall 002 2019 Annual TP/NO2+NO3-N DMR.

On August 14, 2020 I entered in the TP/NO3+NO2-N results into the NetDMR database and submitted them. The reason we did not have them on the 002-Y was that our permit had recently changed to not require testing for that and we were unaware that it still needed to be done once a year. We did have it done, but we did not report it on NetDMR. That has been corrected and we now know what we need to do going forward. See attached picture.

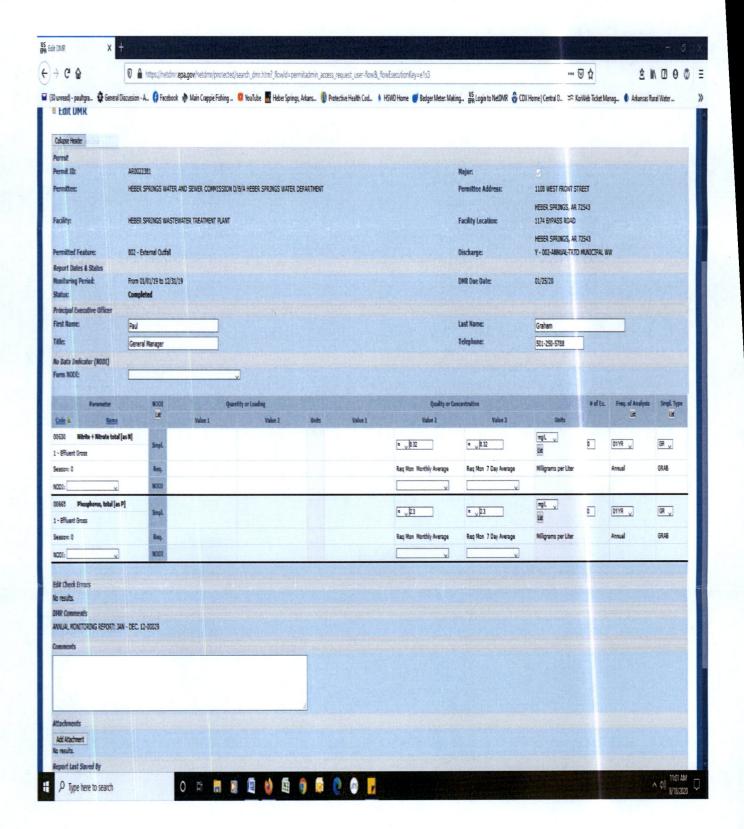
1. The readings were 0.32 for Nitrate, and 2.30 for Phosphorous. 8/14/20

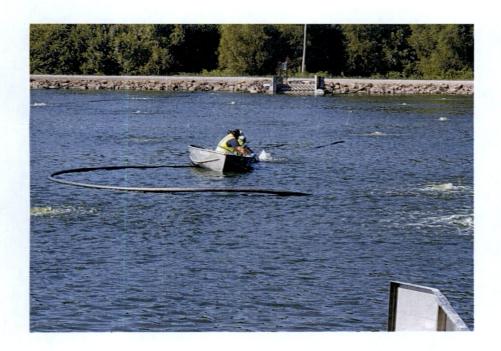
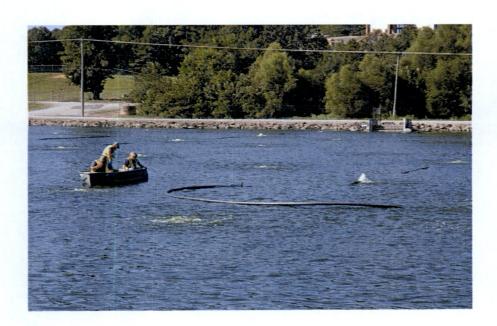
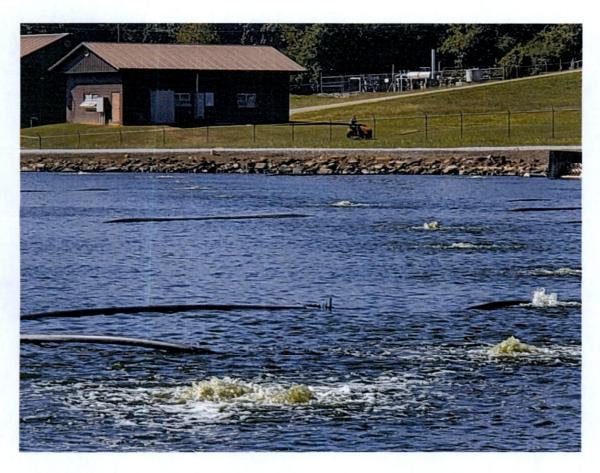
2. TREATMENT UNITS PROPERLY MAINTAINED: One airline joint loose or with hole, with spray to air.	□S ☑M □U □NA □NE
3. STANDBY POWER OR OTHER EQUIVALENT PROVIDED:	⊠S □M □U □NA □NE

2. A subsurface airline had a leak in it.

2 A. The crew repairing the broken airline in the lagoon. 8/18/20

Mr. Massey determined what parts were needed to fix the leak and he had it repaired on August 18, 2020. The crew used a full-circle repair clamp to repair the line. Please see attached pictures.

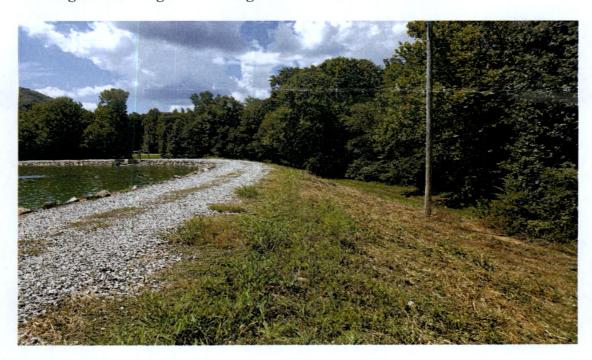
2B. Vegetation is established along the 3-cell lagoon.

2 B. Vegetation along the 3-cell lagoon has been removed. 8/18/20

On August 18, 2020, Mr. Massey cut and removed the vegetation. Please see attached picture.
