RE: Osceola WWTP Inspections

AFIN: 47-00956 Permit No.: AR0021580 and ARR000149

OFFICE OF WATER QUALITY INSPECTION REPORT

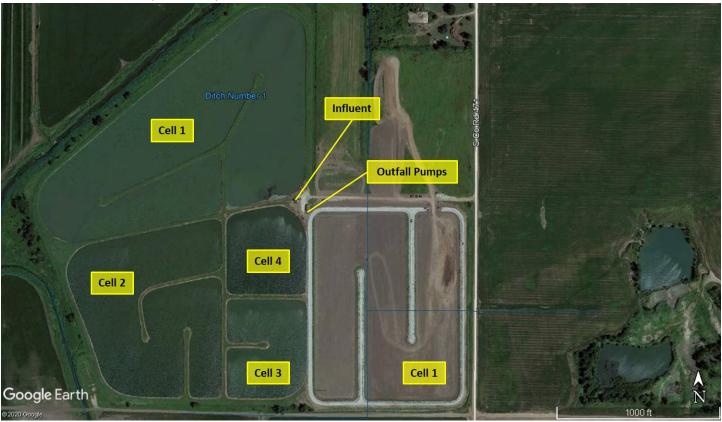
Figure 1. Google Earth image of the City of Osceola WWTP with labels for the different areas of treatment.

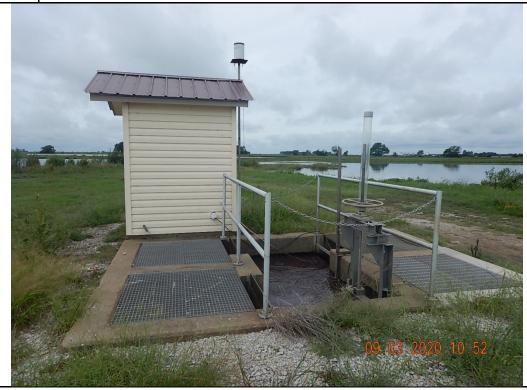
Office of Water Quality Photographic Evidence Sheet								
Location: Osceola WWTP								
Photographer: Sarah Frasher			Date:	09/03/2020	Time:	10:52		
Witness: None Photo #: 1								
Description	. 1	liow of the Influent Structure

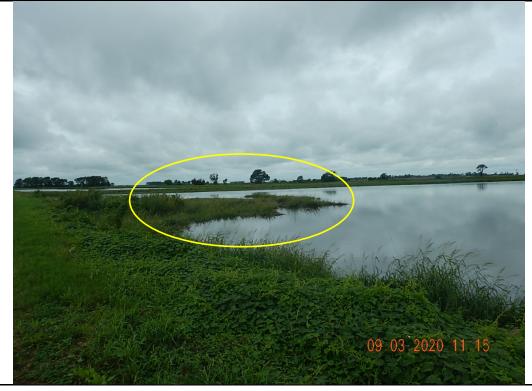
Photographer: Sarah Frasher Date: 09/03/2020 Time: 11:15
Witness: None Photo #: 2

An eroded portion was observed in Cell 1 (Photo 2) due to the construction process of the newly constructed cell addition. The operator, Brandon Haynes, stated that this area was to be corrected by the construction company soon.

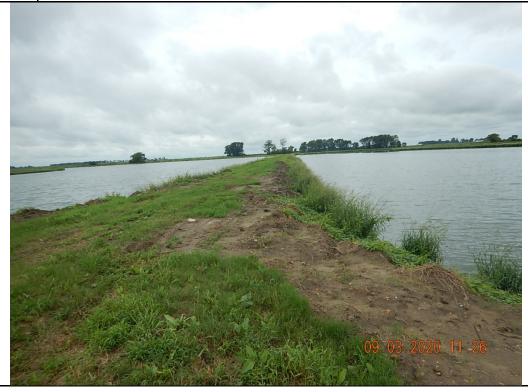
Office of Water Quality Photographic Evidence Sheet Location: Osceola WWTP Photographer: Sarah Frasher Date: 09/03/2020 Time: 11:26 Witness: None Photo #: 3

Description: View of the levee between Cell 1 and Cell 2.

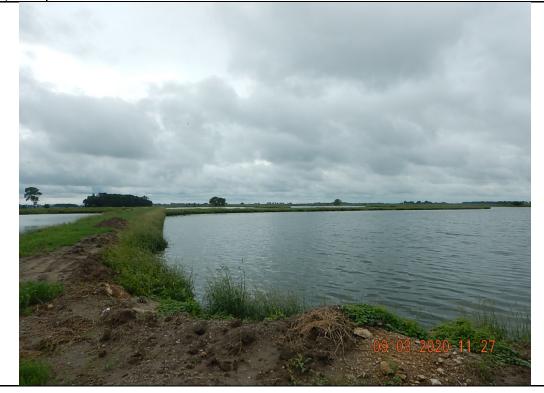
Photographer: Sarah Frasher	Date:	09/03/2020	Time:	11:27
Witness: None			Photo #:	4

Description: View of Cell 2.

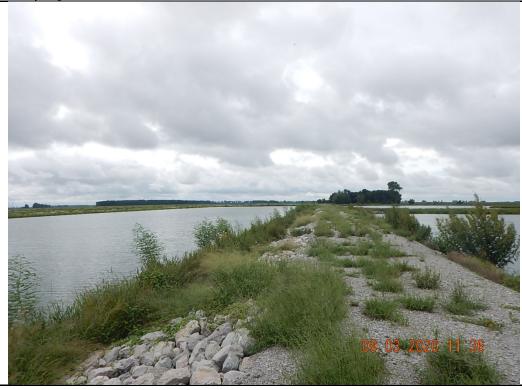
Witness:
 None
 Photo #:
 5

Vegetation was observed on the newly constructed levee dividing constructed Cell 1 from Cell 4 (Photo 5). The area was recently mowed 2 weeks ago according to Mr. Haynes and is scheduled to be mowed again soon.

Description:
 View of the newly constructed levee dividing the new Cell 1 from Cell 4. Note the vegetation.

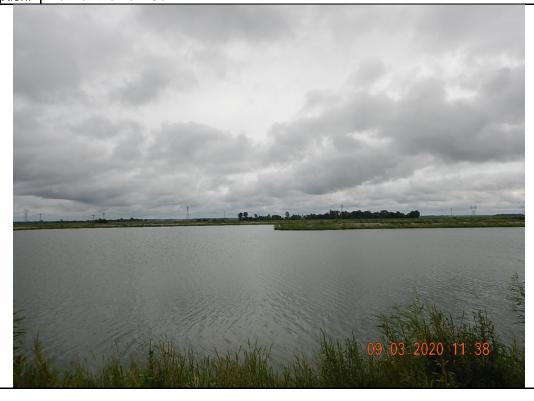
Photographer: Sarah Frasher	Date:	09/03/2020	Time:	11:38
Witness: None			Photo #:	6

Description: View of the new Cell 1.

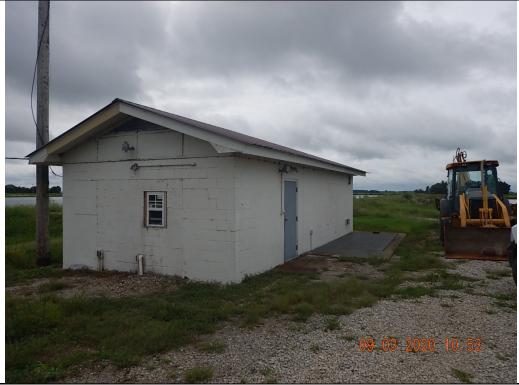
Office of Water Quality Photographic Evidence Sheet								
Location:	Osc	eola WWTP						
Photograp	her:	Sarah Frasher	Date:	09/03/2020	Time:	10:53		
Witness:	None				Photo #:	7

Description: View of the Outfall building.

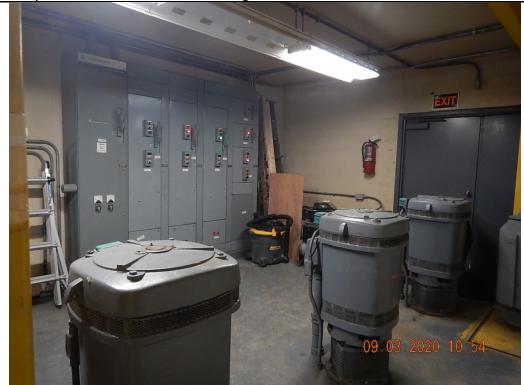
Photographer:	Sarah Frasher	Date:	09/03/2020	Time:	10:54
Witness: None			Photo #:	8

Description: View of the inside of the building.
