**RE:** City of El Dorado - South Plant Inspections (Union Co)

### OFFICE OF WATER QUALITY INSPECTION REPORT

Inspection Report: City of El Dorado - South Plant, AFIN: 70-00341, Permit #: AR0033723

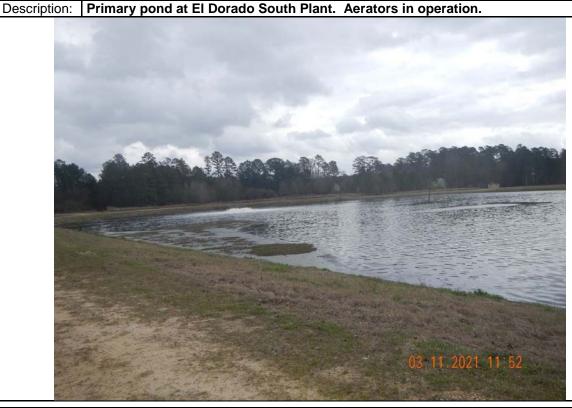
Office of Water Quality Photographic Evidence Sheet						
Location:	City	of El Dorado - South Plan				
Photograp	her:	Michael Young	Date:	03/11/2021	Time:	11:52
Witness:					Photo #:	1
Dagariation	- · F	who am a man at El Danada (	Describ Diamet Asses			•

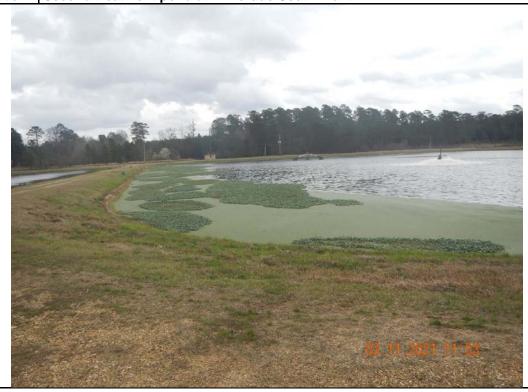
## Office of Water Quality Photographic Evidence Sheet Location: City of El Dorado - South Plan Photographer: Michael Young Date: 03/11/2021 Time: 11:53 Witness: Photo #: 3 Description: Second treatment pond at El Dorado South Plant.

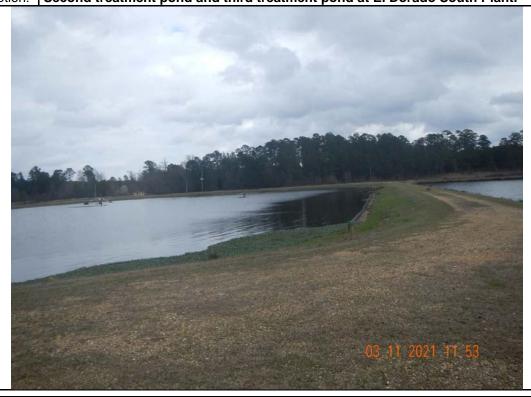
Office of Water Quality Photographic Evidence Sheet							
Location: C	City	of El Dorado - South Plan					
Photographe	er:	Michael Young	Date:	03/11/2021	Time:	11:53	
Witness: Photo #: 5							
Description:	Description:   Second treatment pond and third treatment pond at El Dorado South Plant.

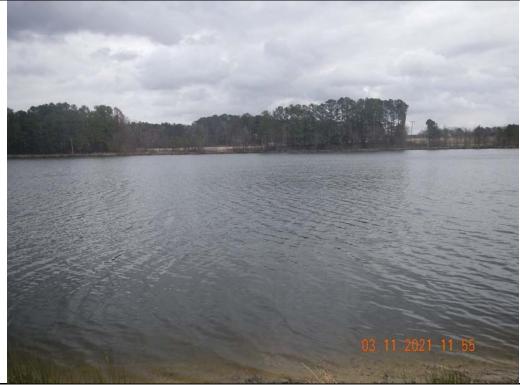
### City of El Dorado - South Plan Photographer: Michael Young Date: 03/11/2021 Time: 11:55 Witness: Photo #: 7

Description: Final treatment pond at El Dorado South Plant.

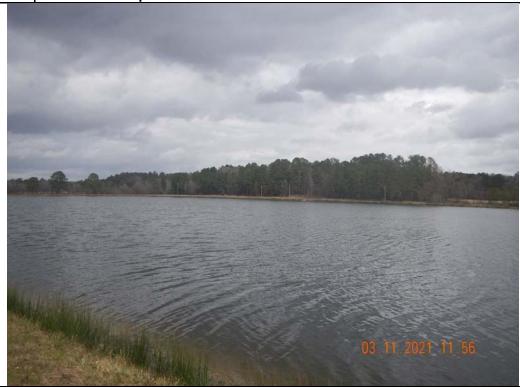
Photographer:	Michael Young	Date:	03/11/2021	Time:	11:56
Witness:				Photo #:	8

Description: Final treatment pond at El Dorado South Plant.

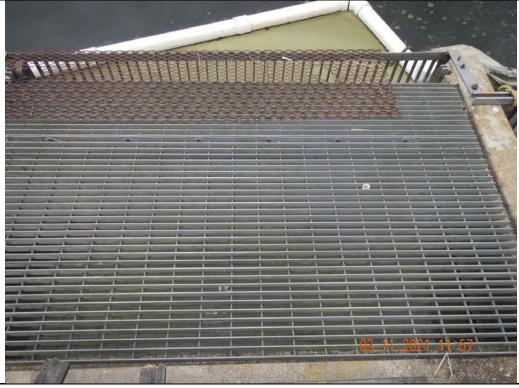
Office of Water Quality Photographic Evidence Sheet						
Location:	City	of El Dorado - South Plan				
Photograp	her:	Michael Young	Date:	03/11/2021	Time:	11:57
Witness:					Photo #	±: 9

Description: Discharge from final treatment pond to DAF units.

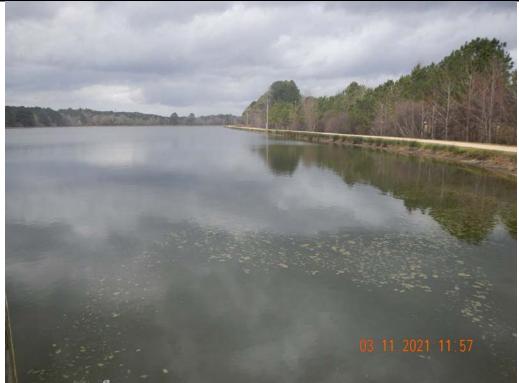
Photographer: Michael Young Date: 03/11/2021 Time: 11:57
Witness: Photo #: 10

Description: View of the entire final treatment pond at El Dorado South Plant.

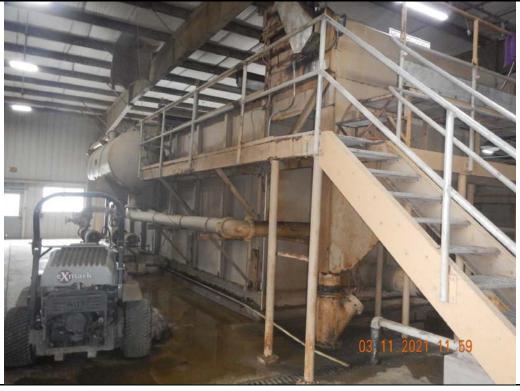
## City of El Dorado - South Plan Photographer: Michael Young Date: 03/11/2021 Time: 11:59 Witness: Photo #: 11

Description: DAF Unit #1 housed inside building.

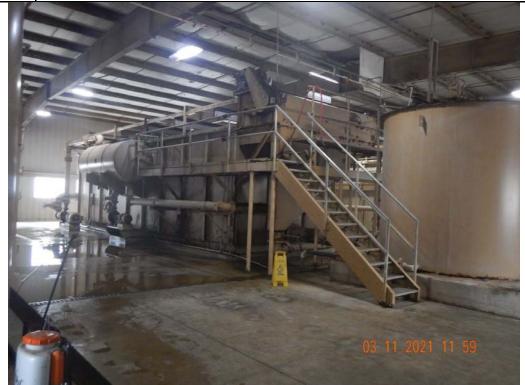
Photographer: Michael Young	Date:	03/11/2021	Time:	11:59
Witness:			Photo #:	12

Description: DAF Unit #2.

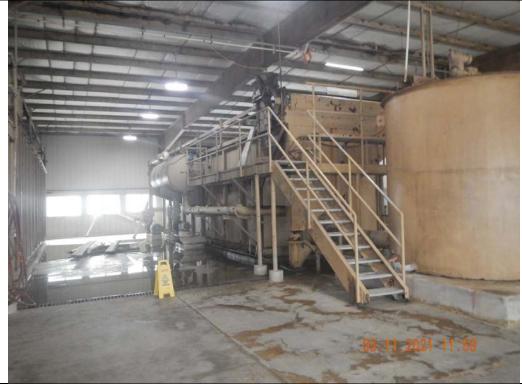
Office of Water Quality Photographic Evidence Sheet							
Location:	City	of El Dorado - South Plan					
Photograph	ner:	Michael Young	Date:	03/11/2021	Time:	11:59	
Witness:					Photo #	: 13

Description: DAF Unit #3. Units have finished operation at time of inspection.

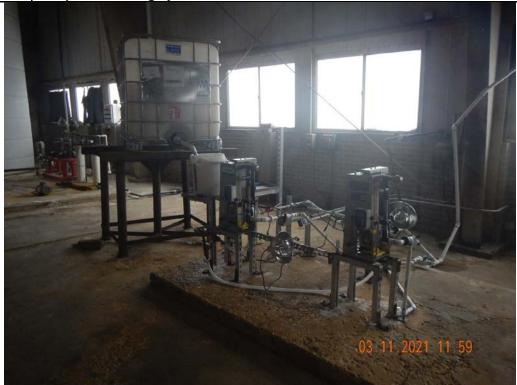
Photographer:	Michael Young	Date:	03/11/2021	Time:	11:59
Witness:				Photo #:	14

Description: Pumps and dosing system for additional chemicals.

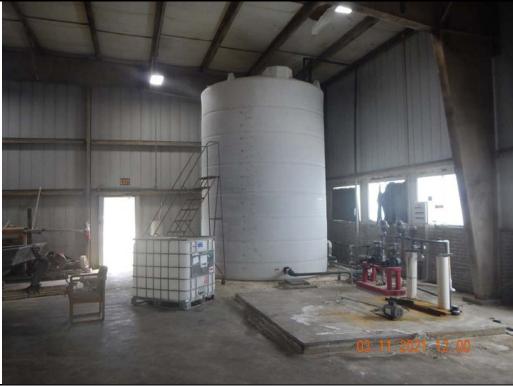
Office of Water Quality Photographic Evidence Sheet							
Location:	City	of El Dorado - South Plan					
Photograph	ner:	Michael Young	Date:	03/11/2021	Time:	12:00	
Witness:					Photo #:	15

Description: Storage for additional chemicals.

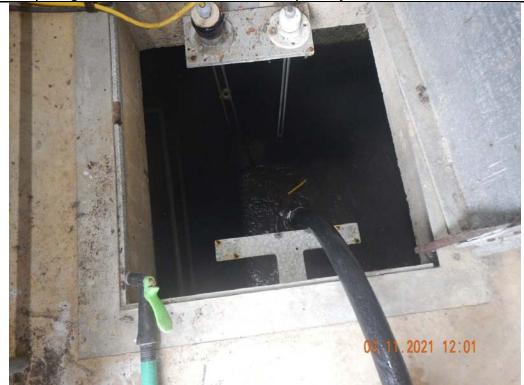
Photographer:	Michael Young	Date:	03/11/2021	Time:	12:01
Witness:				Photo #:	16

Description: Sludge return from the DAF units to the pond system.

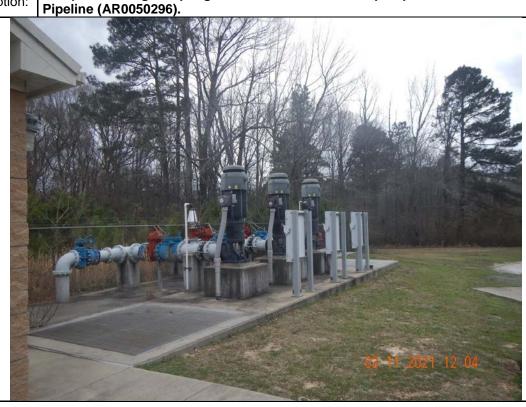
# City of El Dorado - South Plan Photographer: Michael Young Date: 03/11/2021 Time: 12:04 Witness: Pumps following sampling at Outfall 010S. Water is pumped to Ouachita Joint

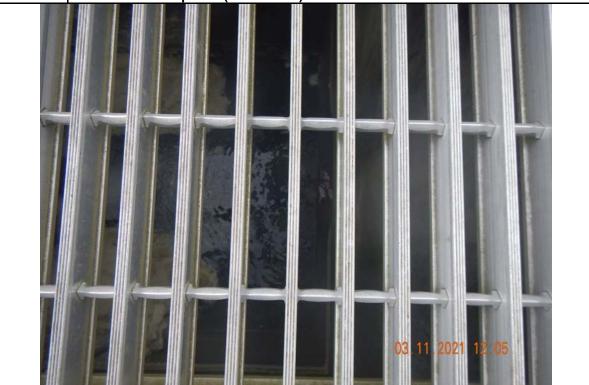
Photographer:	Michael Young	Date:	03/11/2021	Time:	12:05
Witness:				Photo #:	22

Description: Treated effluent following sampling at Outfall 010S and prior to pumping to the Ouachita Joint Pipeline (AR0050296).

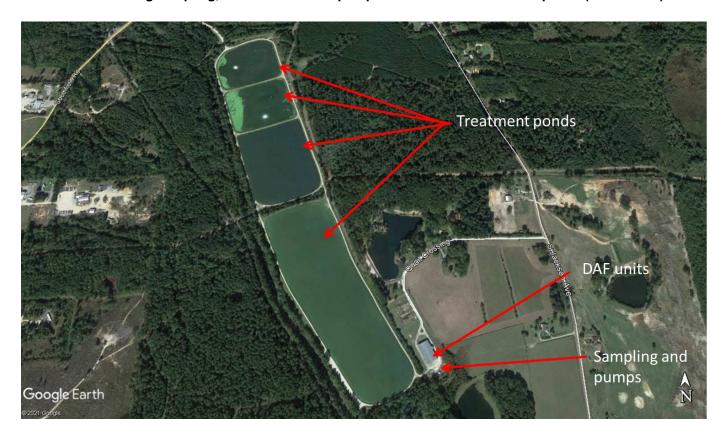
Figure 1. Overview of the City of El Dorado – South Plant treatment system with the different components identified. Following sampling, treated effluent is pumped to the Ouachita Joint Pipeline (AR0050296).
