RE: City of Hot Springs POTW Inspections (Garland Co)

AFIN: 26-00145 NPDES Permit No.: AR0033880

OFFICE OF WATER QUALITY INSPECTION REPORT

Inspection Report: City of Hot Springs POTW, AFIN: 26-00145, Permit #: AR0033880

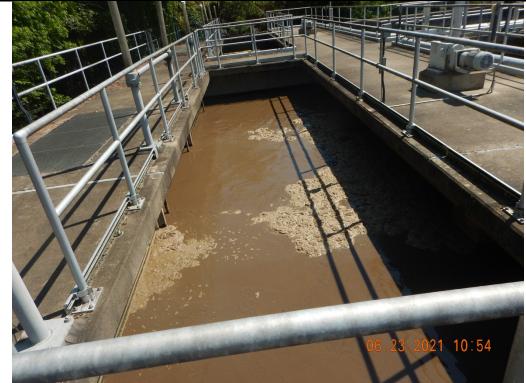
Photographer: Travis Harmon	Date:	6/23/2021	Time:	1054
Witness: None			Photo #:	6

Description: Three trains of aeration with sludge basin for RAS.

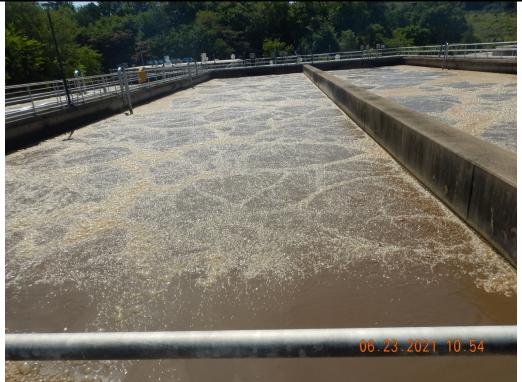
Office of Water Quality Photographic Evidence Sheet Location: City of Hot Springs POTW Photographer: Travis Harmon Date: 6/23/2021 Time: 1054 Witness: None Photo #: 7

Description: View of three aeration basins.

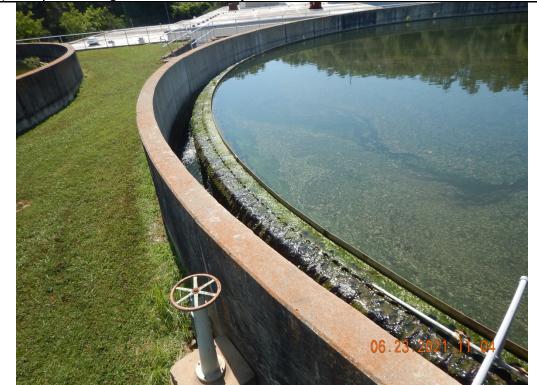
Photographer: Travis Harmon	Date: 6/23/20	D21 Time:	1104
Witness: None		Photo #:	8

- 2. I photographed excessive algae and vegetative growth in the secondary clarifiers and sand filters at the time of inspection. This is a violation of Part III.B.1.A of the permit. The facility is overloaded and currently a new filter system is being installed. Per operators, they need the new filter system on-line prior to washing down excess algae, which would disrupt treatment.

1. TREATMENT UNITS PROPERLY OPERATED:	⊠s □m □u □na □ne
2. TREATMENT UNITS PROPERLY MAINTAINED: <u>Excess algae in clarifiers and sand filters</u>	□S ☑M □U □NA □NE

Description: Excess algae in four secondary clarifiers.

Response: On July 19, 2021 Plant Operators removed the excessive algae and plant growth from

the secondary treatment and sand filters.

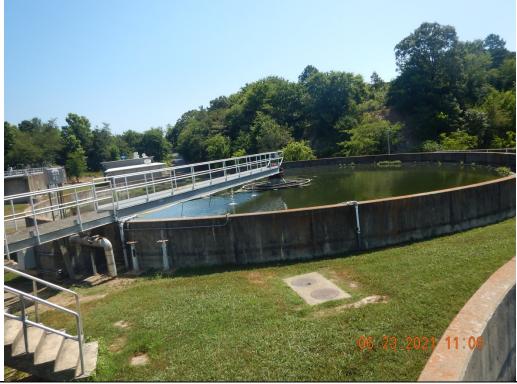
Office of Water Quality Photographic Evidence Sheet Location: City of Hot Springs POTW Photographer: Travis Harmon Date: 6/23/2021 Time: 1106 Witness: None Photo #: 9

Description: Vegetation needing removal at secondary clarifiers.

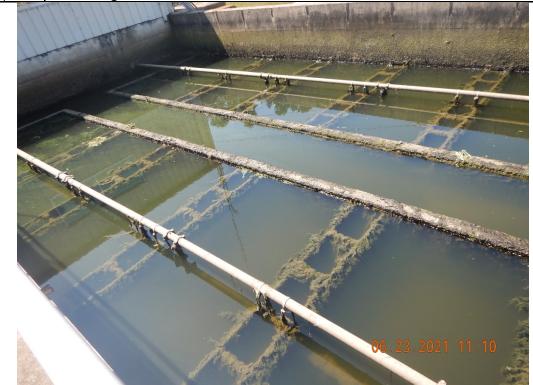
Photographer: Travis Harmon	Date:	6/23/2021	Time:	1110
Witness: None			Photo #:	10

Description: Excess algae in sand filters.

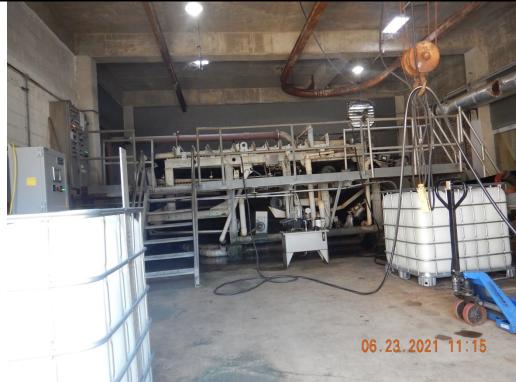
Office of Water Quality Photographic Evidence Sheet							
Location: City of Hot Springs POTW							
Photographer:	Travis Harmon	Date:	6/23/2021	Time:	1115		
Witness: None Photo #:

Description: Sludge belt press.

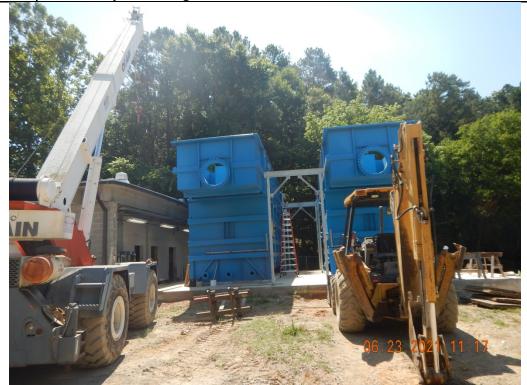
Witness None	Photograp	her:	Travis Harmon	Da	ate:	6/23/2021	Time:	1117
Witness. None	Witness:	None	!				Photo #	: 12

Description: New filter system being installed.

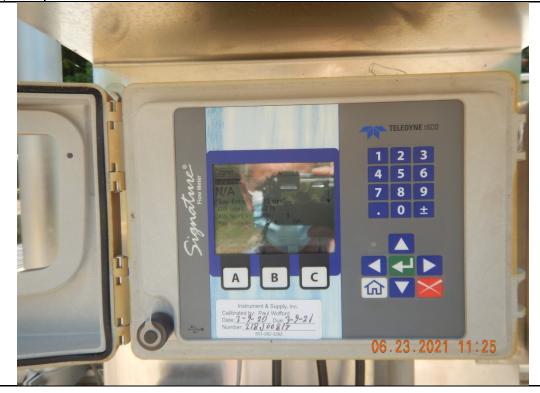
Photographer: Travis Harmon	Date:	6/23/2021	Time:	1125
Witness: None			Photo #:	16

- 3. The effluent flowmeter was last calibrated on March 9, 2020. This is a violation of Part III.C.2 of the permit. The Division requires an annual calibration of the effluent flowmeter, conducted by a qualified technician.

4. CALIBRATION FREQUENCY ADEQUATE: Last calibrated by qualified technician on March 9, 2020	□y ☑n □na □ne
5. RECORDS MAINTAINED OF CALIBRATION PROCEDURES:	☑Y □N □NA □NE

Description: Effluent flowmeter last calibrated March 20, 2020.

Response: The effluent flowmeter has be calibrated as of July 22, 2021 by Paul Wofford with

Instrument & Supply.

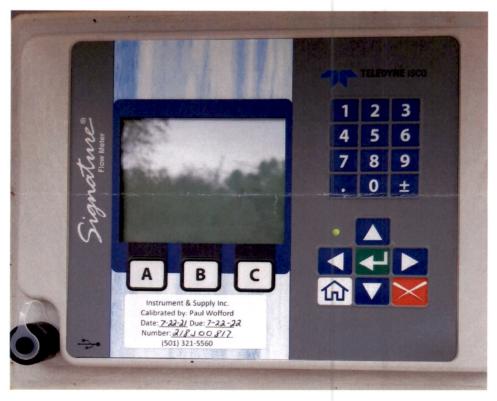
Effluent Meter Calibration July 22, 2021 Instrument & Supply Paul Wofford
