RE: Boyd Point WWTF Inspection (Jefferson Co)

AFIN: 35-00149 NPDES Permit No.: AR0033316

OFFICE OF WATER QUALITY INSPECTION REPORT

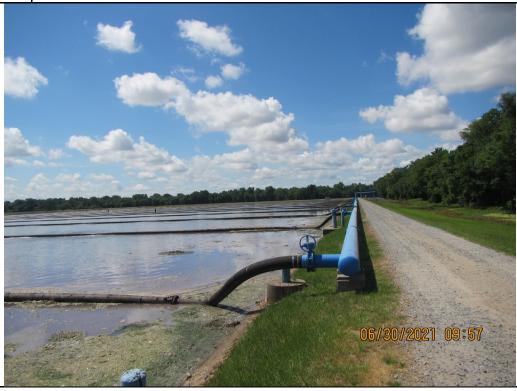
Office of Water Quality Photographic Evidence Sheet											
Location:	Location: Boyd Point WWTF										
Photograp	Photographer: Brittanie Gloyd			06/30/2021	Time:	09:57					
Witness:	Nitness: Kerri McCabe; Trey Butler; Aaron Baggett Photo #: 1										
Description	n. (verview of the North Aeratio	n Pond.

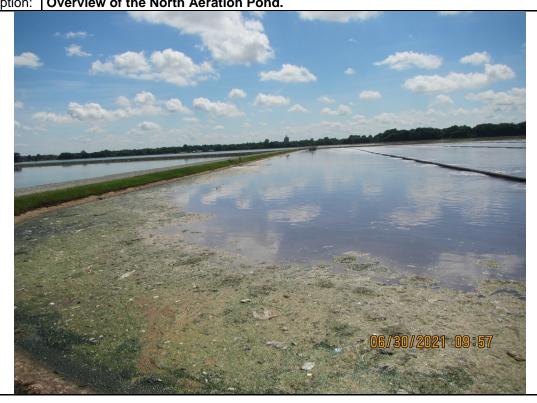
Witness:
 Kerri McCabe; Trey Butler; Aaron Baggett
 Photo #:
 2

Description:
 Overview of the North Aeration Pond.

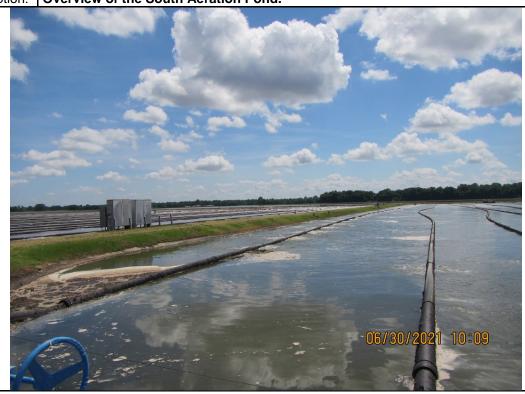
Office of Water Quality Photographic Evidence Sheet Location: Boyd Point WWTF Photographer: Brittanie Gloyd Date: 06/30/2021 Time: 10:09 Witness: Kerri McCabe; Trey Butler; Aaron Baggett Photo #: 3 Description: Overview of the South Aeration Pond.

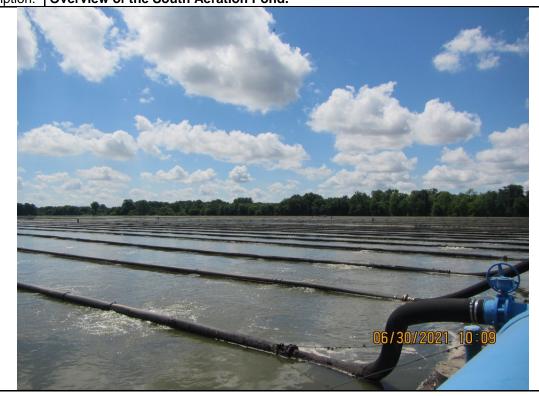
Photogra	pher:	Brittanie Gloyd	Date:	06/30/2021	Time:	10:09
Witness:	Kerri	i McCabe; Trey Butler; Aaron Baggett			Photo #	: 4
Description	n. (Overview of the South Aeration Pond		_

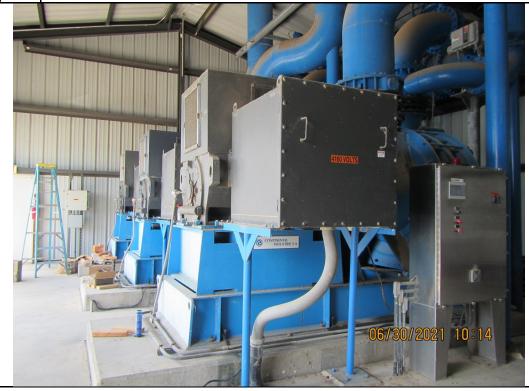
Office of Water Quality Photographic Evidence Sheet Location: Boyd Point WWTF Photographer: Brittanie Gloyd Date: 06/30/2021 Time: 10:14 Witness: Kerri McCabe; Trey Butler; Aaron Baggett Photo #: 5 Description: View of the blowers.

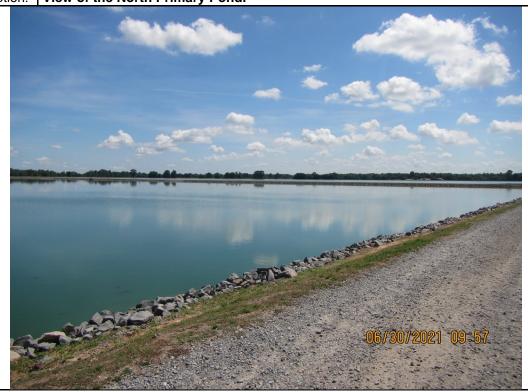
Cocation: Boyd Point WWTF Photographer: Brittanie Gloyd Date: 06/30/2021 Time: 09:57 Witness: Kerri McCabe; Trey Butler; Aaron Baggett Photo #: 7 Description: View of the North Primary Pond.

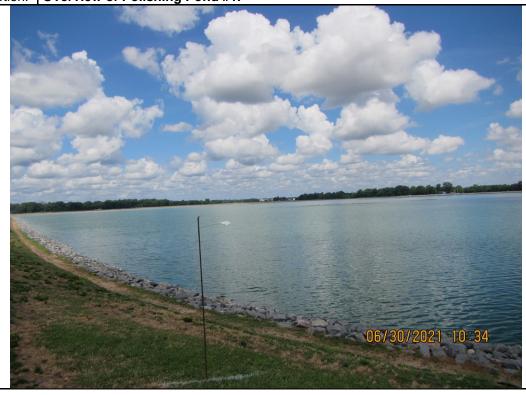
Cocation: Boyd Point WWTF Photographer: Brittanie Gloyd Date: 06/30/2021 Time: 10:34 Witness: Kerri McCabe; Trey Butler; Aaron Baggett Photo #: 9 Description: Overview of Polishing Pond #1.

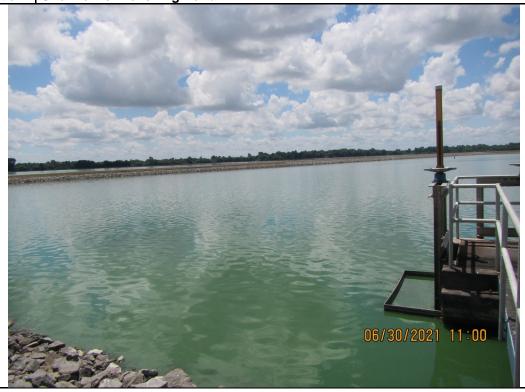
Cocation: Boyd Point WWTF Photographer: Brittanie Gloyd Date: 06/30/2021 Time: 11:00 Witness: Kerri McCabe; Trey Butler; Aaron Baggett Photo#: 00/201 Description: Overview of Polishing Pond #2.
