RE: City of Marion Inspection

AFIN: 18-00110 Permit No.: AR0021971 and ARR000189

OFFICE OF WATER QUALITY INSPECTION REPORT

AFIN: **18-00110** PERMIT #: **AR0021971** DATE: **9/8/2022**

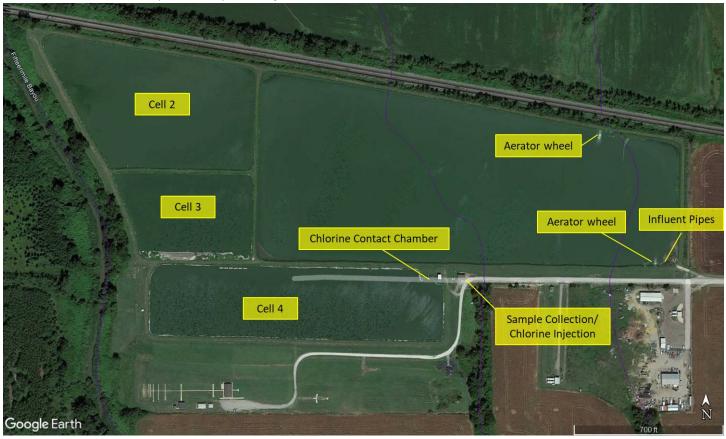
Figure 1. Google Earth image of the City of Marion POTW with labels for the different areas of treatment.

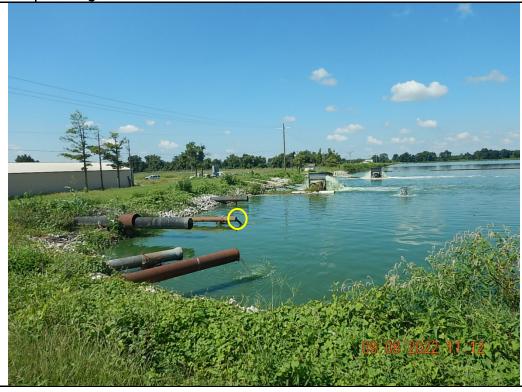
Photogra	pher: Sarah Frasher	Date:	None	Time:	11:17
Witness:	None			Photo #:	2

- 2) A dark influent discharge was observed at the influent pipe of the plant (Photos 1-2). This discharge is not allowed since it could affect the health of the plant and the source must be discovered in violation of Part II, Item 7 of the permit. Please provide any information on this discharge including but not limited to the source, how it was ceased, and any possible affects to the POTW.

Description: View of the influent pipe. Note the dark discharge and discolored water.

- 2. We have investigated the two industries that discharge inro that pumping station. Both have good programs that are following the rules of the permit. We did not find any violations however we have not seen that type of discharge since. We are doing monthly visits to both places.

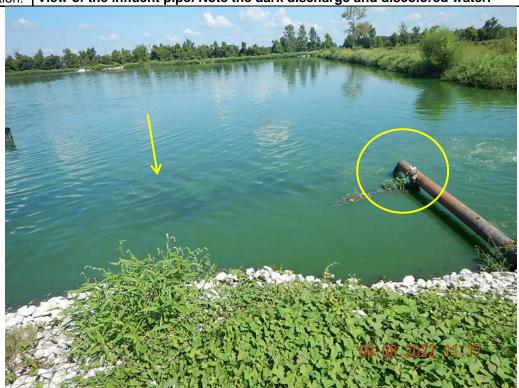
City of Marion Photographer: Sarah Frasher Witness: None Office of Water Quality Photographic Evidence Sheet Date: 9/8/2022 Time: 11:13 Photo #: 3

- 3) The following are in violation of Part III, Section B.1.a of the permit for Improper Operation and Maintenance:
 - (1) Deposited sediment was observed near the aeration wheel (Photo 3)

Description: View of the aerator wheel. Note the deposited sediment near the wheel.

- 3. 1. We have made adjustments with the aeration and have gotten this deposit cleaned up.
 - 2. We have moved and weeded the lagoon and will continue good housekeeping going forward.

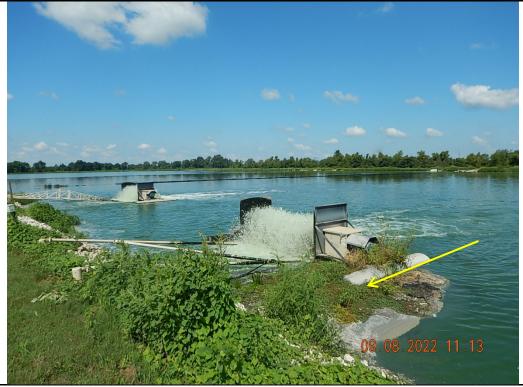
Photographer:	Sarah Frasher	Date:	9/8/2022	Time:	11:14
Witness: None)			Photo #:	4

- (2) High vegetation was observed on lagoon levees (Photos 4-6).
 - (3) Algae was observed in the chlorine contact chamber (Photo 12)
- 4) The facility reported on the July 2022 DMR 456 col/100 mL instead of 43 col/100 mL and 1,676 col/100 mL instead of 1,034 col/100 mL for the 7-day average due to not using the geometric mean for calculations. The facility should examine past DMRs and make proper corrections.

Description: View of Cell 1. Note the high vegetation.

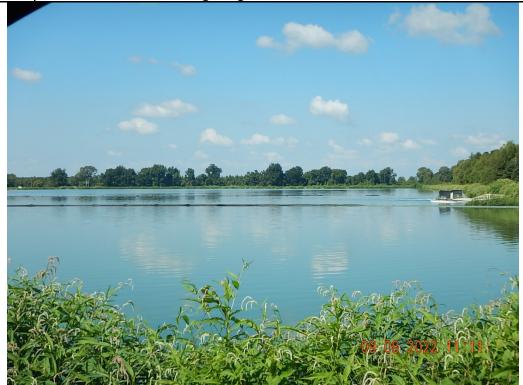
City of Marion Photographer: Sarah Frasher Witness: None Office of Water Quality Photographic Evidence Sheet Date: 9/8/2022 Time: 11:10 Photo #: 5

Description: View of the aerator wheel. Note the vegetation.

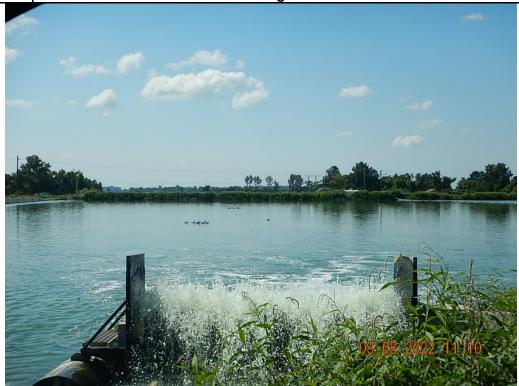
Photographer: Sarah Frasher	Date:	9/8/2022	Time:	11:09
Witness: None			Photo #:	6

Description: View of the baffle curtain dividing the cells. Note the vegetation.

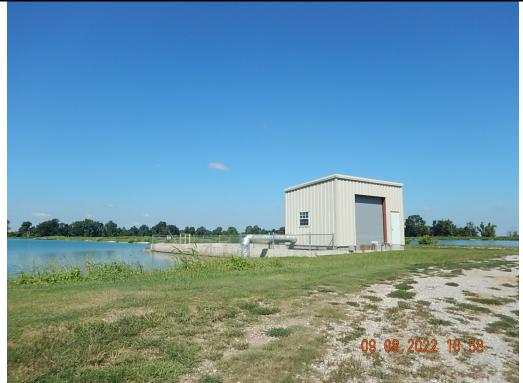
Office of Water Quality Photographic Evidence Sheet						
Location: Ci	ty of Marion					
Photographer	: Sarah Frasher	Date:	9/8/2022	Time:	10:52	
Witness: No	Witness: None Photo #: 9					
Description:	View of Cell 4.

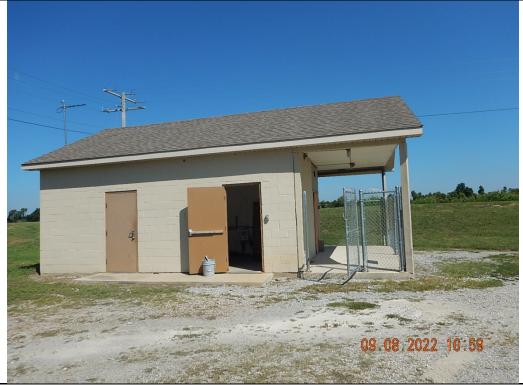
Photographer: Sarah Frasher Date: 9/8/2022 Time: 10:17
Witness: None Photo #: 14

Description: View of the chlorine injection.

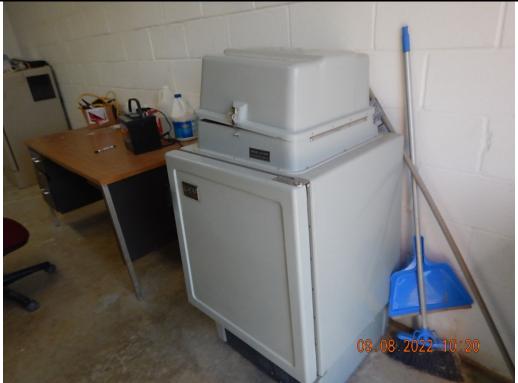
Office of Water Quality Photographic Evidence Sheet Location: City of Marion Photographer: Sarah Frasher Date: 9/8/2022 Time: 10:20 Witness: None Photo #: 17

Description: View of the inside of the sampler.

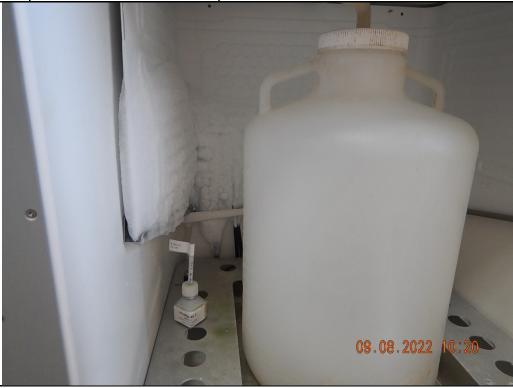
Photographer:	Sarah Frasher	Date:	9/8/2022	Time:	10:22
Witness: None			Photo #:	18

View of the inside of the sample building. Note the electrical controls for the pumps Description:

and the flowmeter.
