RE: Hot Springs - Davidson WWTP Inspections (Garland Co)

AFIN: 26-00145 NPDES Permit No.: AR0033880

OFFICE OF WATER QUALITY INSPECTION REPORT

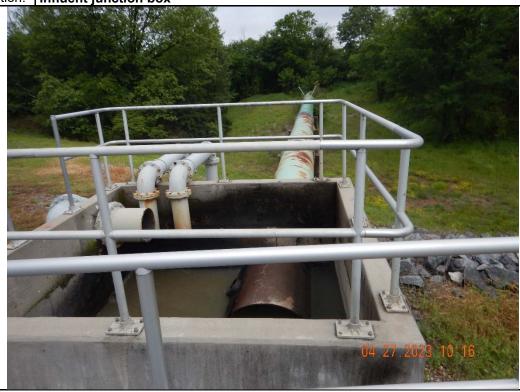
Office of Water Quality Photographic Evidence Sheet						
Location:	Hot	Springs - Davidson WWT	Р			
Photograpl	her:	Travis Harmon	Date:	April 27, 2023	Time:	1016
Witness: I	None	e- no other regulatory pers	sonnel		Photo #	: 1
Description	ı. İr	offuent junction box

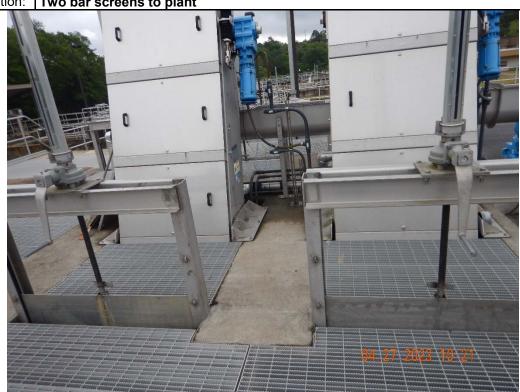
Office of Water Quality Photographic Evidence Sheet Location: Hot Springs - Davidson WWTP Photographer: Travis Harmon Date: April 27, 2023 Time: 1021 Witness: None Photo #: 3 Description: Two bar screens to plant

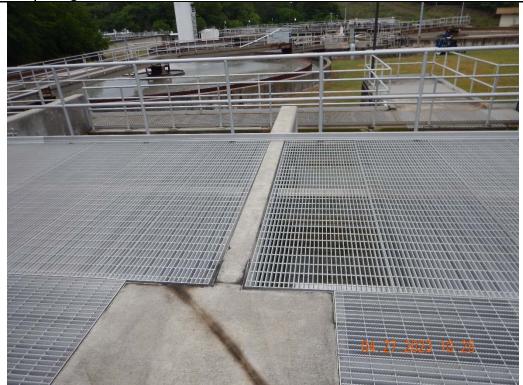
Photographer: Travis Harmon	Date: April 27, 2023	Time:	1025
Witness: None		Photo #:	4

Description: Two grit chambers

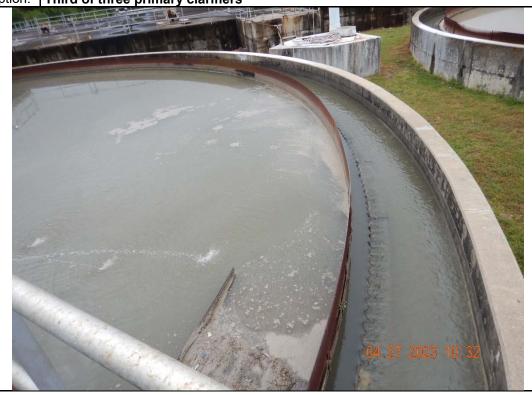
Office of Water Quality Photographic Evidence Sheet Location: Hot Springs - Davidson WWTP Photographer: Travis Harmon Date: April 27, 2023 Time: 1032 Witness: None Photo #: 9 Description: Third of three primary clarifiers

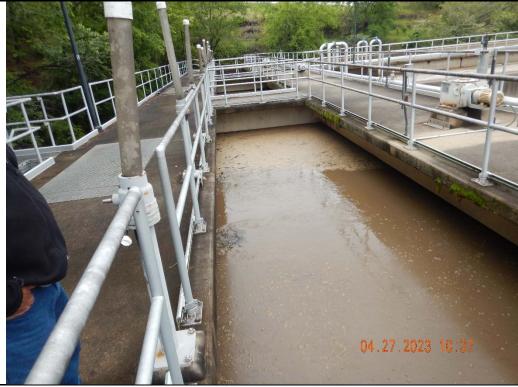
Office of Water Quality Photographic Evidence Sheet						
Location:	Hot	Springs - Davidson WWTP				
Photograp	her:	Travis Harmon	Date:	April 27, 2023	Time:	1037
Witness:	None				Photo #	: 11

Description: Three chamber aeration with view of RAS tank.

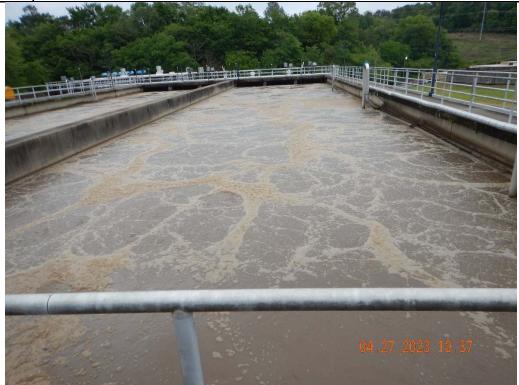
Photographer: Travis Harmon	Date: April 27, 2023	Time:	1037
Witness: None		Photo #	: 12

Description: First aeration tank

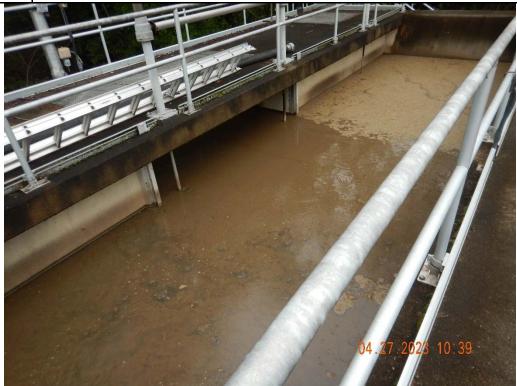
Office of Water Quality Photographic Evidence Sheet Location: Hot Springs - Davidson WWTP Photographer: Travis Harmon Date: April 27, 2023 Time: 1039 Witness: None Photo #: 15 Description: Third RAS tank

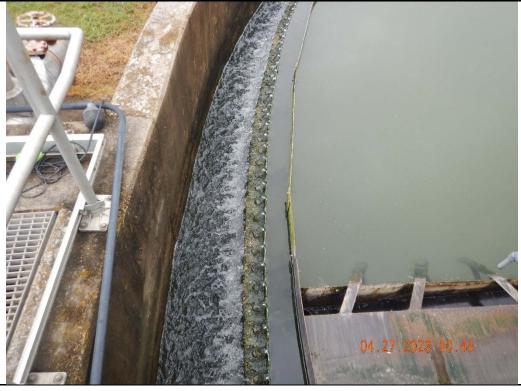
Description: First of four secondary clarifiers with effluent shown.

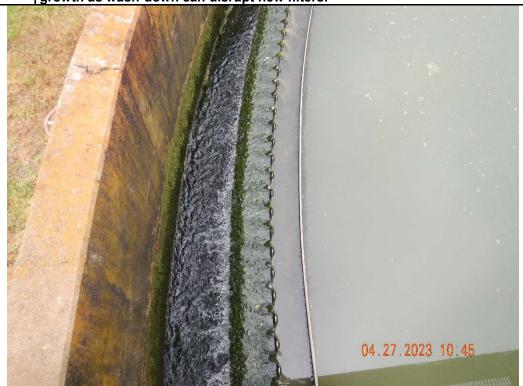
Photographer: Travis Harmon	Date: April 27, 2023	Time:	1045
Witness: None		Photo #	±: 18

Description: Second secondary clarifier. Facility is considering weir covers to prevent algae growth as wash-down can disrupt new filters.

I inspected the plant starting at the headworks and ending at the final effluent. I then inspected the equalization basin. Treatment consists of two bar screens, two grit chambers, three primary clarifiers (one of which was down for maintenance), three-chamber aeration, four secondary clarifiers, two disc filters with cascade post-aeration, and UV disinfection. Sludge is pressed and loaded for transport to a composting facility. The WWTP also operates an equalization basin for high flows with an emergency bar screen operated near the headworks. I found no violations concerning the WWTP during the inspection. The facility should monitor and seal any seeps in the walls of the primary clarifiers as well as monitor burrowing activity. During the inspection, Mr. Yates reported the facility is considering purchasing weir covers for the secondary clarifiers to prevent excessive algae accumulation. He reported that wash down of the algae disrupts the new disc filters.

4. PLANT RECORDS INCLUDE SCHEDULES, DATES OF EQUIPMENT MAINTENANCE AND REPAIR:	□S □M □U □NA ☑NE
5. EFFLUENT LOADINGS CALCULATED USING DAILY EFFLUENT FLOW AND DAILY ANALYTICAL DATA:	⊠y □n □na □ne
SECTION C: OPERATIONS AND MAINTENANCE	
TREATMENT FACILITY PROPERLY OPERATED AND MAINTAINED	☑S □M □U □NA □NE
DETAILS: See narrative regarding clarifier weir algae

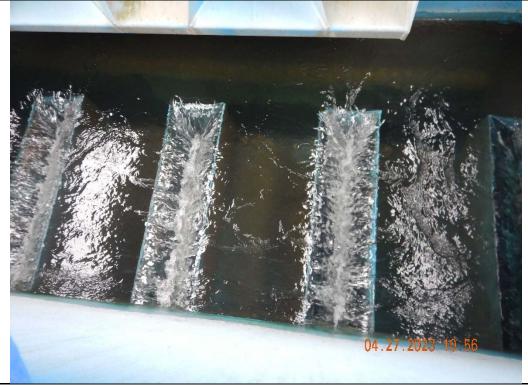
Office of Water Quality Photographic Evidence Sheet						
Location:	Hot	Springs - Davidson WWTP				
Photograp	her:	Travis Harmon	Date:	April 27, 2023	Time:	1056
Witness:	None		•		Photo #	# : 23

Description: Second disc filter effluent

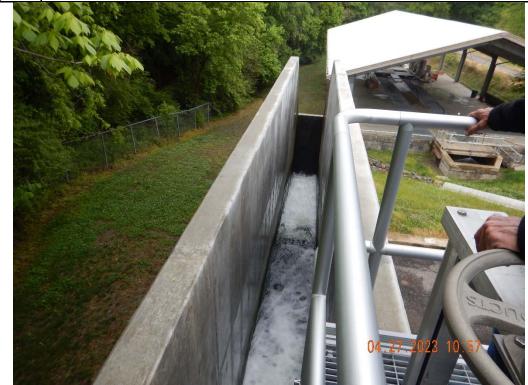
Photographer: Travis Harmon	Date: April 27, 2023	Time:	1057
Witness: None		Photo #	: 24

Description: Disc filter effluent from both with cascade aeration

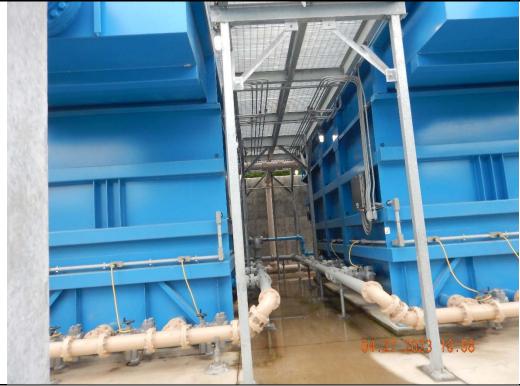
Description: View of disc filter housing

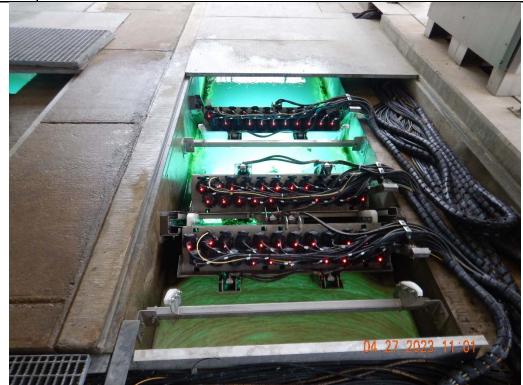
Photographer: Travis Harmon	Date: April 27, 2023	Time:	1101
Witness: None		Photo #:	26

Description: Two lines of UV disinfection

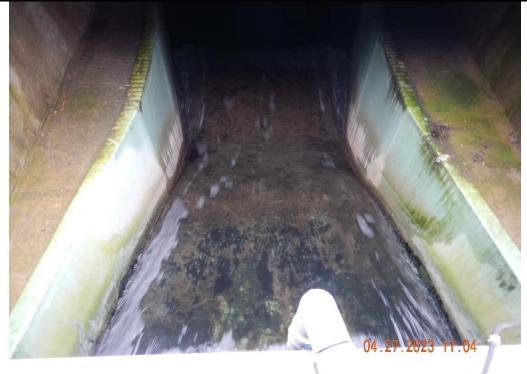
Office of Water Quality Photographic Evidence Sheet Location: Hot Springs - Davidson WWTP Photographer: Travis Harmon Date: April 27, 2023 Time: 1104 Witness: None Photo #: 27

Description: View of final effluent at flume

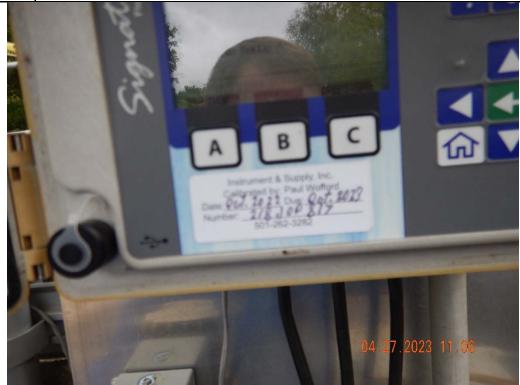
Photographer: Travis Harmon	Date:	April 27, 2023	Time:	1106
Witness: None			Photo #:	28

Description: Flowmeter calibrated October 2022

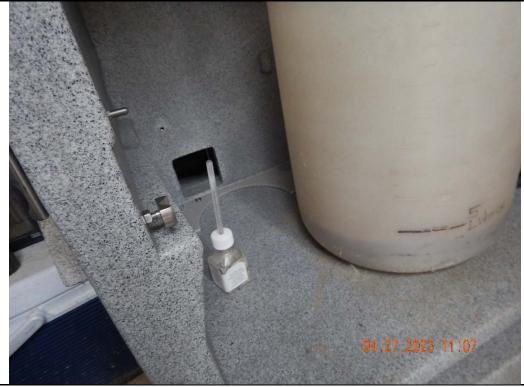
Office of Water Quality Photographic Evidence Sheet							
Location:	Hot	Springs - Davidson WWTP					
Photograp	her:	Travis Harmon	Date	: 7	April 27, 2023	Time:	1107
Witness:	None					Photo #	: 29

Description: Composite sampler with thermometer

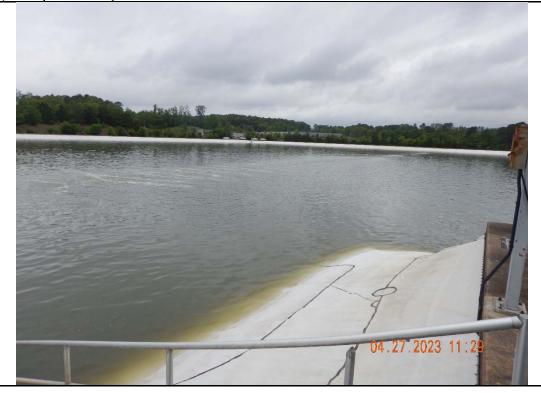
Photographer: Travis Harmon	Date: April 27, 2023	Time:	1129
Witness: None		Photo #	±: 30

Description: View of equalization basin
