OFFICE OF WATER QUALITY INSPECTION REPORT

AFIN: 47-00956 | PERMIT #: AR0021580 | DATE: 9/29/2022

GPS LAT: 35.679585 LONG: -90.038580 LOCATION: Entrance							
	FACILITY INFORMAT	ION		INSPECTION INFORMATION				
NAME: Osceola WWTP LOCATION:			1 - Municipal Inspector ID#: 112347 S - State					
~1.	~1.27 miles W. Keiser			FACILITY EVALUATION RATING: INSPECTION TY SSO/Co			Collection System	
	ceola			\ /	RY TIME:		12:14	PERMIT EFFECTIVE DATE:
	RESPONSIBLE OFFIC	CIAL		0/20/2022	,.41		12.17	10/1/2016 PERMIT EXPIRATION DATE:
	E Harris, Jr. / Mayor							9/30/2021
COME	PANY:			FAYETTEVILLE SHALE RELATED: N				
	y of Osceola			FAYETTEVILLE SHALE VIOLATIONS: N

SUMMARY OF FINDINGS

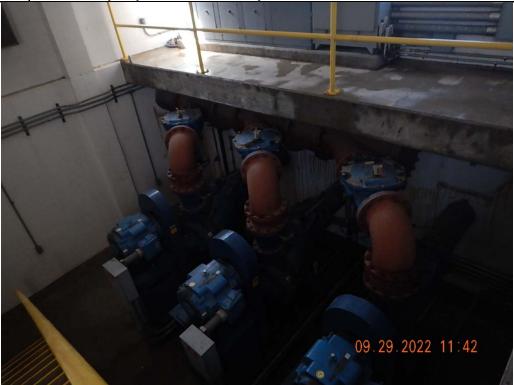
Photographer:	Sarah Frasher	Date:	9/29/2022	Time:	11:42
Witness: None				Photo #	: 2

The Pump Stations inspected were recently cleaned on the inside (Photos 2 and 5).

Description: View of the pumps in the Main Pump Station.

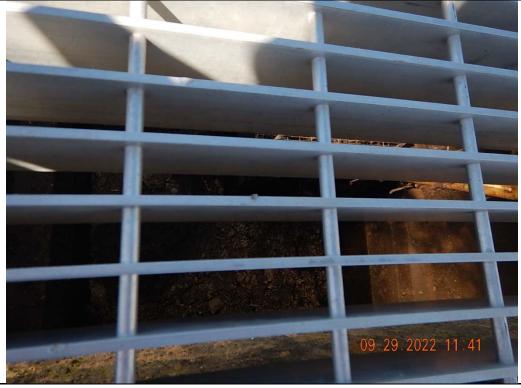
Office of Water Quality Photographic Evidence Sheet Location: Osceola WWTP Photographer: Sarah Frasher Date: 9/29/2022 Time: 11:41 Witness: None Photo #: 3

The wet wells to both pump stations inspected were observed to have a high accumulation of grease/solids in violation of Part III, Section B.1.a of the permit. These wet wells were scheduled to be cleaned by the Operator. Please provide an update with your response.

Description: View of the wet well to the Main Pump Station.

This is a written response pertaining to the SSO/ Collection system inspection conducted on September 29,2022. The findings were an accumulation of grease/solids in the wet well area. This particular day was in between cleanings and the problem area was taken care of and cleaned the following week. All of our collection system is regularly inspected and cleaned appropriately.

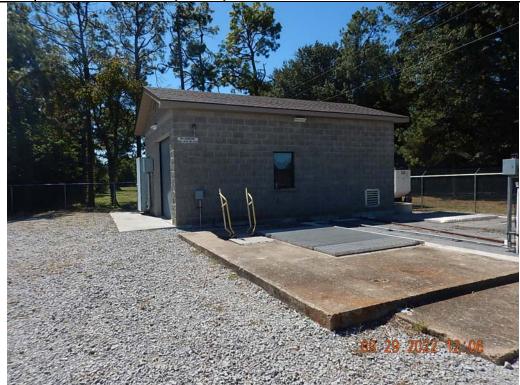
Photographer:Sarah FrasherDate:9/29/2022Time:12:06Witness:NonePhoto #:4

Description: Overview of the Phillips Pump Station.

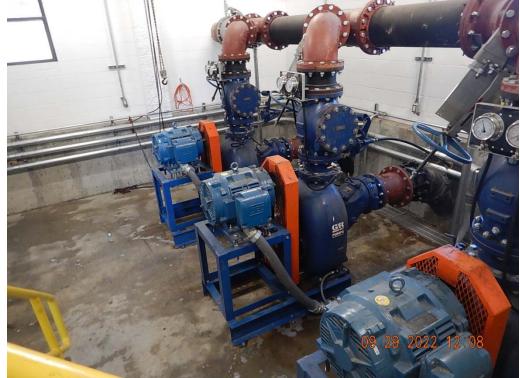
Description: View of the inside of the Phillips Pump Station. Note the cleanliness of the floor.

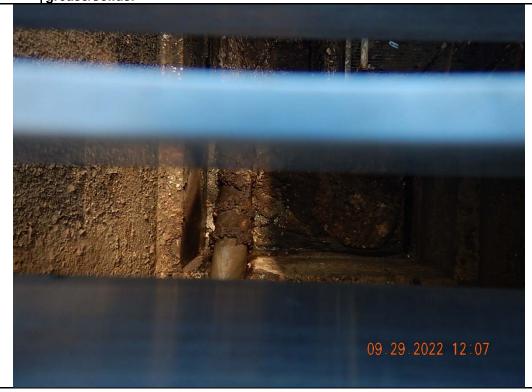
Photographer: Sarah Frasher Date: 9/29/2022 Time: 12:07
Witness: None Photo #: 6

Description: View of the wet well to the Phillips Pump Station. Note the accumulation of grease/solids.
