RE: Kohler Company Inspection – PDS# 127041  
AFIN: 27-00022 Permit No.: AR0034347

<p><b>ENVIRONMENTAL QUALITY</b></p>	<b>OFFICE OF WATER QUALITY INSPECTION REPORT</b>				
	AFIN: 27-00022	PERMIT #: AR0034347	DATE: 8/17/2023		
	COUNTY: 27 Grant	PDS #: 127041	MEDIA: WN		
	GPS LAT: 34.302207 LONG: -92.393639 LOCATION: Entrance				
<b>FACILITY INFORMATION</b>		<b>INSPECTION INFORMATION</b>			
NAME: <b>Kohler Company</b> LOCATION: <b>415 S. Oklahoma St.</b> CITY: <b>Sheridan</b>		FACILITY TYPE: <b>2 - Industrial</b> INSPECTOR ID#: <b>83321 S - State</b> FACILITY EVALUATION RATING: <b>4 - Satisfactory</b> INSPECTION TYPE: <b>Industrial User</b>			
<b>RESPONSIBLE OFFICIAL</b>		DATE(S):      ENTRY TIME:      EXIT TIME:      PERMIT EFFECTIVE DATE: <b>8/17/2023      09:30      10:48</b>			
NAME: / TITLE <b>Mr. Russell Skinner / Plant Manager</b> COMPANY: <b>Kohler Company</b> MAILING ADDRESS: <b>415 S. Oklahoma St.</b> CITY, STATE, ZIP: <b>Sheridan AR 72150</b> PHONE & EXT: / FAX: <b>870-942-2111 46201 /</b> EMAIL: <b>Russell.Skinner@kohler.com</b> CONTACTED DURING INSPECTION: <b>Yes</b>		PERMIT EXPIRATION DATE:  FAYETTEVILLE SHALE RELATED: <b>N</b> FAYETTEVILLE SHALE VIOLATIONS: <b>N</b>

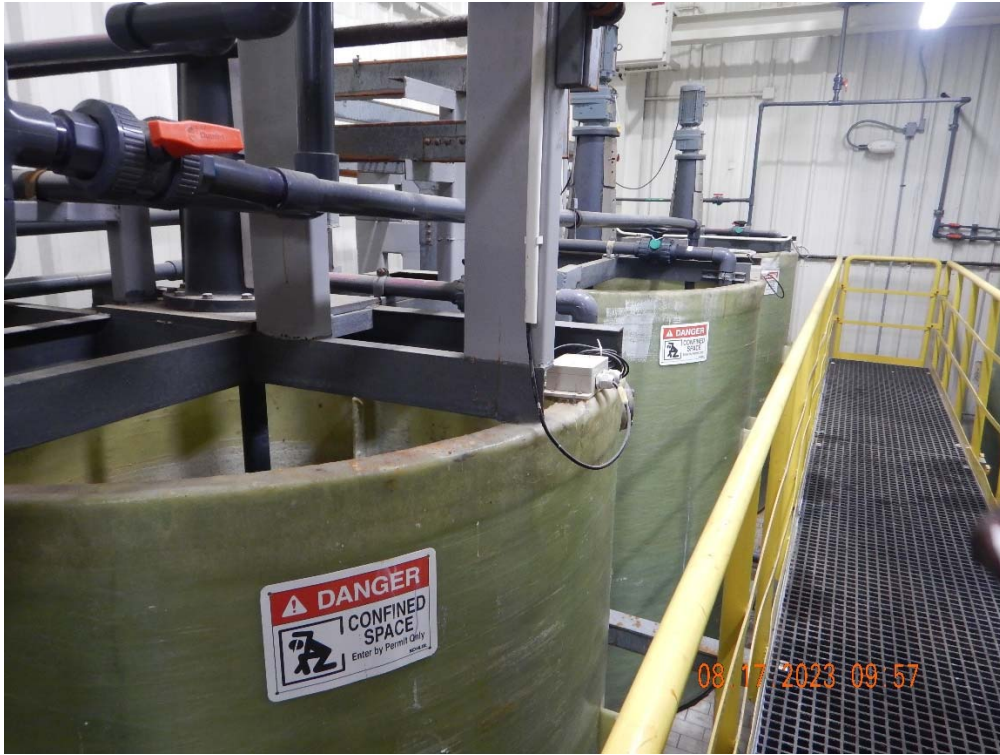
Location:	<b>Kohler Company</b>		
Photographer:	<b>Jason Bolenbaugh</b>	Date:	<b>8/17/2023</b>
Time:	<b>09:57</b>	Photo #:	<b>1</b>
Witness:			
Description:	<b>DSCN6285: Rinse tanks for nickel, Acid/Alkaline (A/A), copper and chrome (Tanks 001-004).</b>

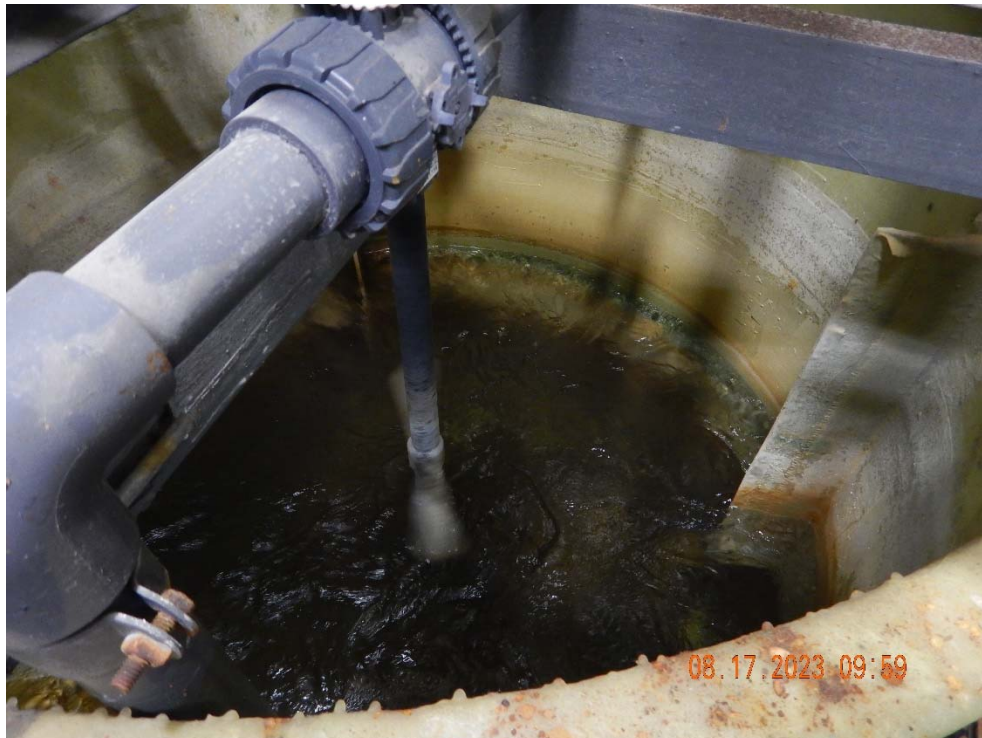
Photographer:	<b>Jason Bolenbaugh</b>	Date:	<b>8/17/2023</b>
Time:	<b>09:59</b>	Photo #:	<b>2</b>
Witness:			
Description:	<b>DSCN6287: Inside of the copper rinse tank (Tank 002).</b>

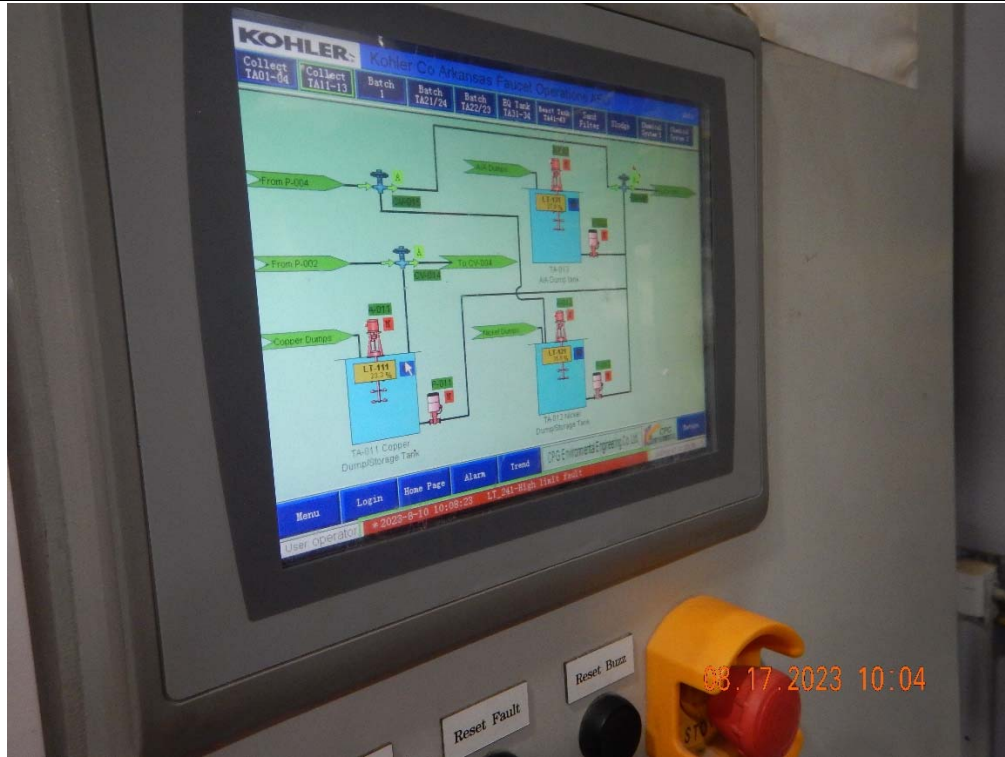
Location:	<b>Kohler Company</b>		
Photographer:	<b>Jason Bolenbaugh</b>	Date:	<b>8/17/2023</b>
Witness:		Time:	<b>10:04</b>
		Photo #:	<b>3</b>
Description:	<b>DSCN6289: Operations screen for the nickel, A/A, and copper dump tanks (Tanks 011-013).</b>

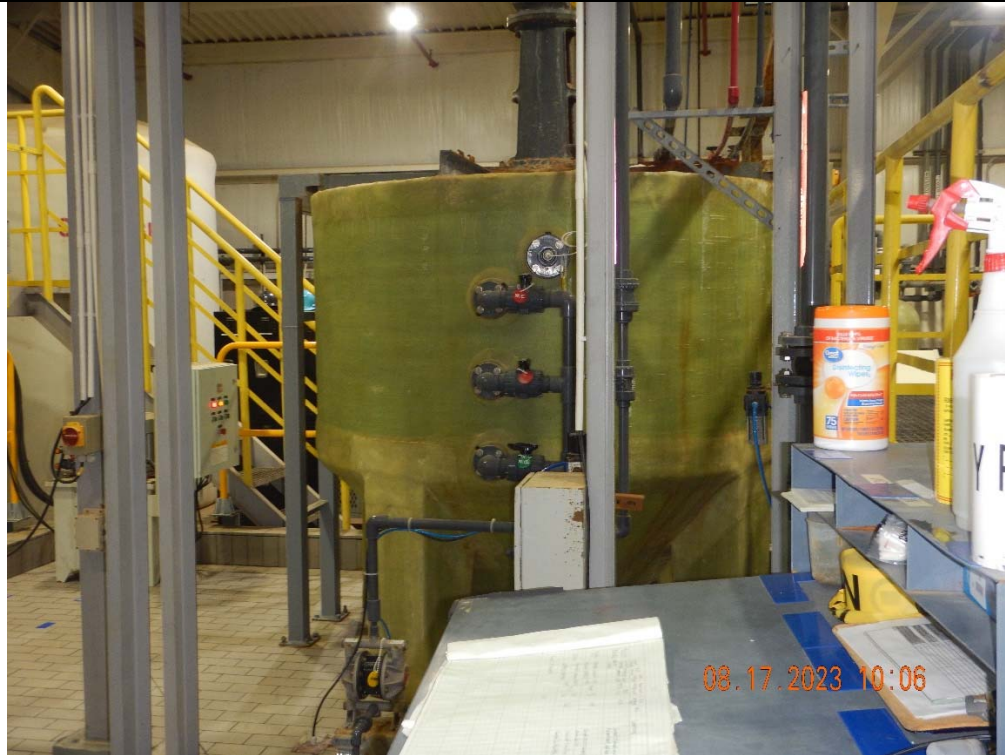
Photographer:	<b>Jason Bolenbaugh</b>	Date:	<b>8/17/2023</b>
Witness:		Time:	<b>10:06</b>
		Photo #:	<b>4</b>
Description:	<b>DSCN6290: Chrome dump tank (Tank 21).</b>

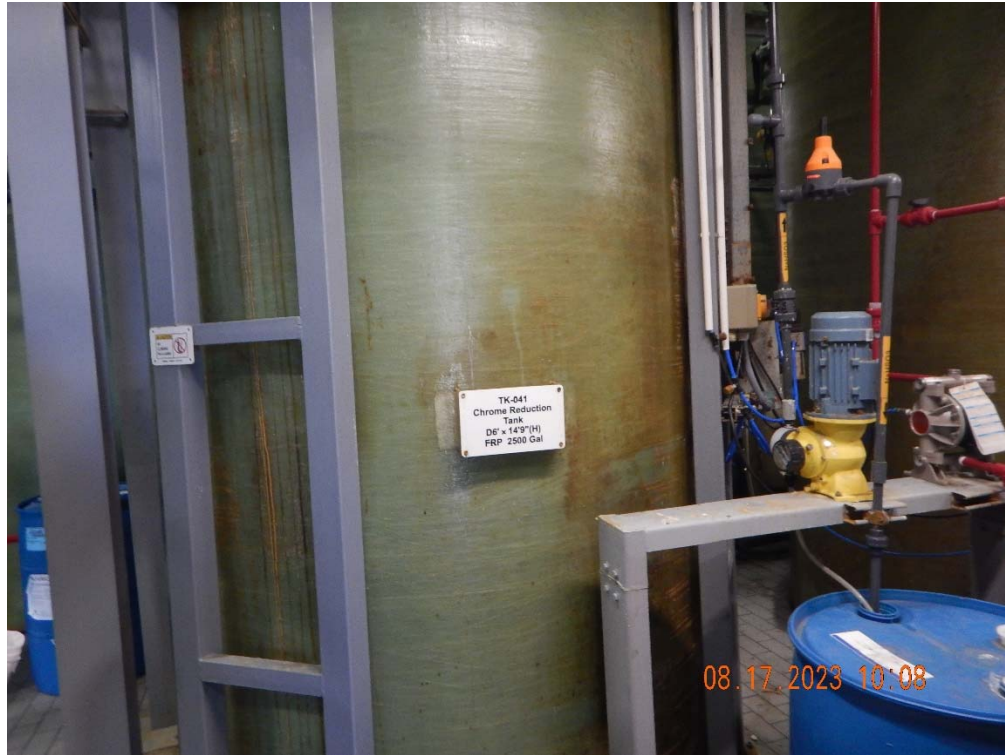
Location:	<b>Kohler Company</b>		
Photographer:	<b>Jason Bolenbaugh</b>	Date:	<b>8/17/2023</b>
Time:	<b>10:08</b>	Witness:	
Photo #:	<b>5</b>	Description:	<b>DSCN6292: Chrome reduction tank (Tank 41).</b>

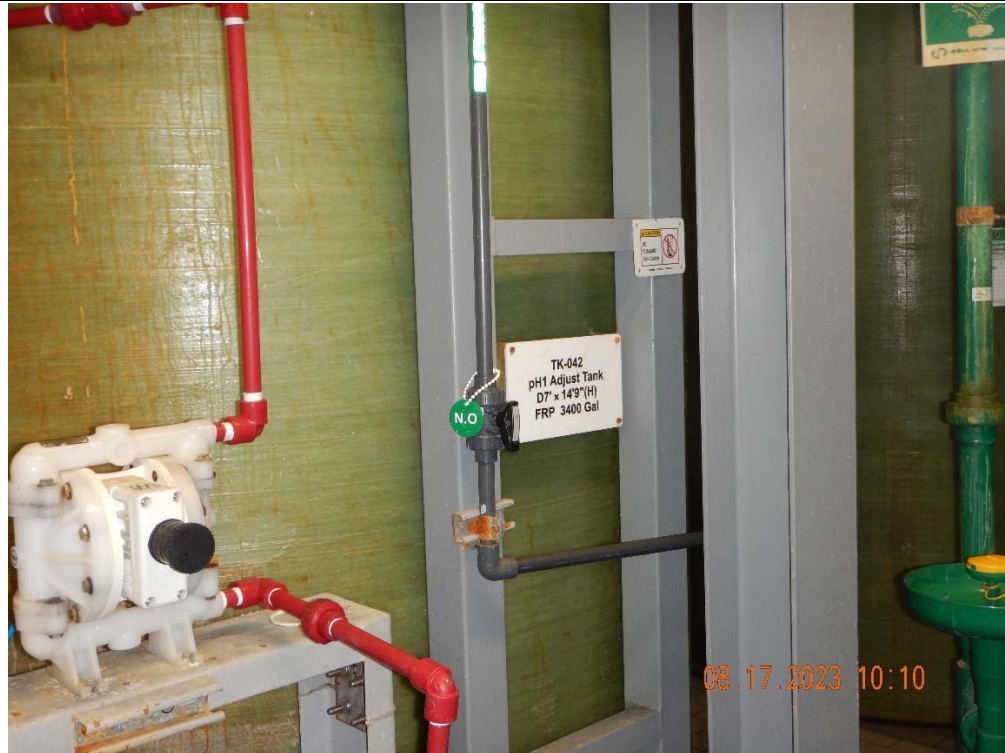
Photographer:	<b>Jason Bolenbaugh</b>	Date:	<b>8/17/2023</b>
Time:	<b>10:10</b>	Witness:	
Photo #:	<b>6</b>	Description:	<b>DSCN6297: pH adjustment tank (Tank 042).</b>

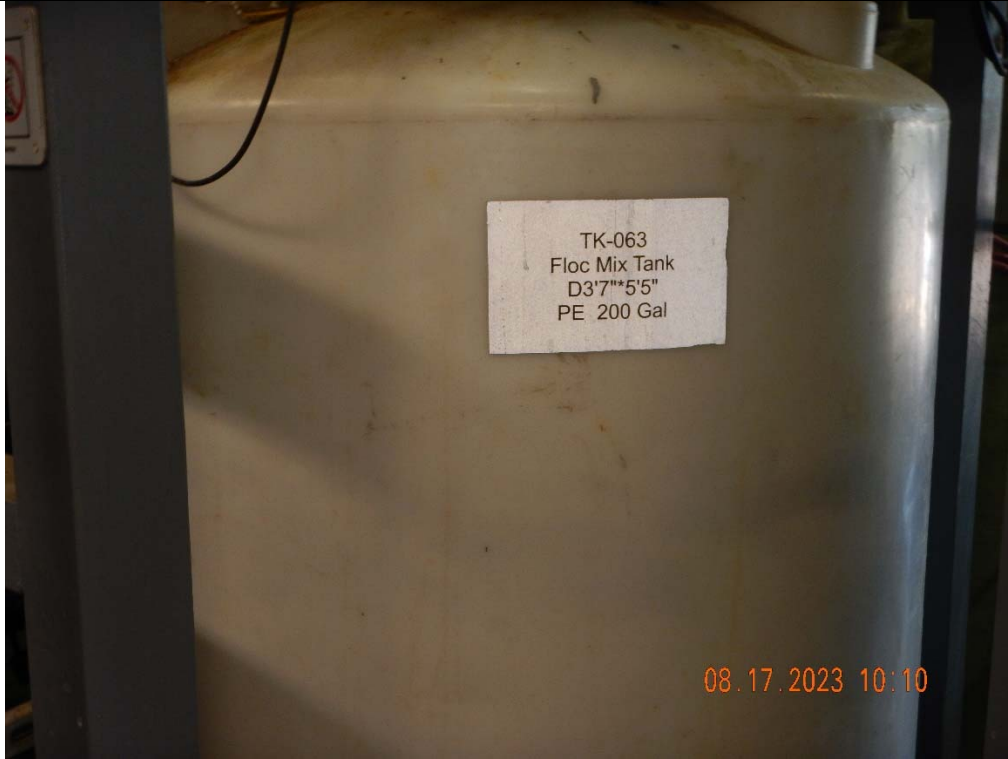
Location:	<b>Kohler Company</b>				
Photographer:	<b>Jason Bolenbaugh</b>	Date:	<b>8/17/2023</b>	Time:	<b>10:10</b>
Witness:				Photo #:	<b>7</b>
Description:	<b>DSCN6298: Floc mix tank at clarifier.</b>

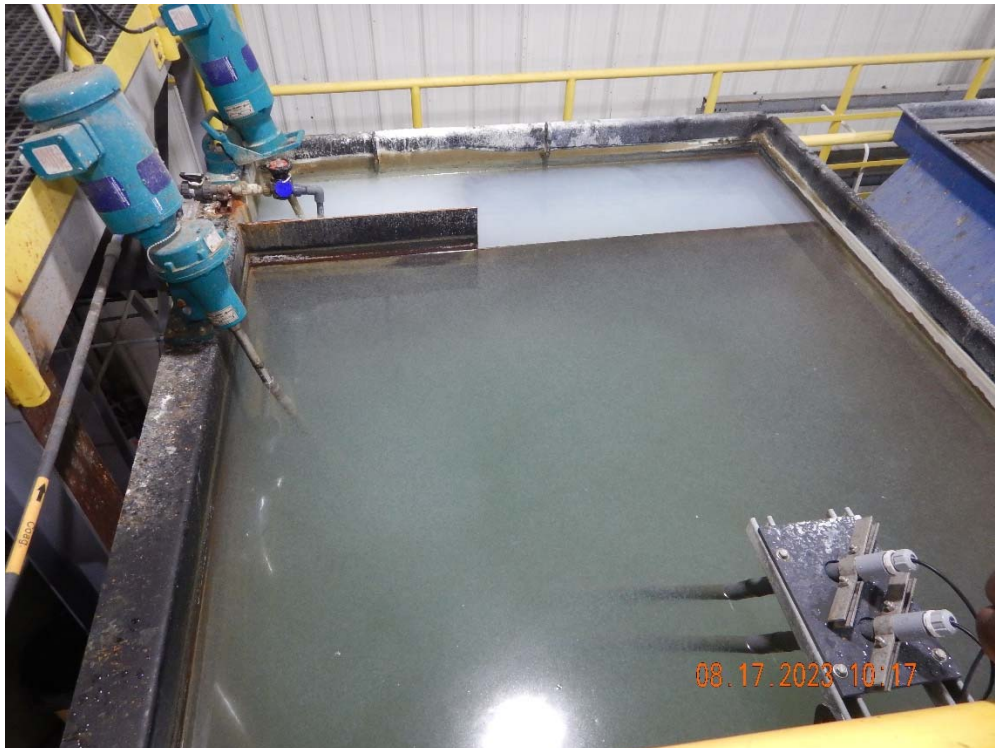
Photographer:	<b>Jason Bolenbaugh</b>	Date:	<b>8/17/2023</b>	Time:	<b>10:17</b>
Witness:				Photo #:	<b>8</b>
Description:	<b>DSCN6302: Stages 1 and 2 of the clarifier.</b>

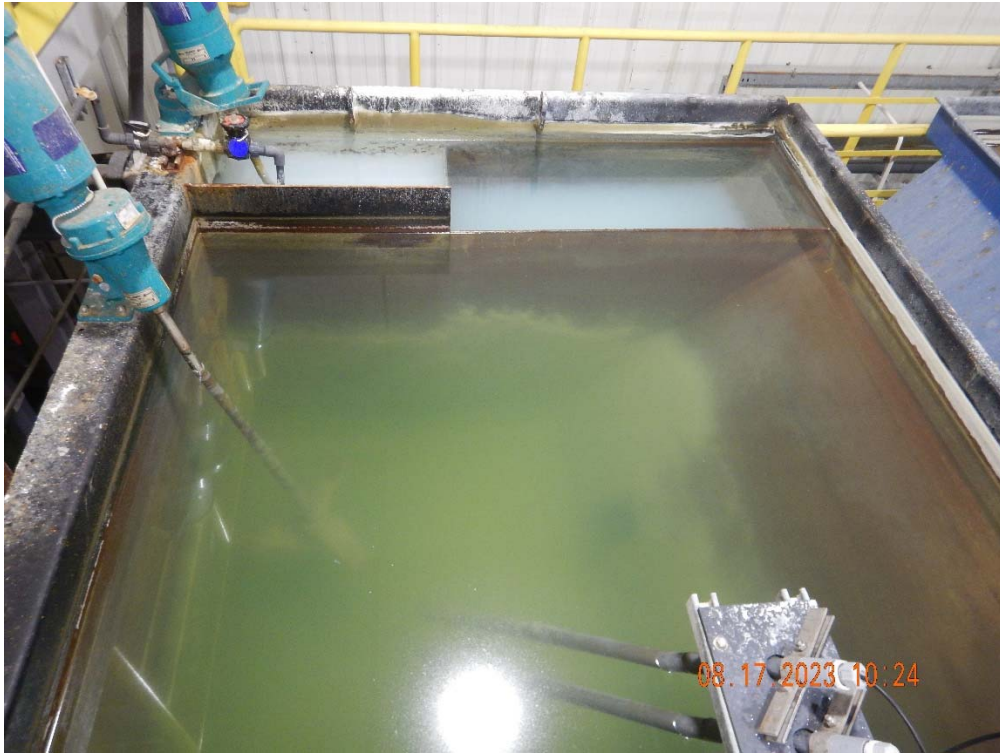
Location:	<b>Kohler Company</b>		
Photographer:	<b>Jason Bolenbaugh</b>	Date:	<b>8/17/2023</b>
Time:	<b>10:24</b>	Witness:	
Photo #:	<b>9</b>	Description:	
<b>DSCN6308: Another view of the clarifier during solids settling.</b>

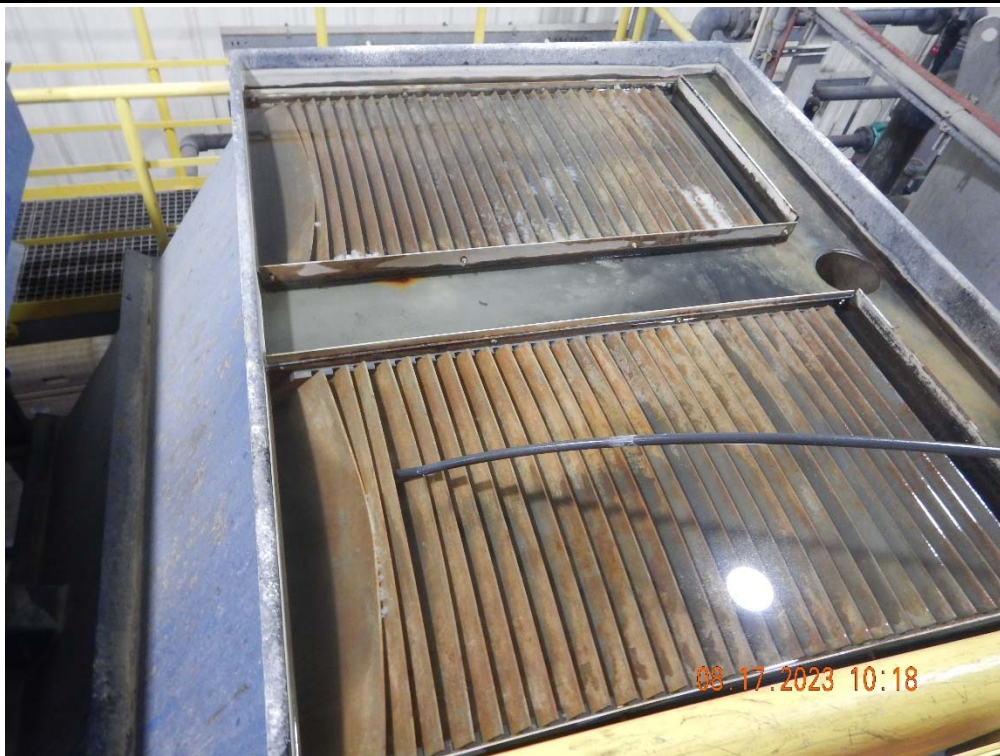
Photographer:	<b>Jason Bolenbaugh</b>	Date:	<b>8/17/2023</b>
Time:	<b>10:18</b>	Witness:	
Photo #:	<b>10</b>	Description:	
<b>DSCN6304: Clarifier at the discharge point prior to final pH adjustment and ultimate discharge to the City of Sheridan's collection system.</b>

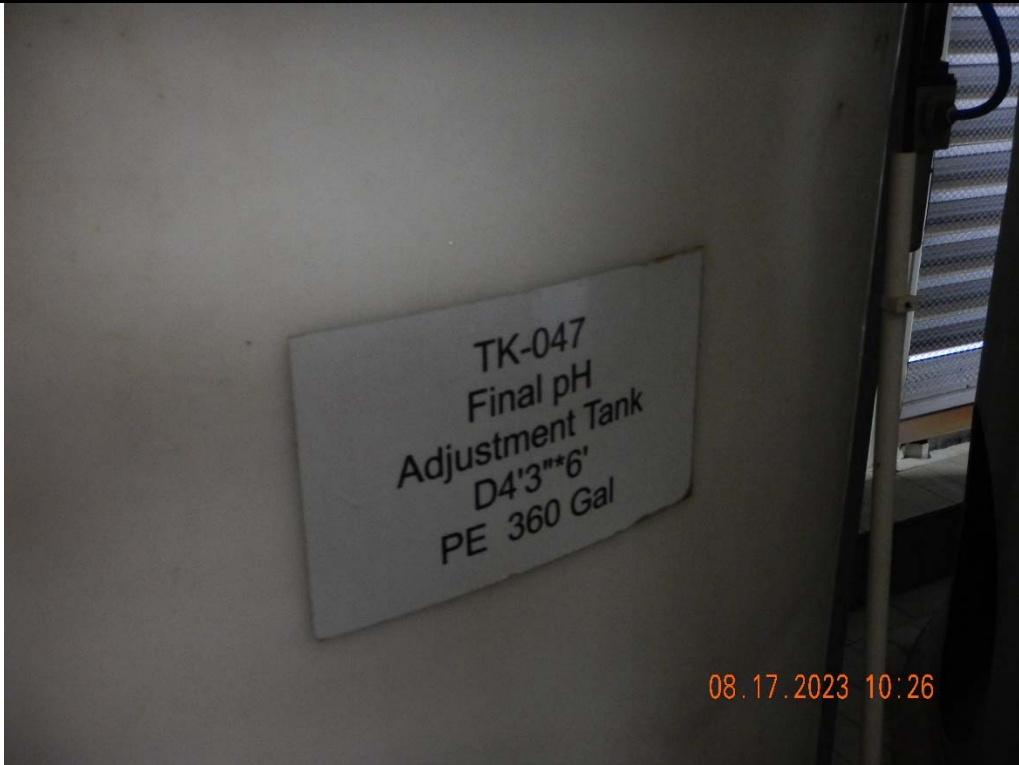
Location:	<b>Kohler Company</b>		
Photographer:	<b>Jason Bolenbaugh</b>	Date:	<b>8/17/2023</b>
Time:	<b>10:26</b>	Witness:	
Photo #:	<b>11</b>	Description: <b>DSCN6310: Final pH adjustment tank.</b>

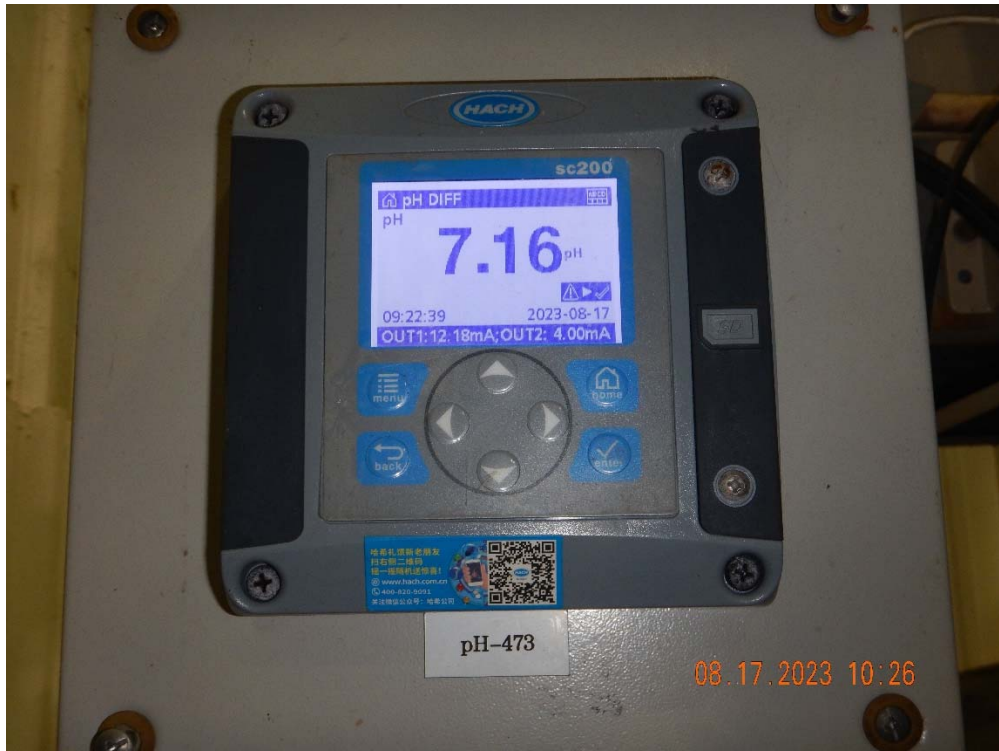
Photographer:	<b>Jason Bolenbaugh</b>	Date:	<b>8/17/2023</b>
Time:	<b>10:26</b>	Witness:	
Photo #:	<b>12</b>	Description: <b>DSCN6312: Final effluent pH.</b>

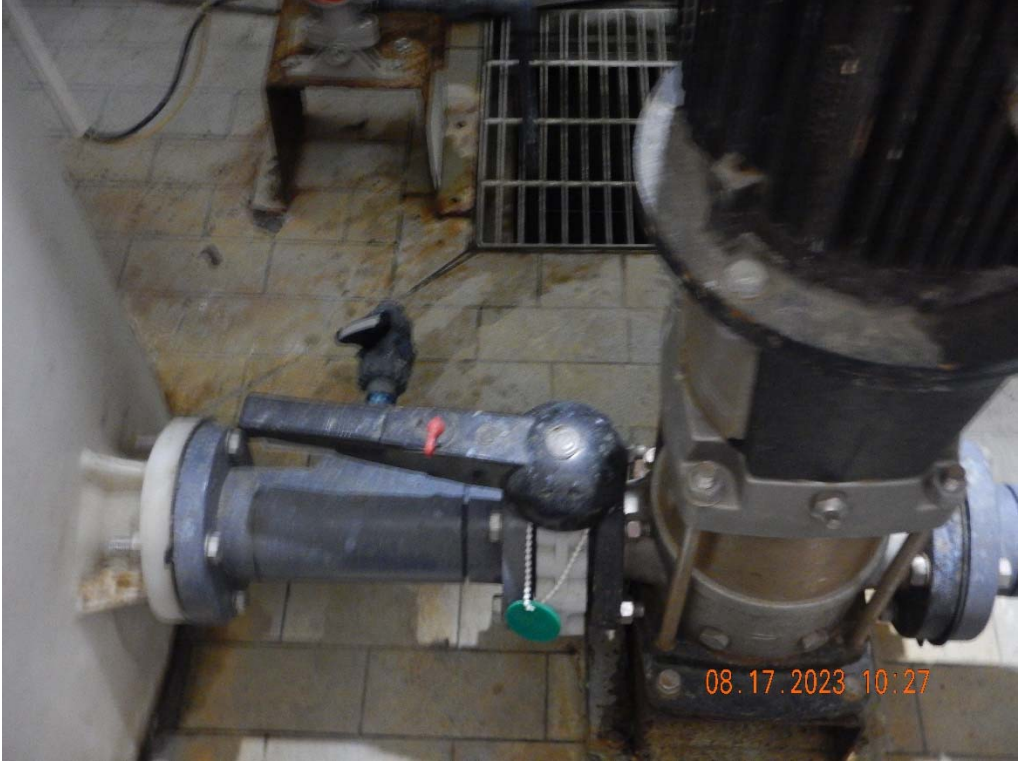
Location:	<b>Kohler Company</b>				
Photographer:	<b>Jason Bolenbaugh</b>	Date:	<b>8/17/2023</b>	Time:	<b>10:27</b>
Witness:				Photo #:	<b>13</b>
Description:	<b>DSCN6313: Sampling port for grab samples.</b>

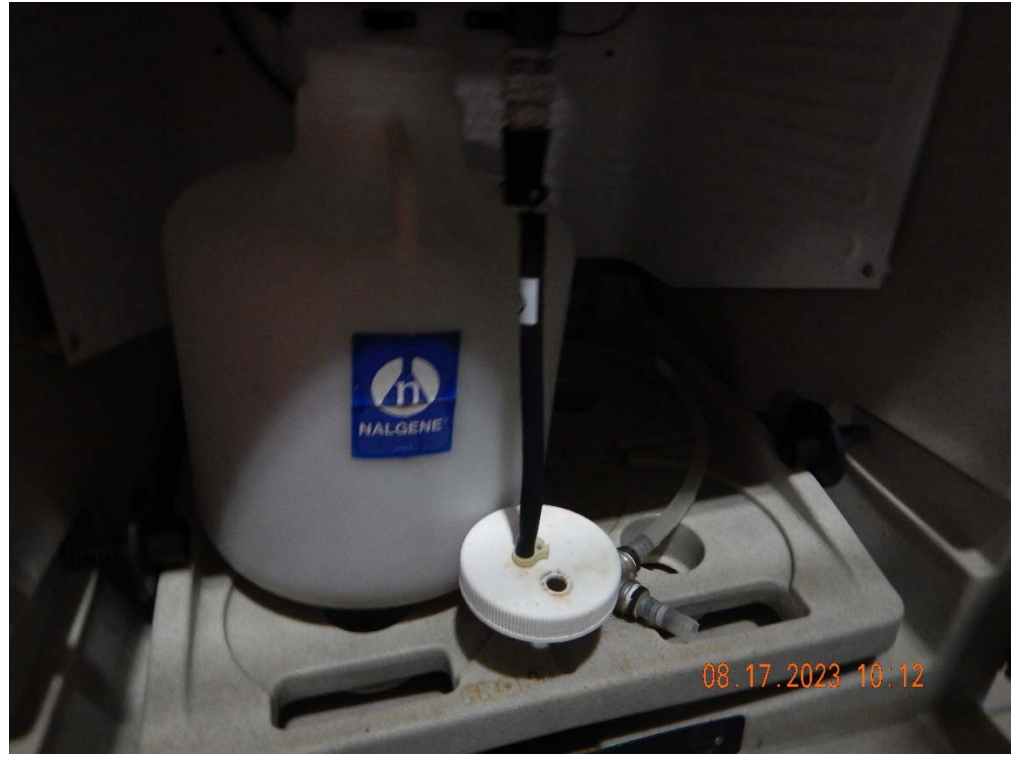
Photographer:	<b>Jason Bolenbaugh</b>	Date:	<b>8/17/2023</b>	Time:	<b>10:12</b>
Witness:				Photo #:	<b>14</b>
Description:	<b>DSCN6300: Inside of composite sampler.</b>

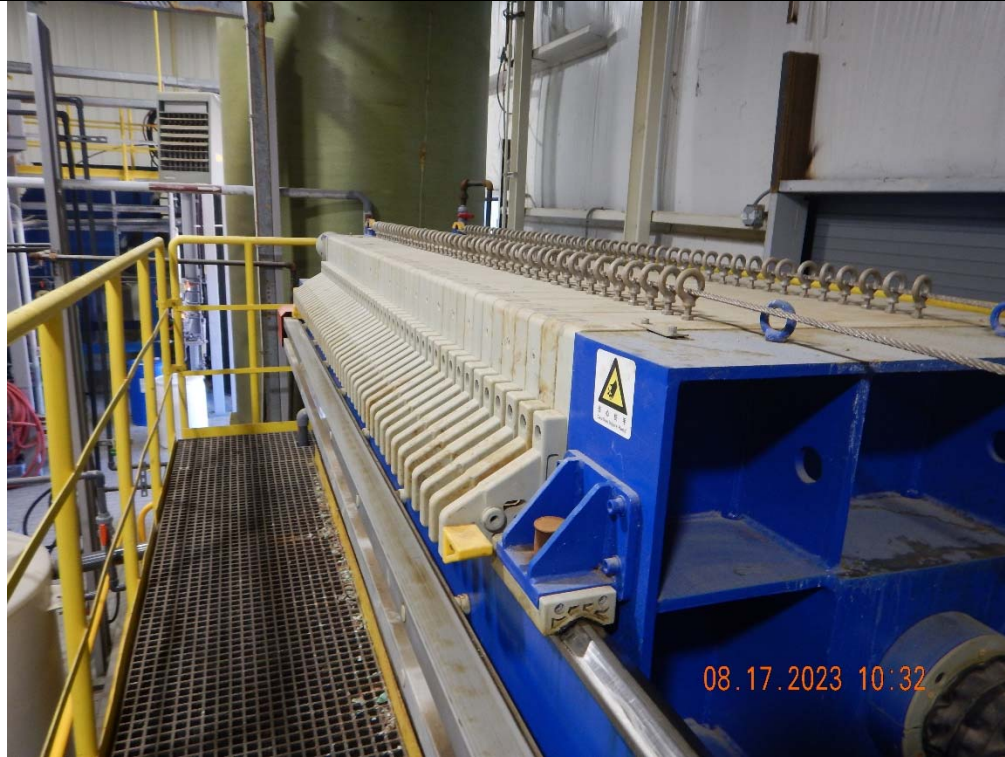
Location:	<b>Kohler Company</b>		
Photographer:	<b>Jason Bolenbaugh</b>	Date:	<b>8/17/2023</b>
Time:	<b>10:32</b>	Witness:	
Photo #:	<b>15</b>	Description:	<b>DSCN6317: Filter press.</b>

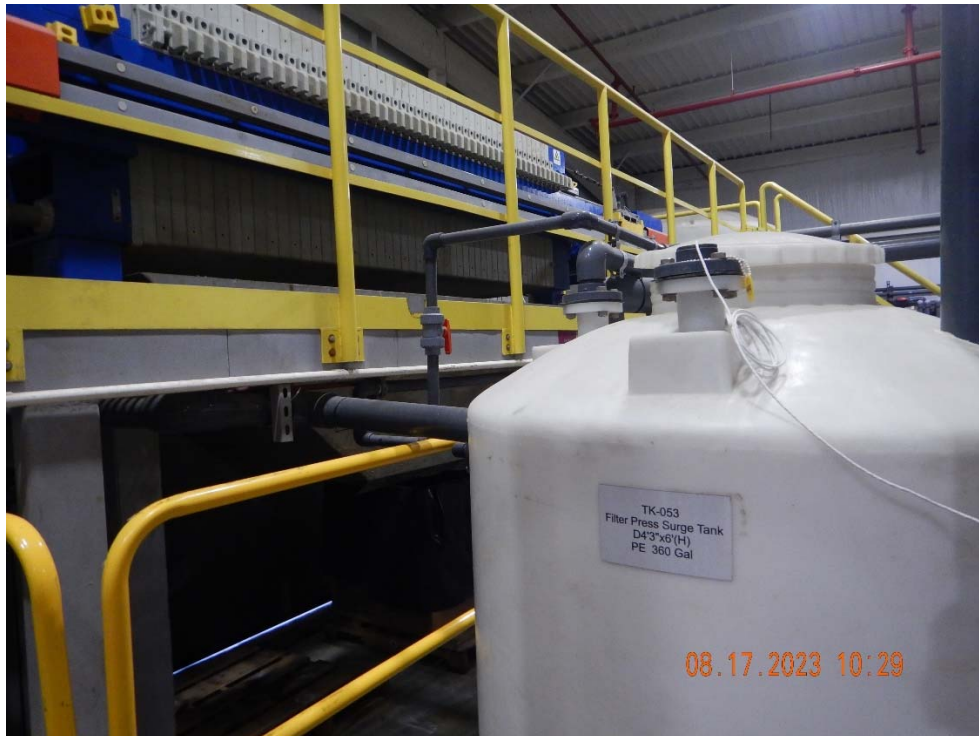
Photographer:	<b>Jason Bolenbaugh</b>	Date:	<b>8/17/2023</b>
Time:	<b>10:29</b>	Witness:	
Photo #:	<b>16</b>	Description:	<b>DSCN6314: Filter press surge tank.</b>

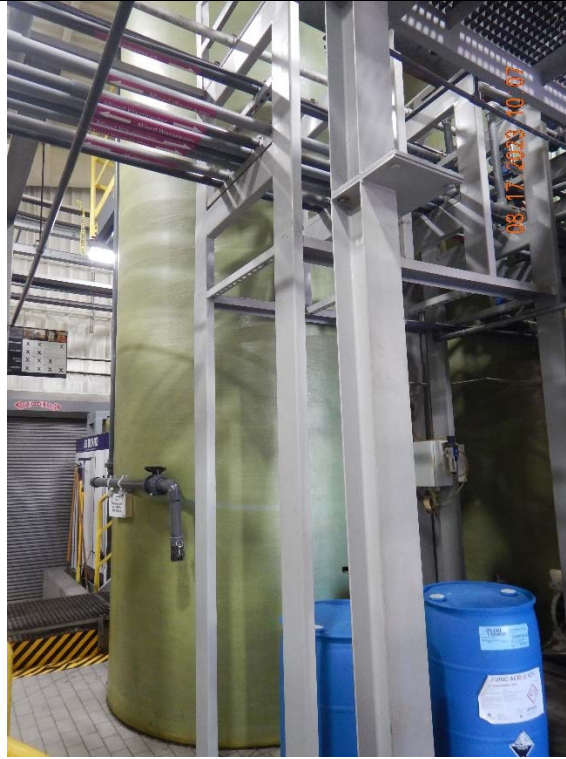
Location:	<b>Kohler Company</b>				
Photographer:	<b>Jason Bolenbaugh</b>	Date:	<b>8/17/2023</b>	Time:	<b>10:07</b>
Witness:				Photo #:	<b>17</b>
Description:	<b>DSCN6291: Emergency Tank</b>

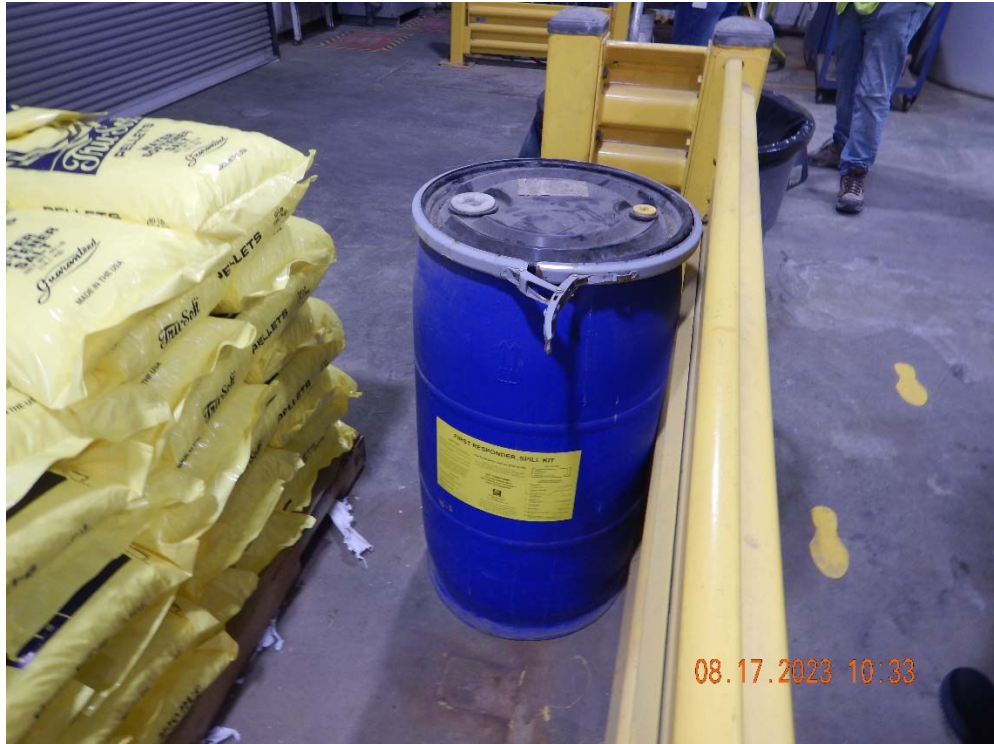
Photographer:	<b>Jason Bolenbaugh</b>	Date:	<b>8/17/2023</b>	Time:	<b>10:33</b>
Witness:				Photo #:	<b>18</b>
Description:	<b>DSCN6318: Spill kit.</b>
