RE: Berryville Waste Water Plant Inspection – PDS# 129411 (Carroll Co.)

OFFICE OF WATER QUALITY INSPECTION REPORT

SUMMARY OF FINDINGS

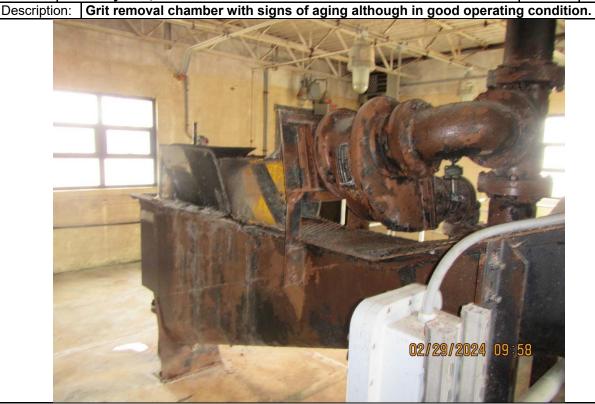
Office of Water Quality Photographic Evidence Sheet Location: Berryville Waste Water Plant Photographer: William Cody Date: 2/29/2024 Time: 10:00 Witness: Mike Maynard, Austin Hawes Photo #: 3 Description: Grit tank where a sump pulls grit back to removal/solid waste building.

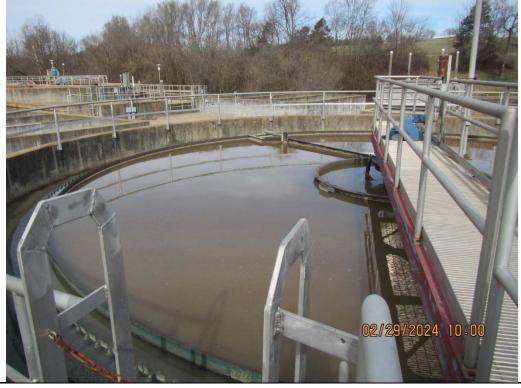
Photographer: William Cody	Date:	2/29/2024	Time:	10:02
Witness: Mike Maynard, Austin Hawes			Photo #:	4

Description: Anaerobic selector basins with multiple cells.

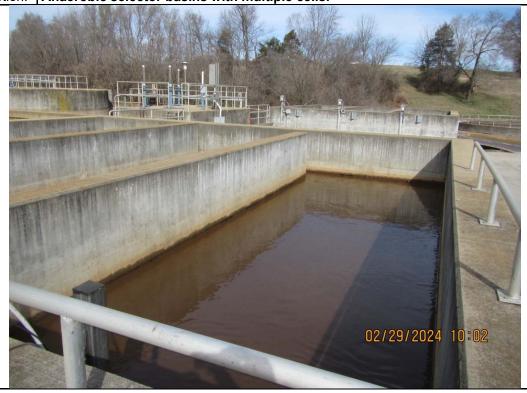
Cocation: Berryville Waste Water Plant Photographer: William Cody Witness: Mike Maynard, Austin Hawes Description: Anoxic zone before oxidation ditch/aeration basin.

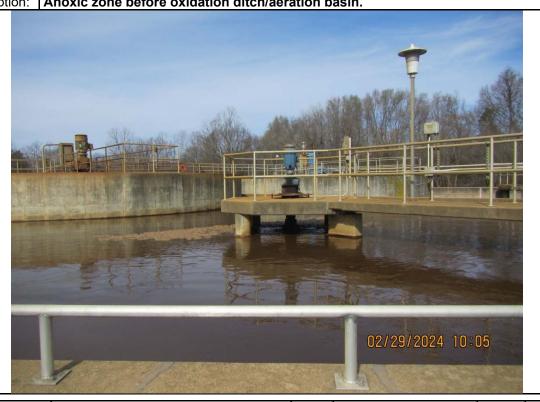
Photographer: William Cody	Date:	2/29/2024	Time:	10:08
Witness: Mike Maynard, Austin Hawes			Photo #:	6

Description: Oxidation ditch.

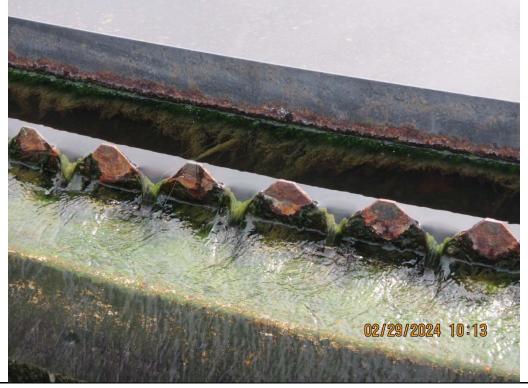
Photographer:William CodyDate:2/29/2024Time:10:13Witness:Mike Maynard, Austin HawesPhoto #:10

Description: New weirs and additional parts installed on the second clarifier.
