**Subject:** City of West Helena WWTP and Collection Sysrtem Inspections, NPDES Permit

**RE:** West Helena WWTP Inspections (Phillips Co)

# OFFICE OF WATER QUALITY INSPECTION REPORT

AFIN: **54-00086** PERMIT #: **AR0022021** DATE: **3/22/2022**

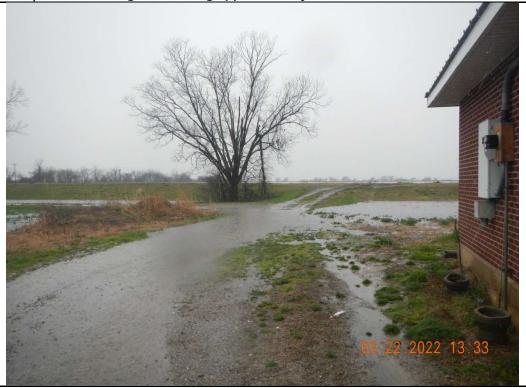
Description: Entrance to lagoons, facing approximately west.

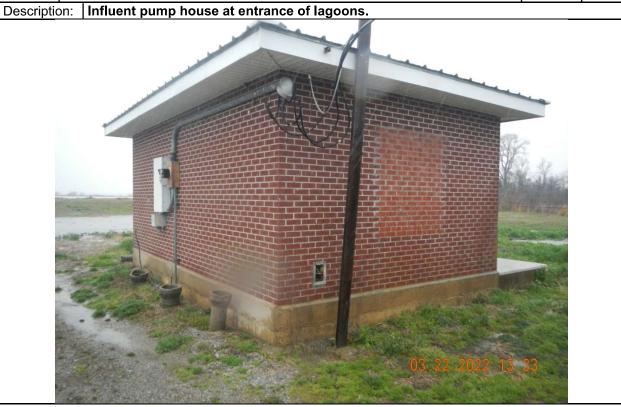
# Office of Water Quality Photographic Evidence Sheet Location: West Helena WWTP Photographer: Aaron Baggett Date: 3/22/2022 Time: 1333 Witness: Kerri McCabe Photo #: 3 Description: Effluent pump house in background of photo taken from entrance, facing south.

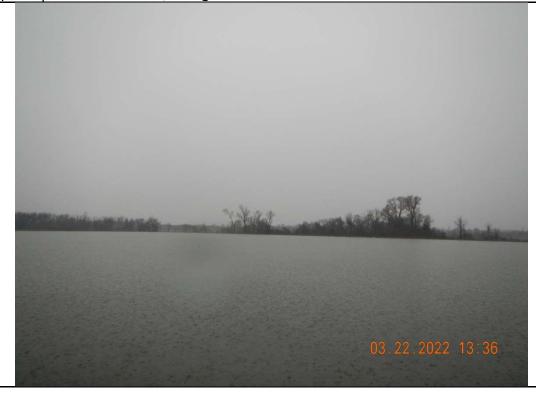
| Photograp | oher: Aaron Baggett | Date: 3/22/2022 | Time: | 1336 |
|---|---|---|---|---|
| Witness: | Kerri McCabe | | Photo #: | 4 |

Description: Overview of Cell 1, facing west.

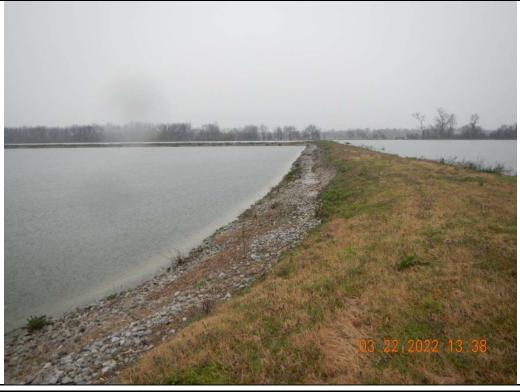
| Office of Water Quality Photographic Evidence Sheet | | | | | | |
|---|---|---|--|--|--|--|
| Witness: I | Witness: Kerri McCabe Photo #: 5 | | | | | |

- Due to significant erosion from inadequate freeboard, there are sections of levees in need of repair in all three lagoons inspected.
- Sections of the lagoon levees were not safely accessible by vehicle at the time of inspection.

| Office of Water Quality Photographic Evidence Sheet | | | | | | |
|---|---|---|--|--|--|--|
| Description | Description: Levee running between Cell 1 and Cells 2 and 3; levee is significantly eroded and in | | | | | |

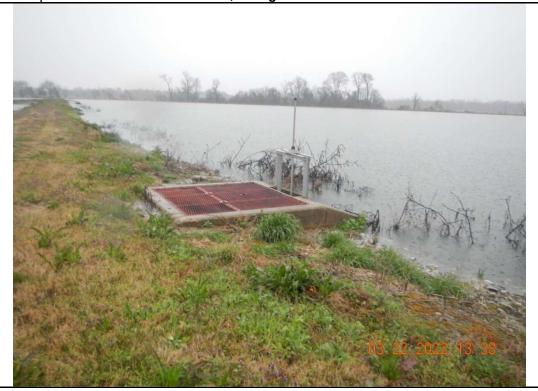
| Photographer: Aaron Baggett | Date: 3/22/2022 | Time: | 1338 |
|---|---|---|---|
| Witness: Kerri McCabe | | Photo #: | 6 |

- The access road to the treatment facility is damaged and in need of repair.
- There was inadequate freeboard in the lagoons at the time of the inspection.

Description: Location of flow between Cell 1 and Cell 2 at southwest corner of Cell 1; note the lack of freeboard in the levee, facing northeast.

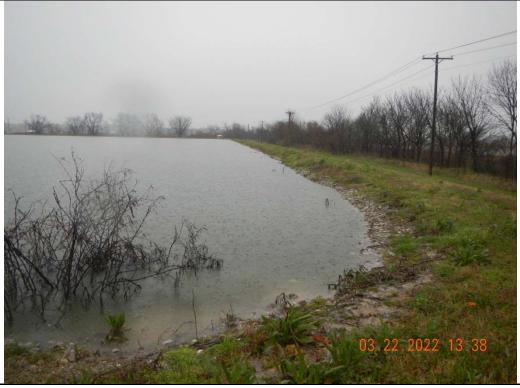
| Photographer: Aaron Baggett | Date: 3/22/2022 | Time: | 1338 |
|---|---|---|---|
| Witness: Kerri McCabe | | Photo #: | 8 |

Description: Photo taken at north end of levee separating Cell 1 and Cells 2 and 3; note lack of freeboard on both sides of the levee, facing south.

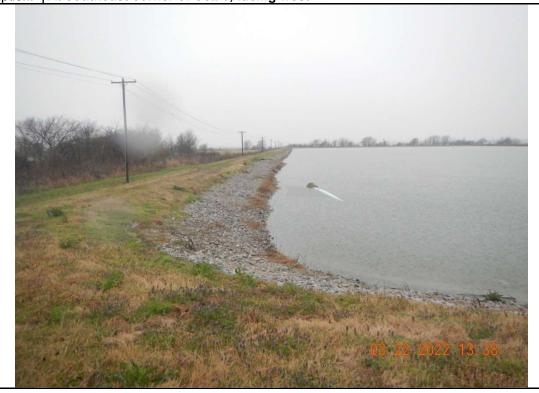
Description: At southeast corner of Cell 3, facing west.

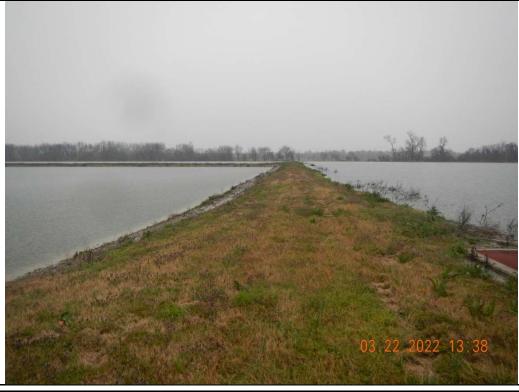
| Office of Water Quality Photographic Evidence Sheet | | | | | | | |
|---|--|---|---|---|---|--|--|
| Description: Photo taken at south end of levee between Cell 1 and Cells 2 and 3; note lack of | | | | | | | |
| Describitor | '· f | rooboard and loves procior | in Call 3 (laft of n | hotal facing port | h | | |

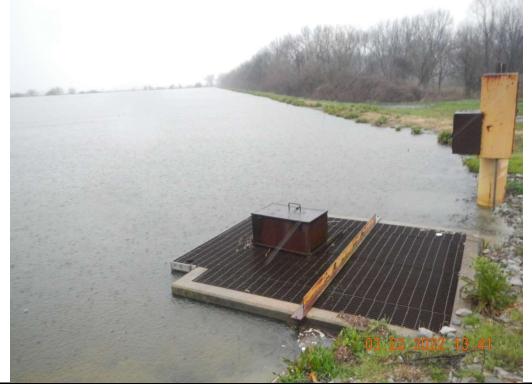
| Office of Water Quality Photographic Evidence Sheet | | | | | | |
|---|---|---|---|---|--|--|
| Witness: I | Witness: Kerri McCabe Photo #: 13 | | | | | |

- The access road to the lagoons was damaged and in need of repair at the time of inspection. Water damage along a steep slope near the entrance prohibits safe entry and exit, particularly during wet weather. The facility must be accessible by vehicle for inspection and maintenance at all times.
- Some sections of the levees were not accessible by vehicle at the time of inspection. The lagoons must be accessible by vehicle for inspection and maintenance at all times.
- There is inadequate freeboard in the lagoons. Levels in all lagoons have caused significant erosion along the levees, and levels in Cell 2 were nearly over the levees at the time of inspection (Photos 9-13).

| Office of Water Quality Photographic Evidence Sheet | | | | | | |
|---|---|---|---|---|--|--|
| Description: From northeast corner of Cell 2; water levels are nearly at the top of the levee, facing west. | | | | | | |

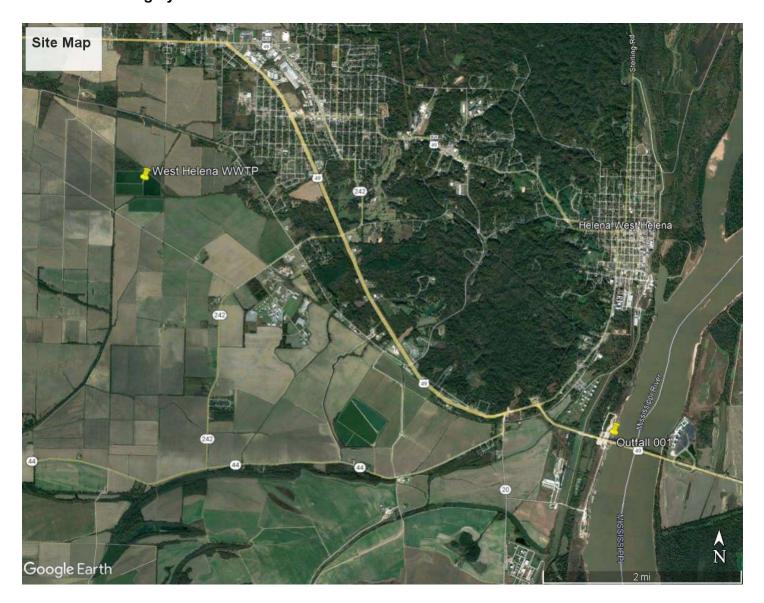
Figure 1. Google Earth image depicting overview of West Helena WWTP location and Outfall001; satellite base imagery dated 11/11/2020.

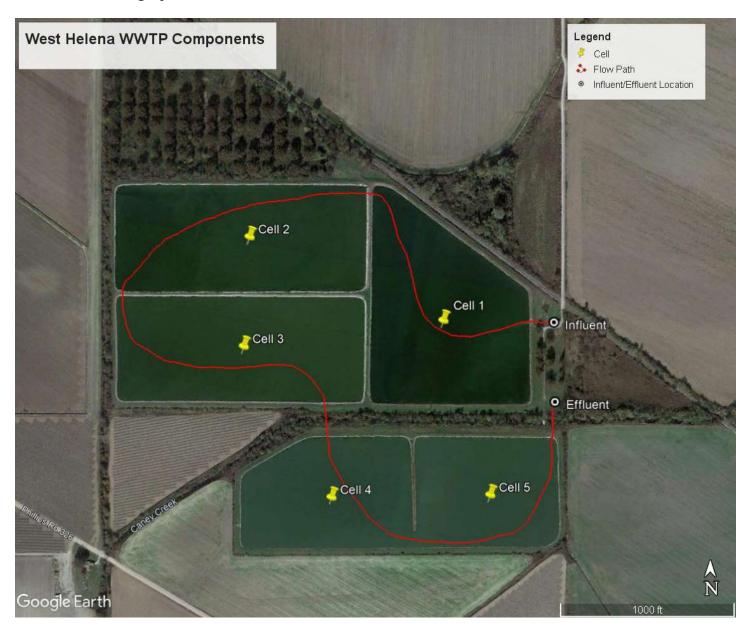
The treatment system for Outfall 001 consists of a five-cell lagoon system.

Figure 2. Google Earth image depicting West Helena WWTP components and simplified flow path; satellite base imagery dated 11/11/2020.

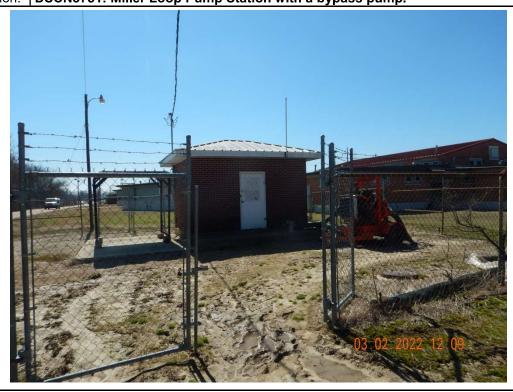
| Office of Water Quality Photographic Evidence Sheet | | | | | | | |
|---|---|--|--|--|--|--|--|
| Witness: | Witness: Photo #: 1 | | | | | | |

- The Miller Loop Pump Station is using a bypass pump as the main pumping mechanism due to both 60-hp pumps within the pump station not operating. Additionally, both pumps at the Denise Drive pump station were not operating at the time of the inspection. The permittee's failure to properly operate and maintain the pump stations is in violation of Part III, Section B.1.A of the permit.

| PUMP STATION VISIT (COMPLETE A SEPARATE CHECKLIST | PUMP STATION VISIT (COMPLETE A SEPARATE CHECKLIST FOR EACH PUMP STATION VISITED) | | | | | |
|--|--|---|--|--|--|--|
| Comments: This location had a bypass pump installed at it because both pumps are inoperable. Pump 1 requires a pump assembly but even if repaired this station requires both pumps to be operational in order for it to function. The bypass pump is monitored more closely during wet weather events otherwise if the rpm's are too low it will cause the line to begin to backup and sewer will discharge from cleanouts at a nearby apartment complex. During rain events the permittee will increase the rpms and monitoring of the station. | | | | | | |

| Office of Water Quality Photographic Evidence Sheet | | | | | | | |
|---|---|--|--|--|--|--|--|
| Description | Description: DSCN3751: Miller Loop Pump Station with a bypass pump. | | | | | | |

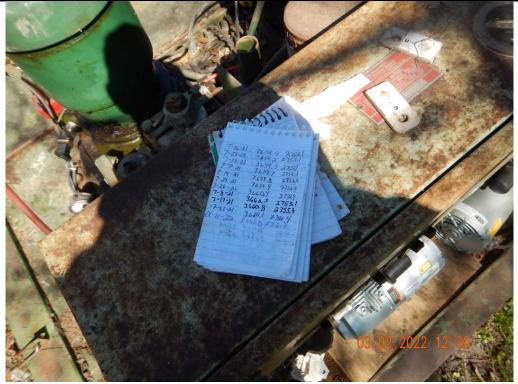
| Photographer: Jason Bolenbaugh | Date: 3/2/2022 | ? Time: | 1230 |
|---|---|---|---|
| Witness: | | Photo # | 6 |

Description: DSCN3755: Denise Drive pump station log book.

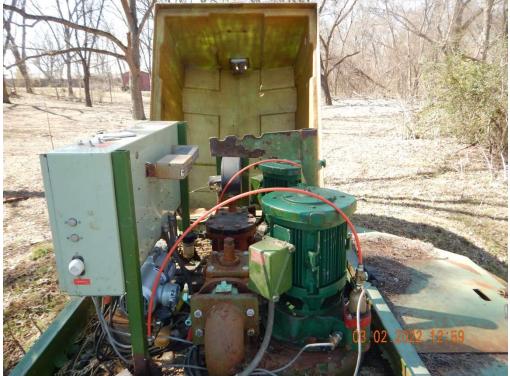
# Office of Water Quality Photographic Evidence SheetLocation:City of West HelenaPhotographer:Jason BolenbaughDate:3/2/2022Time:1259Witness:Photo #:7

Description: DSCN3761: Airport Road pump station.

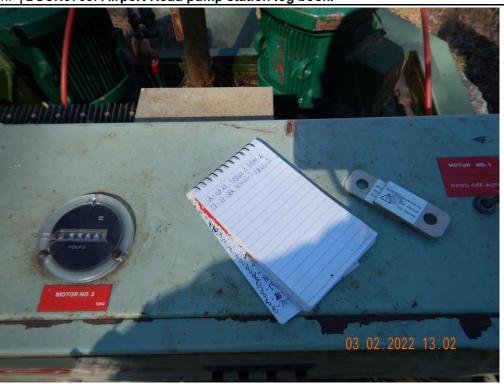
Description: DSCN3763: Airport Road pump station log book.
