RE: PERMIT NO. AR0034380, AFIN 01-00214

CONSENT ADMINISTRATIVE ORDER LIS NO. 16-006

COMPLETE TREATMENT SYSTEM EVALUATION

SEWER PLANT EVALUATION
STUTTGART MUNICIPAL WATER WORKS
JUNE 1, 2016

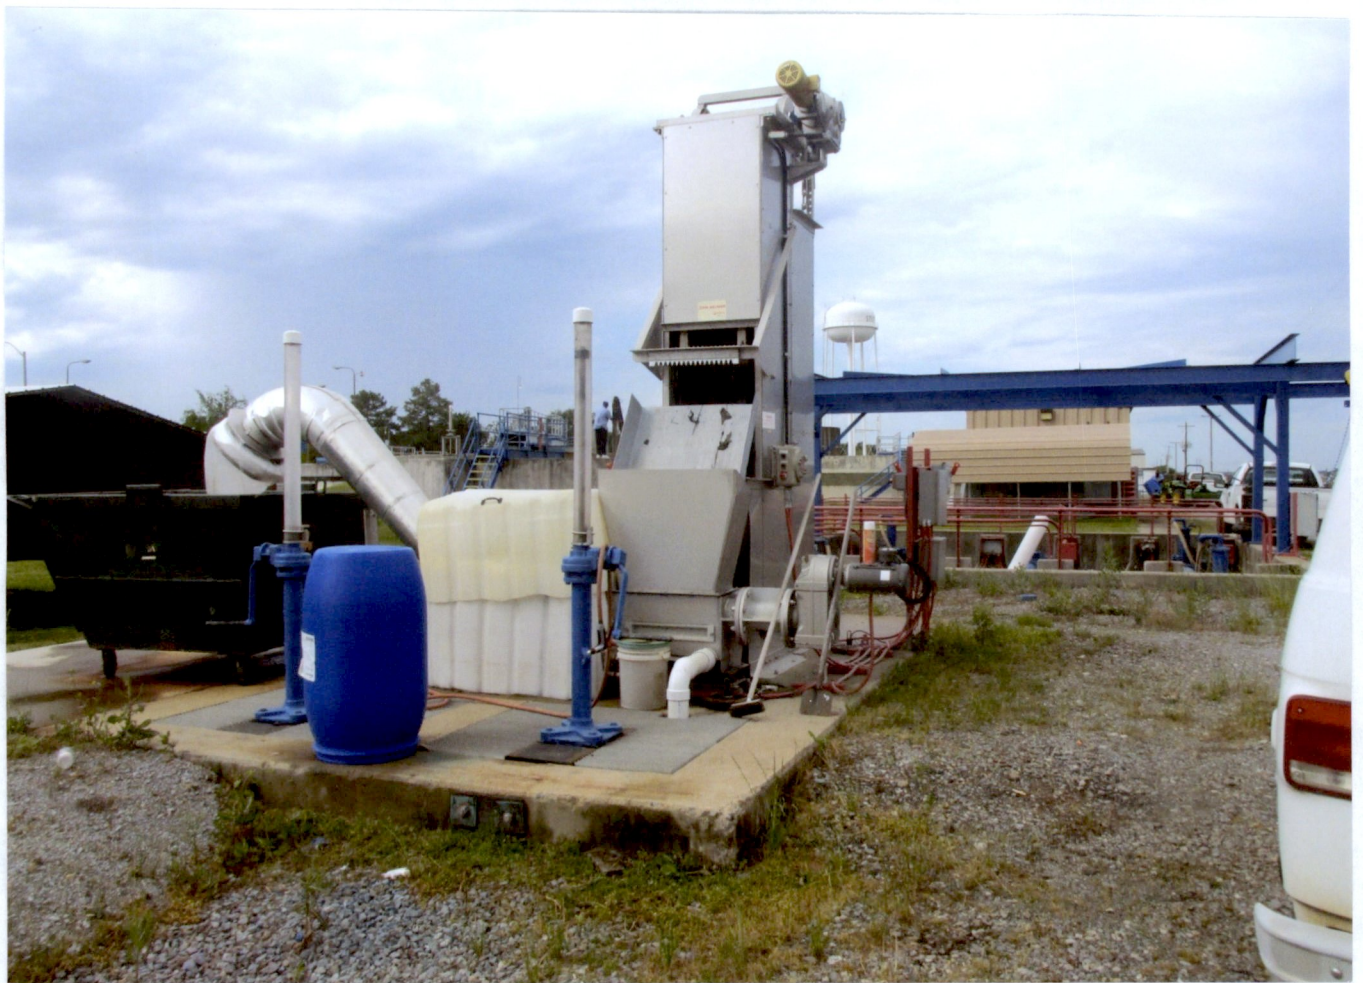
This equipment was installed new in 2015. The new bar screen has a maximum flow capacity of 18.3 MGD. The Rota PAC, after screenings are removed from the wastewater stream by the bar screen, washes and packs the coarse screenings in plastic casings for disposal.

1. BAR SCREEN AND ROTA PAC - NEW 2015

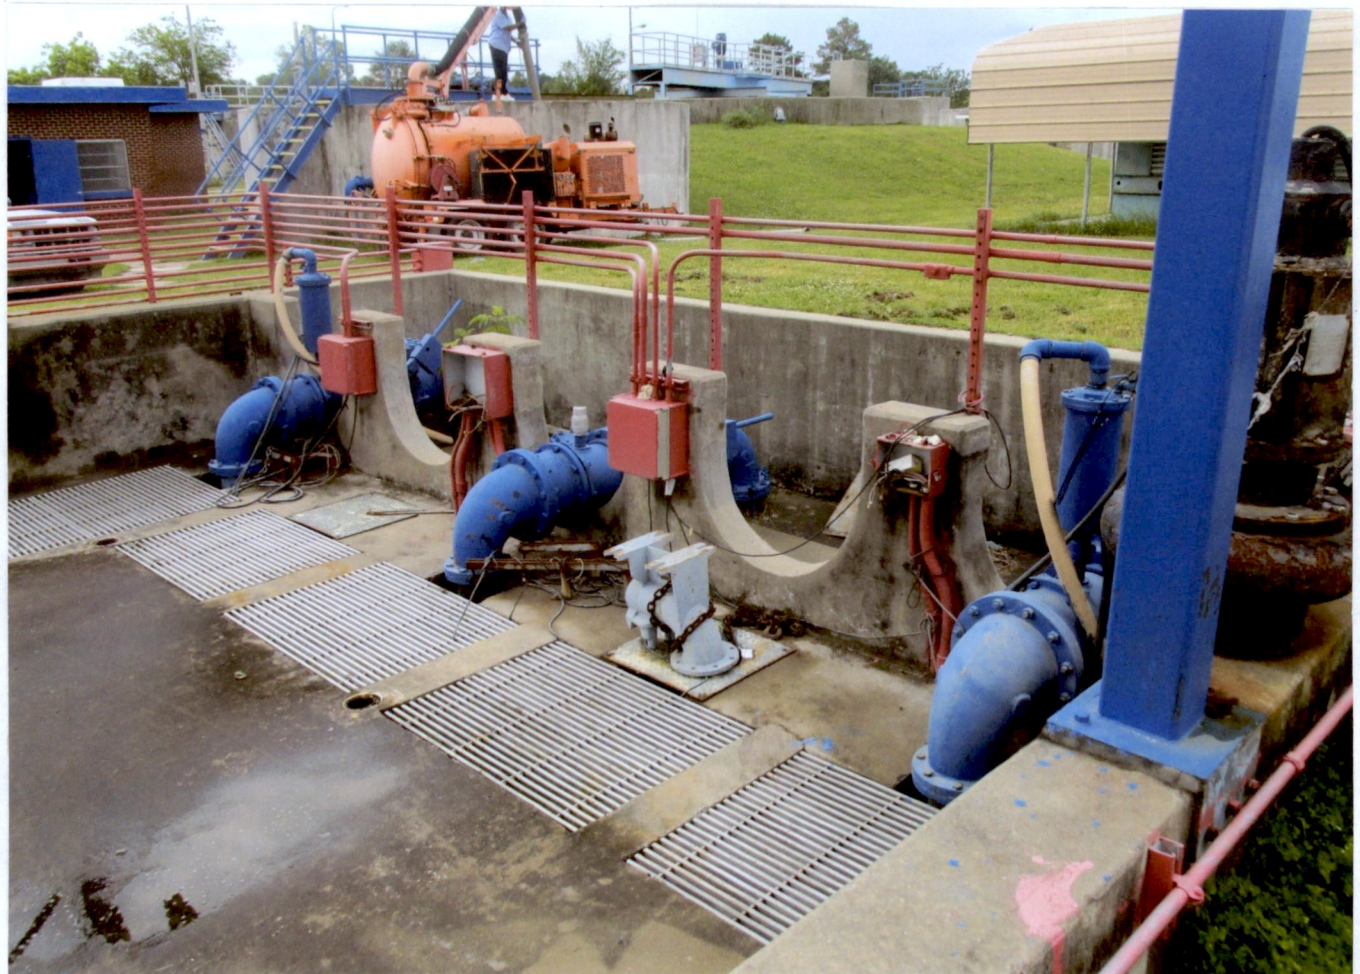
Three pumps, A1, A2, and A3, are submersible 6", 15 Hp-1150 RPM rated at 1215 gpm at 32' TDH pumps that deliver wastewater to the treatment processes for treatment.

The A2 bottom elbow stand needs replacement and possible pump replacement. As a minimum, this pump needs impeller and bottom elbow replacement

2. PRIMARY PUMPING STATION - A PUMPS TO TREATMENT

2. a.	The A2 Pump Impeller and Bottom Elbow Replacement	Estimated Cost	\$ 3,360.00
b.	Primary Influent Meter - New Flanged 18" Mag Meter Replacement	Estimated Cost	24,450.00

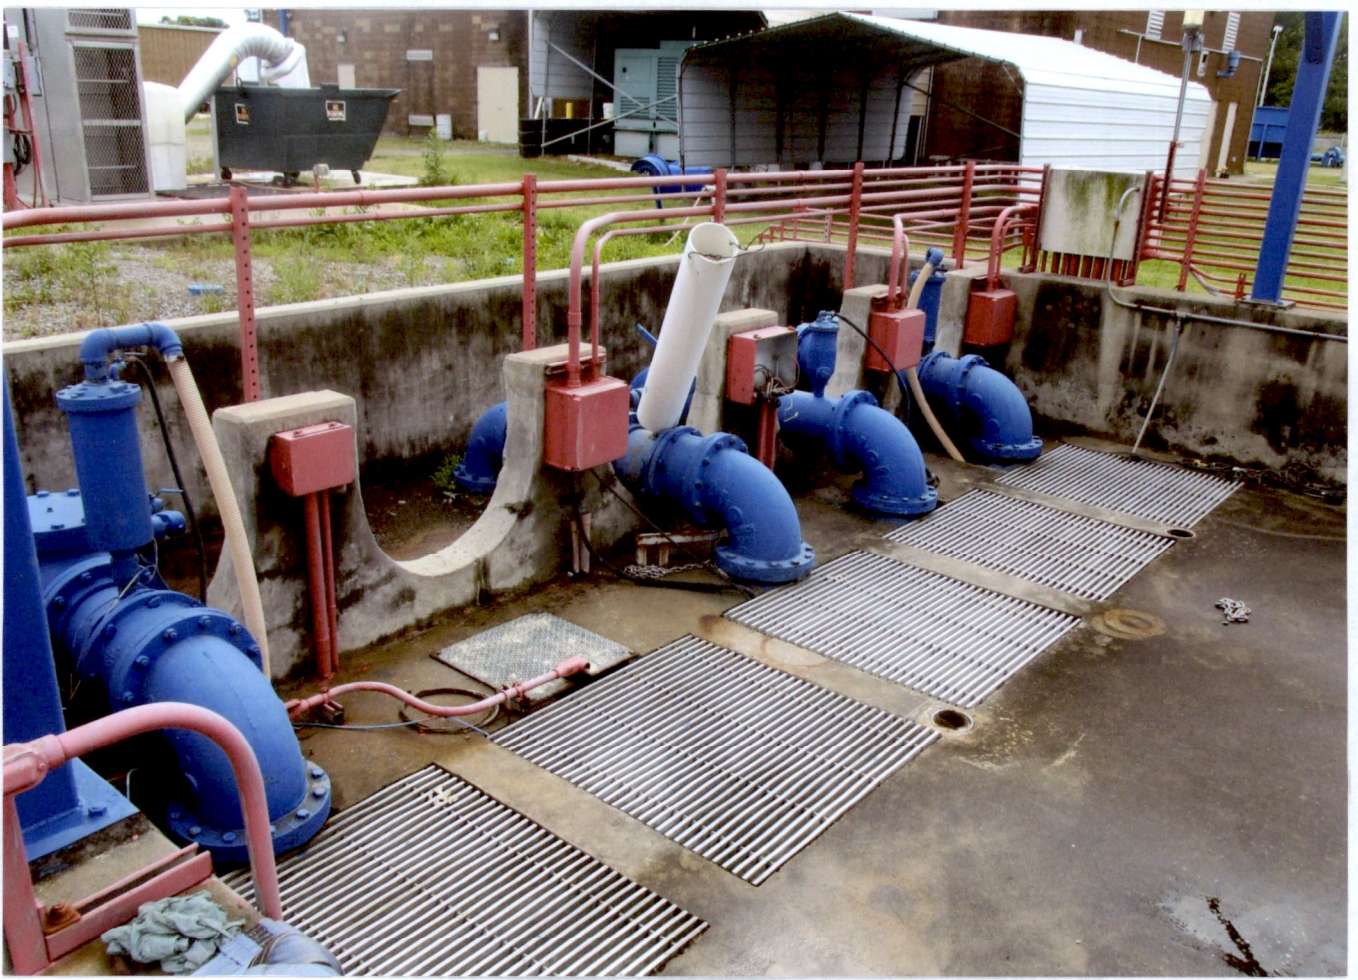
There are also four pumps, B1 thru B4, that pump excess flow above plant capacity into the 48 MG capacity flow regulating pond. The B pumps are 50 Hp rated at 3130 gpm at 47' TDH.

2. PRIMARY PUMPING STATION- 8 PUMPS TO FLOW REGULATION POND

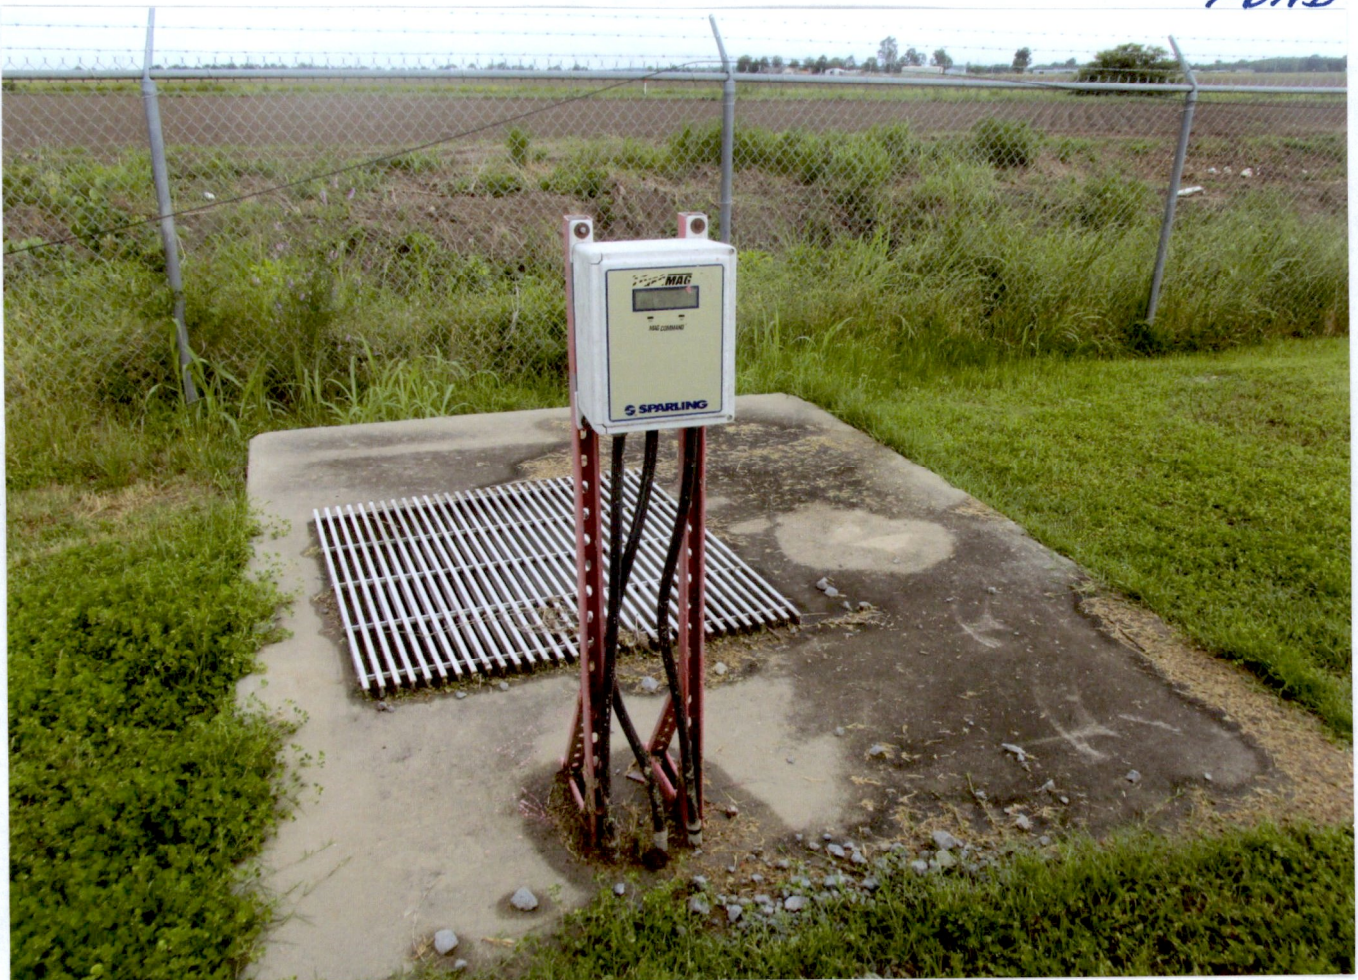
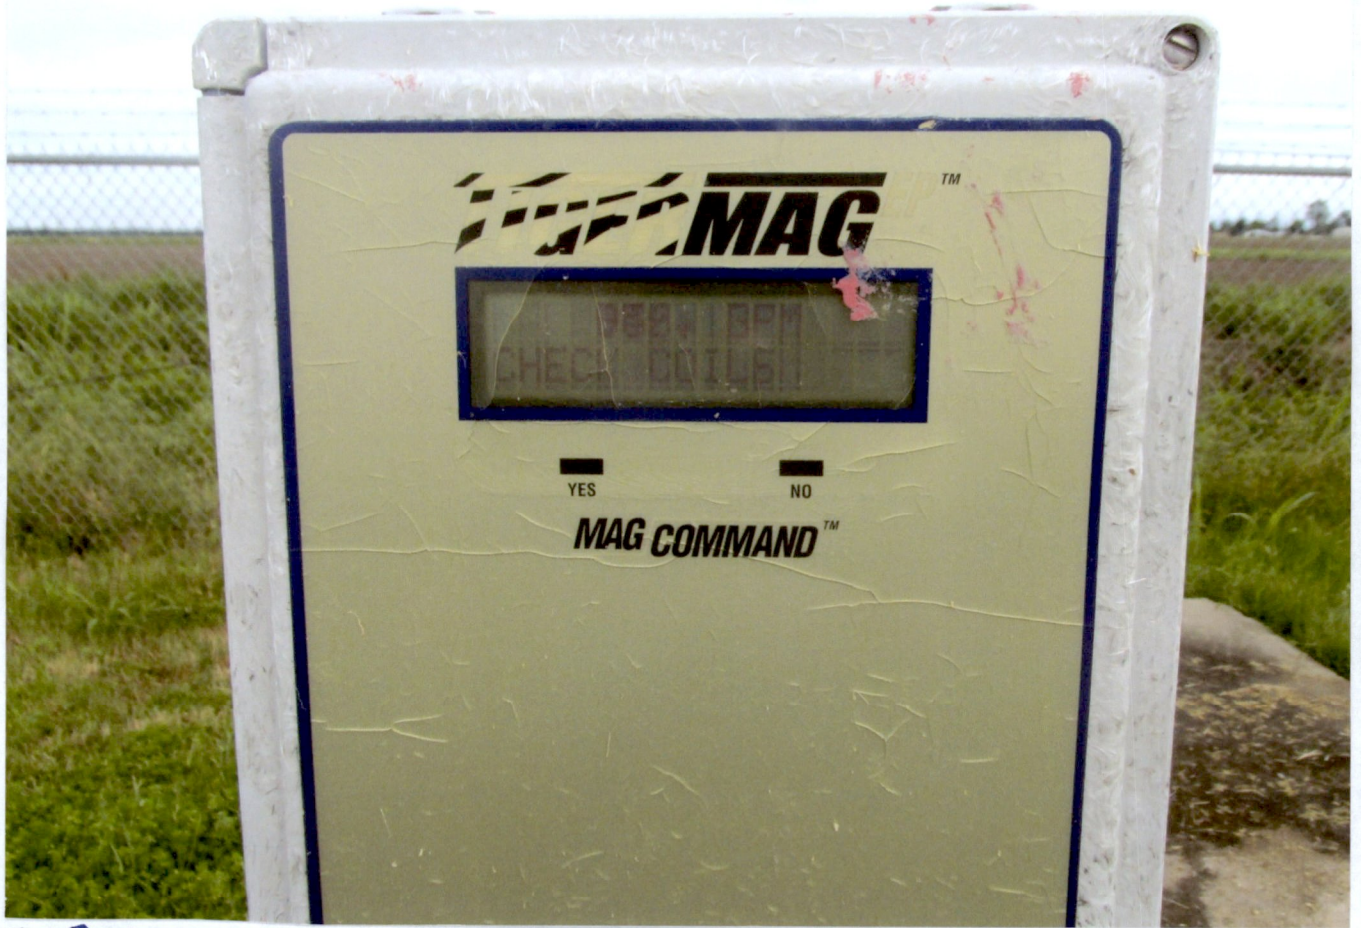
The primary pumping station flow measurement is giving check coil alarms and may be ready for repair or maintenance. The meter is a Tiger Mag 18" flanged meter made by Sparling.

2. PRIMARY PUMPING STATION- FLOW RECORDER

2. PRIMARY PUMPING STATION - FLOW RECORDER

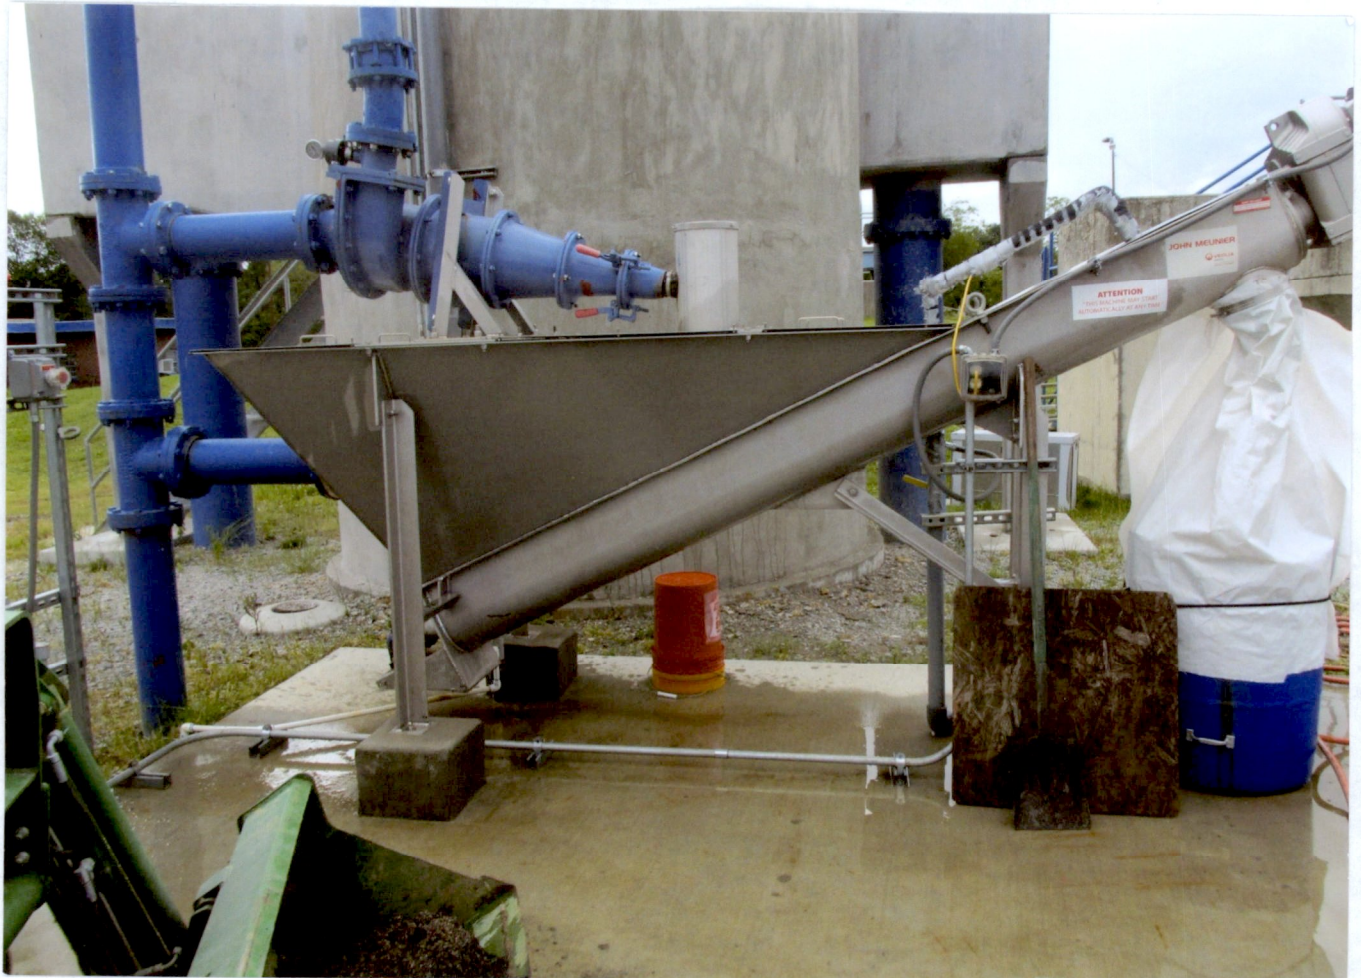
3. Metcan Grit Removal Mechanism and Sam Dewatering Screw were installed in 2015 and have a 5 MGD flow rating. This equipment is new and working fine. The Sam Dewatering Screw takes grit that is removed from the wastewater stream, washes same, and discharges into plastic garbage container. The container is picked up by front loader and carried to drying pad where it is spread and dried.

3. METCAN GRIT REMOVAL AND SAND Dewatering SCREW

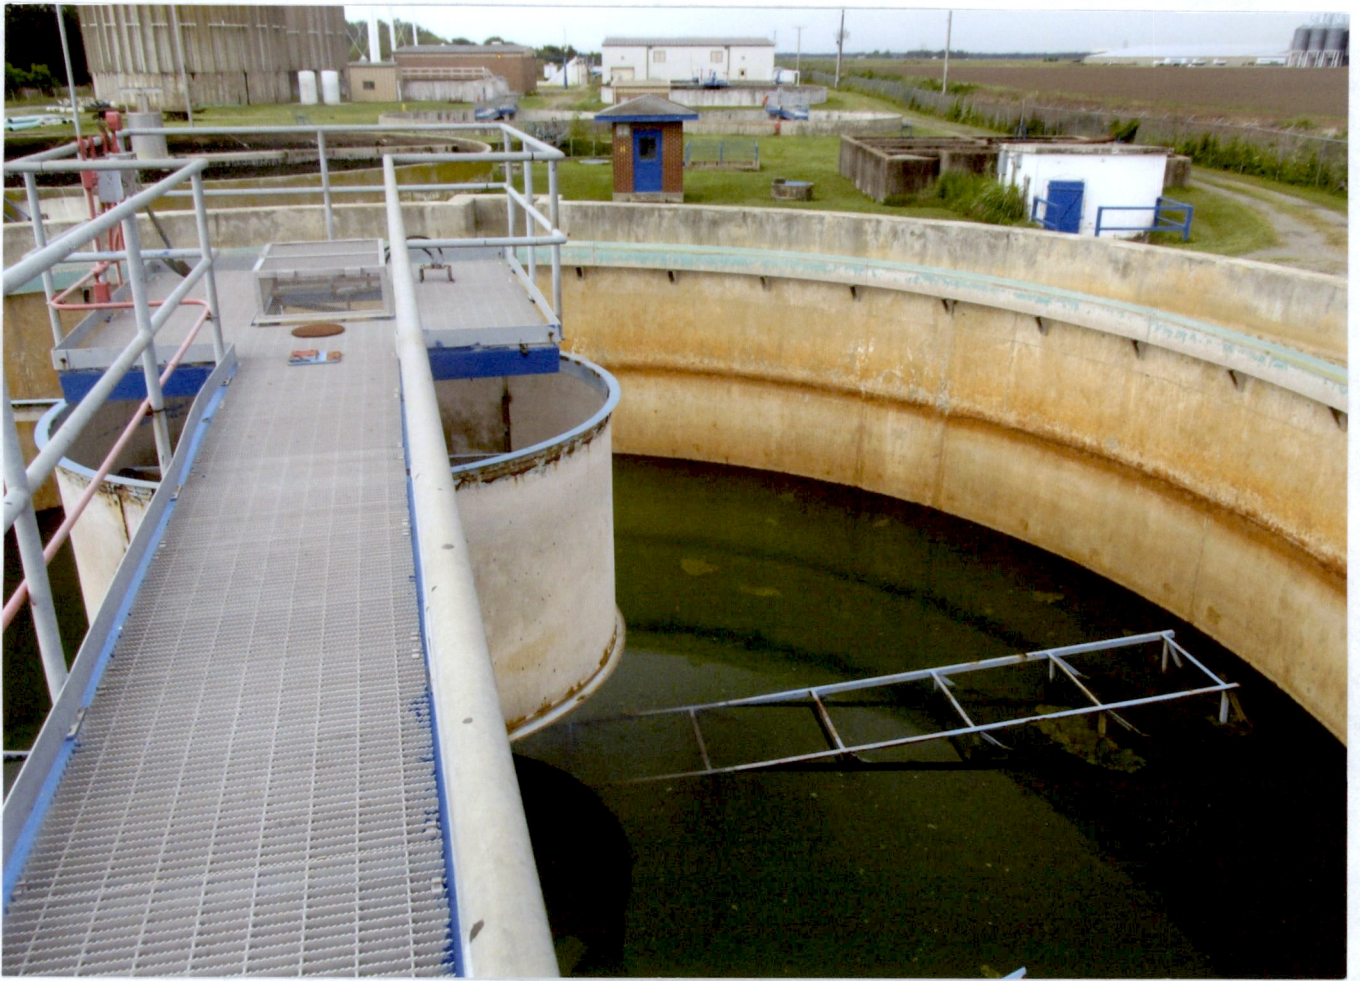
The largest clarifier D1 is out of service currently because the gear drive is being repaired by Layne-Christensen. The gear drive has been on order since January 2016 and should arrive soon and will allow this clarifier to be placed back in service.

4. LARGER PRIMARY CLARIFIER - GEAR DRIVE OUT FOR REPAIRS

4. a.	At Intermediate Size Clarifier Replacing Existing Box Valve and Tank Valve with 6" Gate Valves	Estimated Cost	4,500.00
b.	Repairing and Reinstalling Gear Drive on Largest Primary Clarifier D1	Estimated Cost	12,050.00

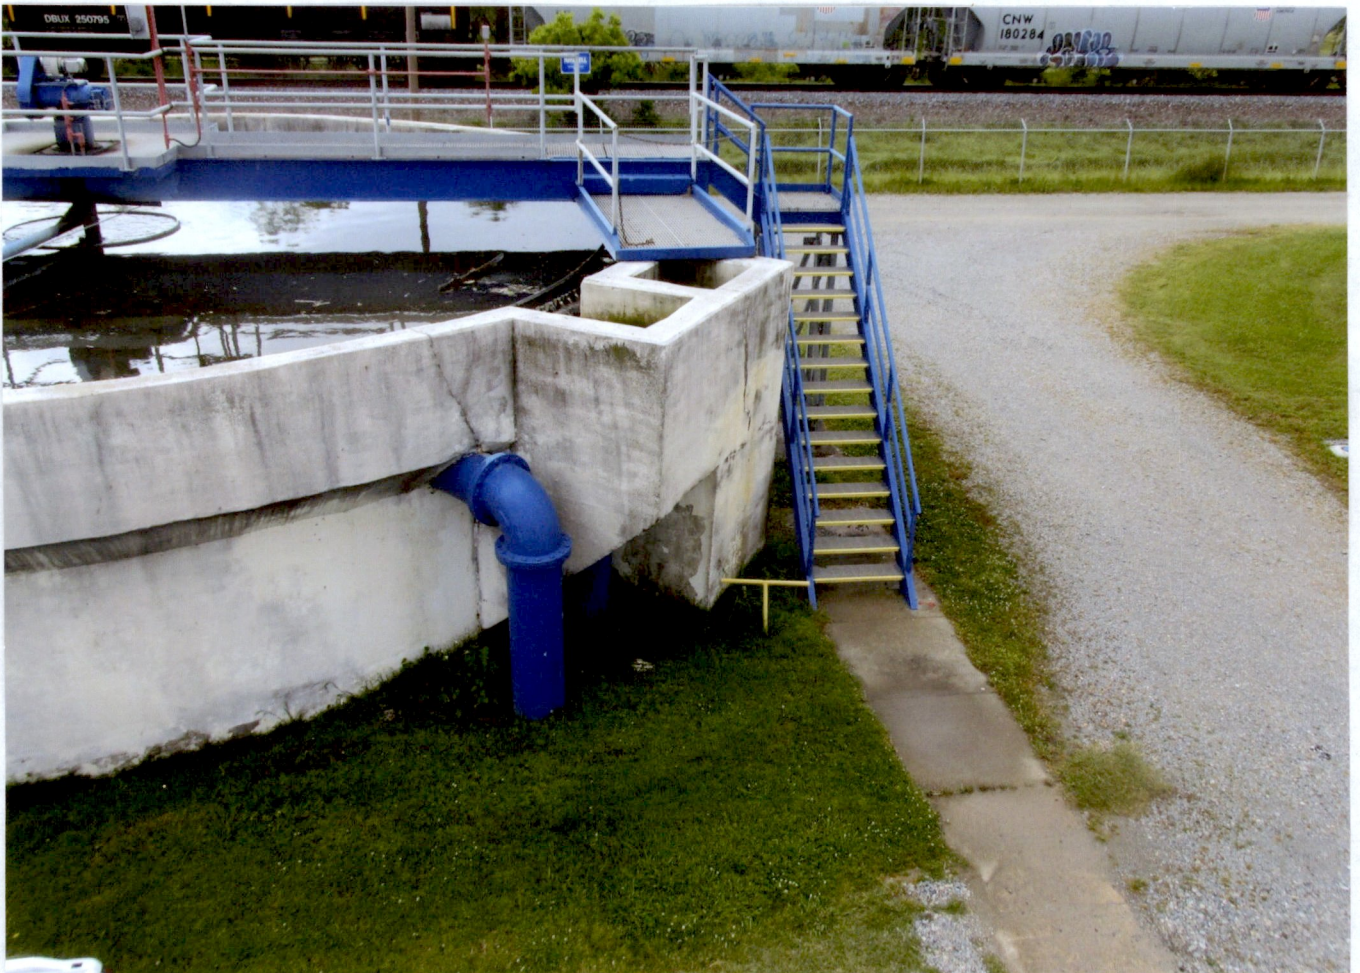
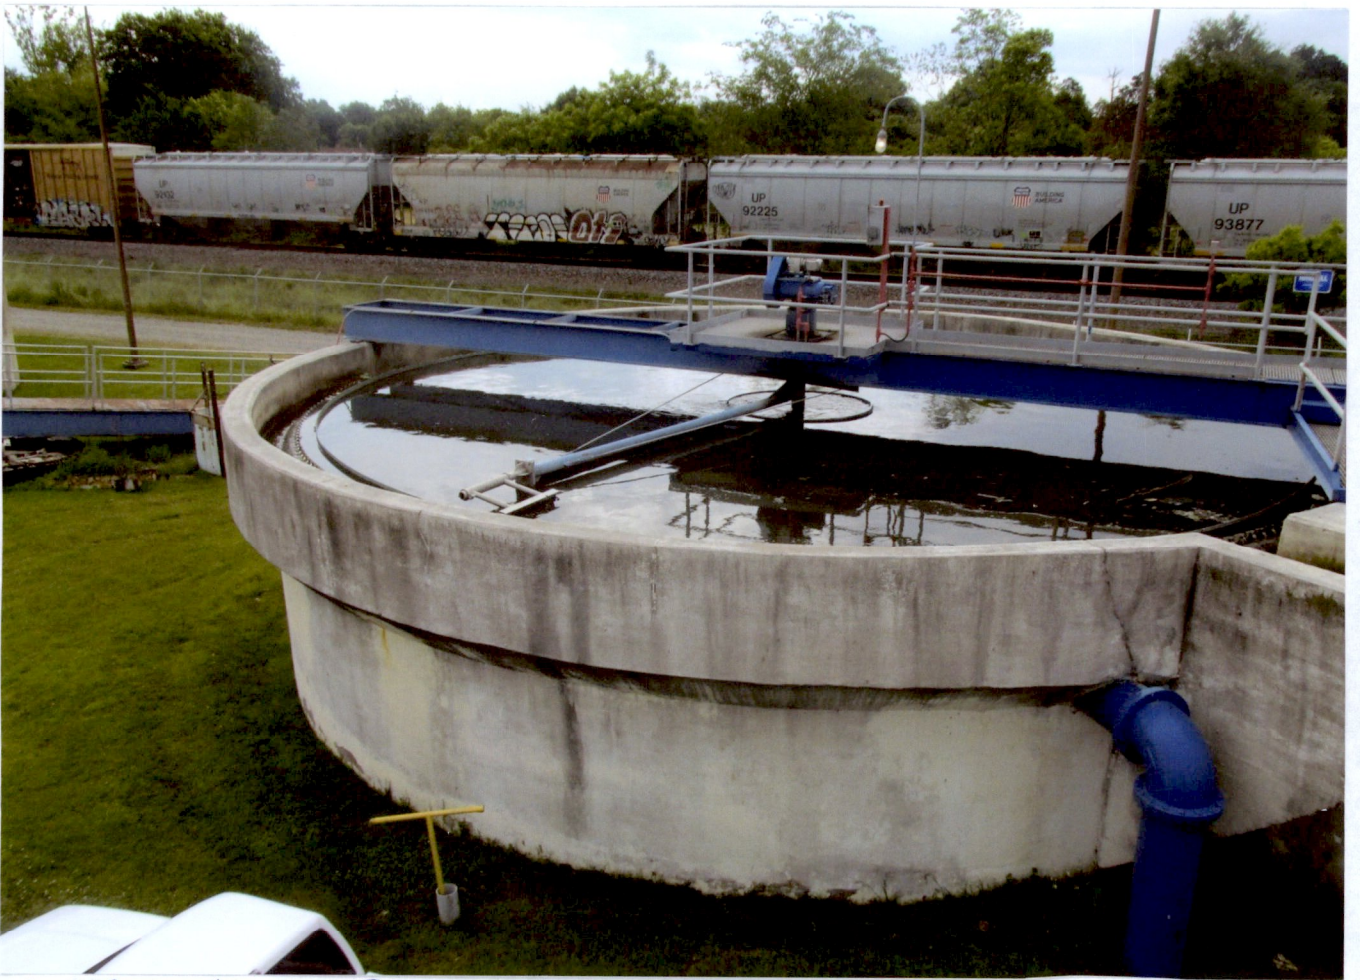
The D3 intermediate size clarifier needs New Box Valve (underground) and a new tank valve. The valves were plug valves and will probably be replaced with 6" gate valves.

4. MID SIZE PRIMARY CLARIFIER

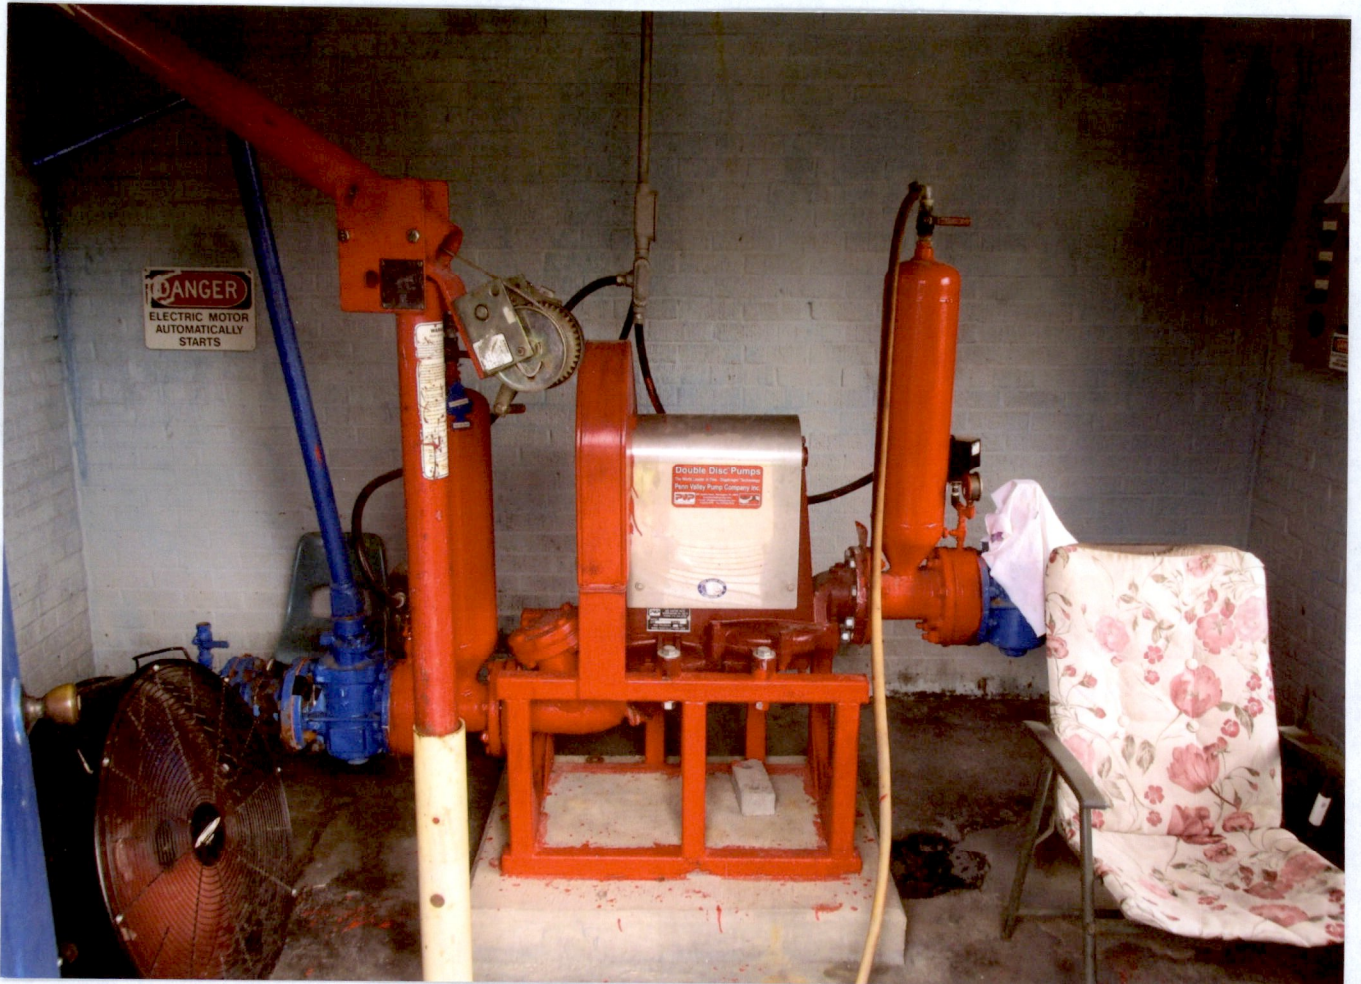
In Building D that pumps sludge from the largest west clarifier has a Penn Valley Pump that was installed in 1998 that is in good repair and is operating satisfactorily.

4. PENN VALLEY PRIMARY SLUDGE PUMP

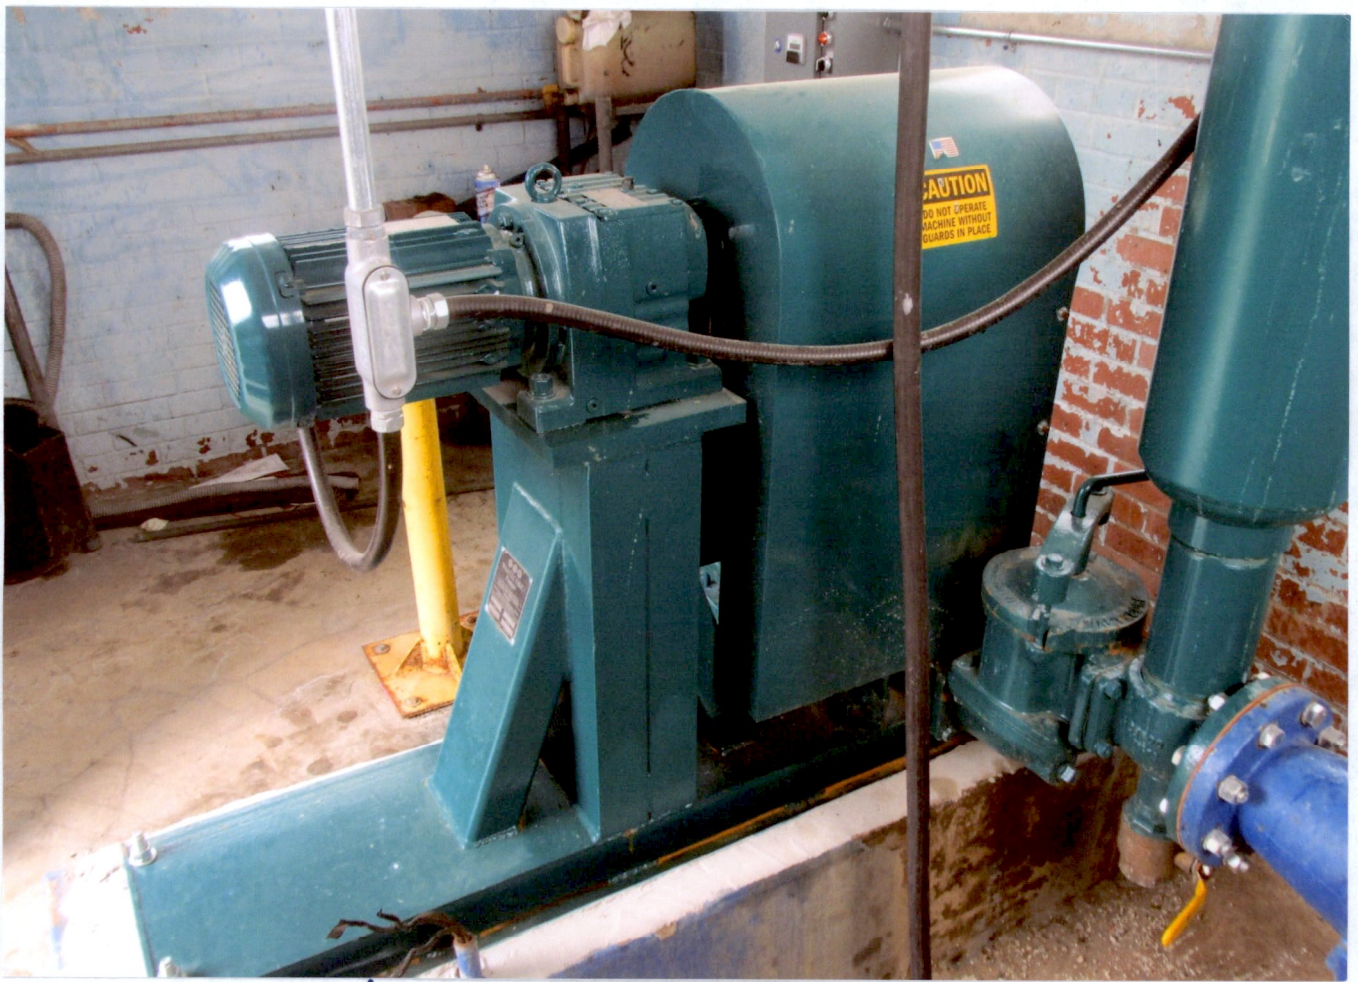
In Building E which pumps sludge from the smallest clarifier, the sewer plant personnel installed a new Marlow Wastecore Pump in 2015.

4. MARLOW WASTECORE PUMP - NEW 2015

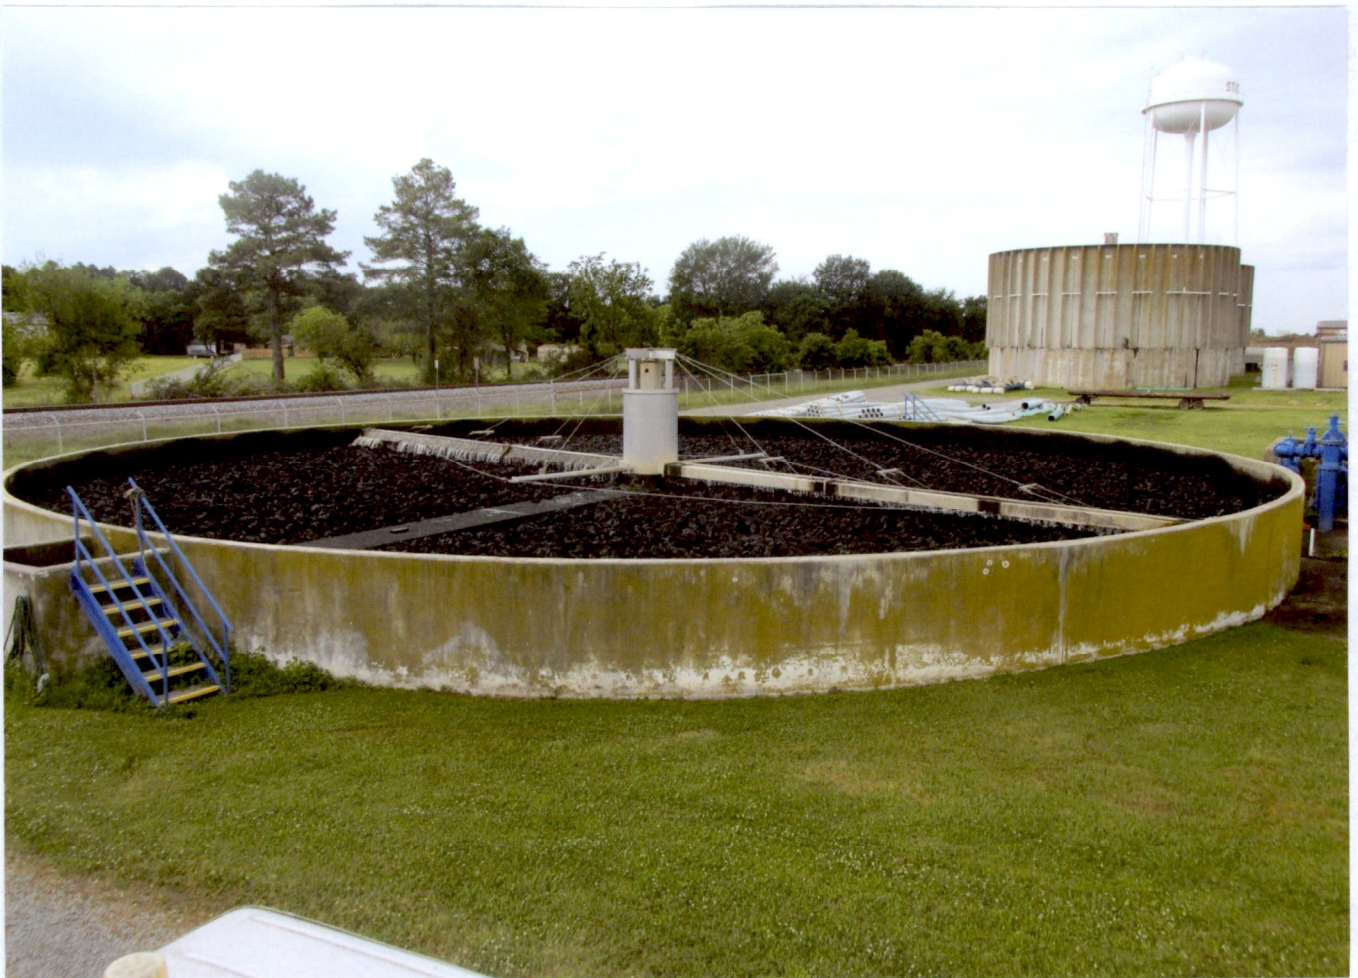
Both trickling filters are operating satisfactorily

5. OPERATING TRICKLING FILTER

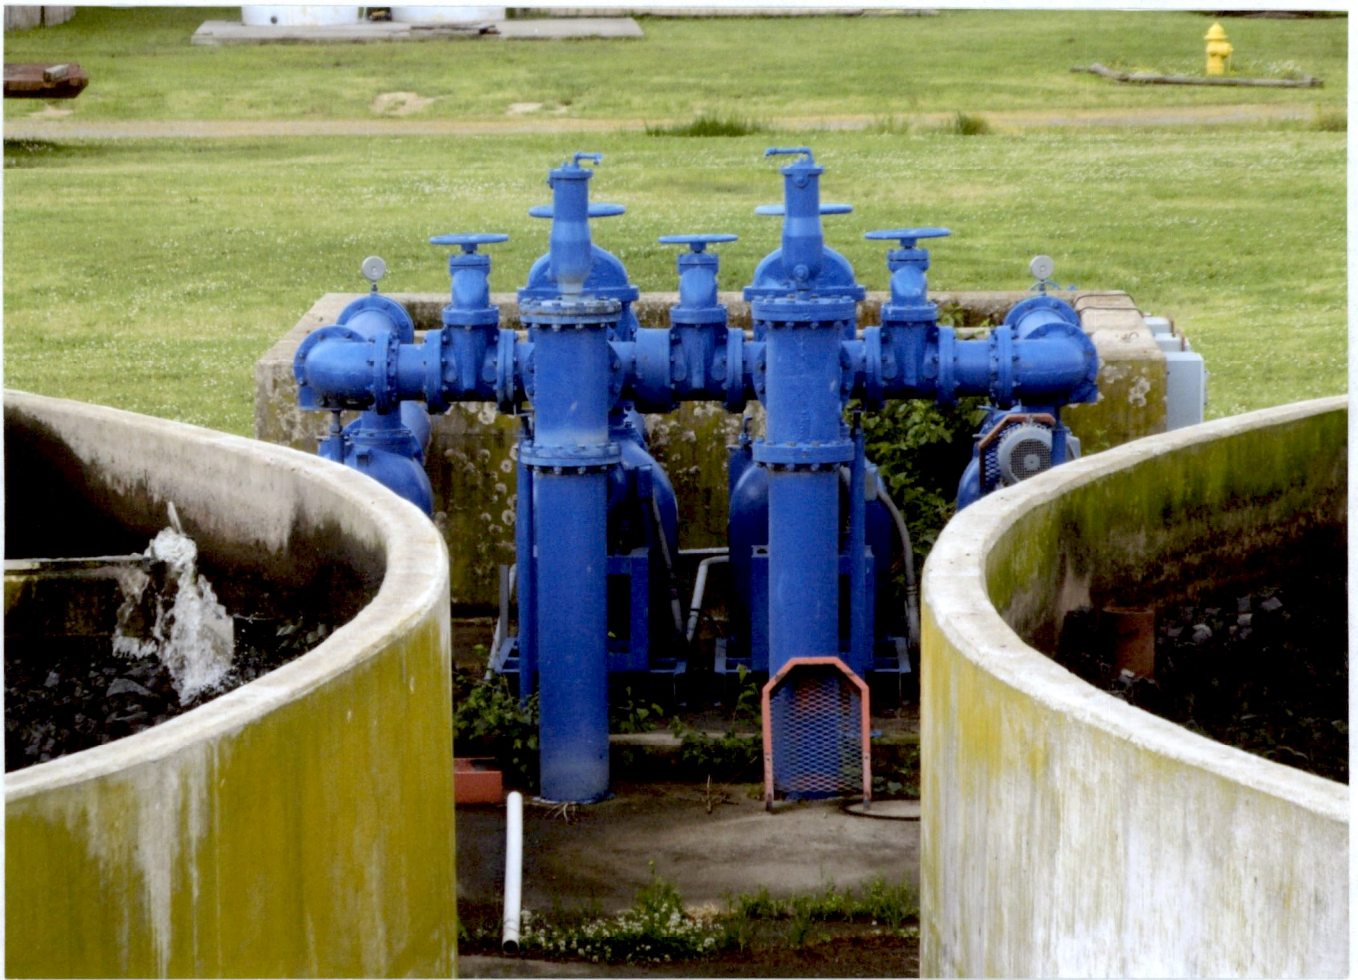
The trickling filter recirculation pumping station has four T6 Gorman-Rupp Pumps. All four (4) pumps are operating satisfactorily

5. TRICKLING FILTERS RECIRCULATION PUMP STATION
4TH PUMP REPAIRED AND BACK IN SERVICE

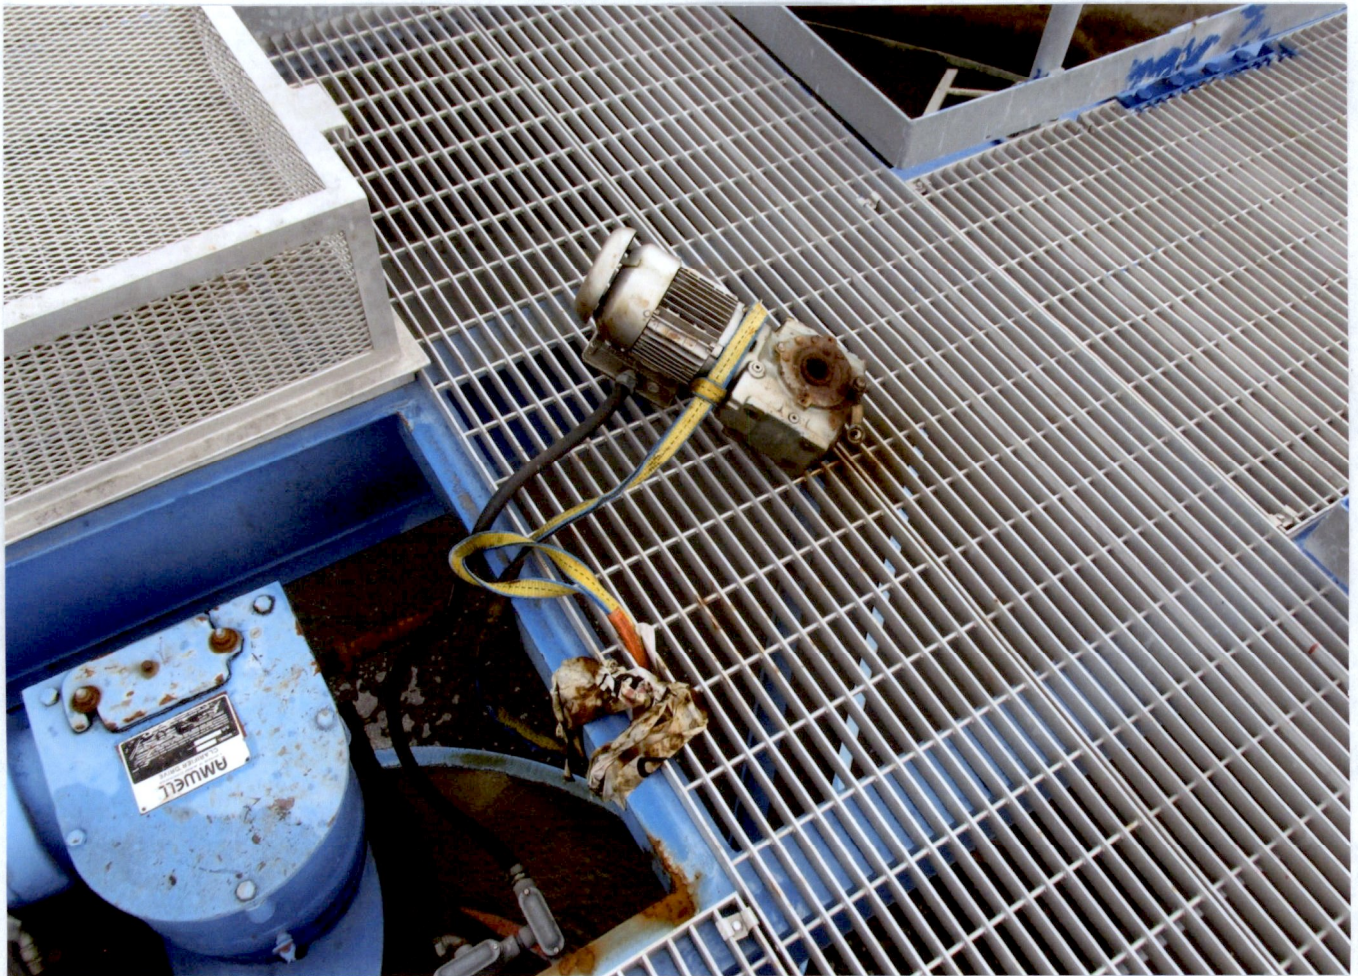
The east intermediate clarifier needs cleaning out and has a gear drive problem.

6. INTERMEDIATE EAST CLARIFIER - GEAR DRIVE OUT

6. a.	West Intermediate Clarifier - Cleaning Out Stopped Up Sludge Line	Estimated Cost	10,500.00
b.	East Intermediate Clarifier - Cleaning Out and Repairing Gear Drive - Parts on Hand	Estimated Cost	6,500.00

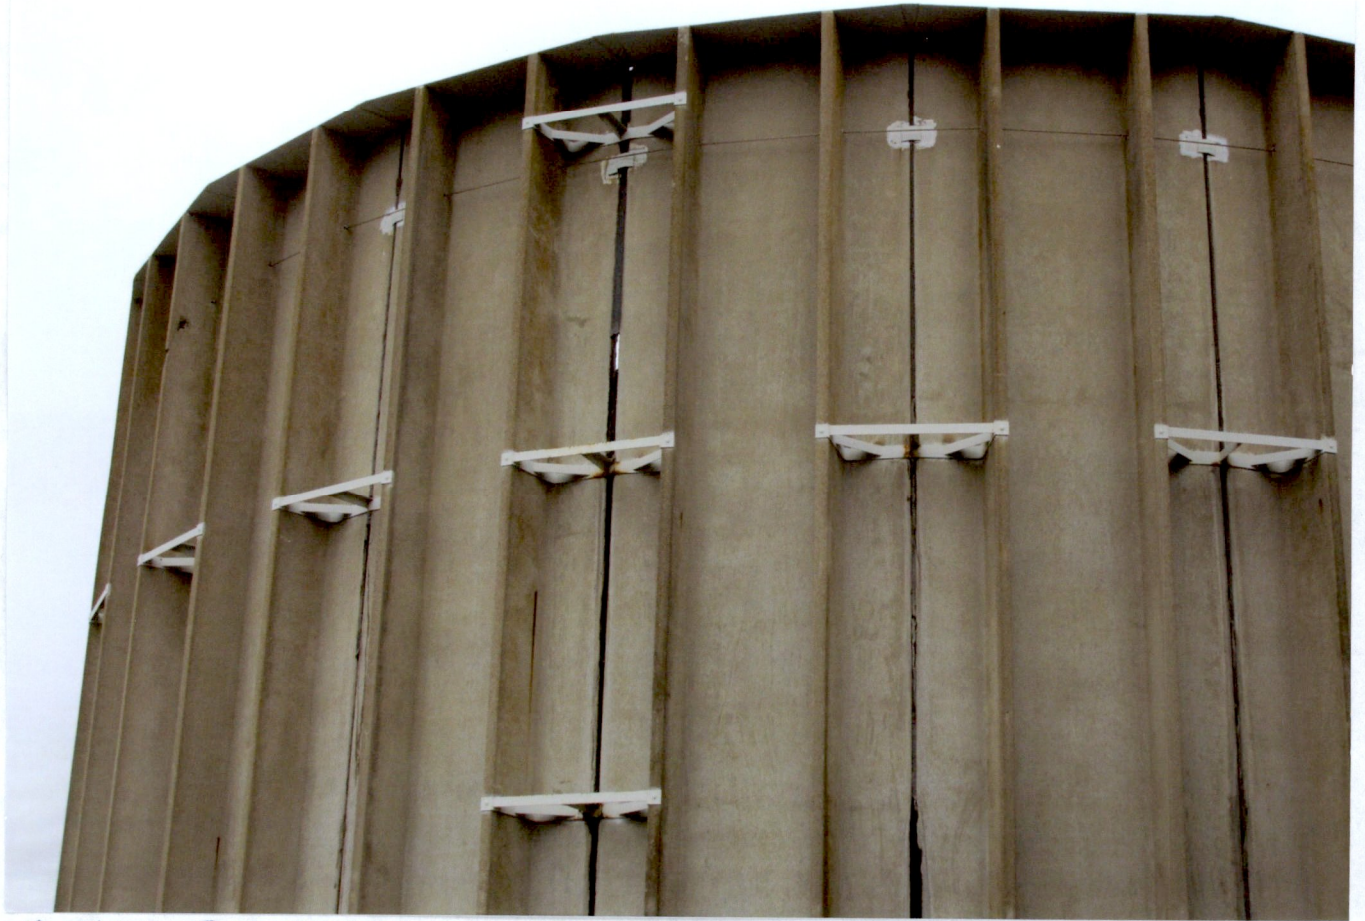
The Bio Towers have had field repairs to structure. They are now performing satisfactorily.

7. BIO TOWER FIELD REPAIRS TO STRUCTURE

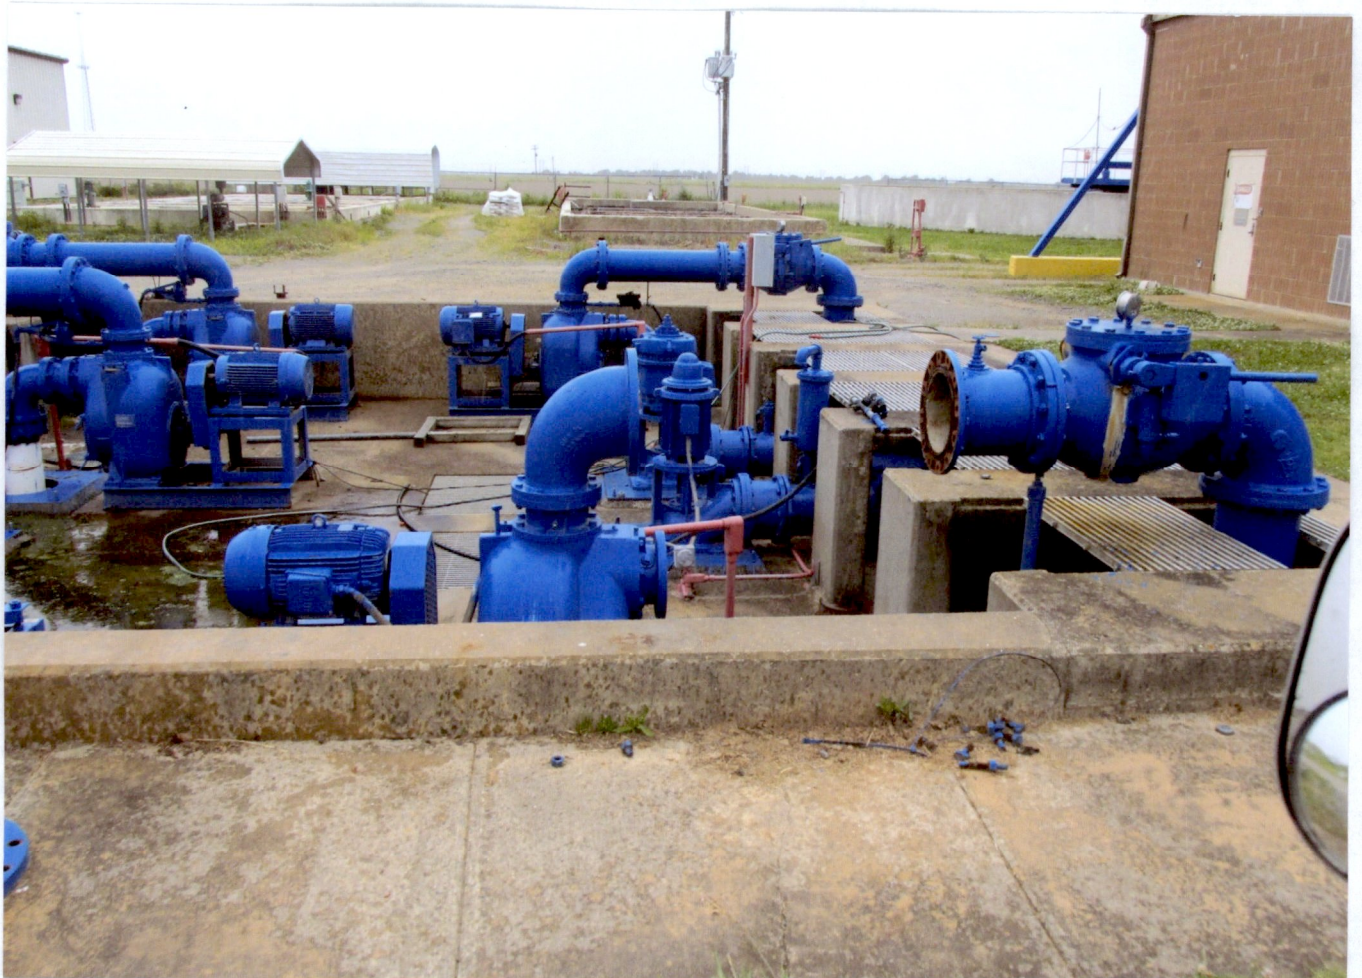
8. BIO TOWERS RECIRCULATION PUMP STATION - REPAIRS MADE BACK IN SERVICE
