RE: PERMIT NO. AR0034380, AFIN 01-00214

CONSENT ADMINISTRATIVE ORDER LIS NO. 16-006

COMPLETE TREATMENT SYSTEM EVALUATION

SEWER PLANT EVALUATION
STUTTGART MUNICIPAL WATER WORKS
JUNE 1, 2016

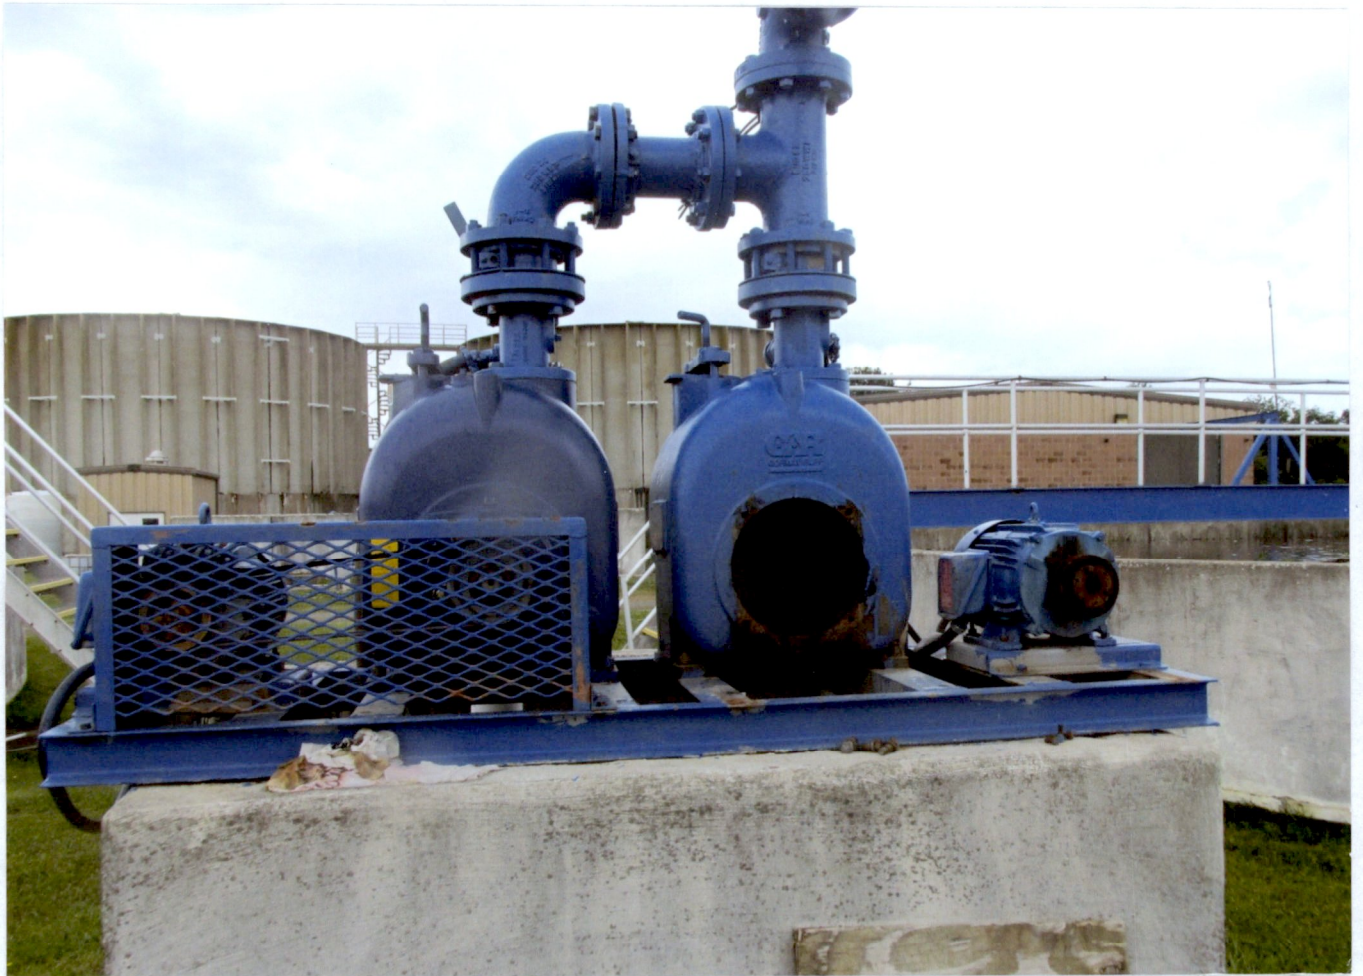
The north clarifier sludge pump station is out of service awaiting repair or replacement. The south clarifier sludge pump is also in need of repair.

9. NORTH CLARIFIER PUMP STATION- DOWN FOR REPAIR

9. a.	Must Obtain Parts for Gear Drive, Repair and Put Back in Service. This is an 80' diameter clarifier.	Estimated Cost	100,000.00
b.	The Gorman-Rupp T-3 Sludge Pump is out of service on North Clarifier.	Estimated Cost	7,500.00

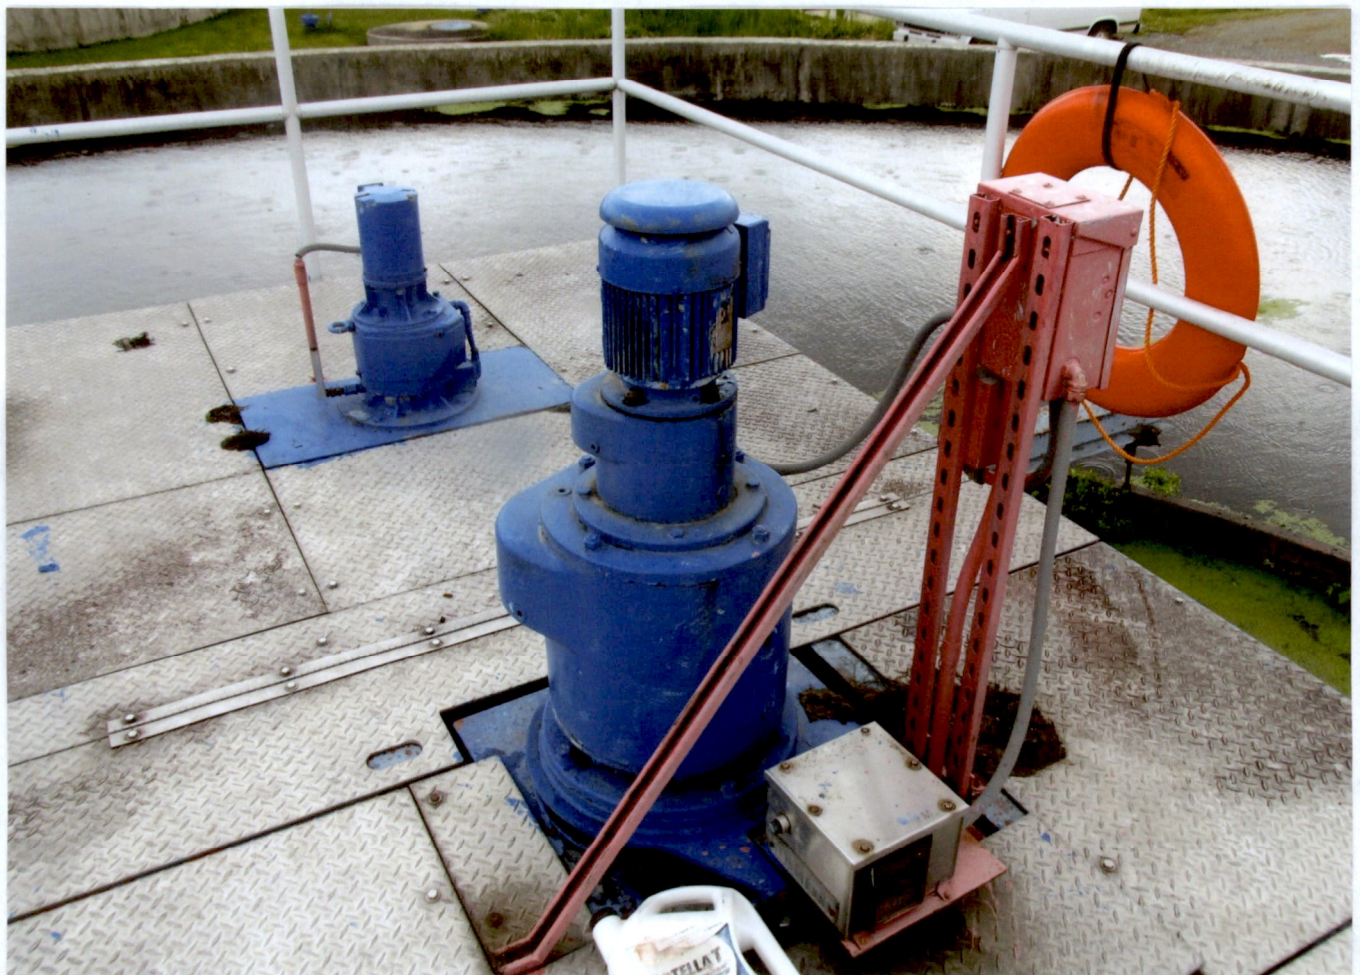
The north clarifier is down for gear drive repair. The operator must obtain parts, repair gear drive and put back in service.

9, NORTH CLARIFIER- DOWN FOR GEAR DRIVE REPAIR

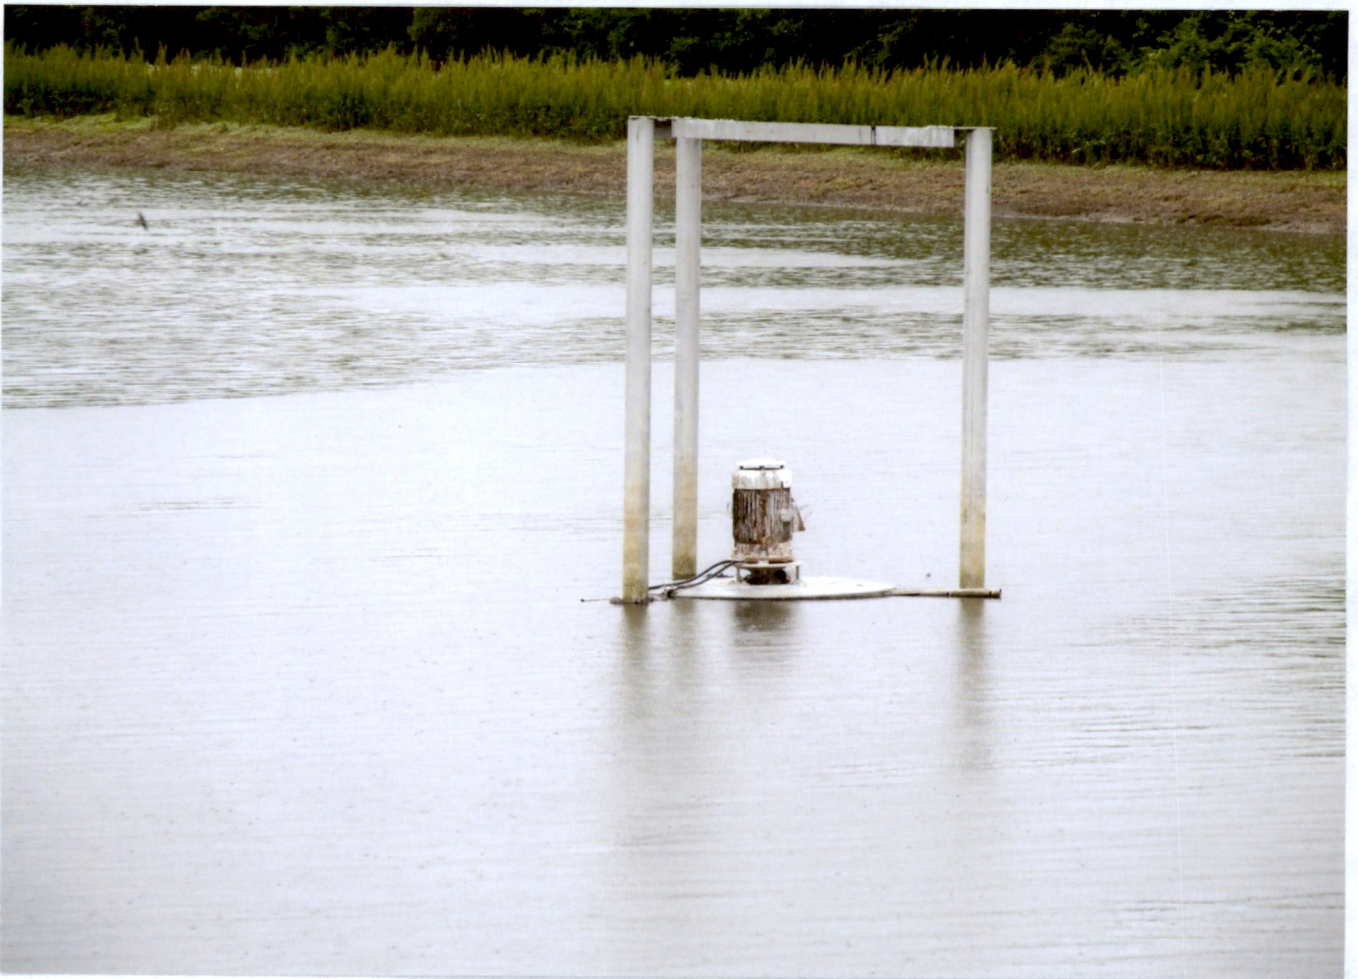
The north surface aerator is now back in service. The three intermediate aerators in the pond are operating normally. The plant superintendent plans to remove the south aerator for repair and place back in service. In the pump back pump station on north side of flow regulation pond, the northerly pump is not operating. The 2nd pump is operating satisfactorily.

14. SOUTH AERATOR IN FLOW REGULATION POND TO BE REPAIRED

13. a.	Standby Compressor for Post Aeration System	Estimated Cost	8,500.00
14. a.	South Aerator to be taken out of service for repairs.	Estimated Cost	9,000.00

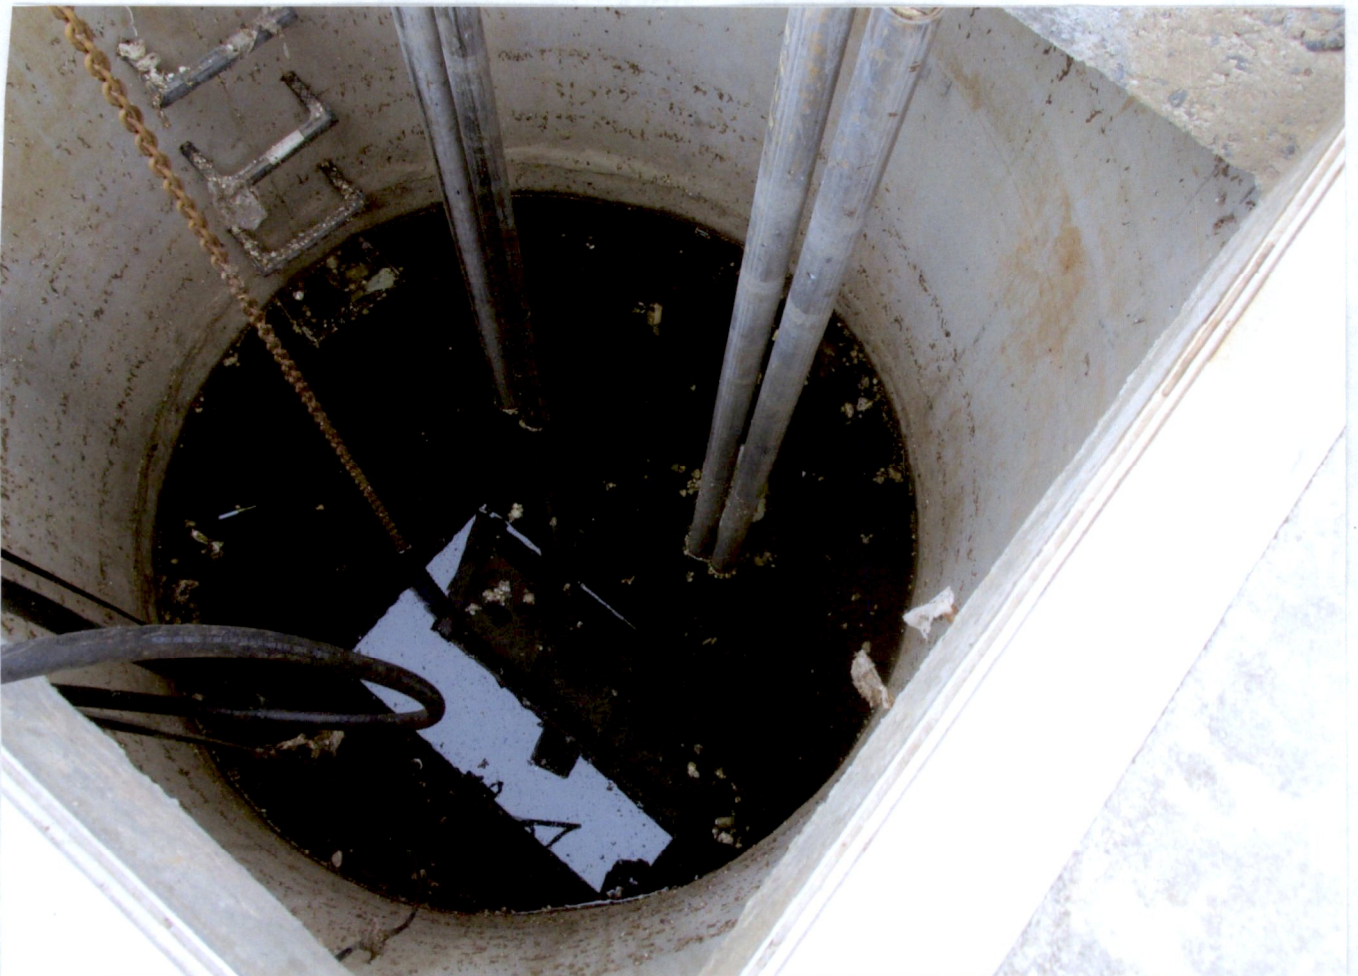
Also, I'm told that during construction, there was no valve installed in line between pond and pump back station. Now operator has no way of lowering water level in pump back station to service the dual pumps.

14. PUMP BACK PUMP STATION-LOOKING DOWN THRU MANWAY

b.	Line between flow regulating pond and pump back pumping station is 24-inch ductile iron and is about 27-foot deep, a 24-inch gate valve needs to be installed in line.	Estimated Cost	74,500.00

c.	Once the valve is in place, the pump back station can be dewatered so personnel can get into Wet Well and examine the loose rail and the 20 Hp Fairbanks Submersible Pump for possible repair and put back in service.	Estimated Cost	<u>2,900.00</u>
	Subtotal		\$ 277,760.00
	Contingency		<u>28,000.00</u>
	Suggested Budget		\$ 305,760.00
	Tertiary Pumping Equipment Budget		263,200.00
	New SCADA Control System and Monitoring for Sewer System		<u>700,000.00</u>
	Total Estimated Cost		\$1,268,960.00
	Less Tertiary Pumping Equipment Budget, which is on hand		<u>-263,200.00</u>
	New Funding Needed		\$1,005,760.00

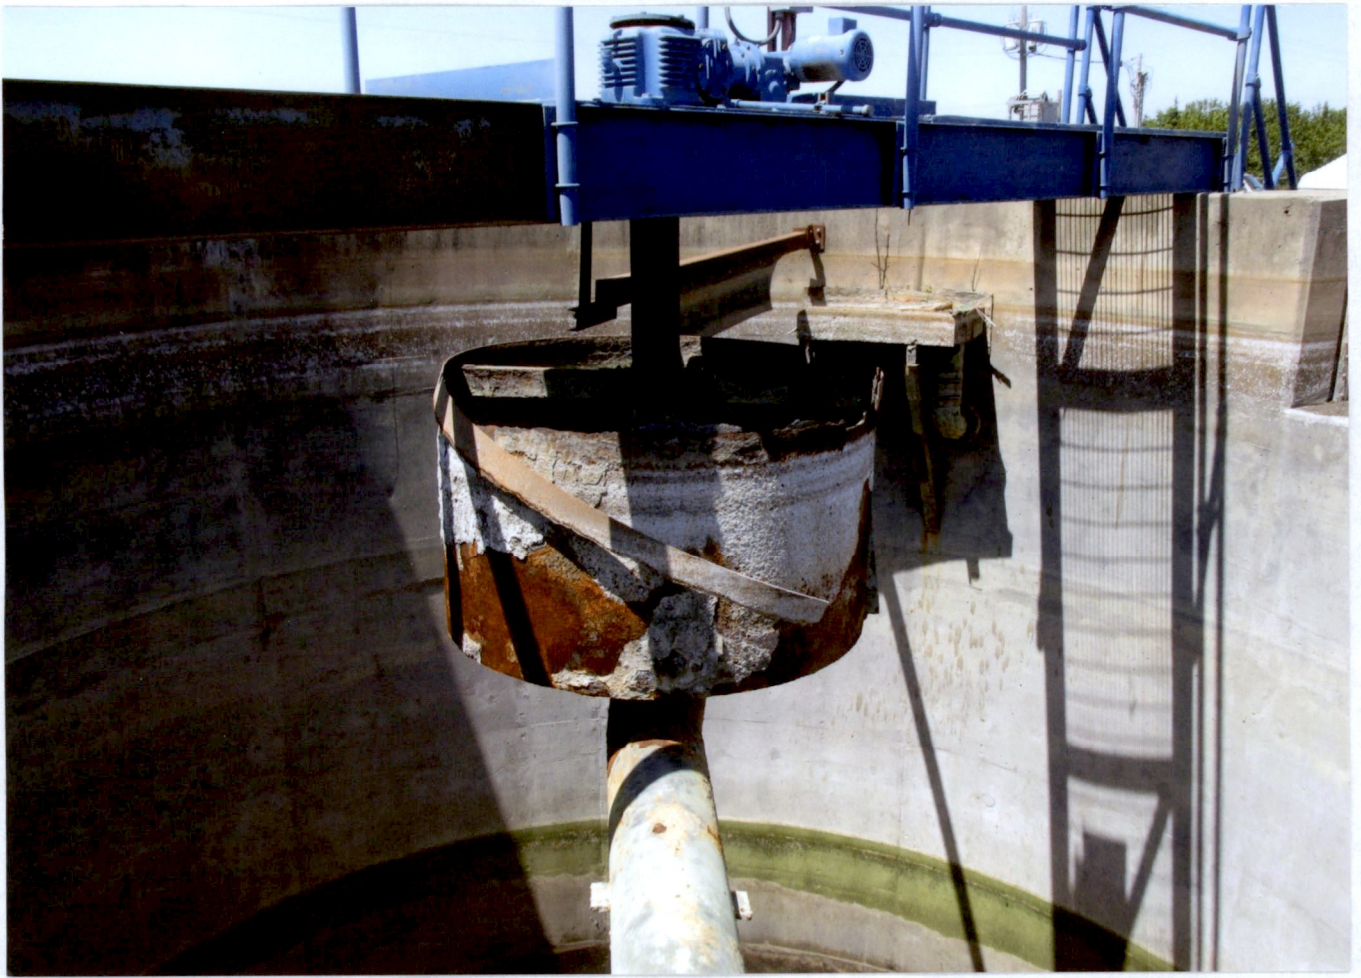
Both aerobic digesters received new aerators and gear drives in 2015. The East Digester also had a new bridge installed, with aerator and gear drive. Now both digesters are performing satisfactorily. However, the west decant clarifier's gear drive and scraper drive have now been repaired and placed back in service.

15. WEST SIDE DECANT- DOWN FOR REPAIRS- REPAIRS
MADE- BACK IN SERVICE
