Jacksonville Wastewater Utility

RE: NPDES Permit No.: AR0041335, AFIN: 60-00543
Sanitary Sewer Overflows (SSOs)

This Corrective Action Plan (CAP) is being provided in response to your letter dated November 7, 2016. I would like to provide some history of inflow/infiltration (I/I) repairs done as a part of our on-going CAP depicting the serious consideration given and actions taken by Jacksonville Wastewater Utility (JWWU) in an attempt to eliminate SSOs from 1995 to date.

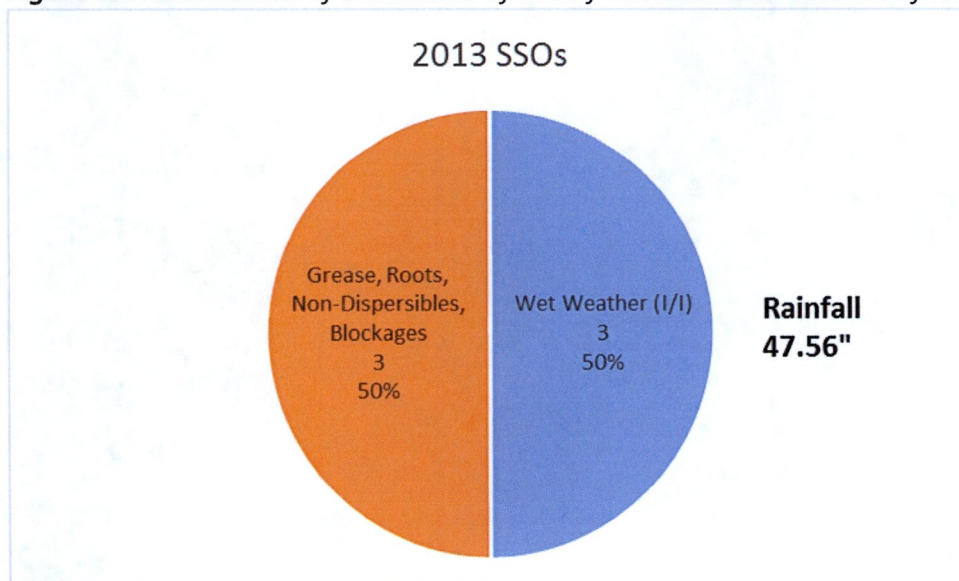
Figure 2: A breakdown of the causes of SSOs from 2013 and amount of rainfall.

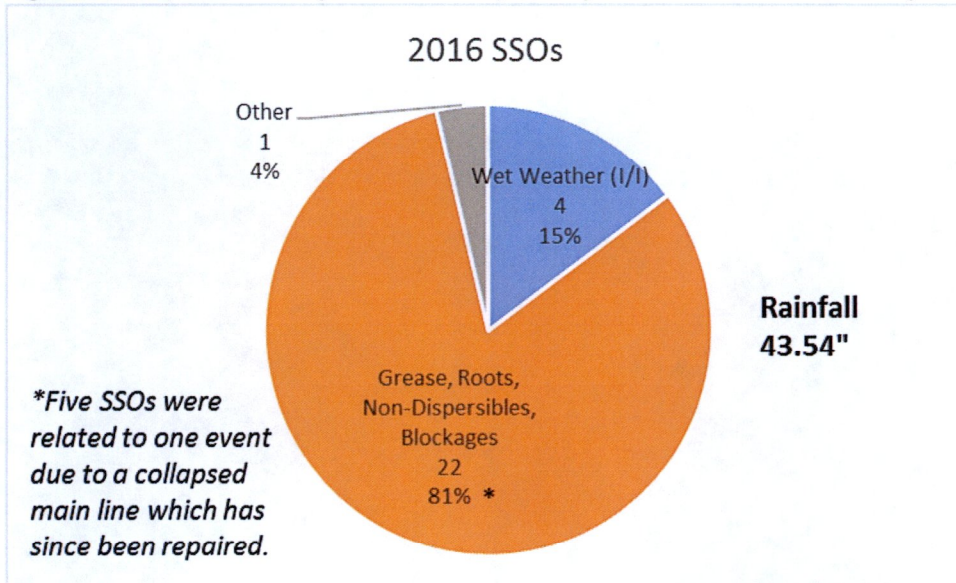
Figure 5: A breakdown of the causes of SSOs from 2016 and amount of rainfall.
