**CITY WATER & LIGHT**

**2019 PROGRESS REPORT  
CORRECTIVE ACTION PLAN**

SANITARY SEWER OVERFLOWS: SUMMARY OF ONGOING ACTIONS  
AND PLAN FOR ADDITIONAL CORRECTIVE MEASURES

December 16, 2019

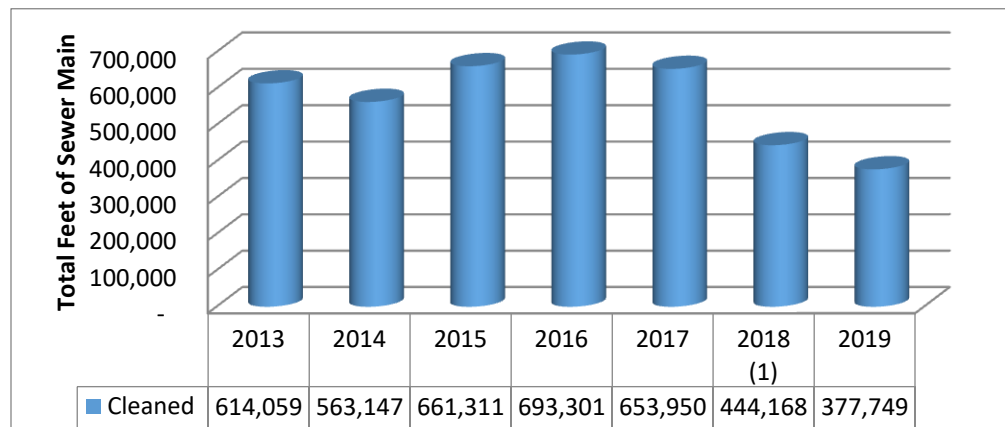
**Graph 3-1: Sewer Mains Cleaned (2013 thru October 31, 2019)**

As presented in the CAP, CWL sewer service trucks maintain the system through routine cleaning. Graph 3-1 provides a summary of the past 6 year totals, along with the total footage cleaned for January 1<sup>st</sup> thru October 31<sup>st</sup> of 2019.

In the 2018 Progress Report, Total Feet of Sewer Main Cleaned was reported as 409,357'. November (16,924') and December (17,887') 2018 is included in the 2018 total shown.
