**CITY WATER & LIGHT**

**2018 PROGRESS REPORT  
CORRECTIVE ACTION PLAN**

SANITARY SEWER OVERFLOWS: SUMMARY OF ONGOING ACTIONS  
AND PLAN FOR ADDITIONAL CORRECTIVE MEASURES

NPDES Permit Number: AR0043401

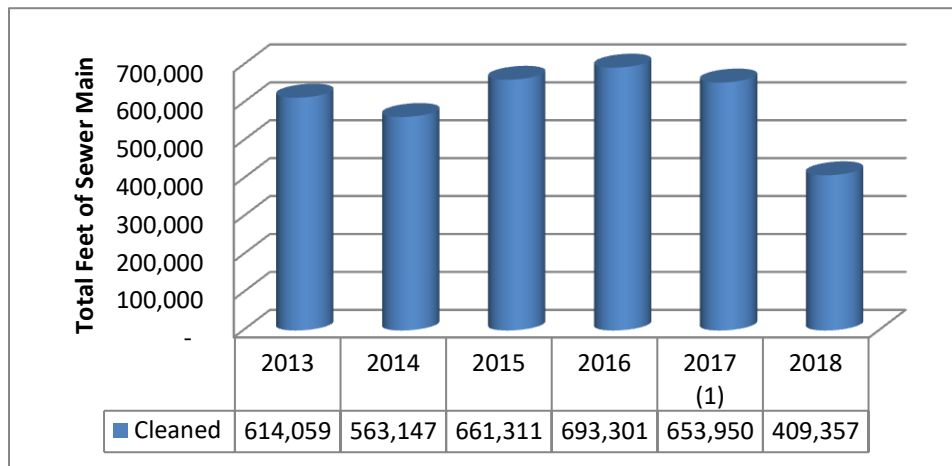
**Graph 3-1: Sewer Mains Cleaned (2013 thru October 31, 2018)**

As presented in the CAP, CWL sewer service trucks maintain the system through routine cleaning. Graph 3-1 provides a summary of the past 5 year totals, along with the total footage cleaned for January 1<sup>st</sup> thru October 31<sup>st</sup> of 2018.

In the 2017 Progress Report, Total Feet of Sewer Main Cleaned was reported as 568,538'. November (52,887') and December (32,525') 2017 is included in the 2017 total above.

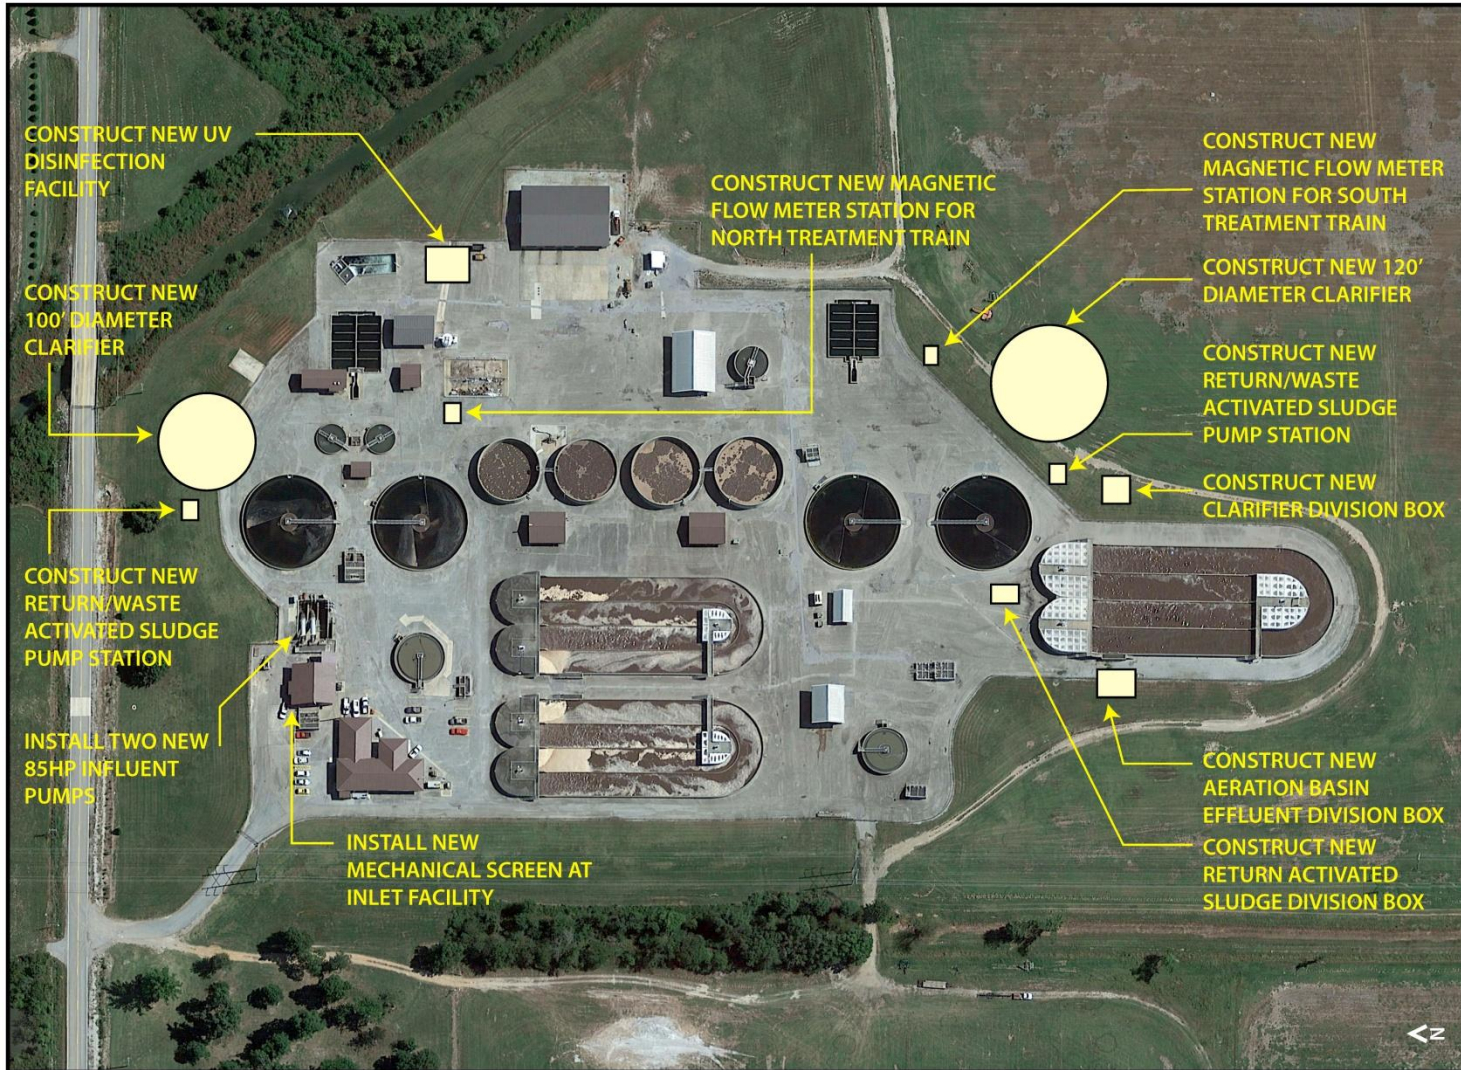
**EASTSIDE WASTEWATER TREATMENT PLANT IMPROVEMENTS**

While the CWL Eastside WWTP biological treatment capacity remains more than sufficient as currently designed, the plant’s hydraulic capacity under wet weather flows was identified for certain capital improvements to optimize operation. Plans and specifications for a hydraulic upgrade were developed by Olsson Associates and included an 18-MGD head works pump addition, bar screen replacement to increase hydraulic throughput, and construction of one 100’-diameter clarifier and one 120’-diameter clarifier. An automated inlet flow-proportioning weir, RAS and WAS pumps, UV disinfection and additional structures and piping are also included in the upgrades.

The plans were approved by the ADEQ, and the construction permit became effective June 8, 2018. Van Horn Construction from Russellville, Arkansas was the successful bidder for the project and was issued a formal Notice to Proceed on July 23, 2018. Work is progressing on schedule despite significant rainfall amounts since construction started. CWL has spent over **\$893,000** with Olsson through October 31, 2018 for their work on this project. This amount does not include significant in-house costs for work performed by CWL Engineering and Management personnel. Van Horn’s contract price for construction is over **\$13 million**, including change orders through October 30, 2018, and CWL has paid Van Horn over **\$2 million**

to date. The total projected cost for this project has been updated to approximately **\$15 million**. The project is planned for completion in the last quarter of 2019.

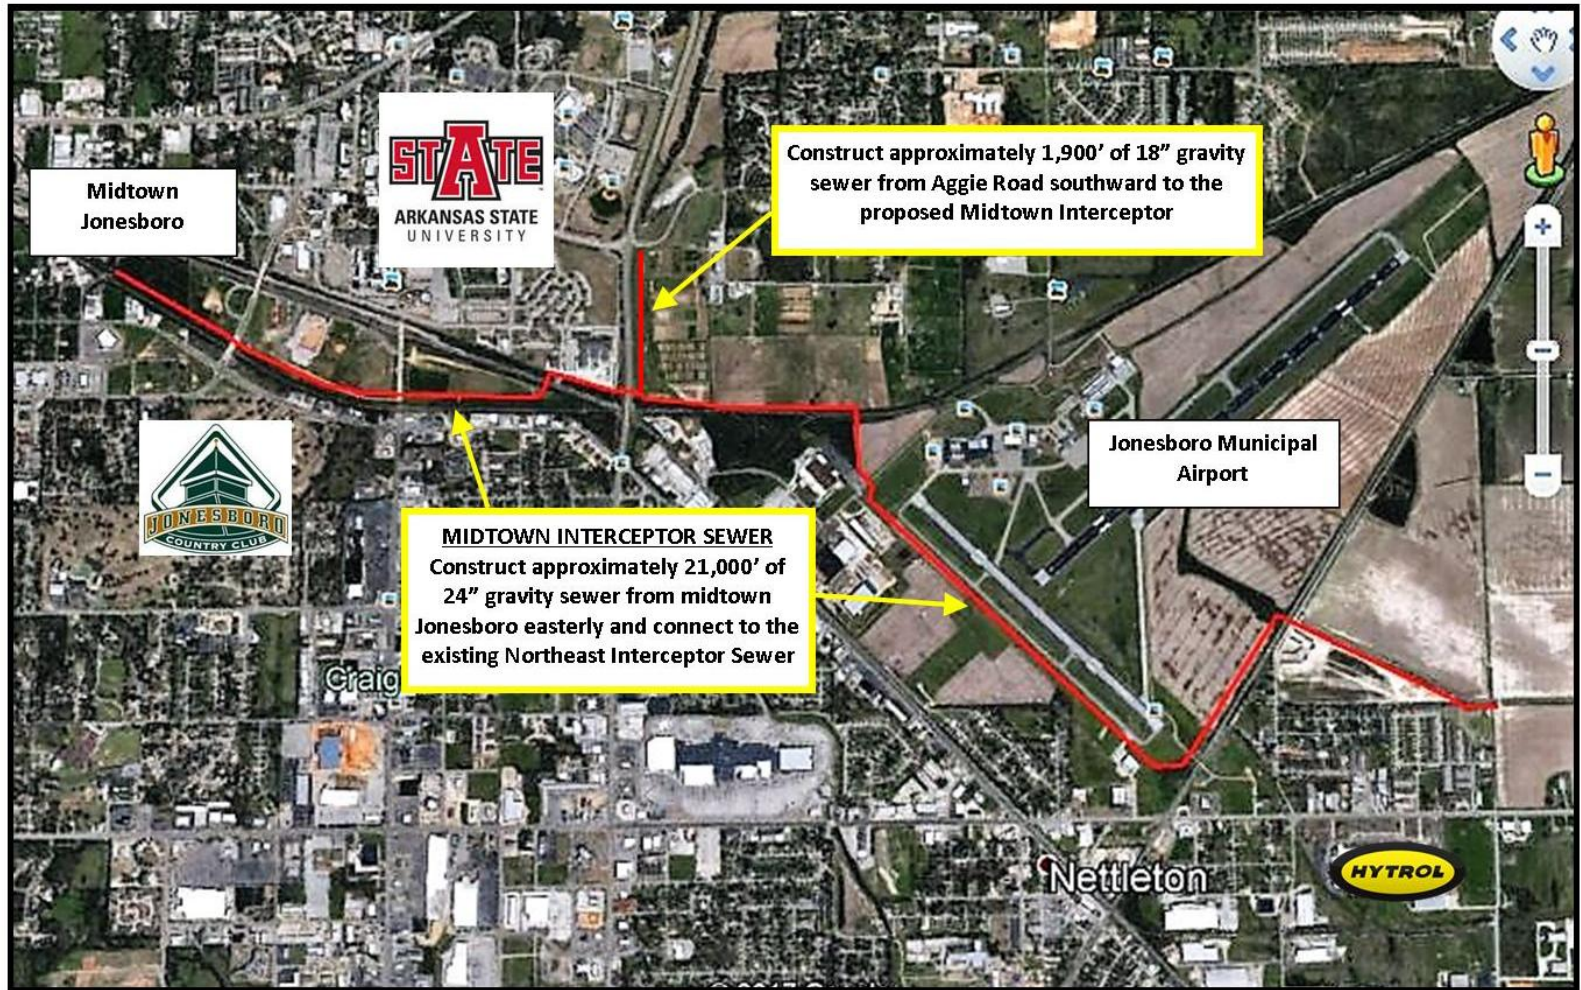
### Midtown Interceptor Sewer

In an effort to address capacity constraints in the midtown Jonesboro (i.e. E. Nettleton Ave, Kitchen St, E. Matthews Ave and Arkansas State University) area, CWL has contracted Olsson to assist in the design of the Midtown Interceptor. The targeted area is defined by sanitary sewer basins JB18, JB19, JB20, and JB21, as shown in Appendix B, Basin Delineation. The survey and design work are complete for the approximately four-mile gravity sewer, which will be a 24"-diameter line connecting the midtown area to the Northeast Interceptor sewer, placed in service September 2014. Easement acquisition and permitting for railroad and highway crossings are underway. CWL has projected a total cost of approximately **\$5.9 million** for the project and plans to begin construction approximately June 1, 2019, allowing CWL to take advantage of the normally dryer weather. This should result in a completion date in late 2019.

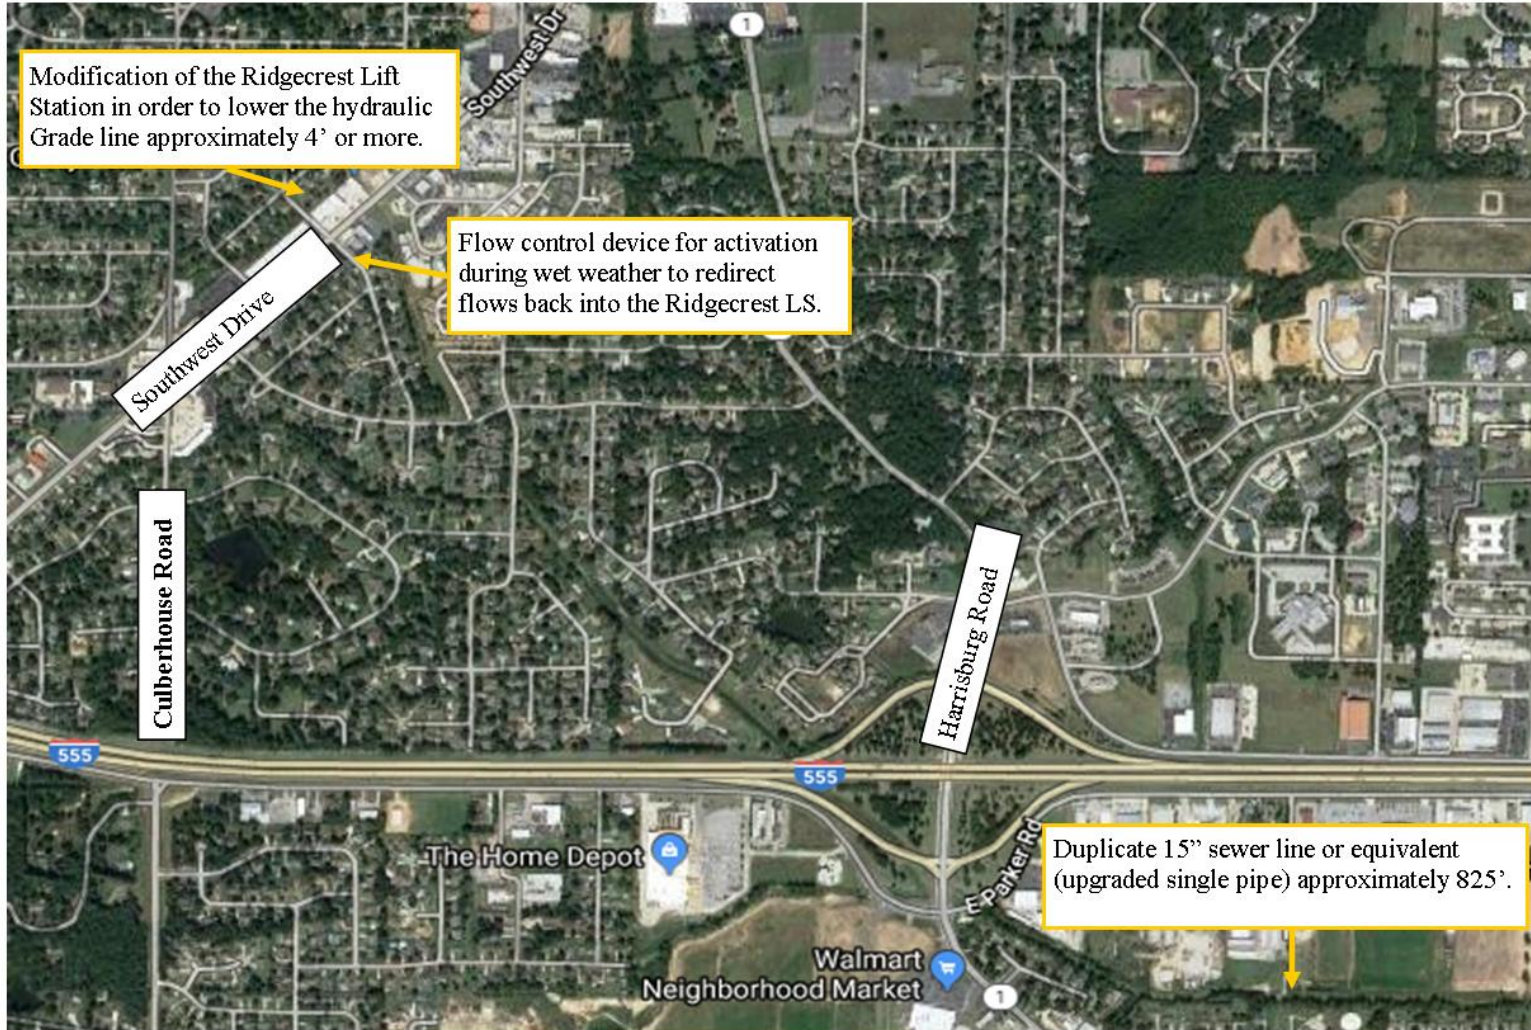
## Ridgecrest Lift Station and Gravity Sewer

CWL has contracted with Crist Engineers, Inc., and continues to work with RJN utilizing the CWL sewer hydraulic model, on the third capital project identified for Phase I, the Ridgecrest Lift Station and associated gravity sewer. This project will serve to optimize the functionality of the lift station through a redesign to a lower hydraulic grade line. This modification is proposed to address capacity constraints in the Ridgecrest St, Sims Ave, Owens Ave, and Parkview St area (basin JB26; see App B, Basin Delineation).

Surveying on the project is nearing completion and the preliminary design and cost estimates have been approved. Depending on the final design of the lift station, gravity sewer upgrades may be required as part of this project to increase upstream conveyance capacity and remove a potential hydraulic throttle downstream of the force main. Crist and CWL have projected, contingent on the final scope of the modifications, a total cost of approximately **\$2 million** for the project. CWL plans to begin construction in 2019 and has invested over **\$19,000** on this project to date.

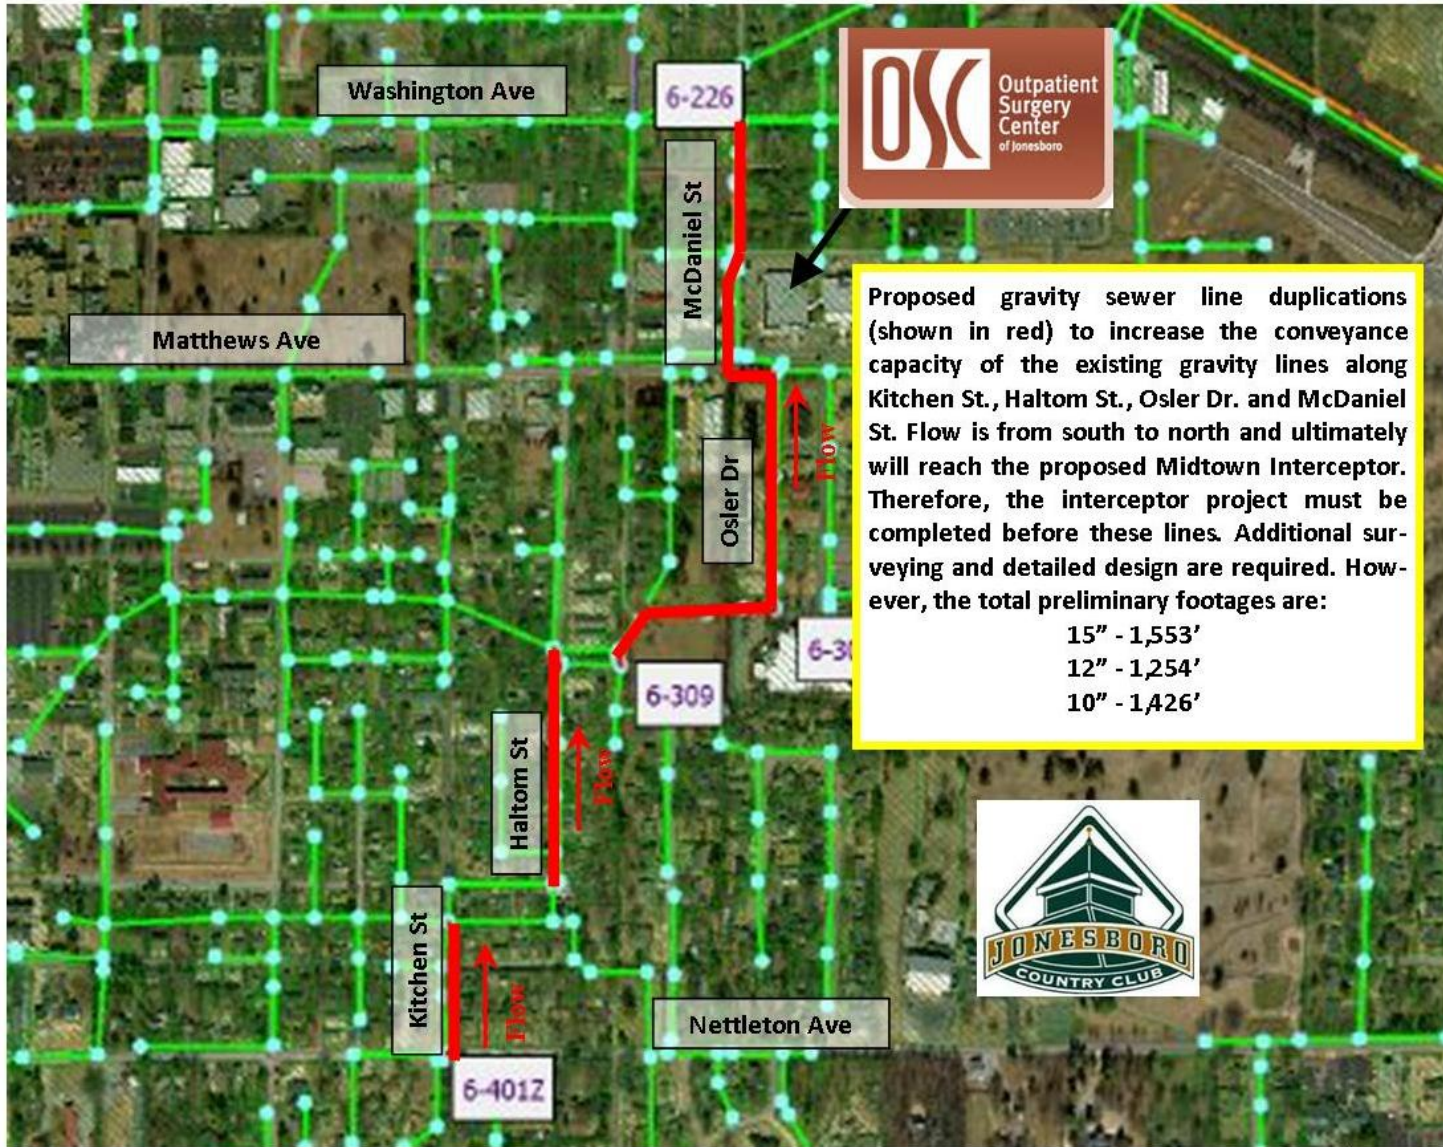
### Kitchen Gravity Sewer

Currently, the final significant capital improvement project scheduled for construction during Phase I involves various upgrades to the existing gravity sewer network in the midtown area bordered by E. Nettleton Ave, Kitchen St, Osler Dr, and E. Washington Ave (JB19 and JB20; see App B, Basin Delineation). The current scope of work is anticipated to include over 4,000 feet of gravity sewer, ranging in size from 10" to 15". However, survey work for model calibration has yet to be performed. CWL has projected a total cost of approximately **\$800,000** for these upgrades. As a gravity system upstream of the proposed Midtown Interceptor, the projected

start date for these sewer network improvements is contingent on the completion of the interceptor construction and, therefore, tentatively planned for 2019.
