RE: White Elephant Flea Market Site

NPDES Permit No.: AR150000

■ CONSTRUCTION SITE STORM WATER ASSESSMENT ■

Site name: White Elephant Flea Market Site **Permit No.** ARR150000

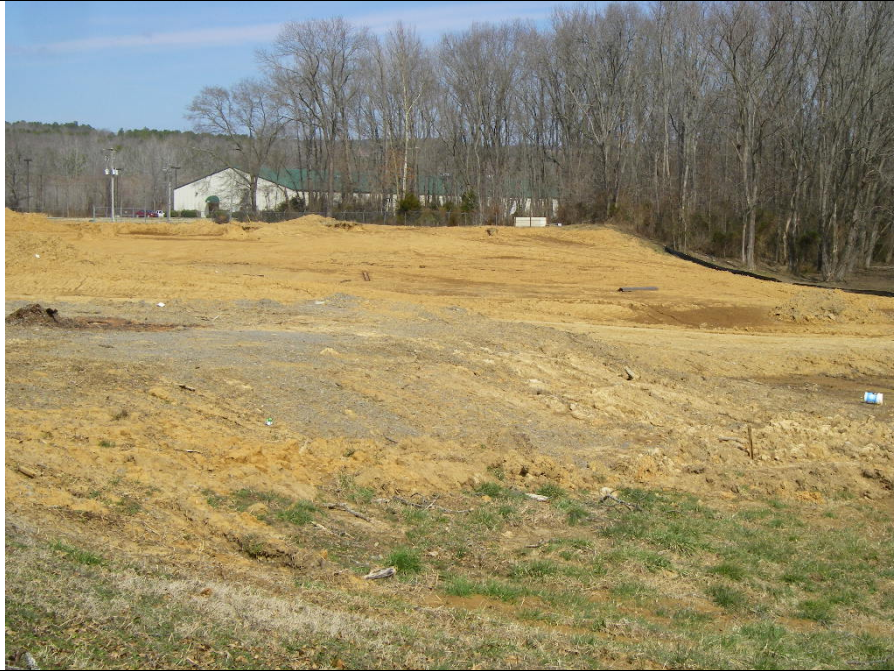
Photo #	3	Of	10	Date:	2-27-08	Time:	1220
----------------	---	-----------	----	--------------	---------	--------------	------

Description:	Looking at the site on the west side from south to north.						
---------------------	---	--	--	--	--	--	--

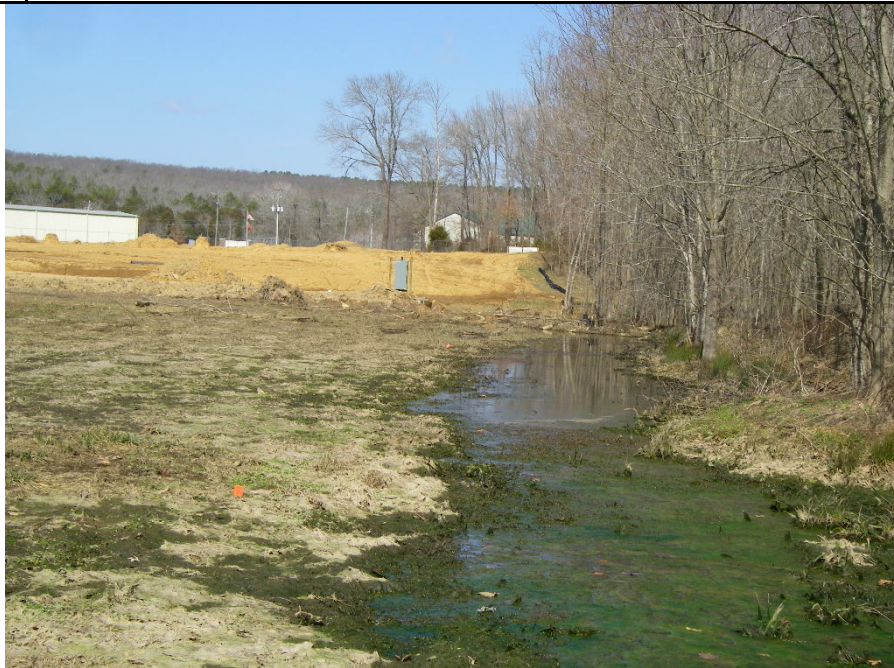
Photo #	4	Of	10	Date:	2-27-08	Time:	1221
----------------	---	-----------	----	--------------	---------	--------------	------

Description:	Another view on the southwest side showing a wet weather water course flowing south.						
---------------------	--	--	--	--	--	--	--

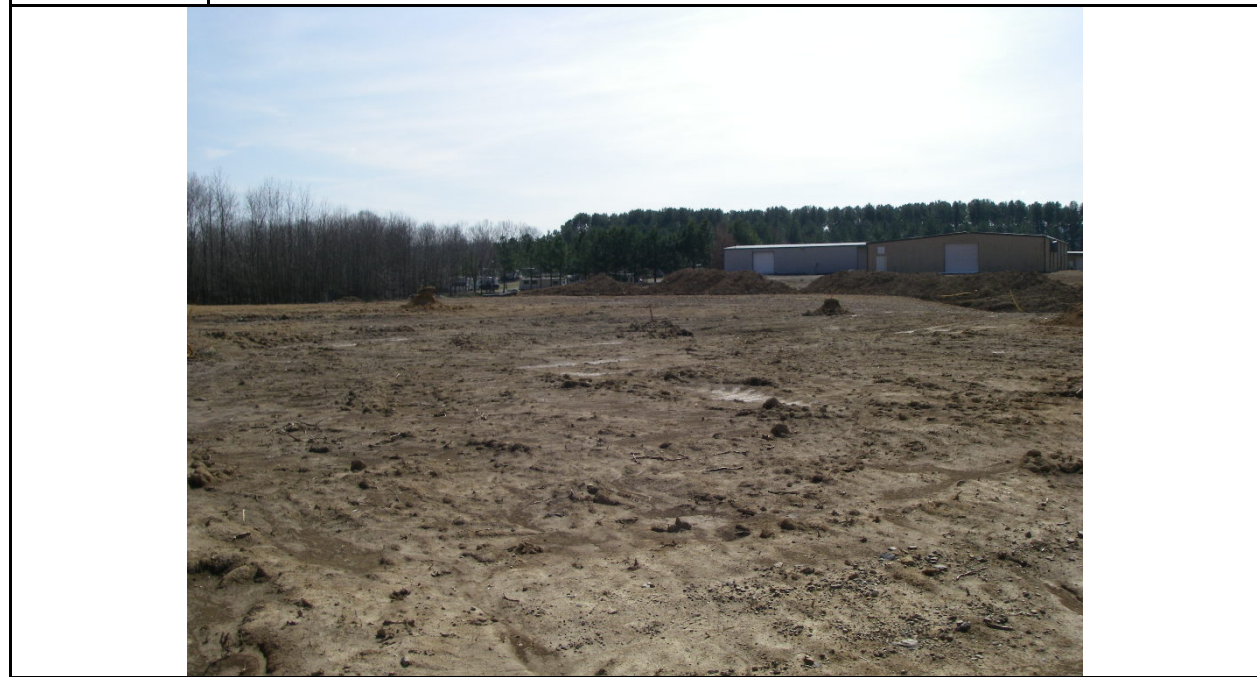
Photo #	7	Of	10	Date:	2-27-08	Time:	1228
----------------	---	-----------	----	--------------	---------	--------------	------

Description:	This view is looking from the northwest end of the site back to the southeast.						
---------------------	--	--	--	--	--	--	--

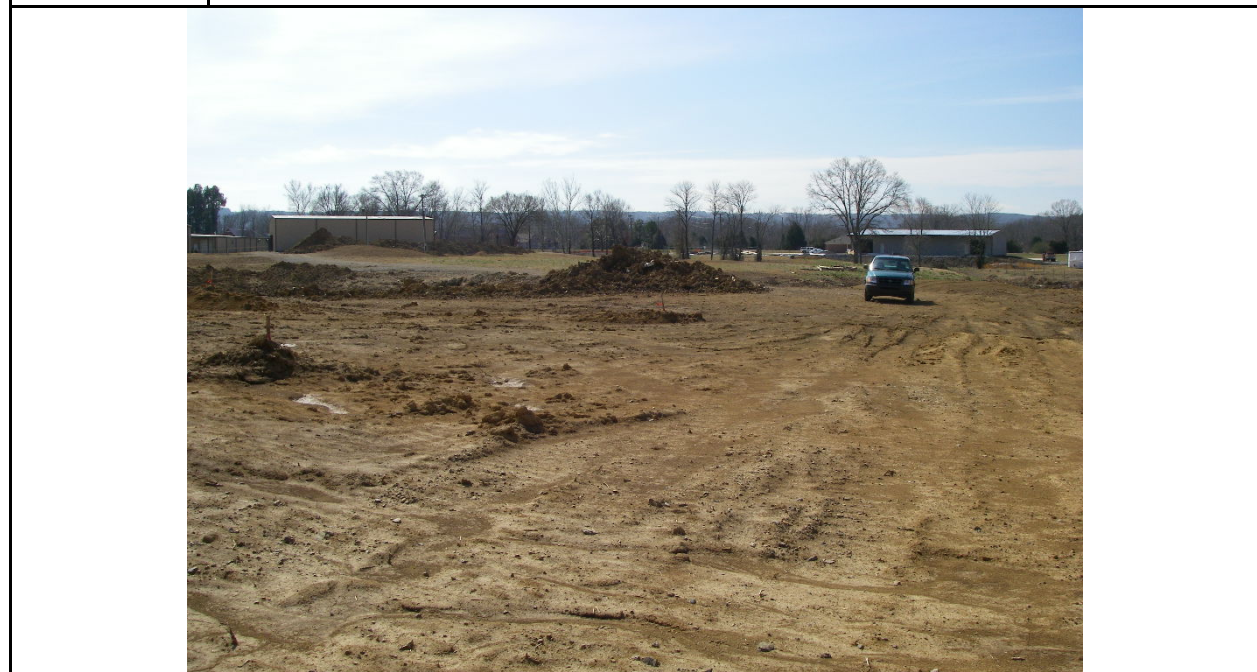
Photo #	8	Of	10	Date:	2-27-08	Time:	1228
----------------	---	-----------	----	--------------	---------	--------------	------

Description:	This view is looking from west to east across the construction site.						
---------------------	--	--	--	--	--	--	--

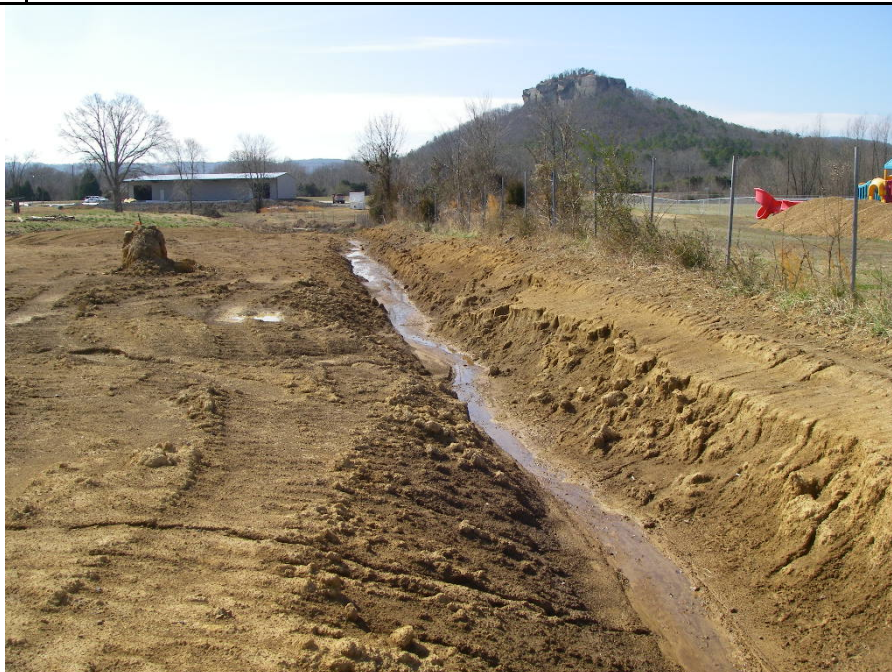
Location:	White Elephant Flea Market Site approximately 3. miles east of Heber Springs, Arkansas (Cleburne County)						
Photographer:	Mike Kennedy			Witness:	None		
Photo #	9	Of	10	Date:	2-27-08	Time:	1228
Description:	This is a ditch running east to west on the side of the site toward a water course flowing on the east side of the site.

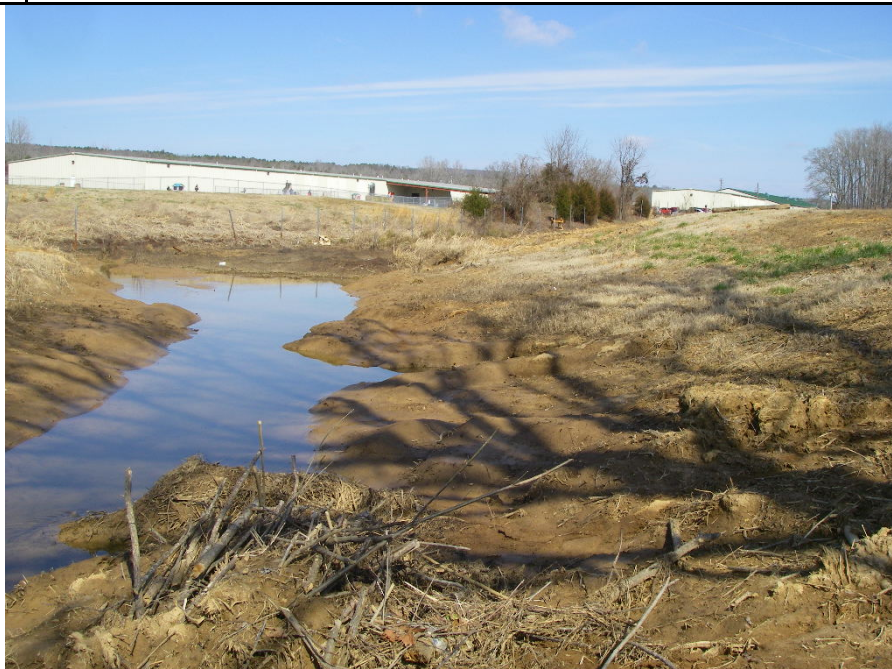
Sediment had washed into Highway #110 ditch that borders the highway on the east side from several places of the construction of the flea market parking lot. The facility is building a parking lot to supplement the flea market, which was an old potpourri plant that had been closed down. The existing site was composed of approximately 5 metal buildings and a paved area around the buildings.

Photographer:	Mike Kennedy			Witness:	None		
Photo #	10	Of	10	Date:	2-27-08	Time:	1231
Description:	This is the water course on the east side of Highway #110, sediment enter the water course from the east side of the site.

4. We will put a rain measuring gauge on the site where the permit is publicly displayed.
5. As previously discussed under #2, we will put up silt fence and hay bales for structural control and stabilization to prevent sediment from leaving offsite, this again will be in the Storm Water Prevention Plan to prevent sediment from coming offsite and this will be on premises for your inspection.
