RE: NPDES Industrial Storm Water Permit

AFIN: 33-00264 NPDES Permit No.: ARR153148

On February 8, 2012, I performed an Industrial Storm Water Permit inspection of the Bluebird Sand processing plant in accordance with the provisions of the Federal Clean Water Act, the Arkansas Water and Air Pollution Control Act, and the regulations promulgated thereunder.

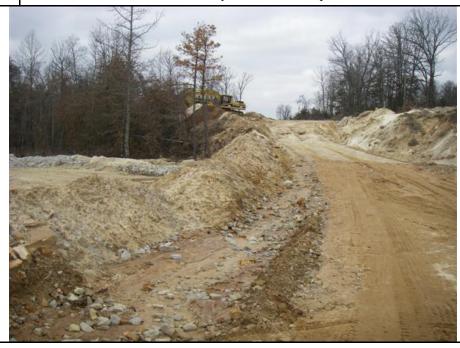
Water Division NPDES Photographic Evidence Sheet										
Location: Bluebird Sand, LLC Izard County											
Photograph	er:	Tony Morris			Witness:	Dusty Coope	Dusty Cooper				
Photo #	1	Of	8	<b>Date:</b> 02/08/12 <b>Time:</b> 12:34							
Description	:	Surfac	Surface water diversion berm recently reconstructed to protect west trib. to East Lafferty Creek.

Until the outside slope of the perimeter berm is stabilized with rip rap or vegetation it will be a potential source of sediment to the adjacent East Fork of Lafferty Creek. This concern also pertains to the recently repaired and reconstructed berm protecting the west tributary from runoff from the

haul road and western portion of the plant site. Both berms are constructed of highly erodible material and should be protected or hardened with some type of suitable erosion control protection;

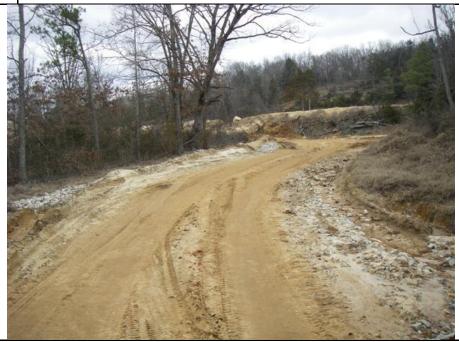
Photo #
 2
 Of
 8
 Date:
 02/08/12
 Time:
 12:40

**Description:** Recently reconstructed berm diverting haul road runoff away from west trib. toward outfall 001.

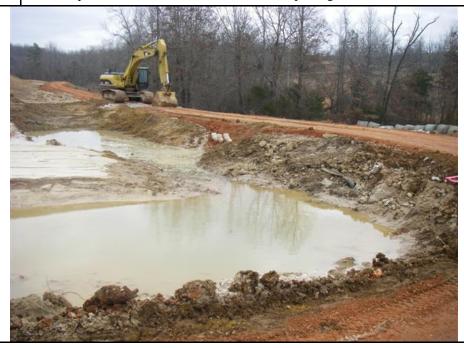
Water Division NPDES Photographic Evidence Sheet										
Location: Bluebird Sand, LLC Izard County											
Photograph	er:	Tony Morris				Dusty Cooper					
Photo #	3	Of	8	<b>Date:</b> 02/08/12 <b>Time:</b> 12:45							
Description	: F	Plant site perimeter berm with a service road on top being constructed, outfall 001 in distance.

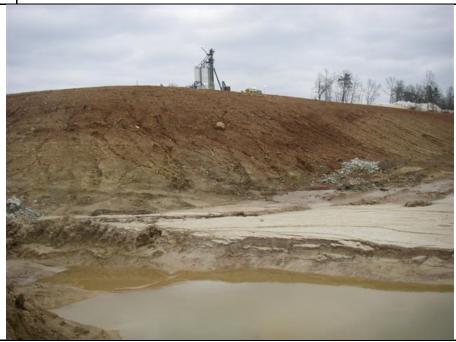
Photograph	ner:	Tony N	<b>I</b> orris	Witness:	Dusty Coope	Dusty Cooper		
Photo #	4	Of	8	Date:	02/08/12	Time:	12:47

**Description:** Massive amounts of sediment accumulating in perimeter ditch with eroding out slope pond levy.

The "Waste Sand Pile" located on the eastern portion of the plant site. This sediment source continues to grow larger and impacts the perimeter "ditch/berm". Maintenance of the "ditch/berm appears to require an inordinate amount of equipment time and labor due to the massive amounts of sediment being delivered from the "Waste Sand Pile" source;

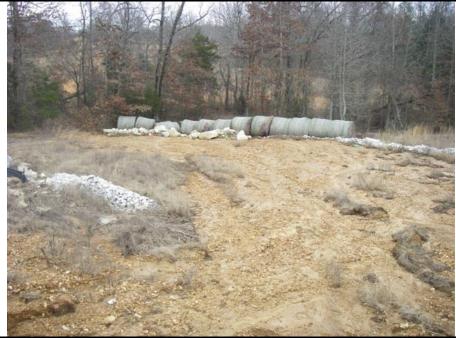
Water Division NPDES Photographic Evidence Sheet									
<b>Location:</b>	Location: Bluebird Sand, LLC Izard County									
Photograph	er:	r: Tony Morris			Witness:	Dusty Cooper				
Photo #	4	5	Of	8		Date:	02/08/12	Time:	12:49	
Description	<b>Description:</b> Sediment accumulation immediately above outfall 001 with East Lafferty Creek in tree line.								in tree line.

The "Vegetated Buffer" located topographically below the perimeter "ditch/berm" and above the hay bales at outfall 001, was observed to be nearing capacity. Due to very difficult equipment access associated with wet soil conditions, the accumulated sediment in this structure will be difficult to remove;

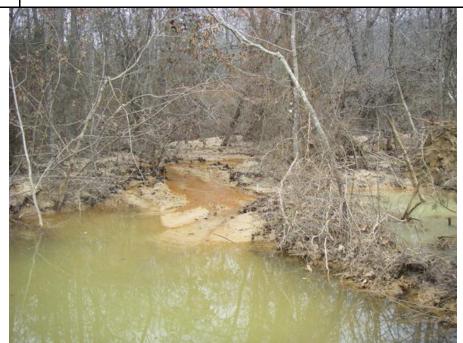
Photo #
 6
 Of
 8
 Date:
 02/08/12
 Time:
 13:00

**Description:**

Sediment accumulation within West Tributary to East Lafferty Creek addressed during previous site visit.

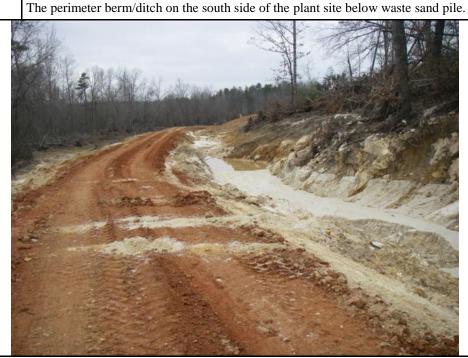
Water Division NPDES Photographic Evidence Sheet										
Location: Bluebird Sand, LLC Izard County											
Photograph	er:	Tony Morris				Dusty Coope	Dusty Cooper				
Photo #	7	Of	8		<b>Date:</b> 02/08/12 <b>Time:</b> 13:16						
Description	: '	The perimeter berm/ditch on the south side of the plant site below waste sand pile.

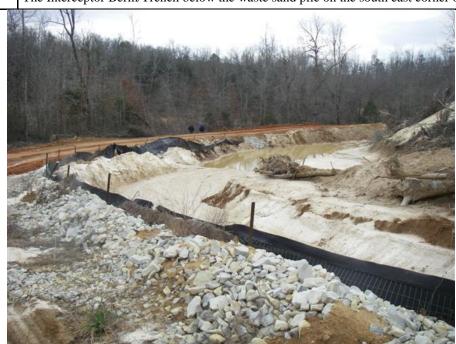
Photographer:		Tony N	Morris		Witness:	Dusty Cooper			
Photo # 8		Of	8		Date:	02/08/12	Time:	13:25

**Description:** The Interceptor Berm/Trench below the waste sand pile on the south east corner of plant site.
