ARKANSAS  
Department of Environmental Quality

RE:      AFIN: 71-00386  
          FACILITY: Clinton Triple Transport Washout Facility

PERMIT NO.: 5075-W  
COUNTY: Van Buren

## NO DISCHARGE INDUSTRIAL PERMIT INSPECTION FORM

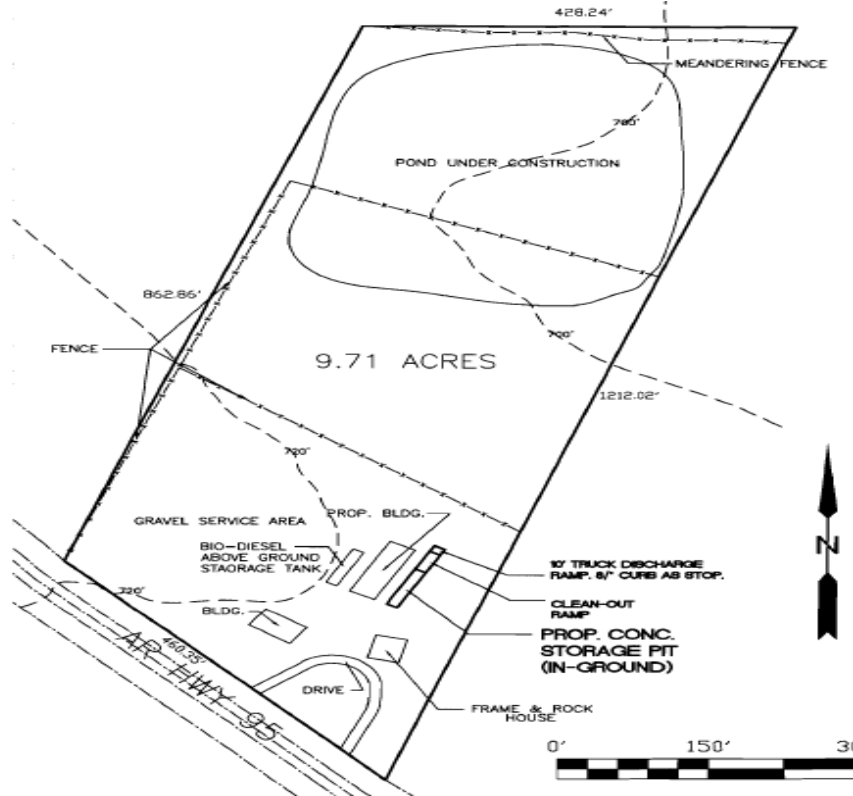
- 1B. Furnish a simplified flow diagram of the treatment system and include main components, flow sequence through plant, and calculated or estimated flows.

5A. Description of Process (including type of industry, materials produced, and major by-products): **The facility was permitted for the operation of a truck washout and waste disposal system of gas well operations generated fluids. The truck washout and storage facility was removed in February of 2011 and has not been replaced at the time of the inspection.**

7A. Are there any additions, modifications, or corrections to the facility since the last inspection? ☒ Yes ☐ No  
**The truck washout and storage facility was removed in February of 2011 and has not been replaced at the time of the inspection.**  
If yes, explain: \_\_\_\_\_

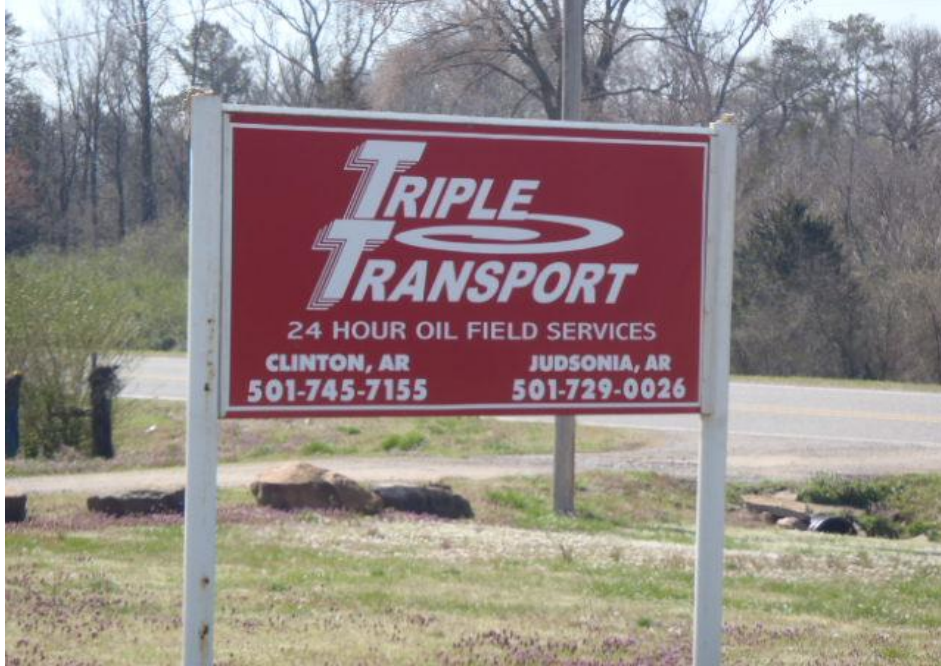
<b>Photo #</b>	1	<b>Of</b>	6	<b>Date:</b>	4-5-13	<b>Time:</b>	1112
----------------	---	-----------	---	--------------	--------	--------------	------

<b>Description:</b>	Site Identification.						
---------------------	----------------------	--	--	--	--	--	--

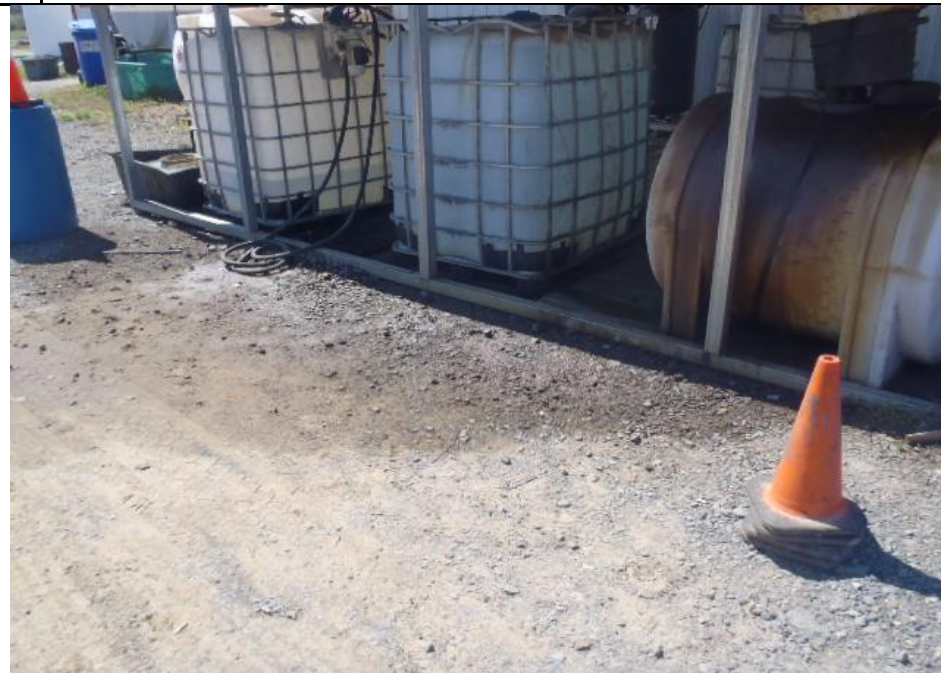
<b>Photo #</b>	2	<b>Of</b>	6	<b>Date:</b>	4-5-13	<b>Time:</b>	1114
----------------	---	-----------	---	--------------	--------	--------------	------

3. There was a large oil stain on the ground adjacent to a covered storage area for oils and other fluids. I told Britt that this area should be cleaned and steps should be taken to avoid further spills.

<b>Description:</b>	Oil stain on ground next to fluid storage area.						
---------------------	---	--	--	--	--	--	--

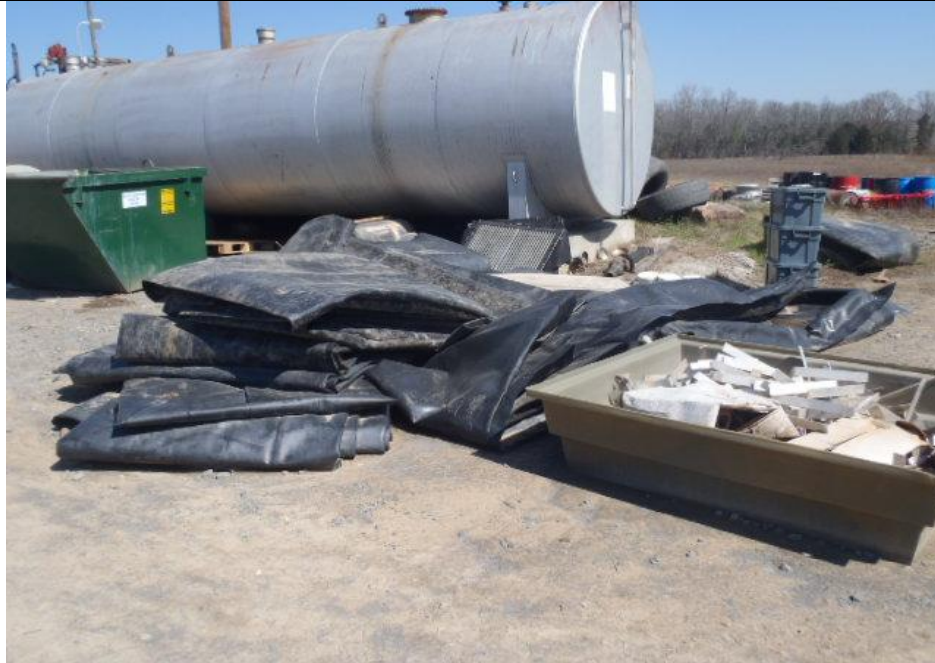
<b>Photo #</b>	3	<b>Of</b>	6	<b>Date:</b>	4-5-13	<b>Time:</b>	1114
----------------	---	-----------	---	--------------	--------	--------------	------

1. Folded up used plastic liners (used for temporary berms around frac tanks) were on the ground next to a diesel storage tank. I told Britt that these should be disposed of or stored under cover from rain.
2. Hoses used to transfer fluids to and from transport trucks were being stored on the ground. I told Britt that these should be disposed of or stored under cover from rain.

<b>Description:</b>	Plastic liner used for temporary berms for frac tanks on the ground; exposed to rain.						
---------------------	---	--	--	--	--	--	--

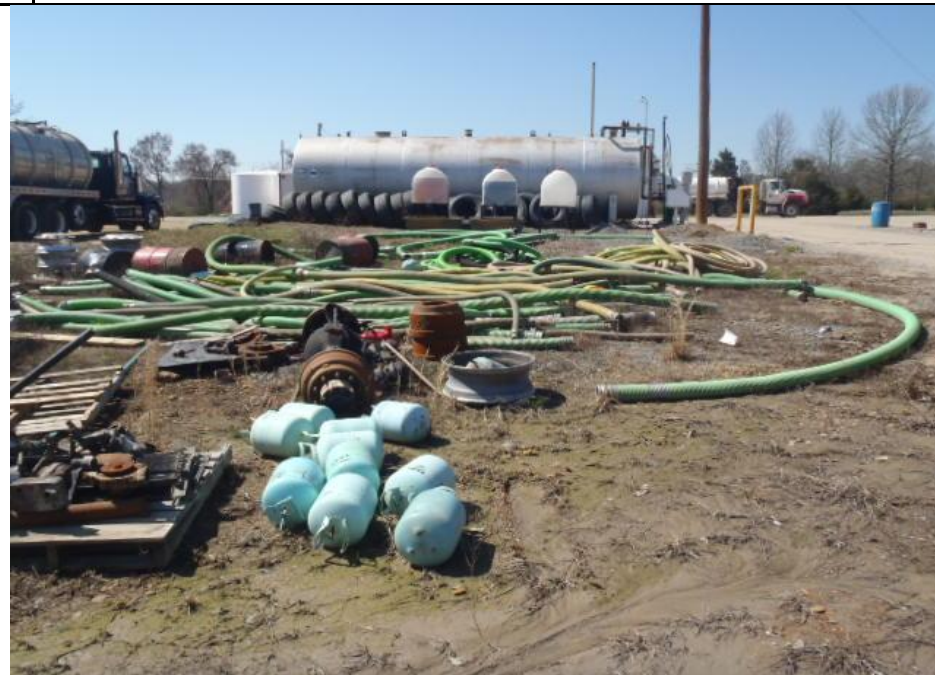
<b>Photo #</b>	4	<b>Of</b>	6	<b>Date:</b>	4-5-13	<b>Time:</b>	1116
----------------	---	-----------	---	--------------	--------	--------------	------

<b>Description:</b>	Hoses used to transfer fluids on the ground; exposed to rain.						
---------------------	---	--	--	--	--	--	--

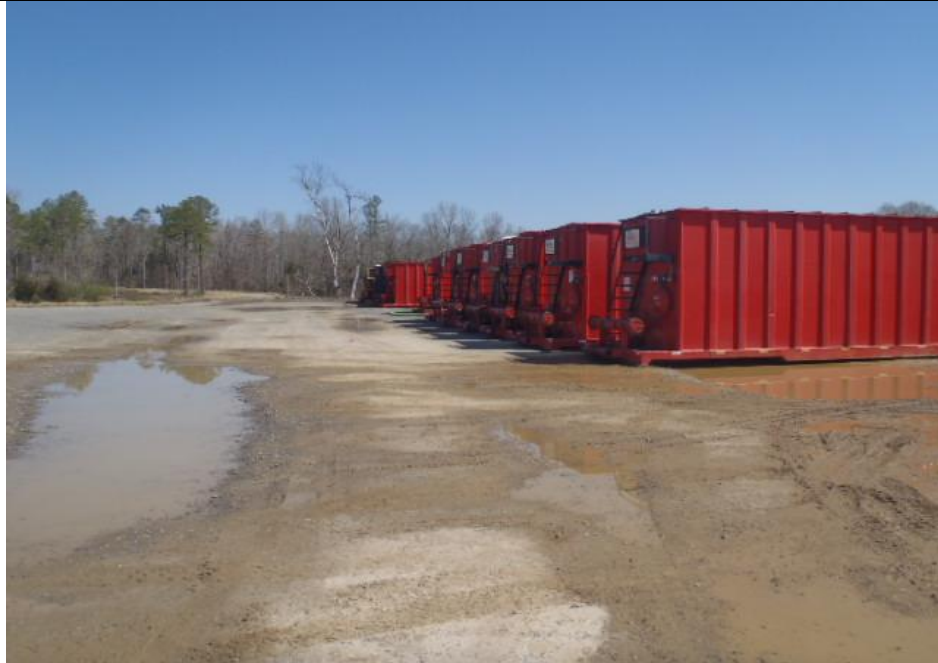
<b>Photo #</b>	5	<b>Of</b>	6	<b>Date:</b>	4-5-13	<b>Time:</b>	1117
----------------	---	-----------	---	--------------	--------	--------------	------

<b>Description:</b>	Empty frac tanks on north side of the facility.						
---------------------	---	--	--	--	--	--	--

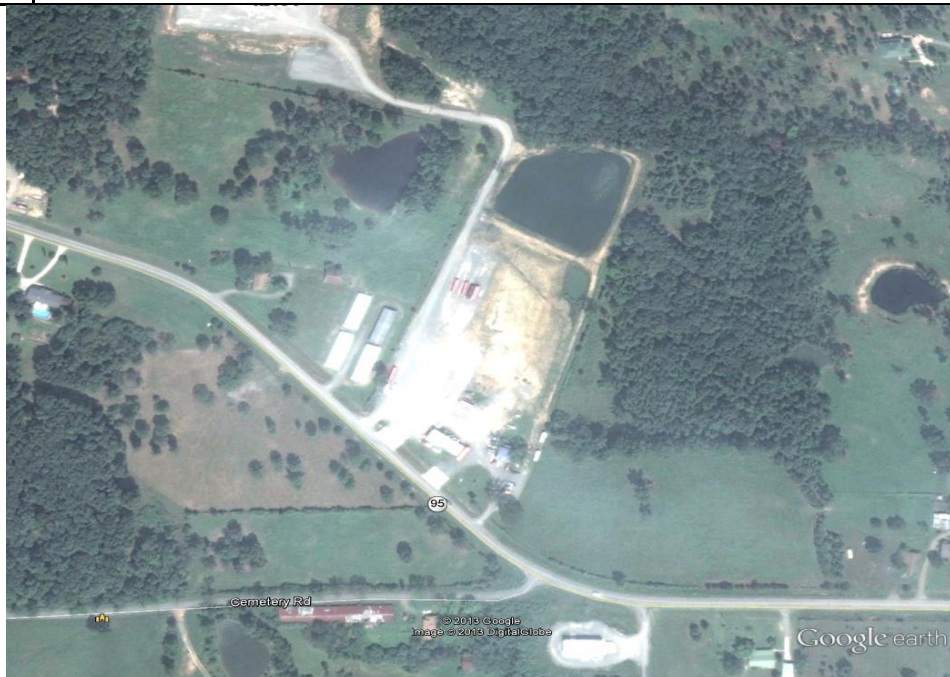
<b>Photo #</b>	6	<b>Of</b>	6	<b>Date:</b>	4-8-13	<b>Time:</b>	N/A
----------------	---	-----------	---	--------------	--------	--------------	-----

<b>Description:</b>	Satellite view of the facility.						
---------------------	---------------------------------	--	--	--	--	--	--
