ARKANSAS  
Department of Environmental Quality

**RE: Compliance Inspection (Crawford County)**  
**AFIN: 17-00056 NPDES Permit No.: ARR000825**

On April 5, 2013, I performed a routine Industrial Stormwater compliance inspection of your facility in accordance with the provisions of the Federal Clean Water Act, the Arkansas Water and Air Pollution Control Act, and the regulations promulgated thereunder. This inspection revealed the following violations:

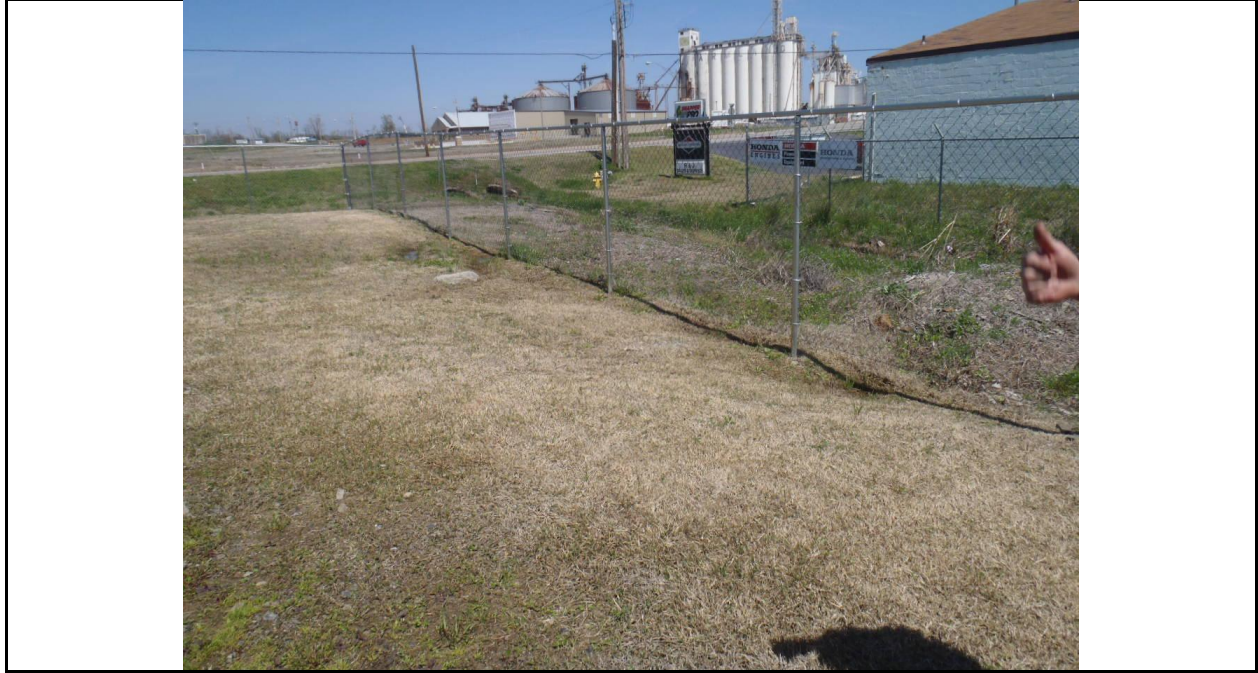
**Photo #** 1    **Of** 8      **Date:** 4/5/13      **Time:** 1336

1. During the inspection, four additional outfalls were noted, two on the east side of the property and two on the south. Currently the facility is not authorized to discharge from these locations. **This is a violation of Part 1.6 of the permit (Photos #1 through #6).**

**Description:** Outfalls noted on the east side of the facility (view to northeast).

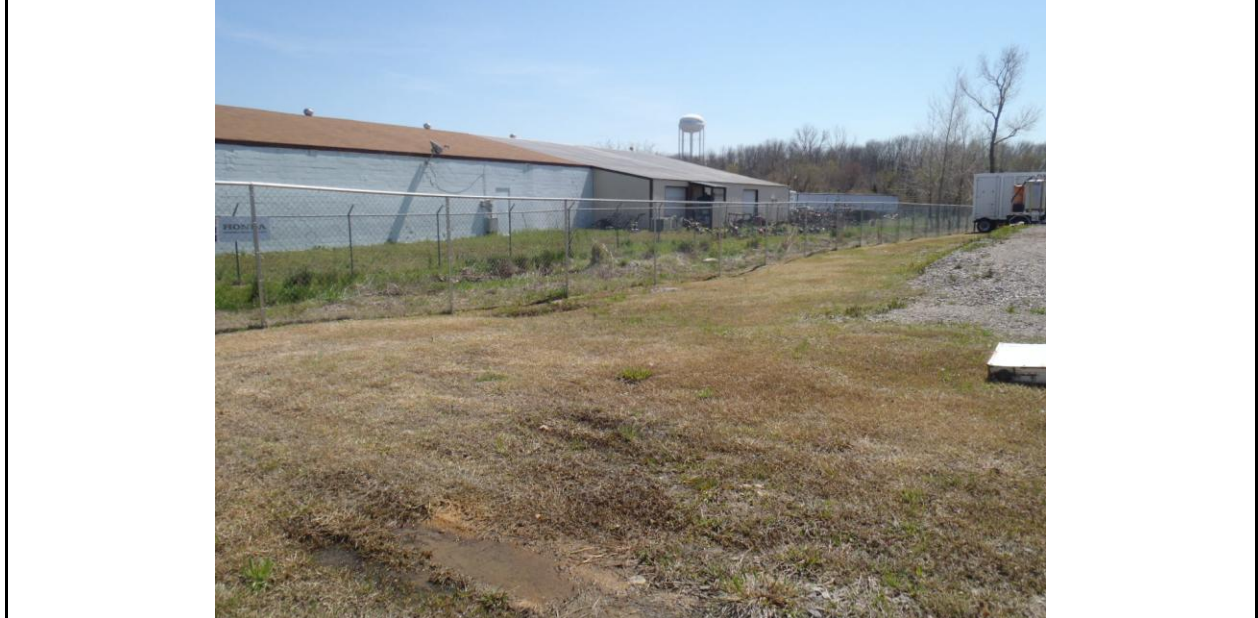
**Photo #** 2    **Of** 8      **Date:** 4/5/13      **Time:** 1338

**Description:** Outfalls noted on the east side of the facility (view to southeast).

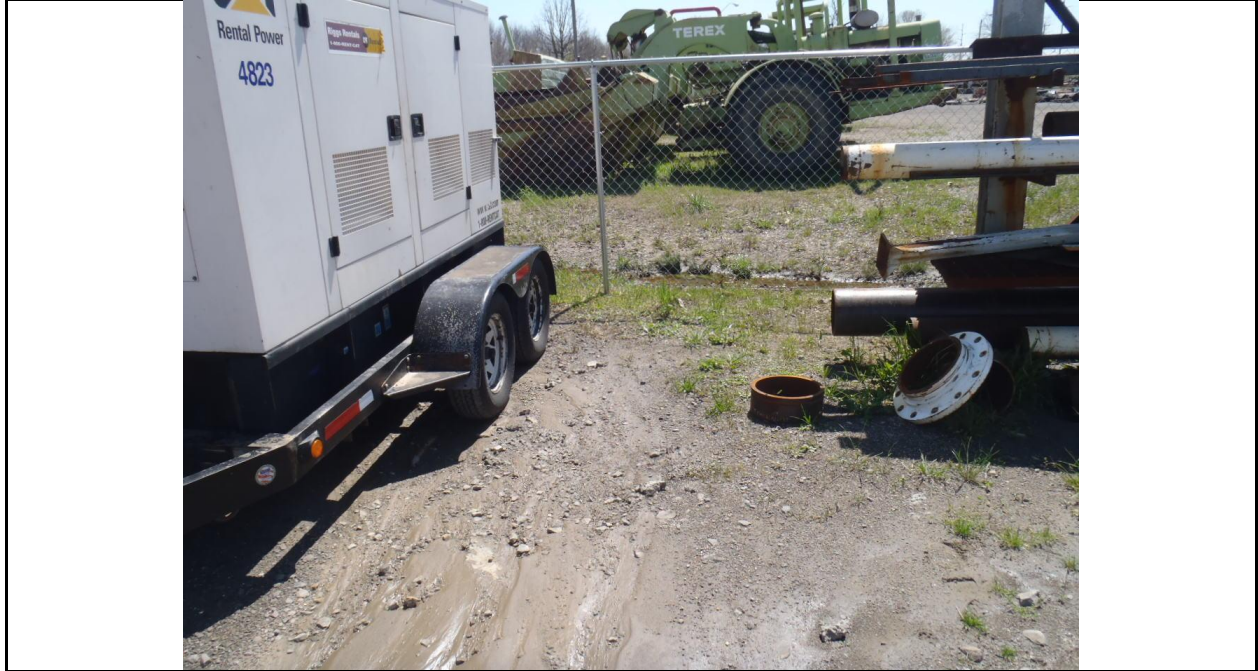
**Photo #** 3    **Of** 8      **Date:** 4/5/13    **Time:** 1348

**Description:** Outfall on facility's south fence line (view to south).

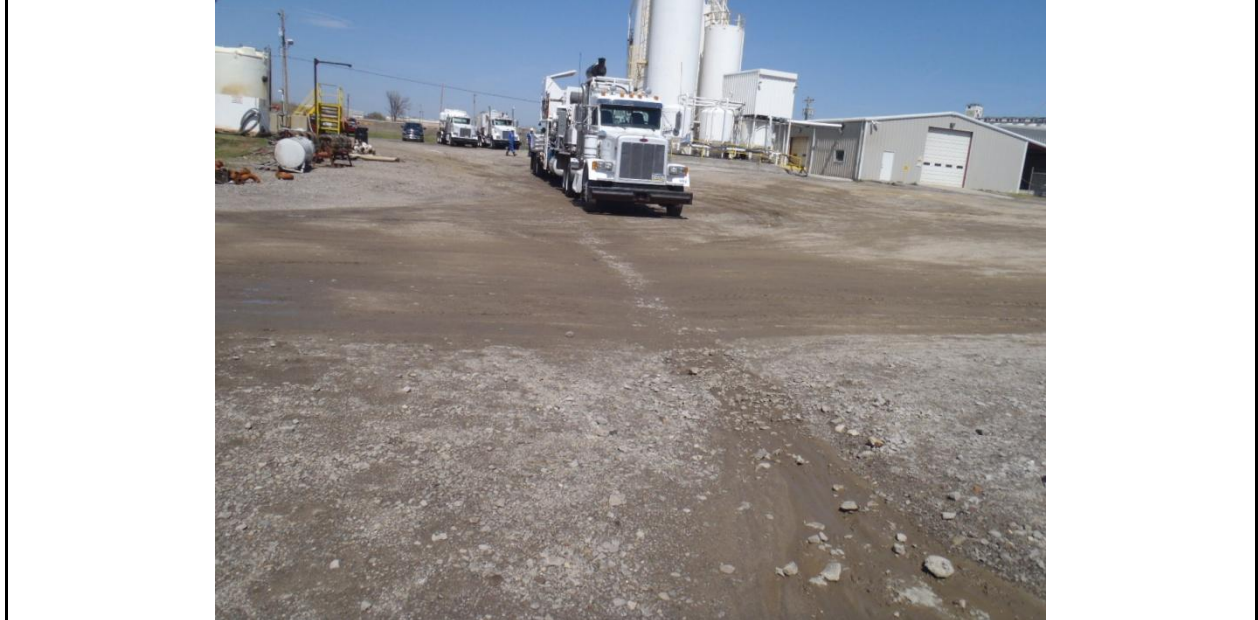
**Photo #** 4    **Of** 8      **Date:** 4/5/13    **Time:** 1348

**Description:** Outfall on facility's south fence line (view to north).

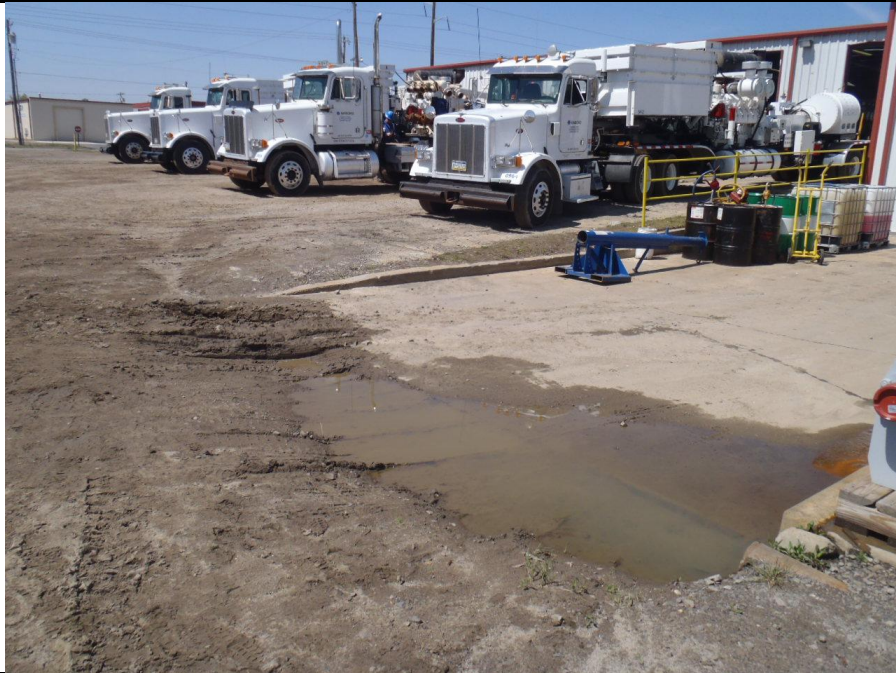
**Photo #**    5    **Of**    8      **Date:**    4/5/13      **Time:**    1350

2. Samples were not collected during the January to June 2012 monitoring period. **This is a violation of Part 3.5 of the permit.**
3. Samples for Outfall #1 were not being collected from the monitoring point specified in the NOI. Samples for 2012 were collected near a drainage pipe by the concrete pad adjacent to the maintenance shop building. **This is a violation of Part 3.6 of the permit (Photo #5).**

9. A drainage pipe running from the concrete slab by the maintenance shop building to the property line is not shown on the site map. **This is a violation of Part 4.6.4.f of the permit (Photos #5 and #6).**

**Description:** Location of where the 2012 samples were taken. Drainage pipe to bottom right discharges at the fence line. Sampling from this area is not representative of the entire facility's stormwater runoff.

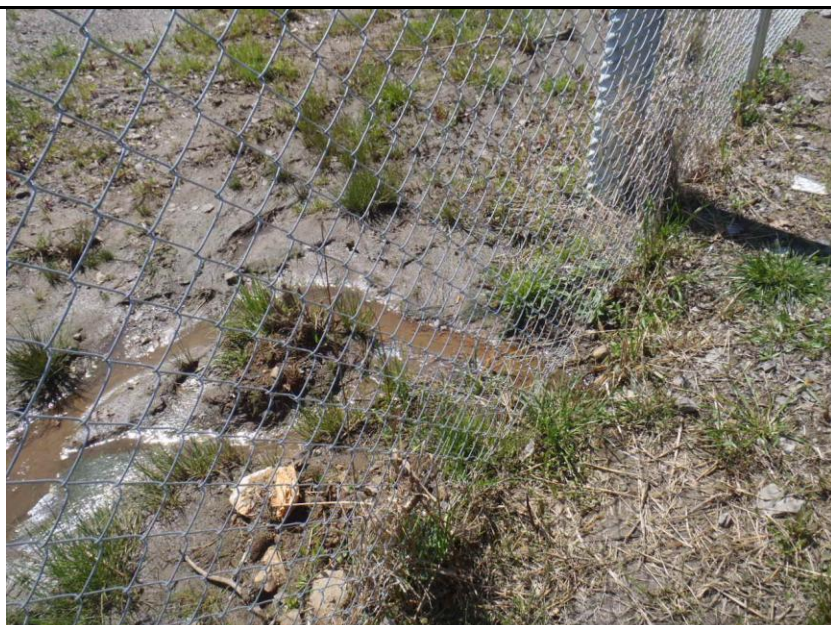
**Photo #**    6    **Of**    8      **Date:**    4/5/13      **Time:**    1348

**Description:** Discharge from pipe that originates by concrete slab in previous photo. This discharge is not permitted.

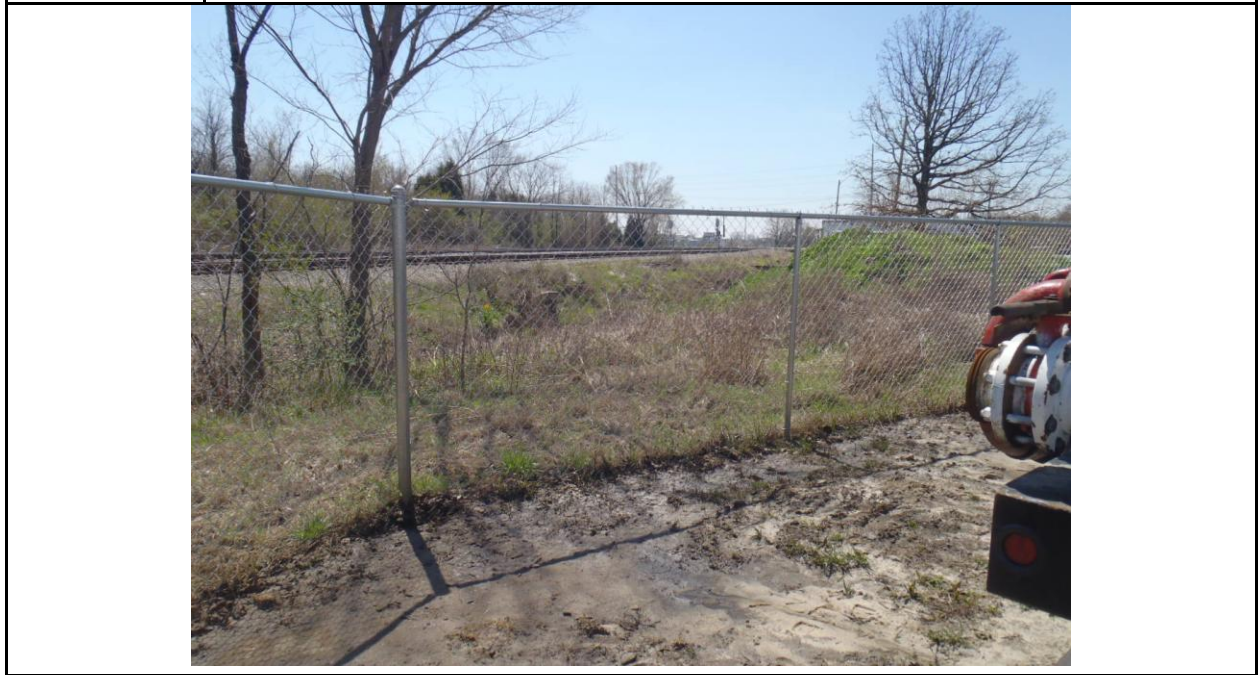
**Photo #** 7    **Of** 8      **Date:** 4/5/13    **Time:** 1345

12. The SWPPP does not include a discussion on minimizing exposure. **This is a violation of Part 4.6.6.2 of the permit.**
13. Evidence of past spills was observed on the south side of the property along the fence line. This area had not been cleaned. **This is a violation of Part 4.6.6.5 of the permit (Photos #5 and #6).**

**Description:** Evidence of a past spill not cleaned along the south fence line.

**NCPS Response No. 13:** This area has been cleaned by NCPS and will not affect future storm water discharge. NCPS contracted Hubbs Construction (Hubbs) to excavate an area of oil-stained gravel on April 22, 2013. Hubbs removed stained gravel to a depth ranging from approximately 0.2 to 0.7 feet below existing grade. One composite sample was collected for disposal characterization using Toxicity Characteristic Leaching Procedures (TCLP). The TCLP results indicated the sample was non-hazardous and the gravel/soil was disposed of off-Site at a licensed disposal facility. The analytical results are included as Attachment A. The area was backfilled with clean gravel. Photographic documentation is included as Attachment B.

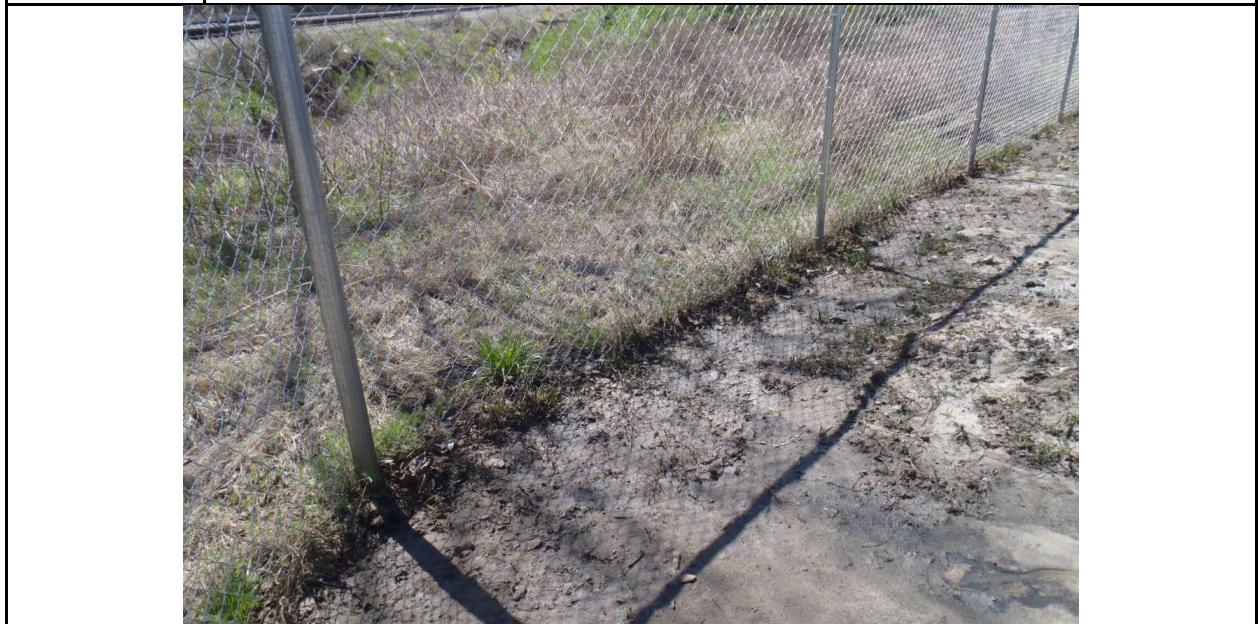
**Photo #** 8    **Of** 8      **Date:** 4/5/13    **Time:** 1345

**Description:** Closer view of the stained ground along the fence line.

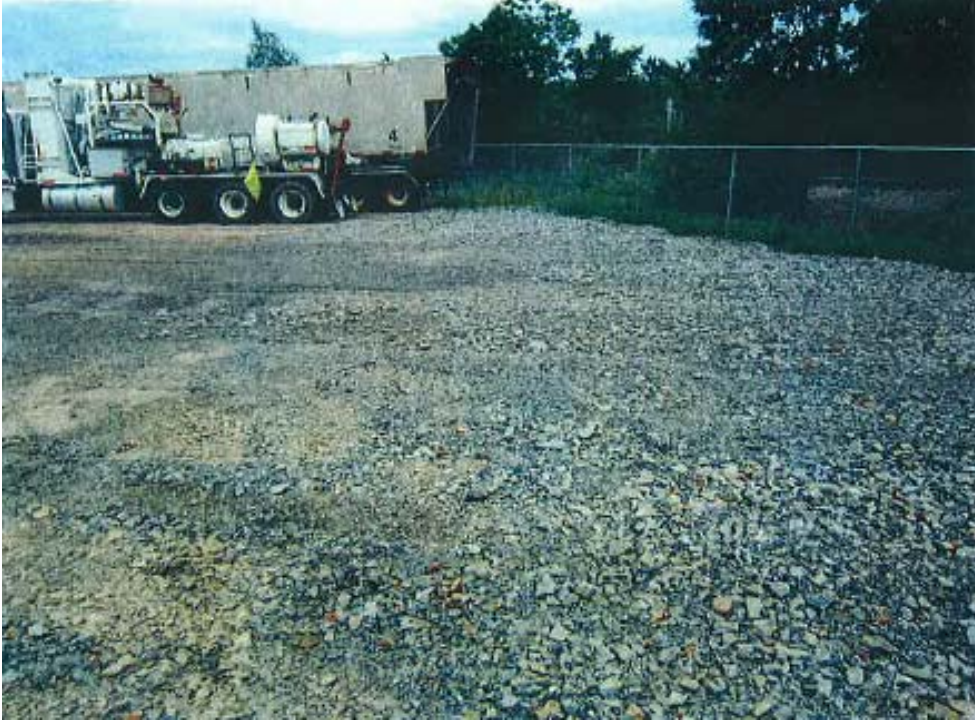
Photo 1: View of remediation conducted for oil-stained gravel in Southern portion of Facility. Backfilled after excavated (Note: ADEQ, Item No. 13).

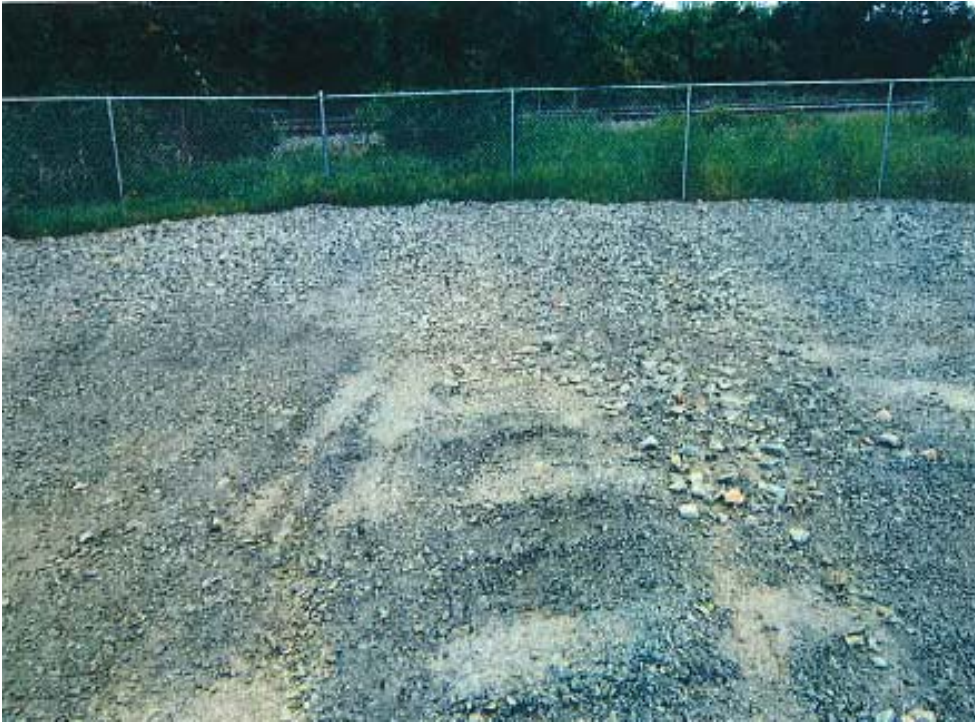
Photo 2: View of final grade and backfill for excavated oil-stained gravel in Southern portion of Facility (Note: ADEQ Item No. 13).

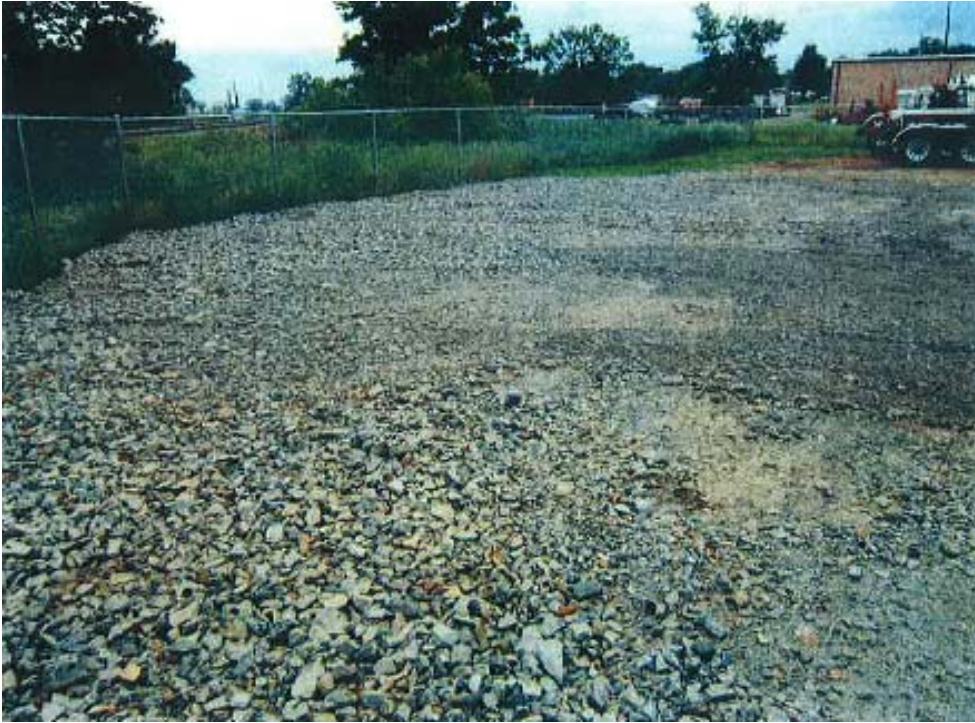
Photo 3: View looking west for remediation conducted in Southern portion of the Facility.

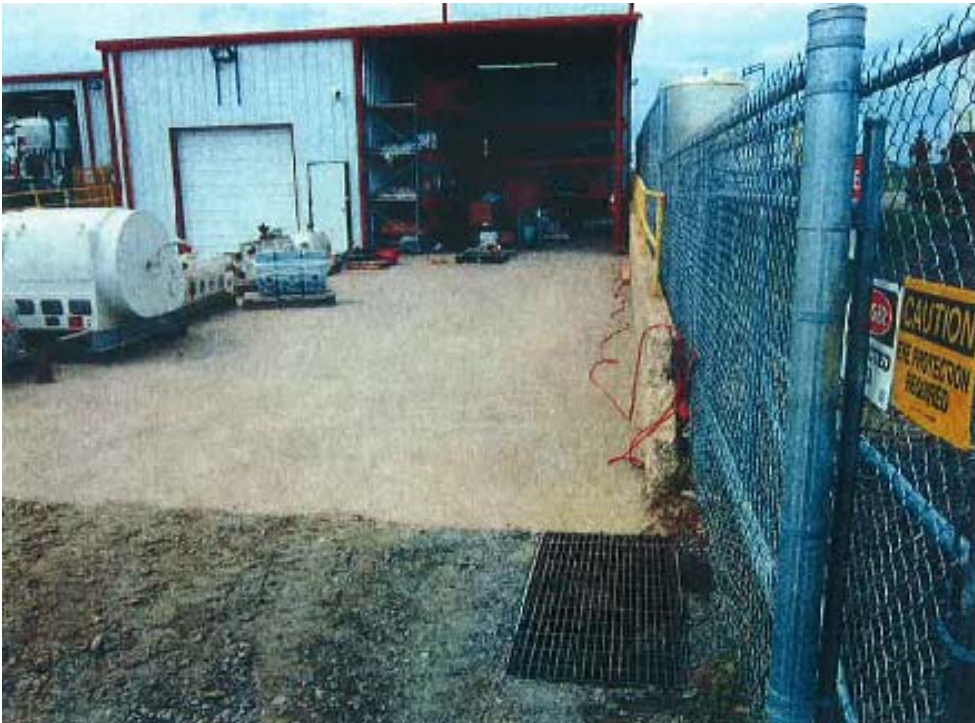
Photo 4: Catch basin with 4-inch diameter pipe at the end of the concrete driveway for the Maintenance Shop Building.

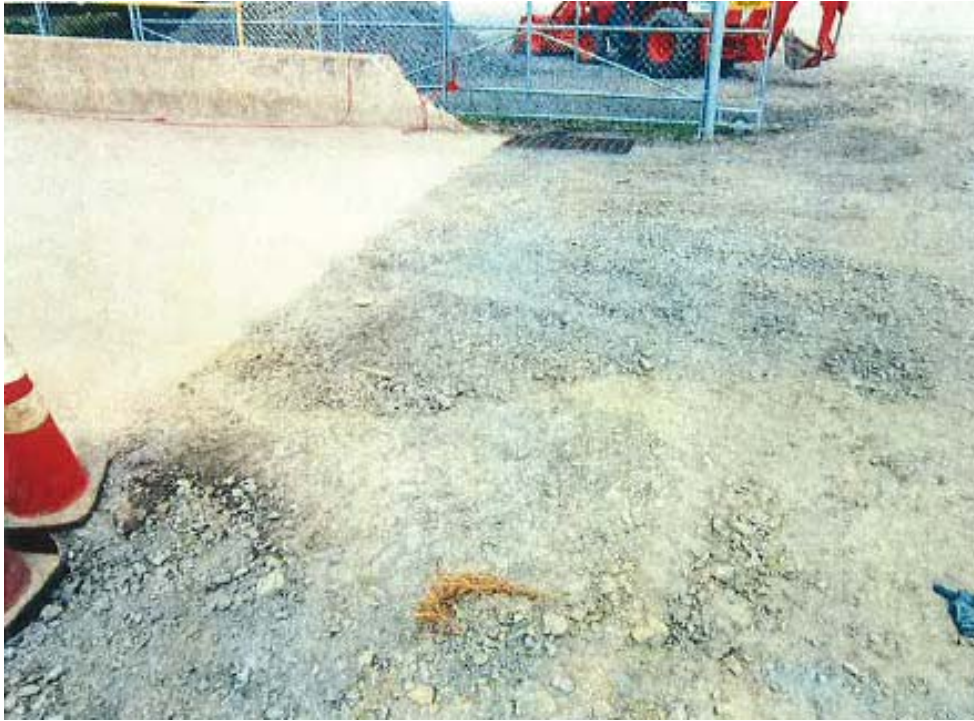
Photo 5: Fill and grading to control storm water flow at the end of the driveway for the Maintenance Shop Building.

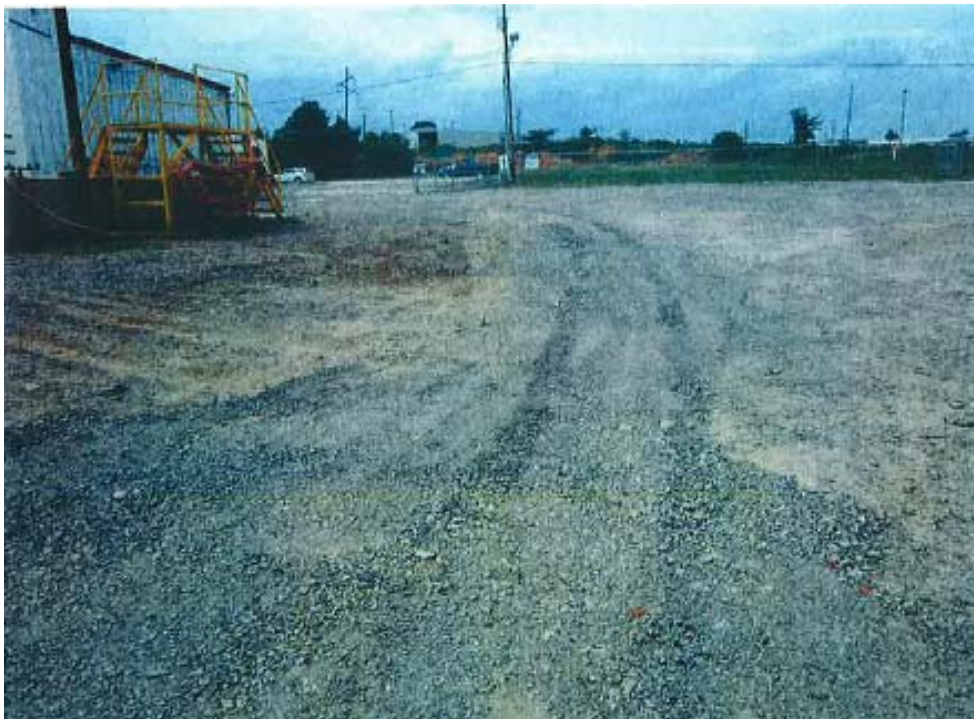
Photo 6: Fill and grade in center of the Property to influence proper drainage.

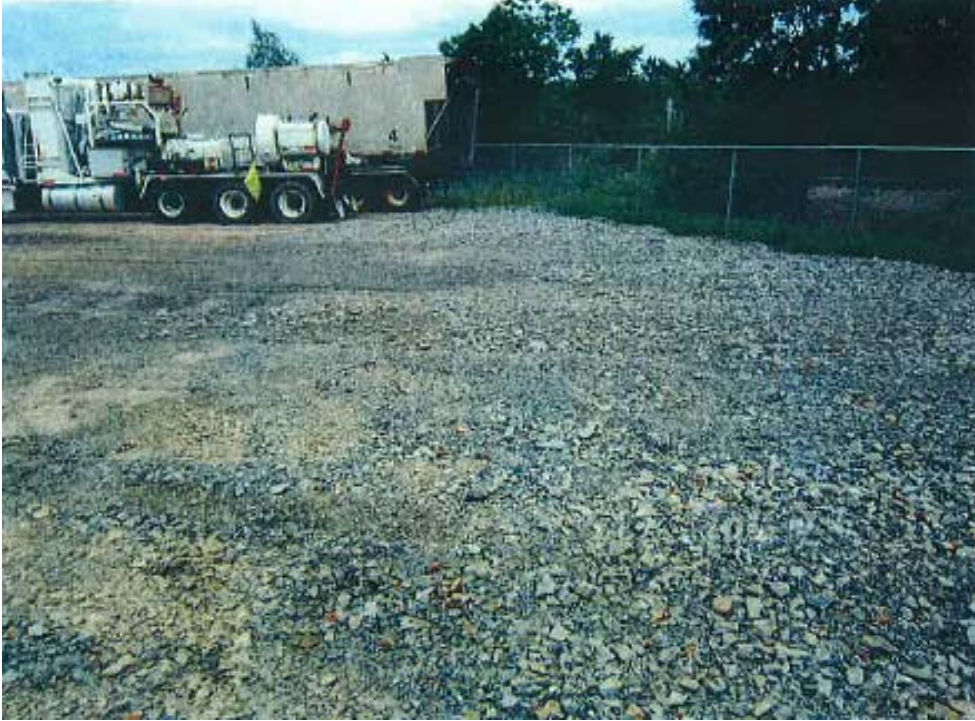
Photo 1: View of remediation conducted for oil-stained gravel in Southern portion of Facility. Backfilled after excavated (Note: ADEQ, Item No. 13).

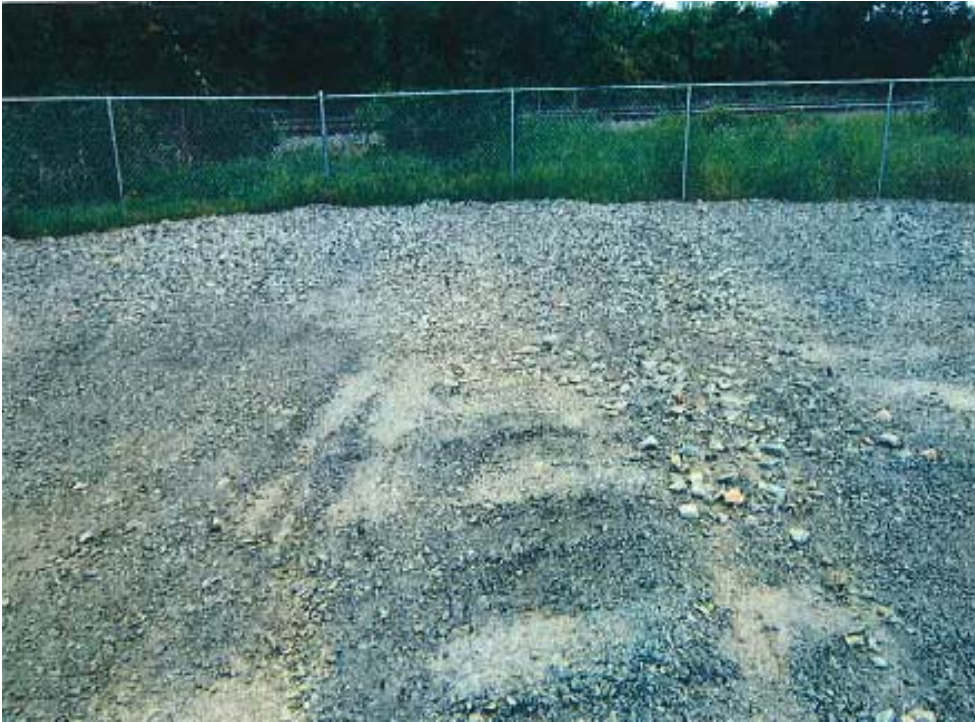
Photo 2: View of final grade and backfill for excavated oil-stained gravel in Southern portion of Facility (Note: ADEQ Item No. 13).

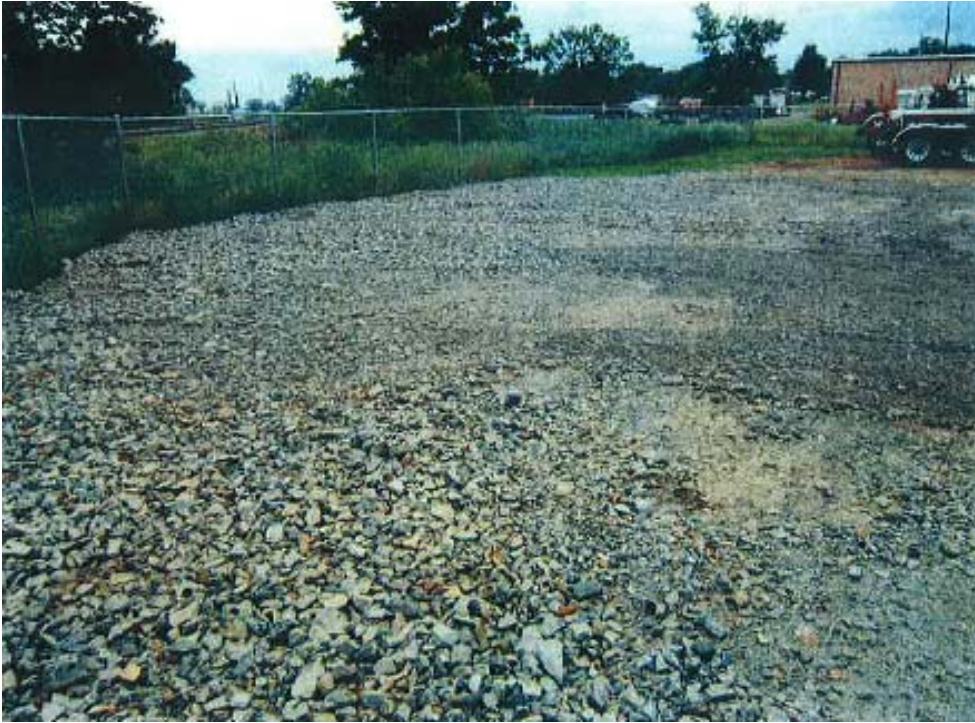
Photo 3: View looking west for remediation conducted in Southern portion of the Facility.

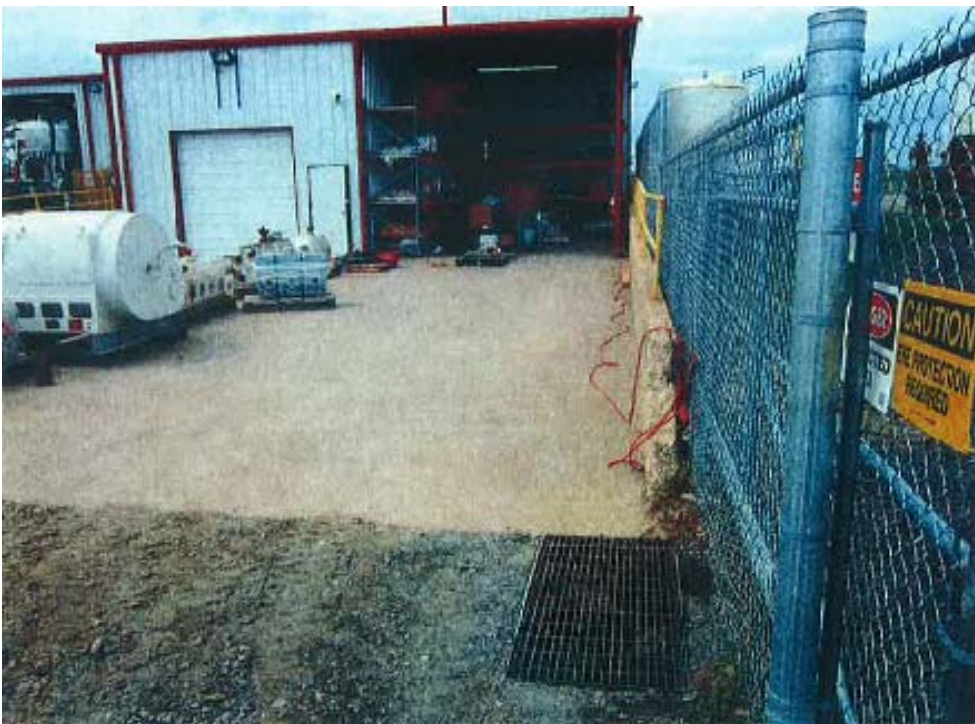
Photo 4: Catch basin with 4-inch diameter pipe at the end of the concrete driveway for the Maintenance Shop Building.

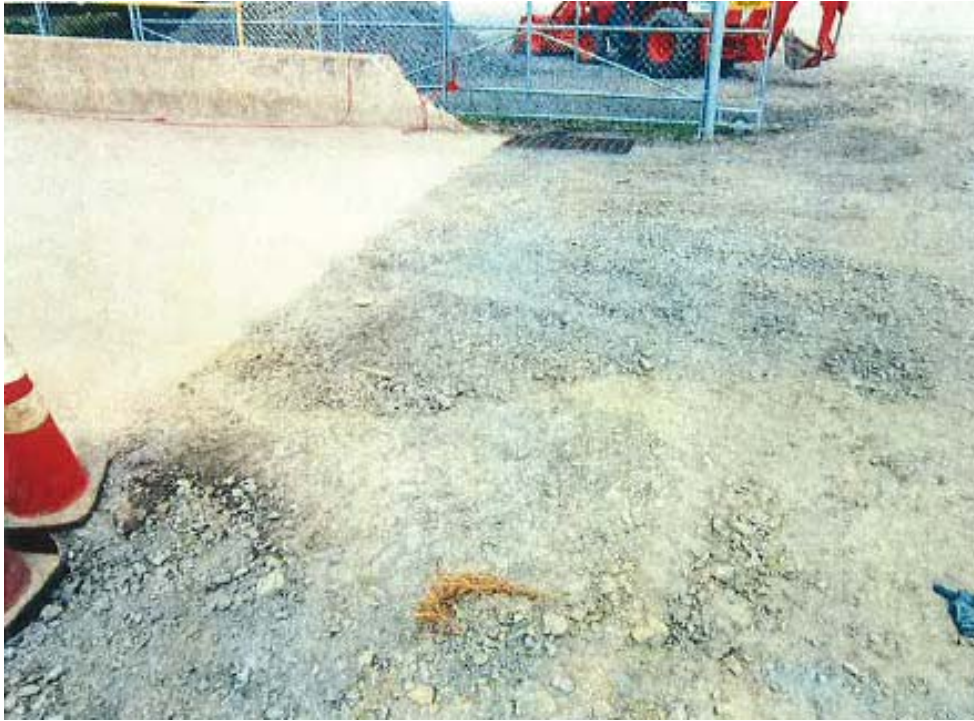
Photo 5: Fill and grading to control storm water flow at the end of the driveway for the Maintenance Shop Building.

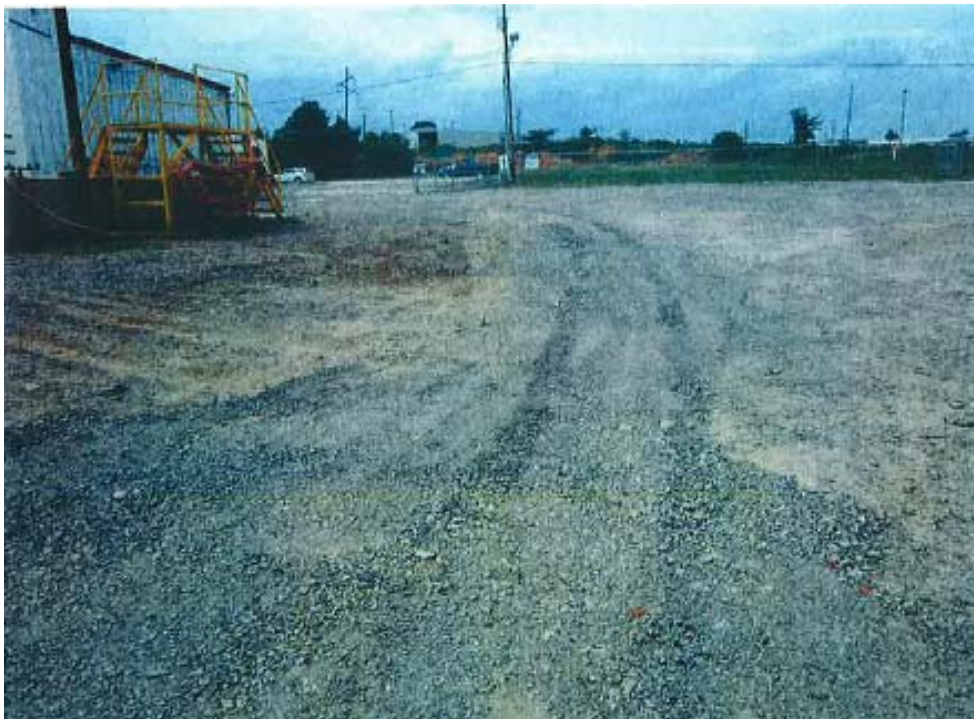
Photo 6: Fill and grade in center of the Property to influence proper drainage.
