**RE: Compliance Inspection of SWN's Cleveland Water Reuse/Recycle Facility**  
**AFIN: 15-00618 NPDES Permit Tracking No.: ARR153579**

## NPDES Compliance Inspection Report

**Cleveland Water Reuse/Recycle Facility**  
SE corner of intersection of Hwy 95 and Hwy 124  
Cleveland, AR 72030

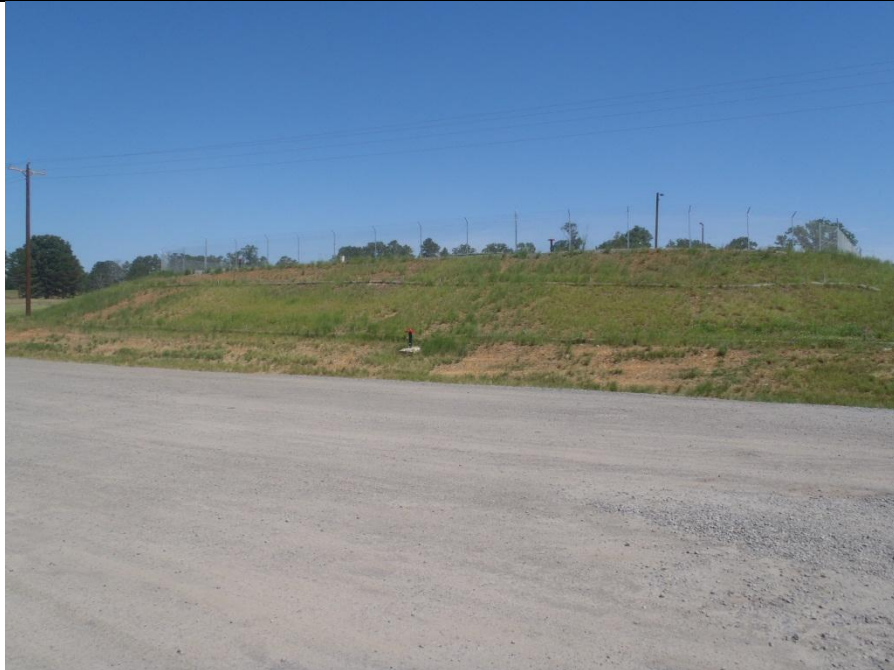
<b>Location:</b>	Cleveland Water Reuse/Recycle Facility								
<b>Photographer:</b>	Stephen DiGiacomo				<b>Witness:</b>				
<b>Photo #</b>	1	<b>Of</b>	8		<b>Date:</b>	06-11-2013	<b>Time:</b>	1039	
<b>Description:</b>	Berm of settling pits. BMPs maintained and ~70% vegetation density.

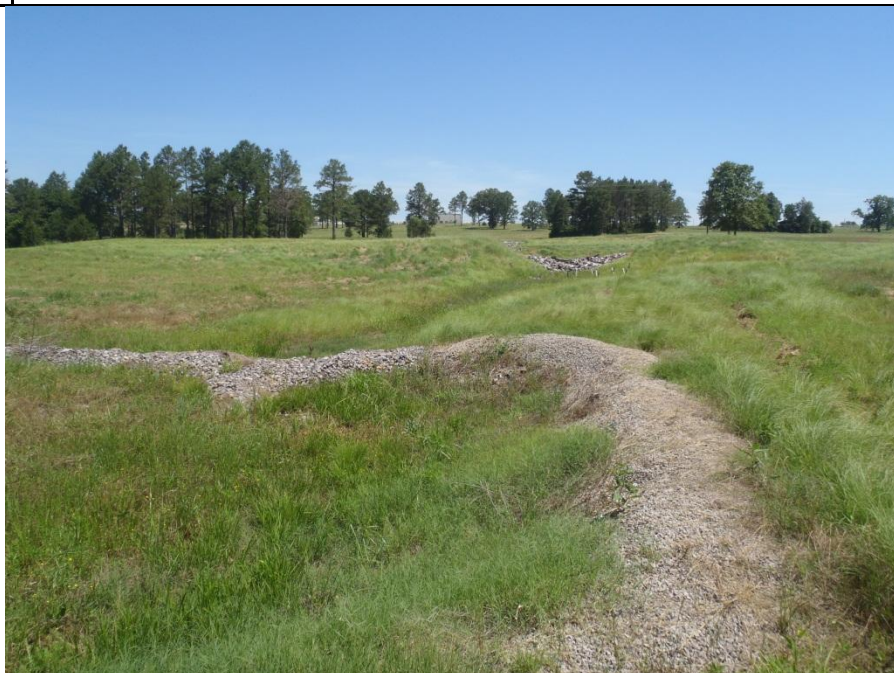
<b>Photographer:</b>	Stephen DiGiacomo				<b>Witness:</b>				
<b>Photo #</b>	2	<b>Of</b>	8		<b>Date:</b>	06-11-2013	<b>Time:</b>	1104	
<b>Description:</b>	Outfall #1. Temporary BMPs to be removed.

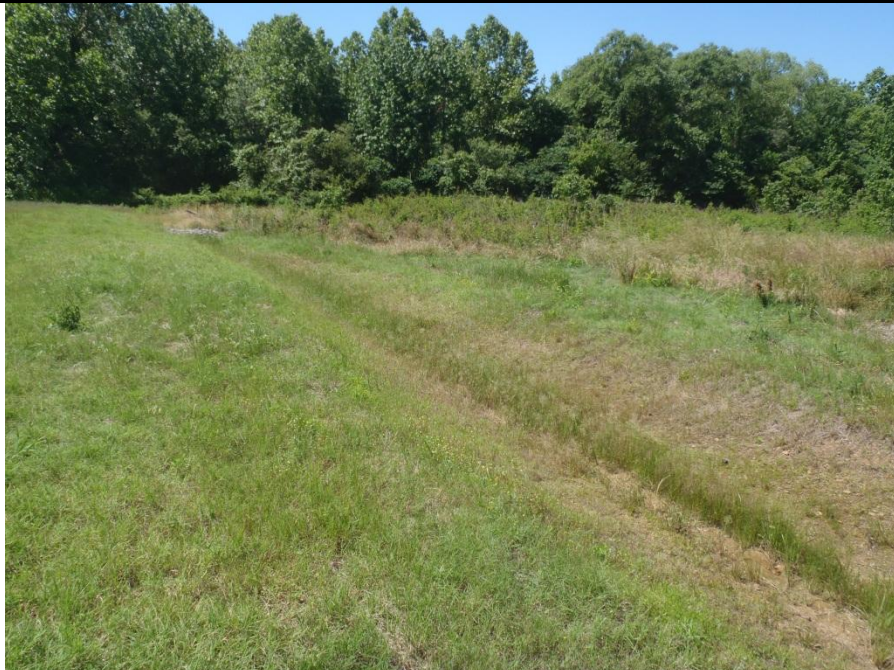
<b>Location:</b>	Cleveland Water Reuse/Recycle Facility						
<b>Photographer:</b>	Stephen DiGiacomo			<b>Witness:</b>			
<b>Photo #</b>	3	<b>Of</b>	8	<b>Date:</b>	06-11-2013	<b>Time:</b>	1103
<b>Description:</b>	Drainage from Outfall #1

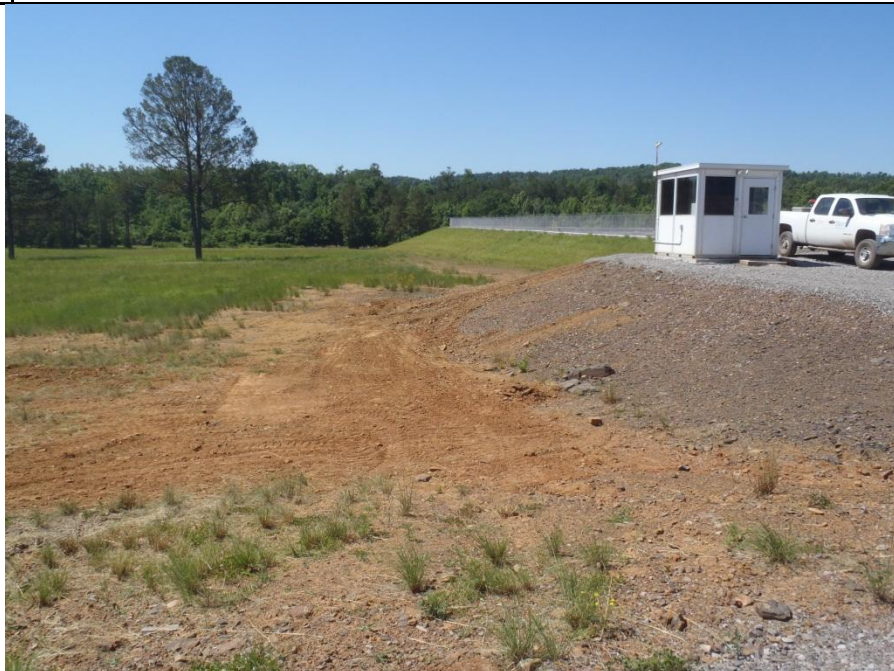
<b>Photographer:</b>	Stephen DiGiacomo			<b>Witness:</b>			
<b>Photo #</b>	4	<b>Of</b>	8	<b>Date:</b>	06-11-2013	<b>Time:</b>	1052
<b>Description:</b>	Bare soil due to recent installation of drain pipe, majority of site well vegetated.

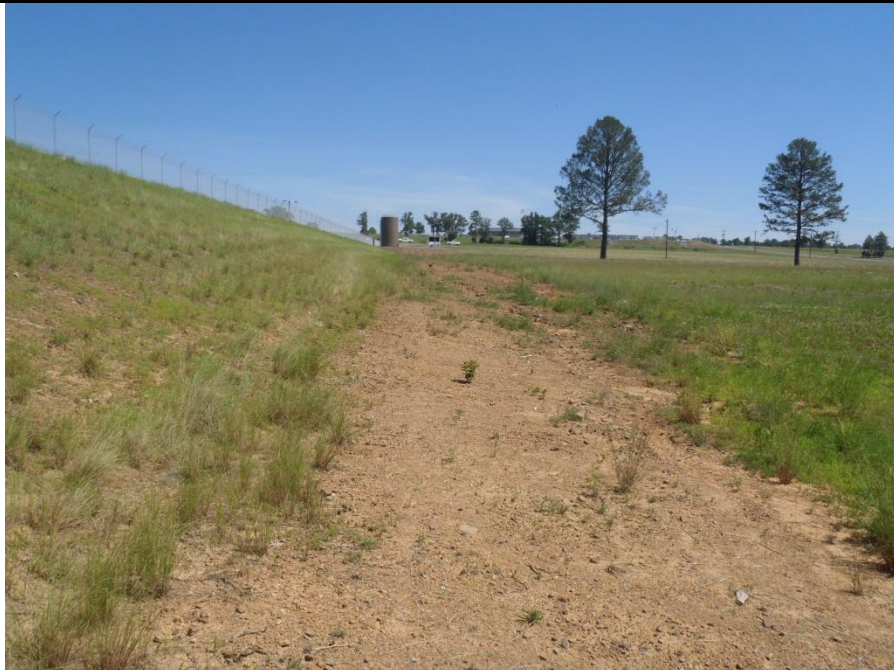
<b>Location:</b>	Cleveland Water Reuse/Recycle Facility						
<b>Photographer:</b>	Stephen DiGiacomo				<b>Witness:</b>		
<b>Photo #</b>	5	<b>Of</b>	8		<b>Date:</b>	06-11-2013	<b>Time:</b> 1058
<b>Description:</b>	Recent installation of drain pipe along the holding ponds, berms well vegetated.

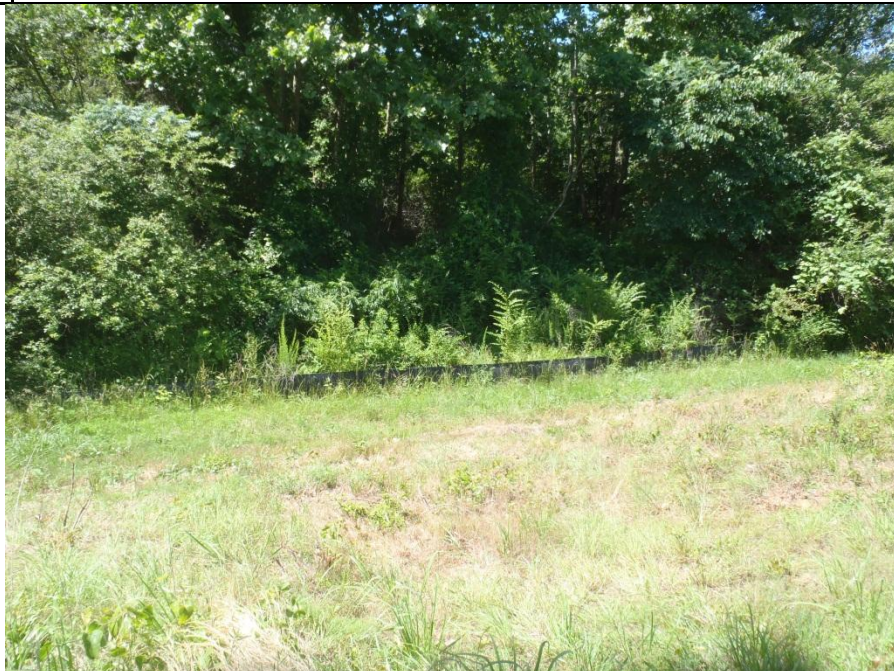
<b>Photographer:</b>	Stephen DiGiacomo				<b>Witness:</b>		
<b>Photo #</b>	6	<b>Of</b>	8		<b>Date:</b>	06-11-2013	<b>Time:</b> 1101
<b>Description:</b>	Silt fence along buffer zone in good working condition.

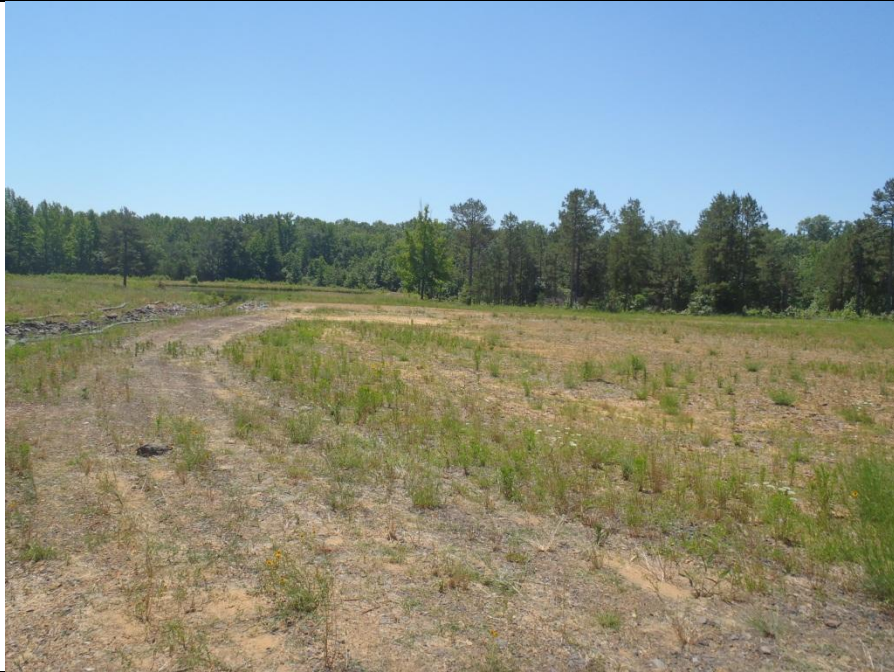
<b>Location:</b>	Cleveland Water Reuse/Recycle Facility						
<b>Photographer:</b>	Stephen DiGiacomo				<b>Witness:</b>		
<b>Photo #</b>	7	<b>Of</b>	8		<b>Date:</b>	06-11-2013	<b>Time:</b> 1135
<b>Description:</b>	2 <sup>nd</sup> Discharge point. Graveled drive and ~1 acre of bare soil with vegetation density of approximately 50%.

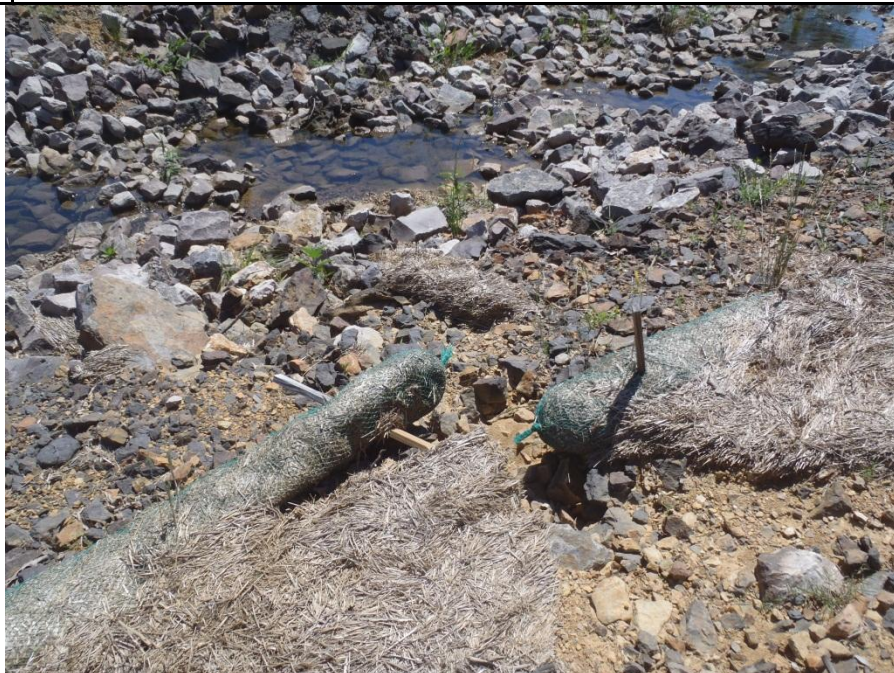
<b>Photographer:</b>	Stephen DiGiacomo				<b>Witness:</b>		
<b>Photo #</b>	8	<b>Of</b>	8		<b>Date:</b>	06-11-2013	<b>Time:</b> 1127
<b>Description:</b>	BMPs compromised after heavy rains at Discharge #2, addressed within 3 days of discovery.
