RE: George's Main Complex at 402 W. Robinson, Springdale, AR

AFIN: 72-00234 NPDES Permit No.: ARR00B454

On July 20, 2010, John Fazio, District 1 Inspector, and I performed a reconnaissance inspection of the industrial stormwater facility in accordance with the provisions of the Federal Clean Water Act, the Arkansas Water and Air Pollution Control Act, and the regulations promulgated thereunder. This reconnaissance inspection was conducted in conjunction with an emergency response incident that resulted in approximately 29 gallons of Caustic Soda Solution (50%) spilling onto the asphalt parking lot and entering George's Main Complex storm drain. This inspection revealed the following violations:

Water Division NPDES Photographic Evidence Sheet									
--	--	--	--	--	--	--	--	--	--

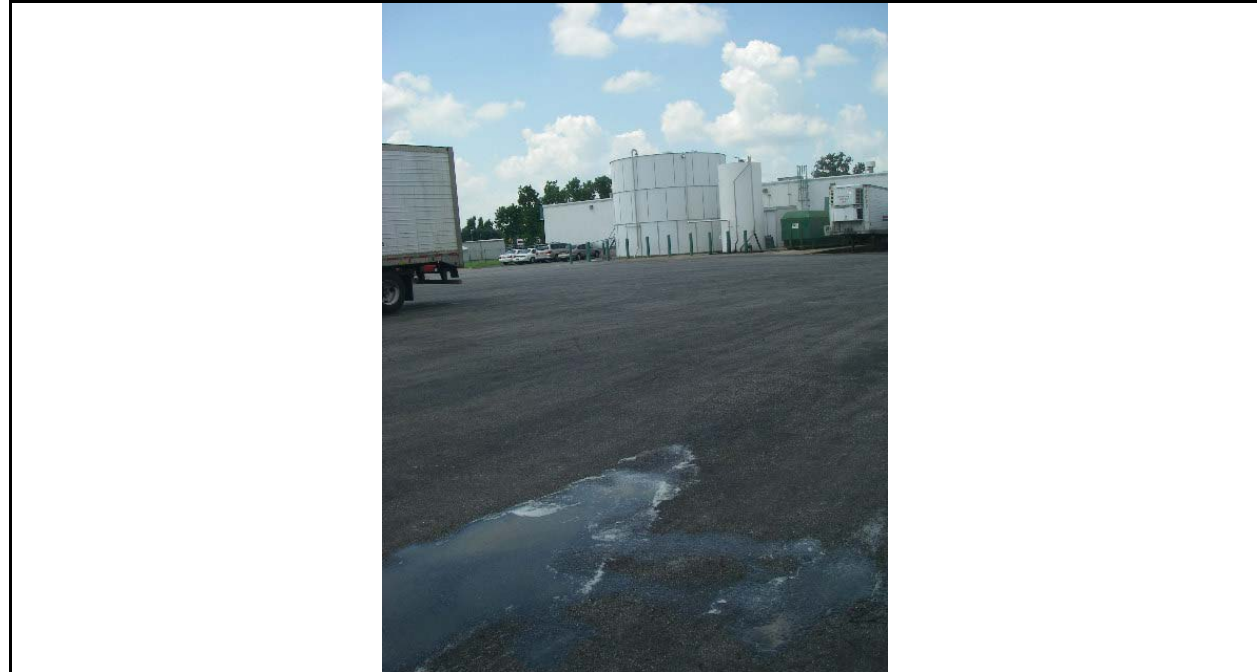
Photo #	1	Of	7	Date:	7-20-2010	Time:	3:18 p.m.		
----------------	---	-----------	---	--------------	-----------	--------------	-----------	--	--

Description:	Waste from reefer truck.								
---------------------	--------------------------	--	--	--	--	--	--	--	--

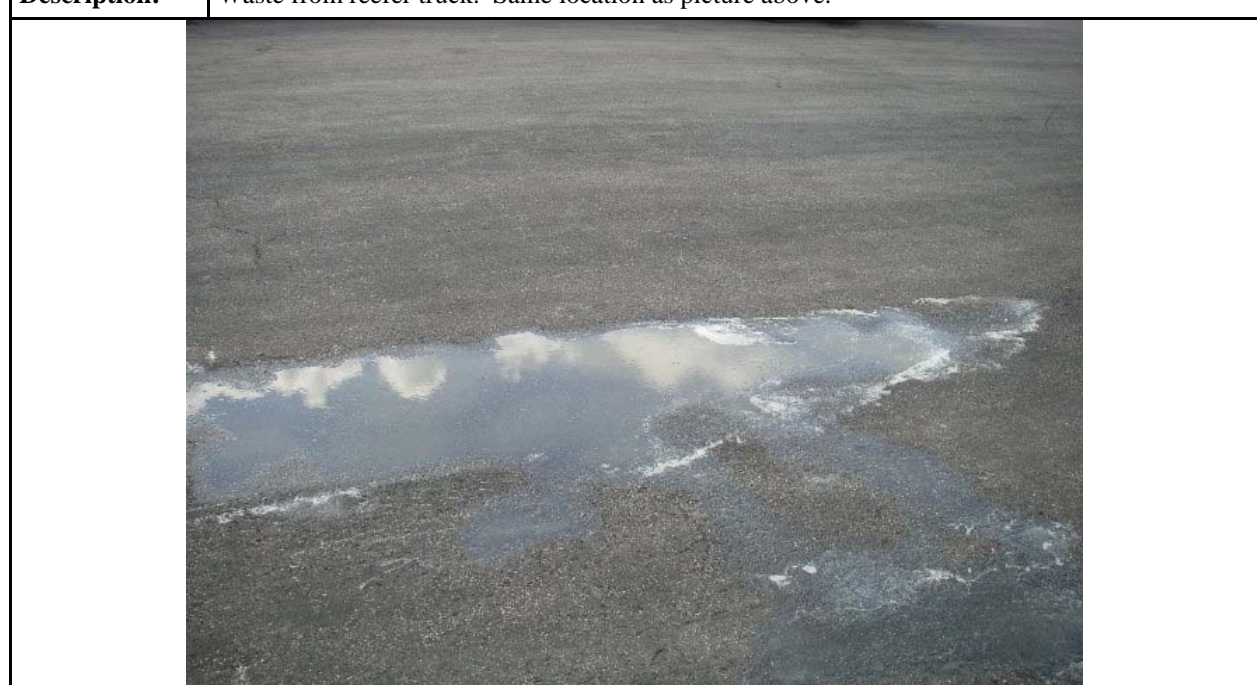
Photo #	2	Of	8	Date:	7-20-2010	Time:	3:17 p.m.		
----------------	---	-----------	---	--------------	-----------	--------------	-----------	--	--

Description:	Waste from reefer truck. Same location as picture above.								
---------------------	--	--	--	--	--	--	--	--	--

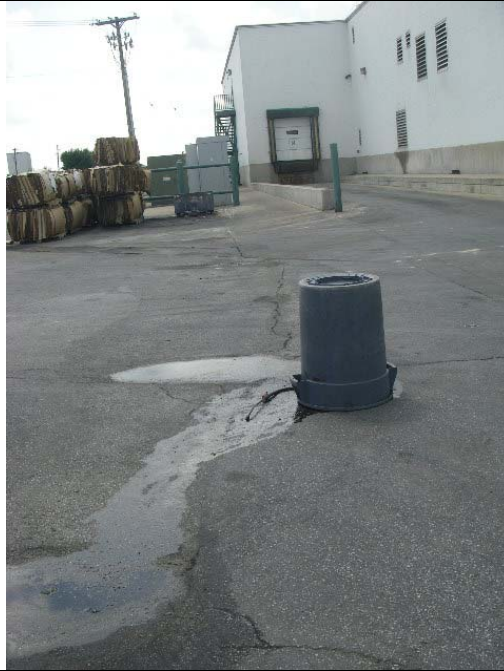
Photo #	3	Of	8	Date:	7-20-2010	Time:	3:19 p.m.		
----------------	---	-----------	---	--------------	-----------	--------------	-----------	--	--

1. At the time of the investigation, there was a container of leaking sulfuric acid solution on the asphalt lot located west of a storm drain. The sulfuric acid was said to have been used to neutralize the caustic soda that had been spilled. The trash can was placed over the sulfuric acid container because the employees stated the container had bloated and they were concerned it would explode. There were no controls around the storm drain to prevent the sulfuric acid solution from entering the storm drain had the container failed or exploded.

Description:	Sulfuric acid in parking lot with a container over it. This is located west of a storm drain located in the parking lot.								
---------------------	--	--	--	--	--	--	--	--	--

The above item requires your immediate attention. Please submit a written response to this finding to Cindy Garner, Water Division Enforcement Branch Manager. This response should be mailed to the address below. This response should contain documentation describing the course of action taken to correct each item noted. This corrective action should be completed as soon as possible, and the written response with all of the necessary documentation (i.e. photographs) is due by September 20, 2010.

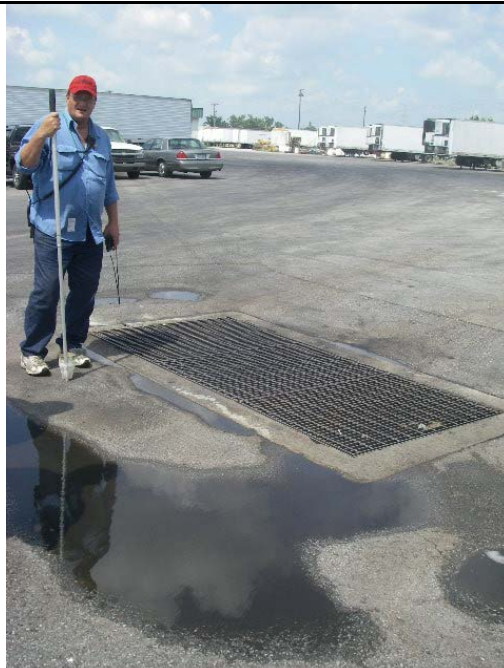
Photo #	4	Of	8	Date:	7-20-2010	Time:	3:21 p.m.		
----------------	---	-----------	---	--------------	-----------	--------------	-----------	--	--

Description:	Storm drain located east of the sulfuric acid.								
---------------------	--	--	--	--	--	--	--	--	--

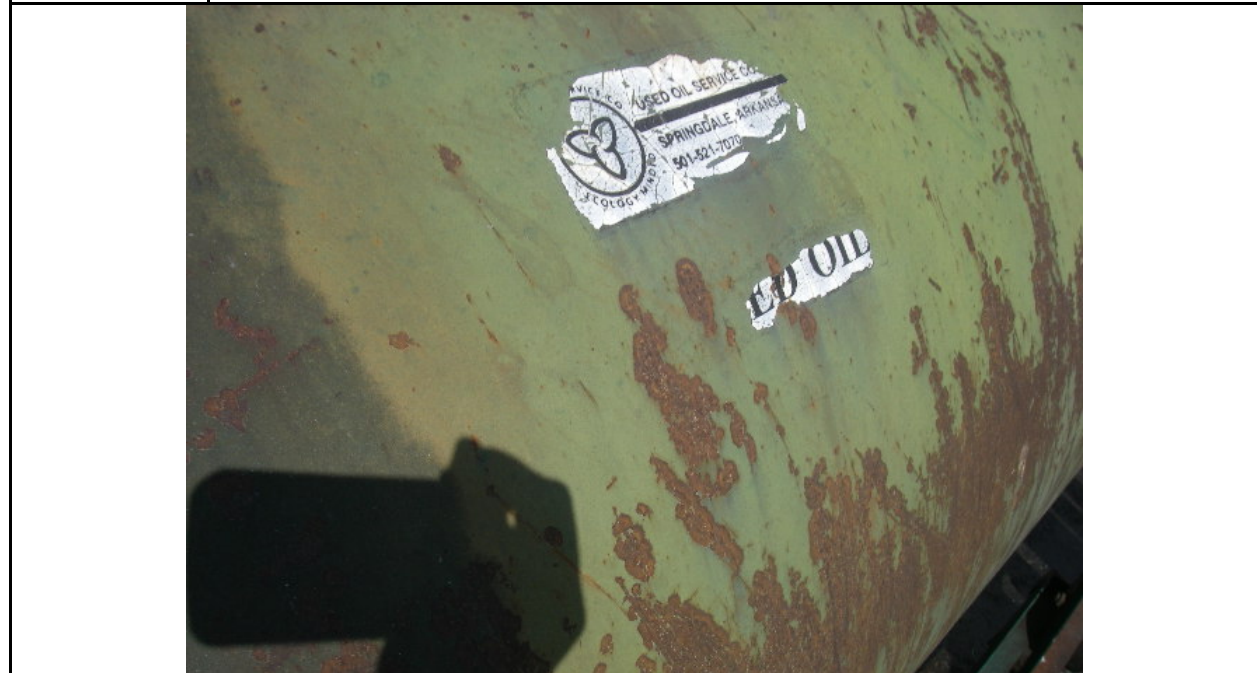
Photo #	5	Of	8		Date:	7-20-2010	Time:	3:26 p.m.	
----------------	---	-----------	---	--	--------------	-----------	--------------	-----------	--

2. Used oil had spilled onto the parking lot located on the northeast side of the facility near a used oil container in the boneyard.

Description:	Used oil container near boneyard.								
---------------------	-----------------------------------	--	--	--	--	--	--	--	--

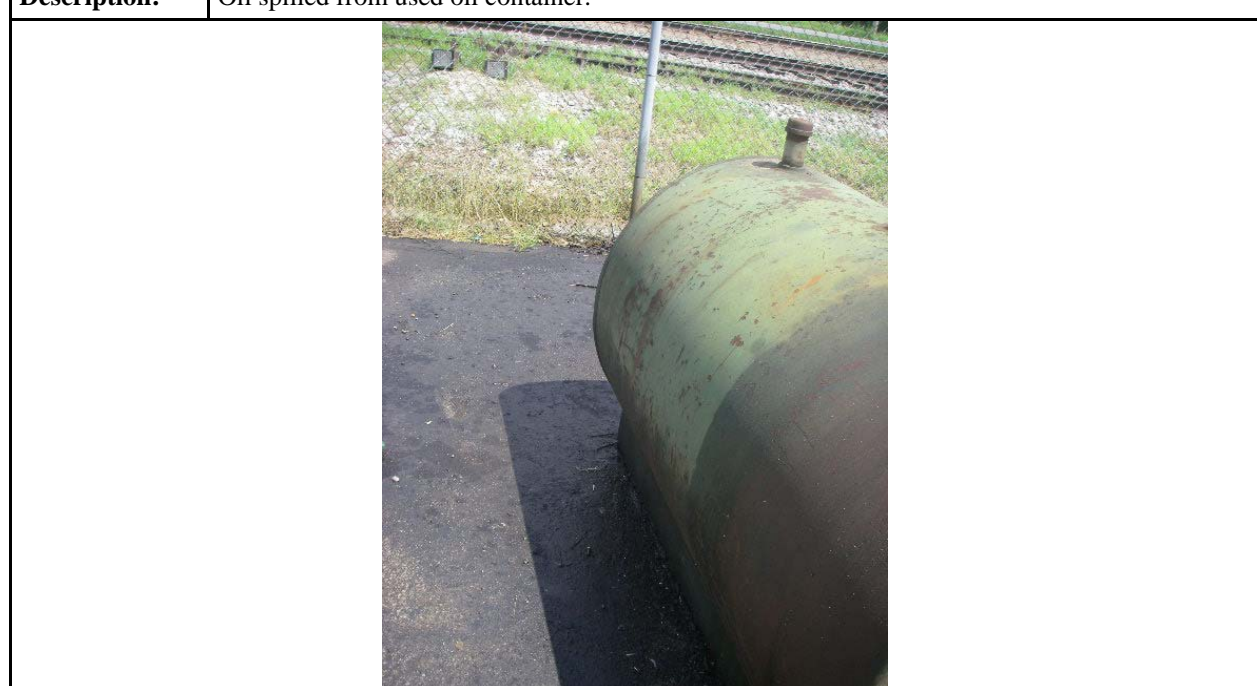
Photo #	6	Of	8		Date:	7-20-2010	Time:	3:25 p.m.	
----------------	---	-----------	---	--	--------------	-----------	--------------	-----------	--

Description:	Oil spilled from used oil container.								
---------------------	--------------------------------------	--	--	--	--	--	--	--	--

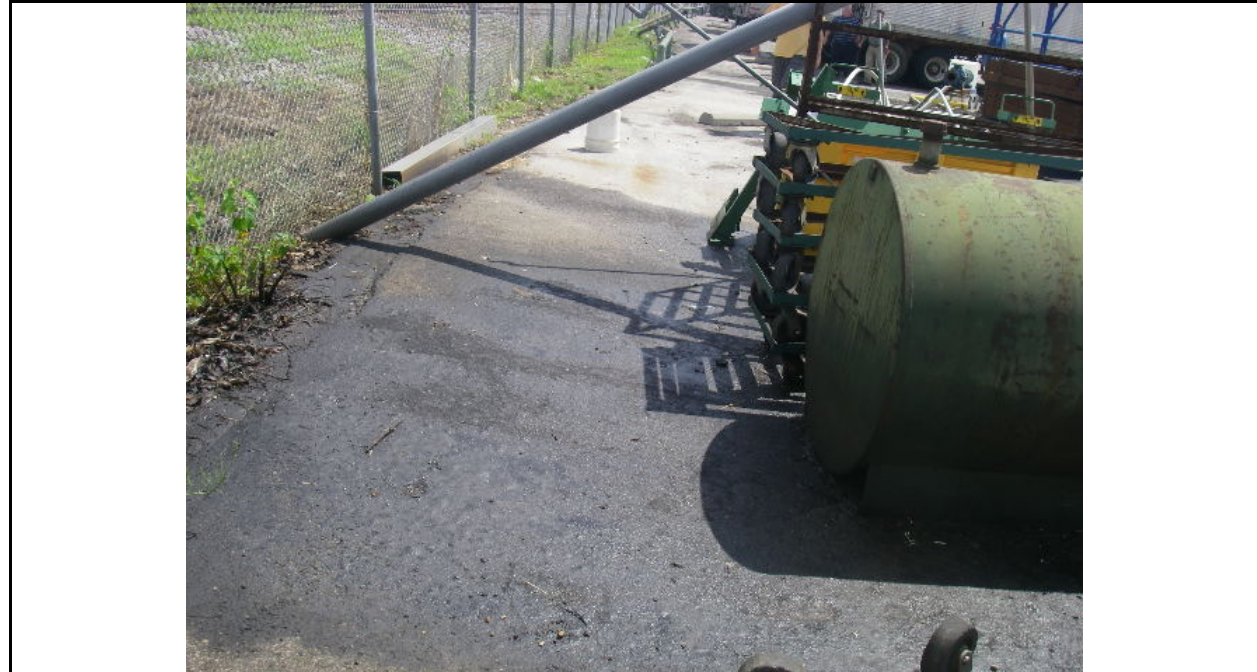
Photo #	7	Of	8	Date:	7-20-2010	Time:	3:25 p.m.		
----------------	---	-----------	---	--------------	-----------	--------------	-----------	--	--

Description:	Oil spilled from used oil container.								
---------------------	--------------------------------------	--	--	--	--	--	--	--	--
