ARKANSAS
Department of Environmental Quality

Permit No.: 5071-W

NO DISCHARGE INDUSTRIAL PERMIT INSPECTION FORM

Water Division No Discharge Industrial Photographic Evidence Sheet							
---	--	--	--	--	--	--	--

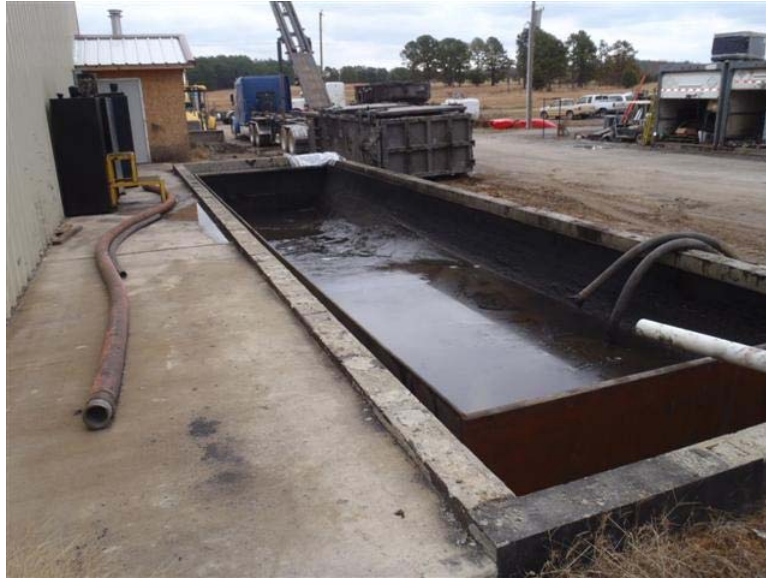
Photo #	1	Of	6	Date:	11/18/10	Time:	15:09
----------------	---	-----------	---	--------------	----------	--------------	-------

Description:	Wash pit with metal container in place inside the pit. The facility was operating the wash pit on the date of inspection.						
---------------------	---	--	--	--	--	--	--

1. No discharge permit (non active permit)
Permit Status: The **construction certification** was not submitted to the ADEQ permitting department so a **letter of authorization to operate** could be issued.
Corrective Action:

The engineer recommended we add additional height to the concrete wall. JMO has completed the task as reflected in the photos.

The **construction certification** is included in this package.

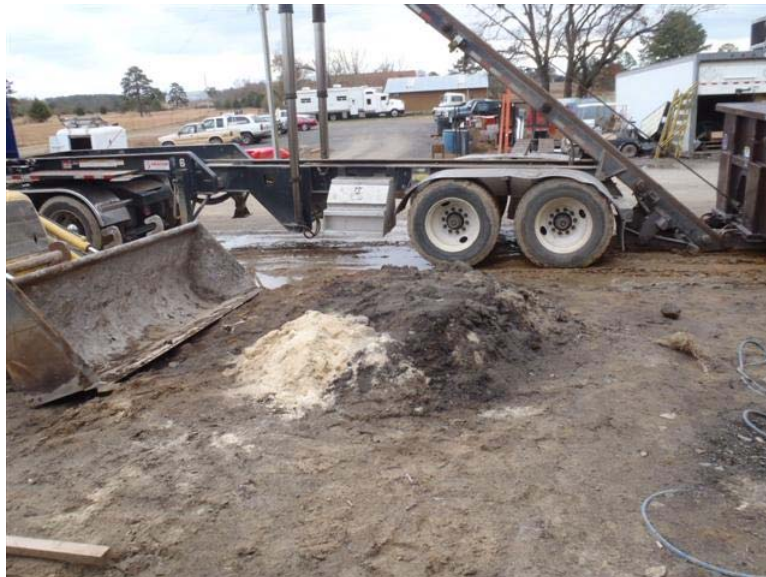
Photo #	2	Of	6	Date:	11/18/10	Time:	1507
----------------	---	-----------	---	--------------	----------	--------------	------

Description:	Sand and solids on the ground near the southeast corner of the wash building.						
---------------------	---	--	--	--	--	--	--

2. Improper storage of solids that may cause runoff water to be polluted prior to entering the drain system.
JM Oilfield Services has removed the solid materials in question and cleaned the area reflected as ADEQ Photo 2 of 6 and Photo 4 of 6. Please refer to the photos in this package for verification.

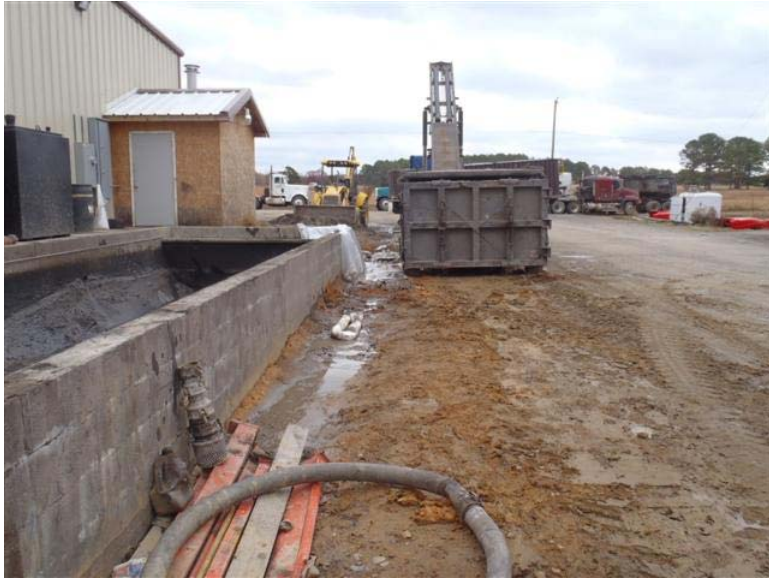
Photo #	3	Of	6	Date:	11/18/10	Time:	1510
----------------	---	-----------	---	--------------	----------	--------------	------

Description:	View of storm water flowing from area where sands and solids were on the ground (in front of loader).						
---------------------	---	--	--	--	--	--	--

3. The fine silt and sands that are being washed from the high points of the property to the lowest point of the property by storm water runoff.
Please refer to the photos that reflect the straw placed in the path of the storm water to prevent the fine silt and sands from being discharge into the storm water drainage ditch that borders JMO property.

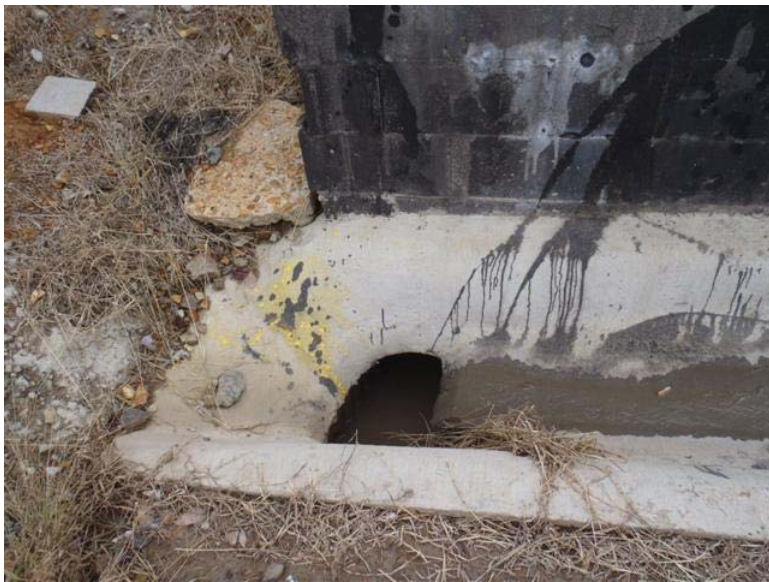
Photo #	4	Of	6	Date:	11/18/10	Time:	
----------------	---	-----------	---	--------------	----------	--------------	--

Description:	The water in photo 3 enters this storm drain and discharges to a tributary running through the middle of the facility.						
---------------------	--	--	--	--	--	--	--

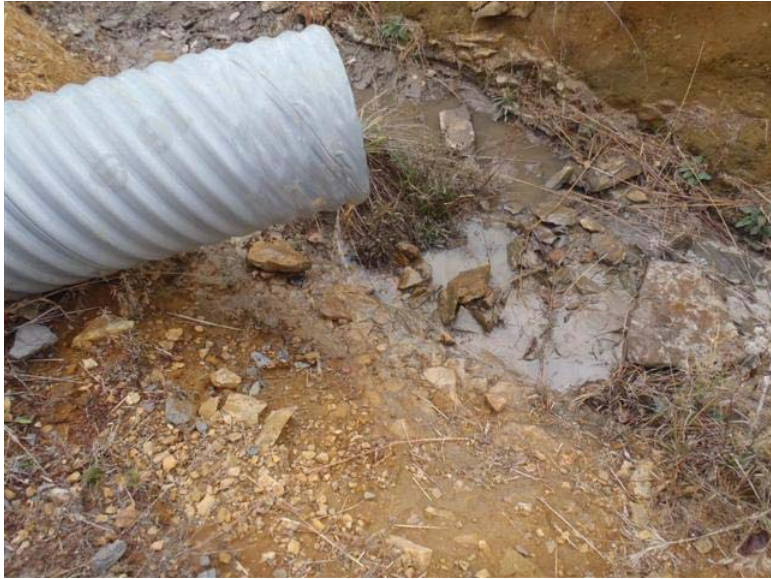
Location:	JM Oilfield Service, Inc.						
Photographer:	Travis Harmon		Witness:	David Young, Kerri McCabe, Risa Parker			
Photo #	5	Of	6	Date:	11/18/10	Time:	
Description:	Outfall of storm drain shown in photo 4.

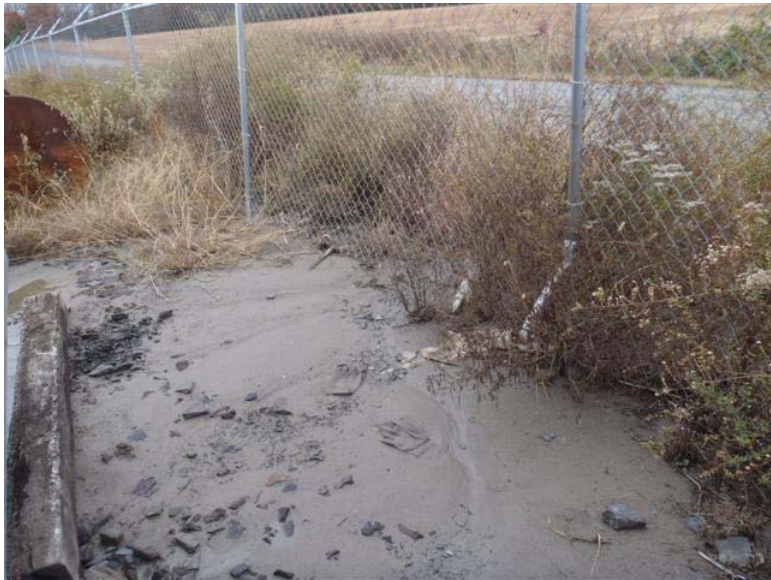
Photographer:	Travis Harmon		Witness:	David Young, Kerri McCabe, Risa Parker			
Photo #	6	Of	6	Date:	11/18/10	Time:	
Description:	Material on the ground near the frac tanks at the northwest corner of the facility.
