ARKANSAS
Department of Environmental Quality

RE: AFIN: 50-00062, Permit Tracking No.: 0323-WG-SW-1
S. W. Willisville SWD System

GENERAL PERMIT 0000-WG-SW INSPECTION FORM

Water Division No Discharge Industrial Photographic Evidence Sheet

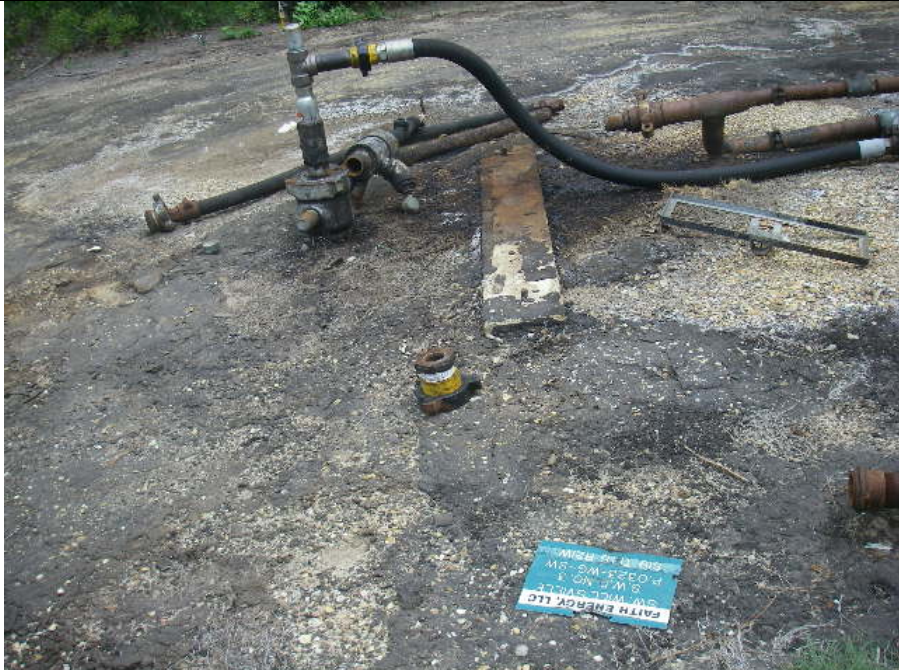
Photo No. 1 **Of** 18 **Date:** 8-10-11 **Time:** 1534

Description: System sign observed on the ground at the S. W. Willisville SWD No. 3 well site.

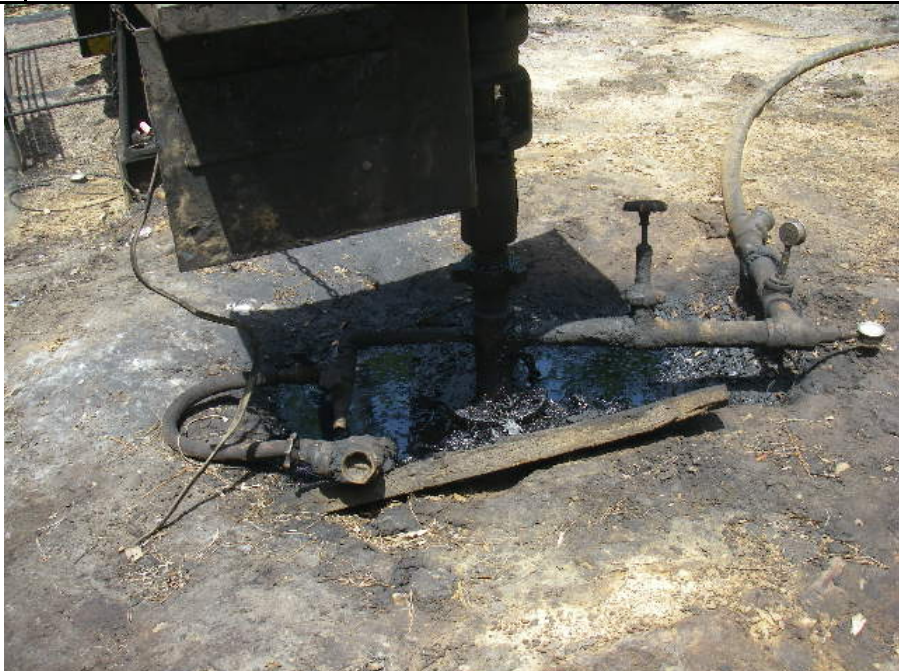
Photo No. 2 **Of** 18 **Date:** 8-10-11 **Time:** 1540

1. Oil waste observed at the wellheads of multiple production well sites. See Photo Nos. 2, 3, 4, 5, 9, 11, 14, 15 & 17. The operator is required to properly operate and maintain all parts of the system and may not place waste in a manner where it is likely to cause pollution of any waters of the state. This is a violation of Part III.B.7. of the general permit and Ark. Code Ann. § 8-4-217(a)(2).

Description: Oil waste observed at the wellhead of the J. E. McKinney No. 1 production well site.

As you may recall, as you made your inspection, you ran across a crew of our employees already addressing many of the issues you documented in your letter to us. We have completed the "clean up" of our field operations which addressed all of the oil waste observed at the wellheads. We are hauling in clay to build up the three firewall berms that were mentioned in your letter. The oil waste within the J A Alder and S W Willisville firewalls has also been removed.

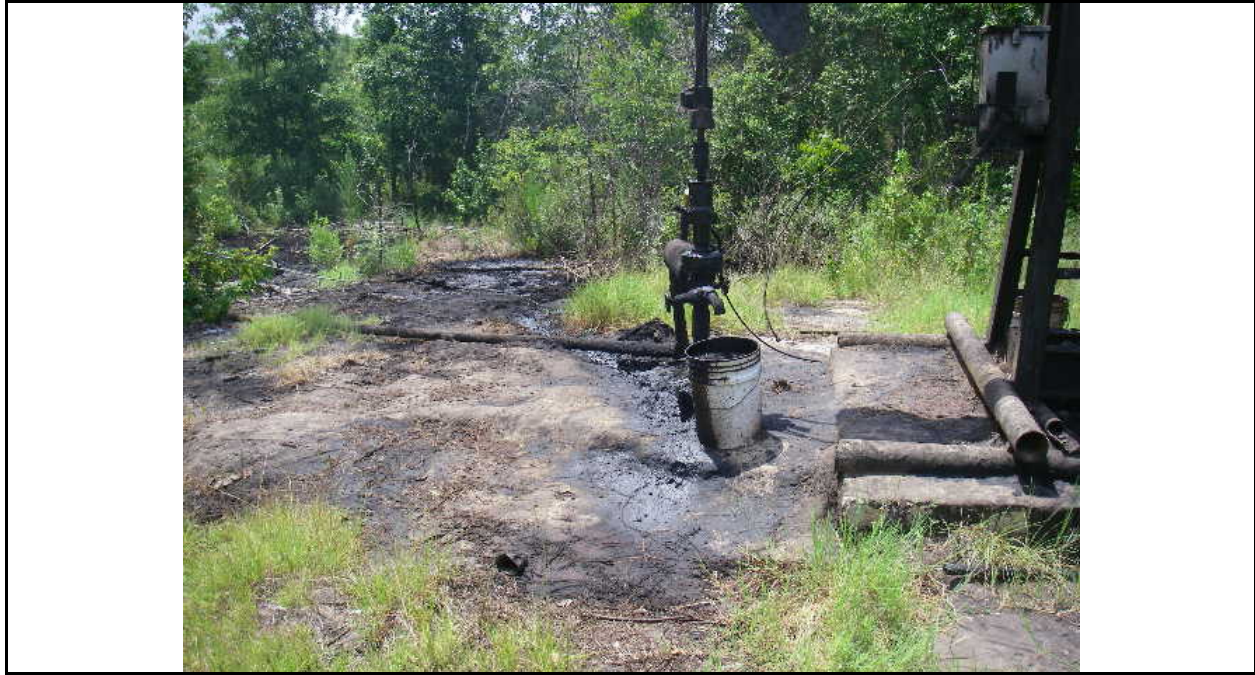
Photo No.	3	Of	18	Date:	8-10-11	Time:	1549
------------------	---	-----------	----	--------------	---------	--------------	------

Description:	Oil waste observed at the wellhead of this unidentified production well site.						
---------------------	-------------------------------------------------------------------------------	--	--	--	--	--	--

The operation depicted by Photos #3 & #4 which are enclosed with your letter, have nothing to do with our operations in this field, this well and this site are owned by another operator.

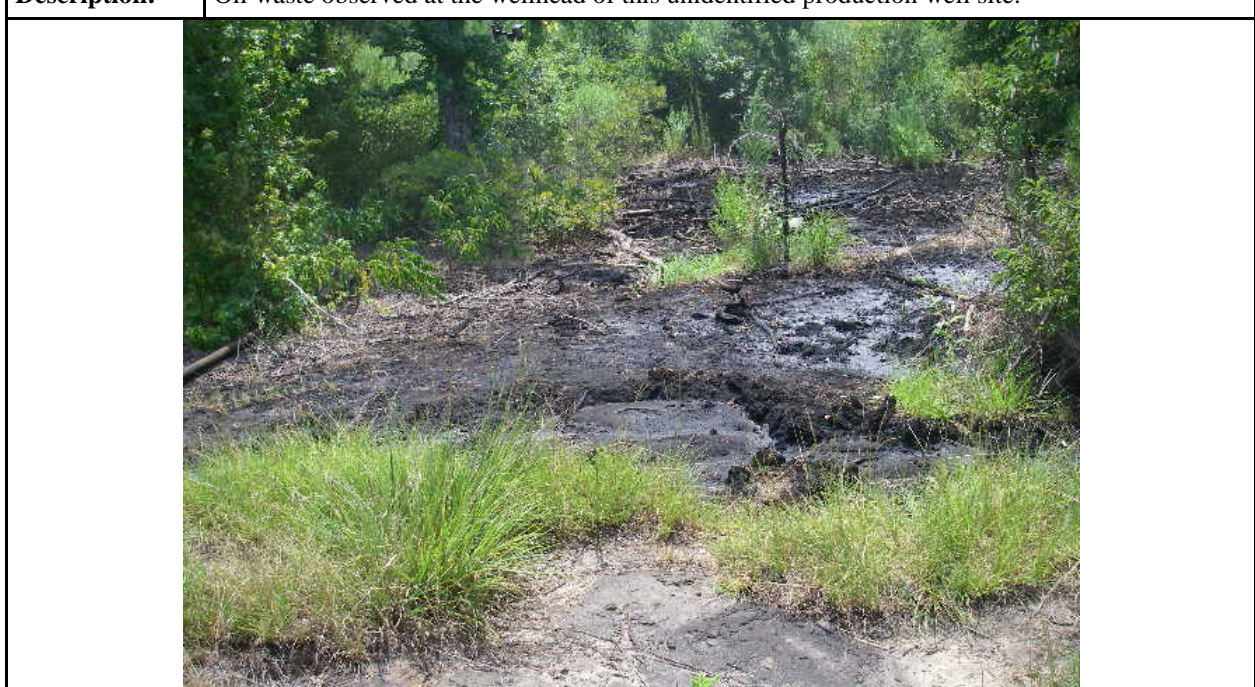
Photo No.	4	Of	18	Date:	8-10-11	Time:	1550
------------------	---	-----------	----	--------------	---------	--------------	------

Description:	Oil waste observed at the wellhead of this unidentified production well site.						
---------------------	-------------------------------------------------------------------------------	--	--	--	--	--	--

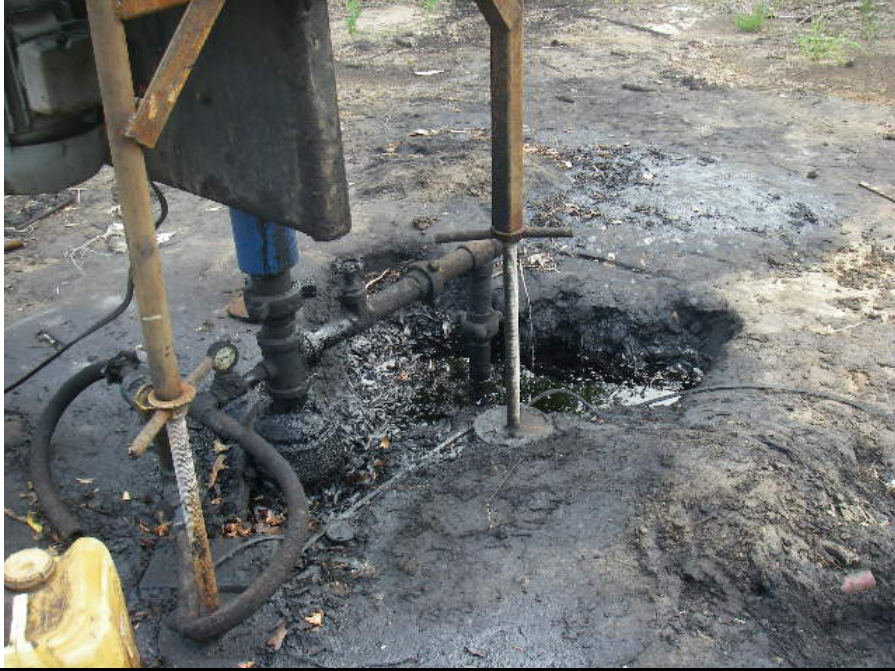
Location:							
Photographer: Connery Salter				Witness: None			
Photo No.	5	Of	18	Date:	8-10-11	Time:	
Description: Oil waste observed at the wellhead of the J. A. Alder No. 4 production well site.

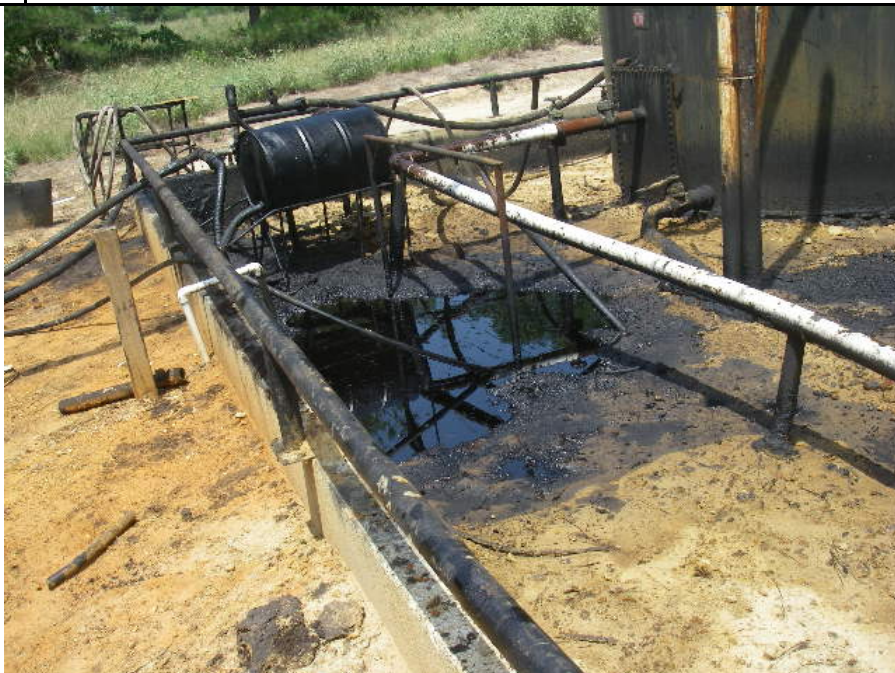
5. Oil waste observed inside the containment areas of the J. A. Alder Battery & S. W. Willisville No. 1 Saltwater Battery. See Photo Nos. 6 & 7. The operator is required to properly operate and maintain all parts of the system and may not place waste in a manner where it is likely to cause pollution of any waters of the state. This is a violation of Part III.B.7. of the general permit and Ark. Code Ann. § 8-4-217(a)(2).

Photographer: Connery Salter				Witness: None			
Photo No.	6	Of	18	Date:	8-10-11	Time:	1401
Description: Oil waste observed inside the containment area of the J. A. Alder Battery.

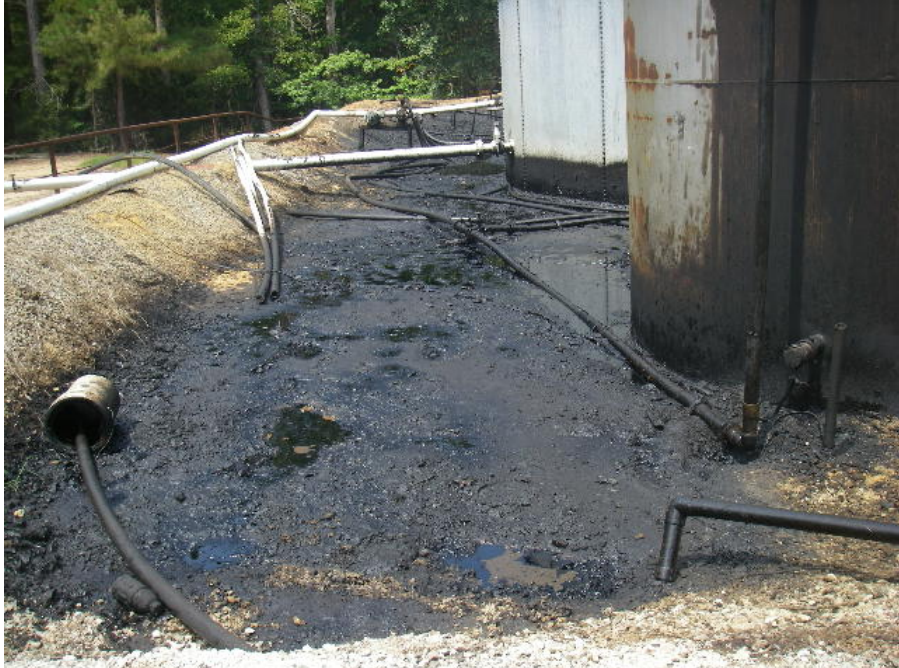
Photo No.	7	Of	18	Date:	8-10-11	Time:	1420
------------------	---	-----------	----	--------------	---------	--------------	------

Description:	Oil waste observed inside the containment of the S. W. Willisville SWD No. 1 S. W. Battery.						
---------------------	---------------------------------------------------------------------------------------------	--	--	--	--	--	--

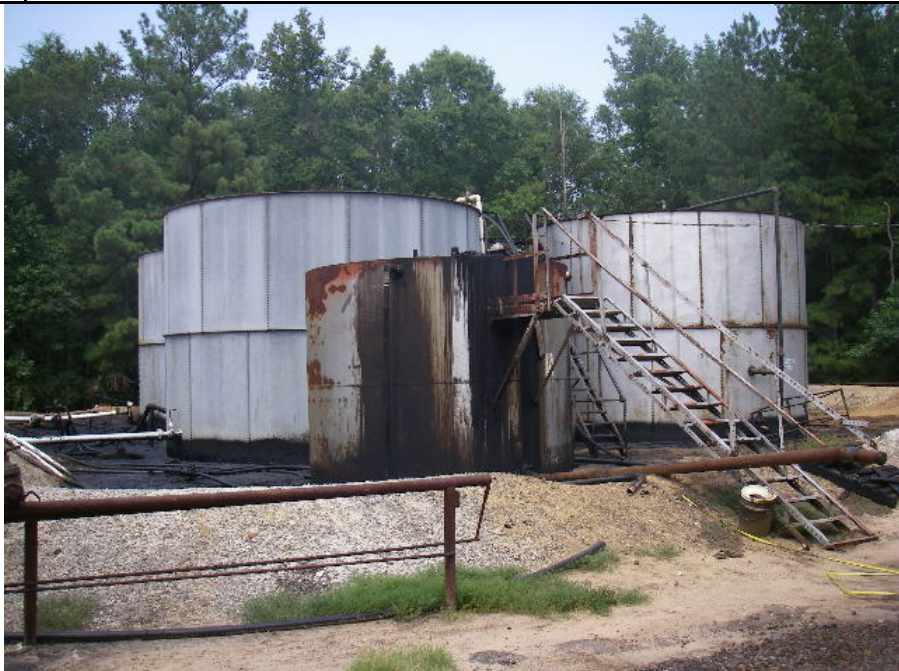
Photo No.	8	Of	18	Date:	8-10-11	Time:	1421
------------------	---	-----------	----	--------------	---------	--------------	------

Description:	The S. W. Willisville SWD No. 1 S. W. Battery configuration does not match current drawings.						
---------------------	----------------------------------------------------------------------------------------------	--	--	--	--	--	--

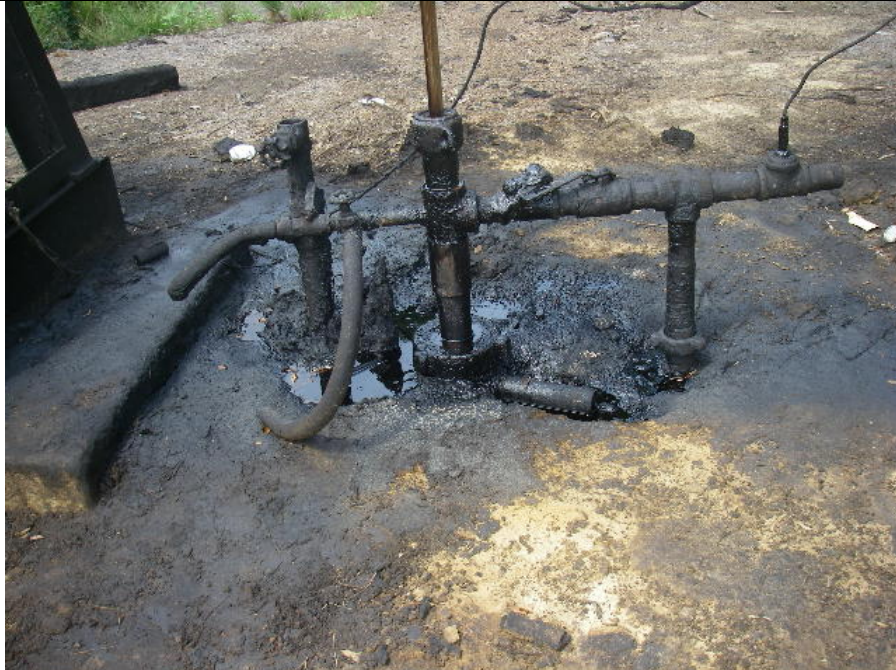
Photo No.	9	Of	18	Date:	8-10-11	Time:	1437
------------------	---	-----------	----	--------------	---------	--------------	------

Description:	Oil waste observed at the wellhead of the J. A. Alder No. 6 production well site.						
---------------------	-----------------------------------------------------------------------------------	--	--	--	--	--	--

I was not able to photograph the J A Alder #6 well due to a workover rig being on it.

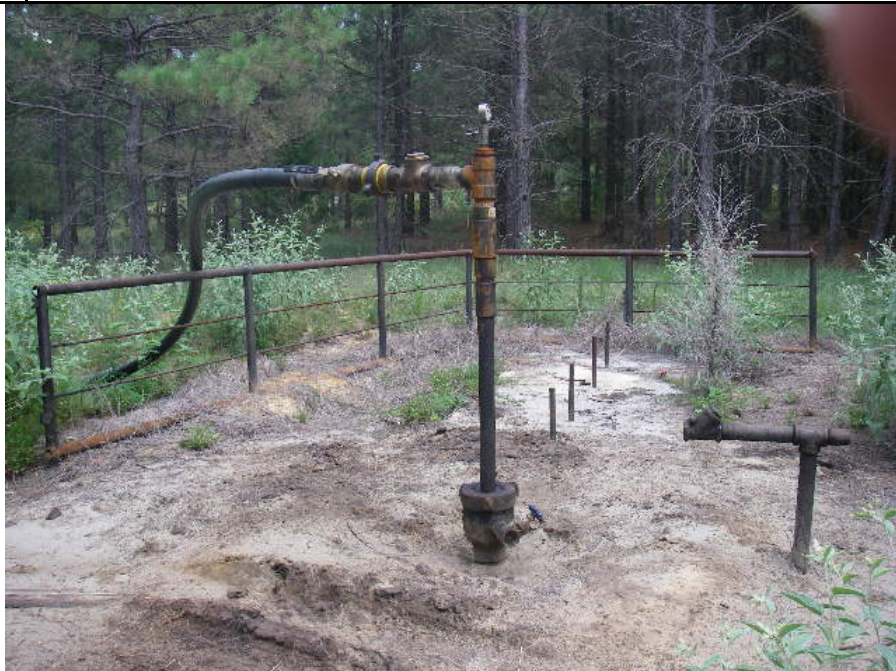
Photo No.	10	Of	18	Date:	8-10-11	Time:	1443
------------------	----	-----------	----	--------------	---------	--------------	------

2. The J. A. Alder No. 14 has been converted into a SWD and is not listed on the current permit. See Photo No. 10. Any change to the information previously submitted in an NOI requires submittal of a new NOI prior to the changes taking effect. This is a violation of Part III.A.1. of the general permit..

Description:	The J. A. Alder No. 14 has been converted into a SWD and is not listed on the current permit.						
---------------------	-----------------------------------------------------------------------------------------------	--	--	--	--	--	--

We are in the process of updating our permit to reflect some changes made and will be sending the changes to your office soon.

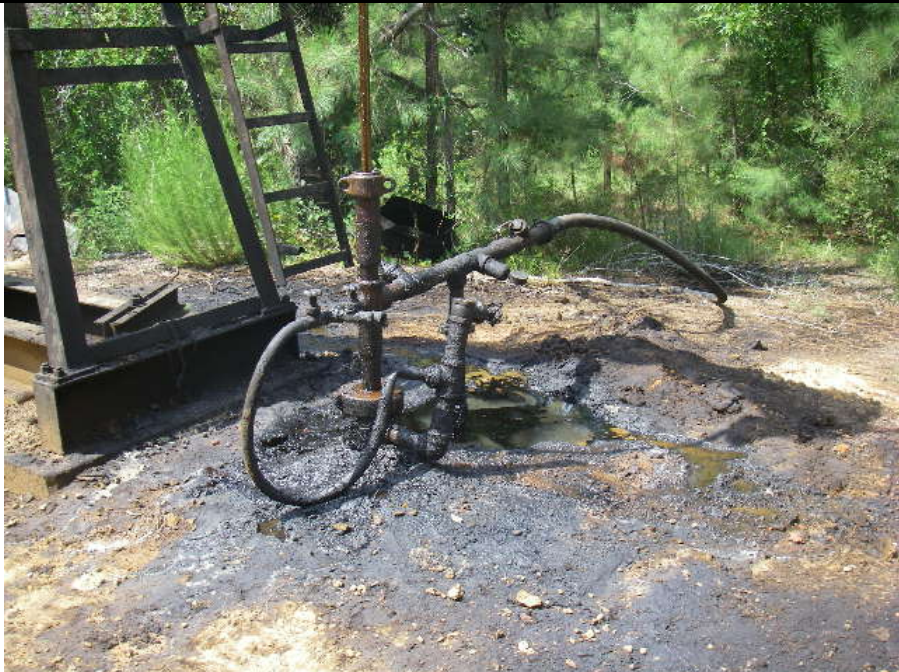
Photo No. 11 **Of** 18 **Date:** 8-10-11 **Time:** 1450

Description: Oil waste observed at the wellhead of the J. A. Alder No. 8 production well site.

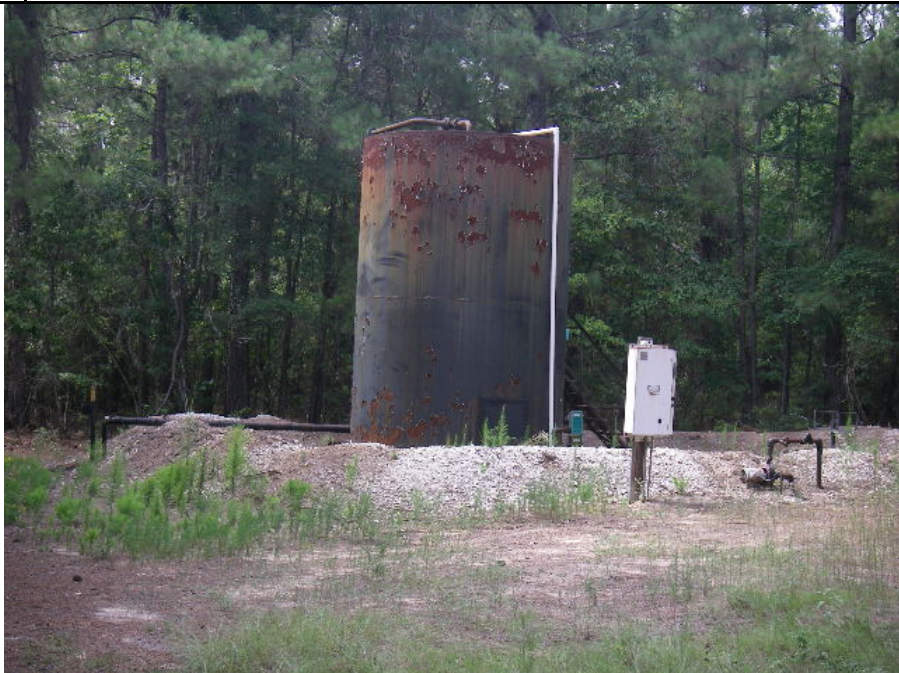
Photo No. 12 **Of** 18 **Date:** 8-10-11 **Time:** 1458

3. Firewall berms observed low at the Warmack-Montgomery, Phillips & Phillips A Batteries. See Photo Nos. 12, 16 & 18. Any change to the information previously submitted in an NOI requires submittal of a new NOI prior to the changes taking effect. This is a violation of Part III.A.1. of the general permit.

Description: Firewall berm is low at the Warmack-Montgomery Battery.

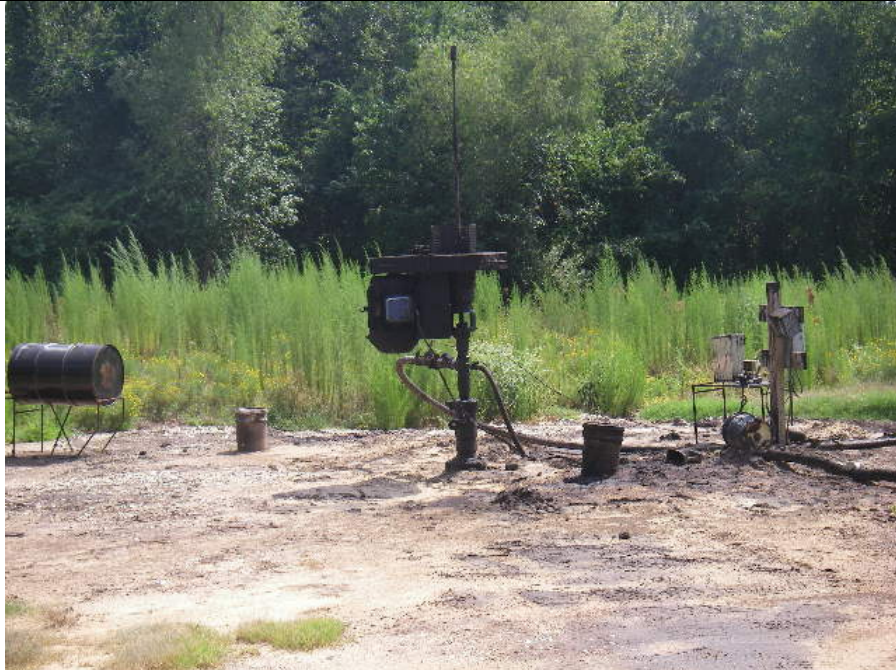
Photo No.	13	Of	18	Date:	8-10-11	Time:	1513
------------------	----	-----------	----	--------------	---------	--------------	------

4. The T. E. Ellis No. 5 production well observed to be actively part of this system & is not listed on current permit. See Photo No. 13. Any change to the information previously submitted in an NOI requires submittal of a new NOI prior to the changes taking effect. This is a violation of Part III.A.1. of the general permit...

Description:	The T. E. Ellis No. 5 prod. well observed actively part of this system & not listed on permit.						
---------------------	------------------------------------------------------------------------------------------------	--	--	--	--	--	--

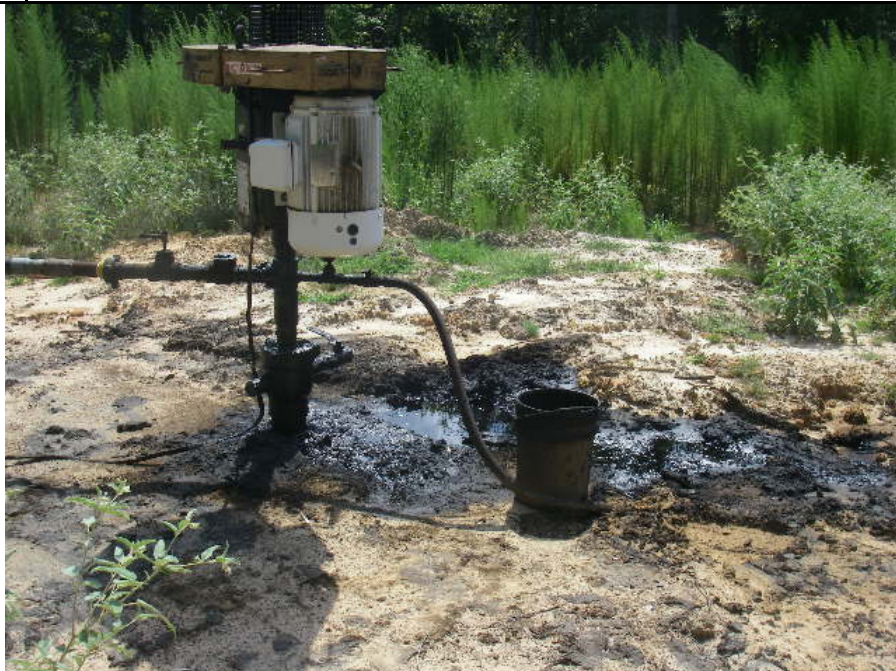
Photo No.	14	Of	18	Date:	8-10-11	Time:	1516
------------------	----	-----------	----	--------------	---------	--------------	------

Description:	Oil waste observed at the wellhead of this unidentified production well site.						
---------------------	-------------------------------------------------------------------------------	--	--	--	--	--	--

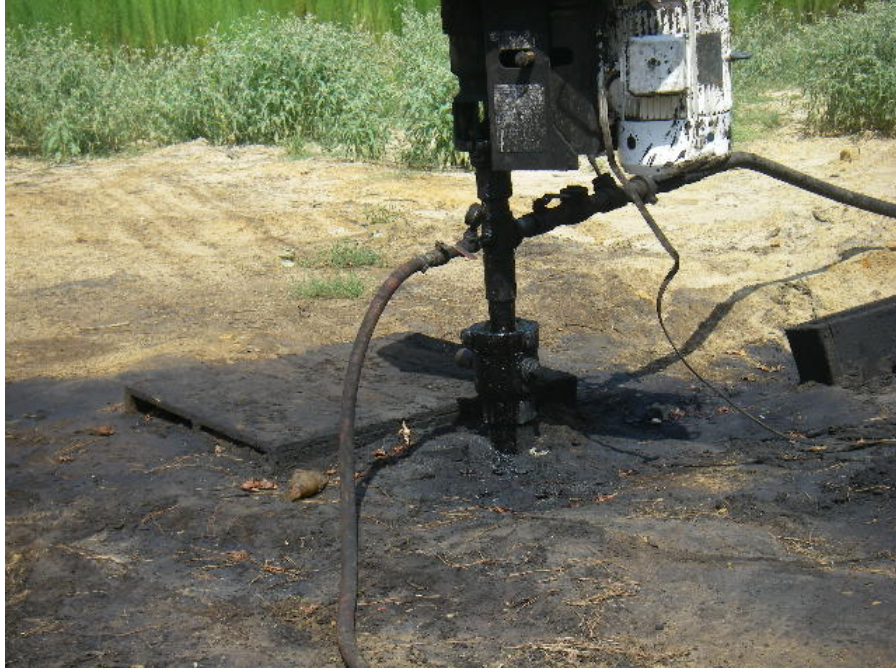
Photo No.	15	Of	18	Date:	8-10-11	Time:	1517
------------------	----	-----------	----	--------------	---------	--------------	------

Description:	Oil waste observed at the wellhead of the T. E. Ellis No. 3 production well site.						
---------------------	-----------------------------------------------------------------------------------	--	--	--	--	--	--

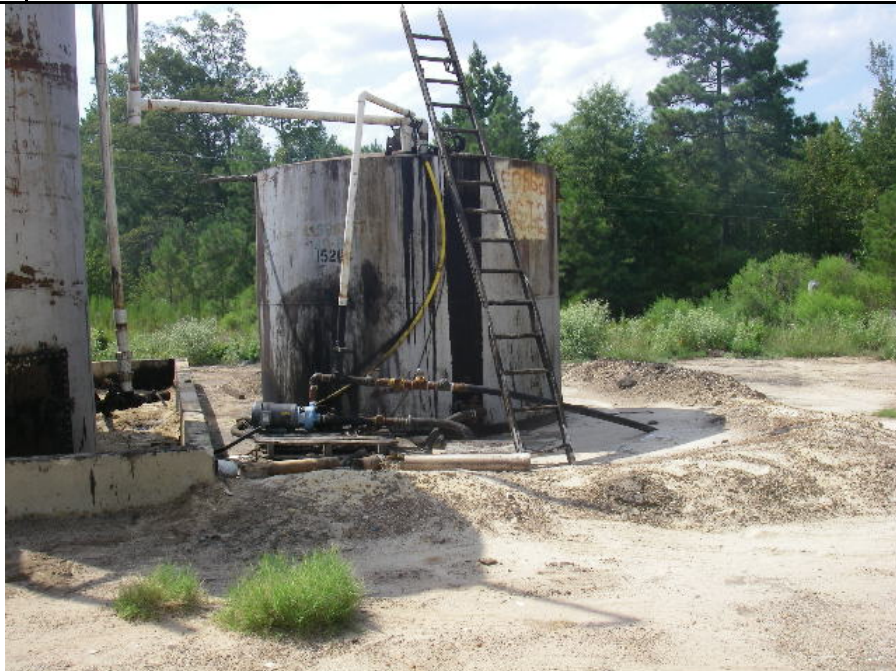
Photo No.	16	Of	18	Date:	8-10-11	Time:	1528
------------------	----	-----------	----	--------------	---------	--------------	------

Description:	Firewall berm is low at the Phillips A Battery.						
---------------------	-------------------------------------------------	--	--	--	--	--	--

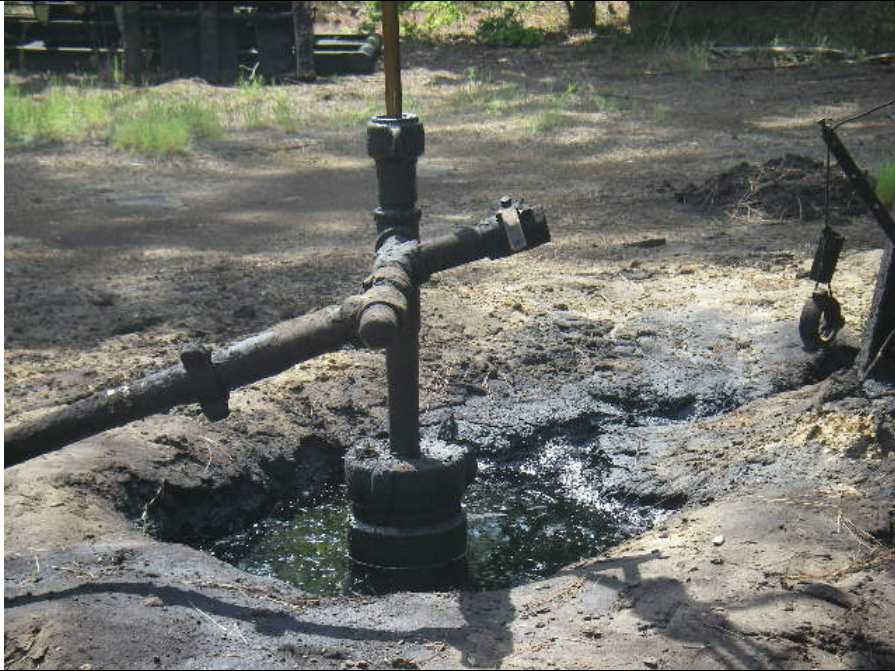
Location:	S. W. Willisville SWD System						
Photographer:	Connery Salter			Witness:	None		
Photo No.	17	Of	18	Date:	8-10-11	Time:	1531
Description:	Oil waste observed at the wellhead of the Fed. Land Bank No. 1 production well site.

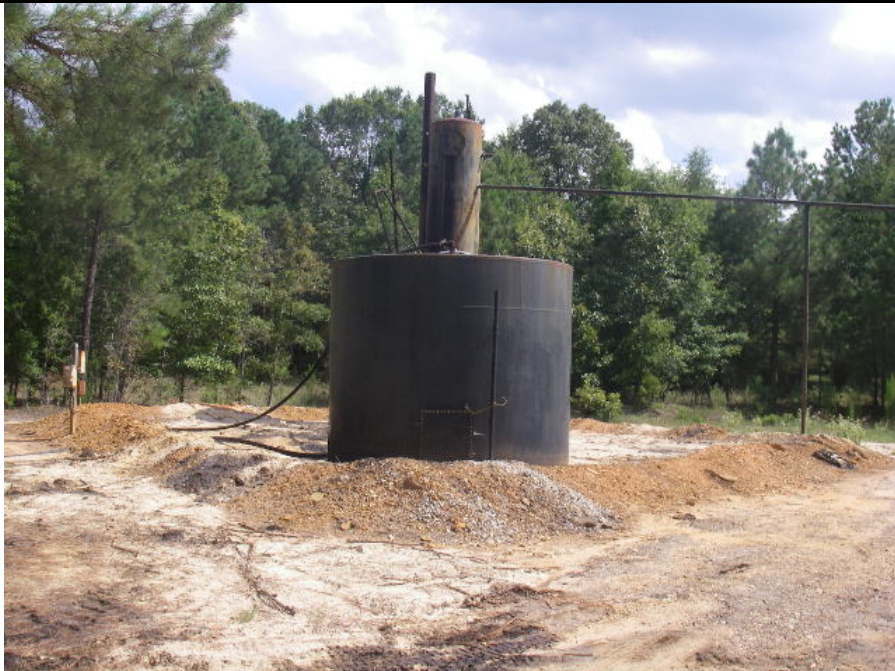
Photographer:	Connery Salter			Witness:	None		
Photo No.	18	Of	18	Date:	8-10-11	Time:	1533
Description:	Firewall berm is low at the Phillips (saltwater tank) Battery.

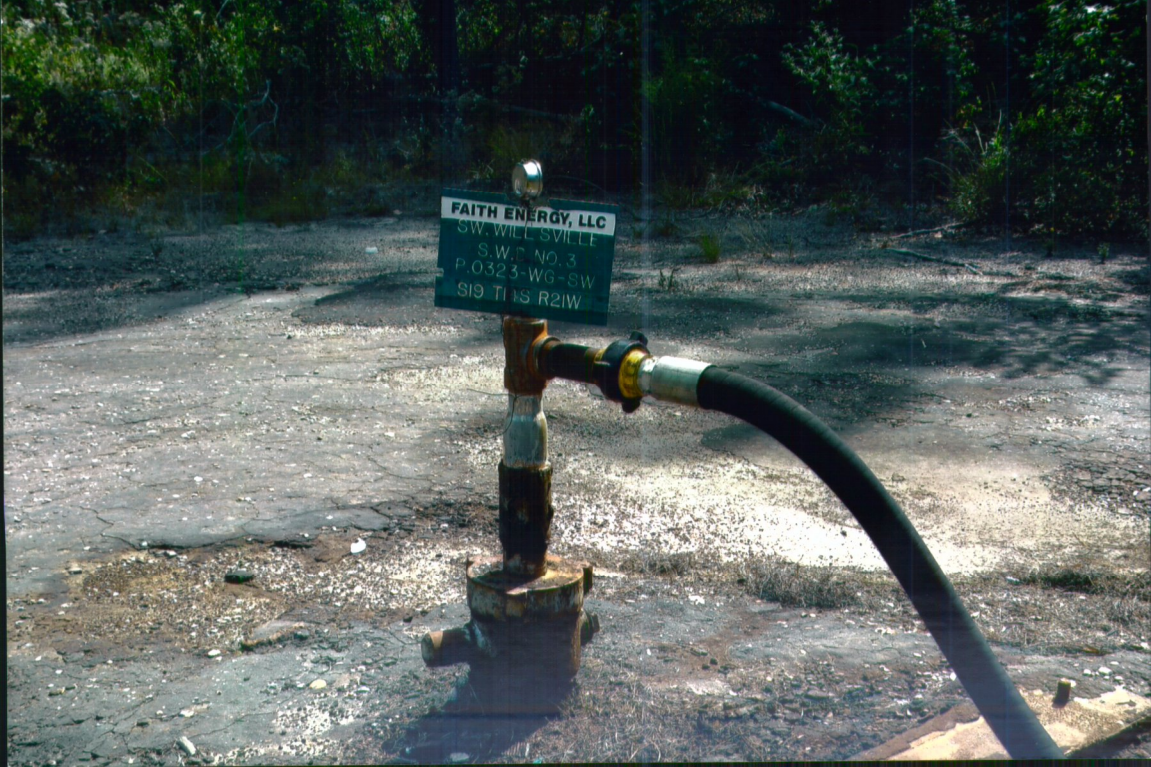
(Photo #1)

FAITH ENERGY, LLC
SW. WILL SVILLE
S.W.D NO. 3
P.0323-WG-SW
S19 T11S R21W

S W Willisville SWD #3

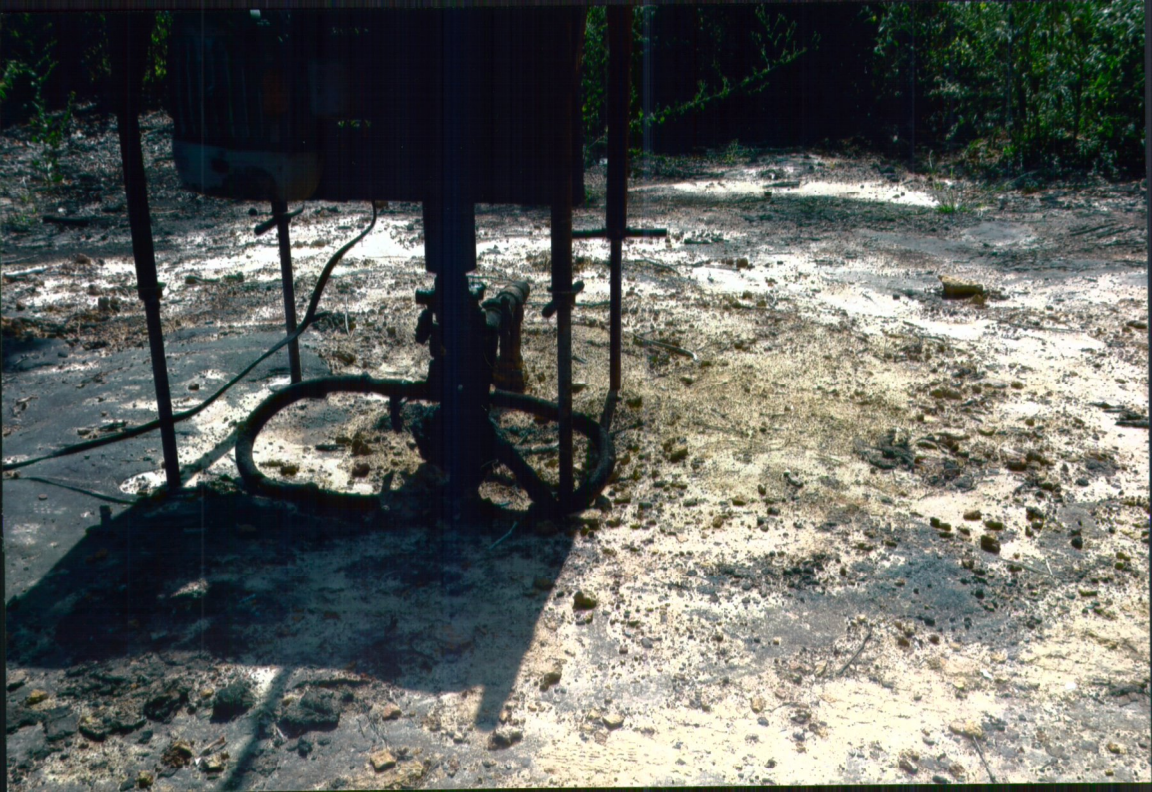
(Photo #5)

J A Alder #4

Please find enclosed, photo documentation of the items addressed in our September 9, 2011 letter. Also, please accept our apology for not including them with that letter.

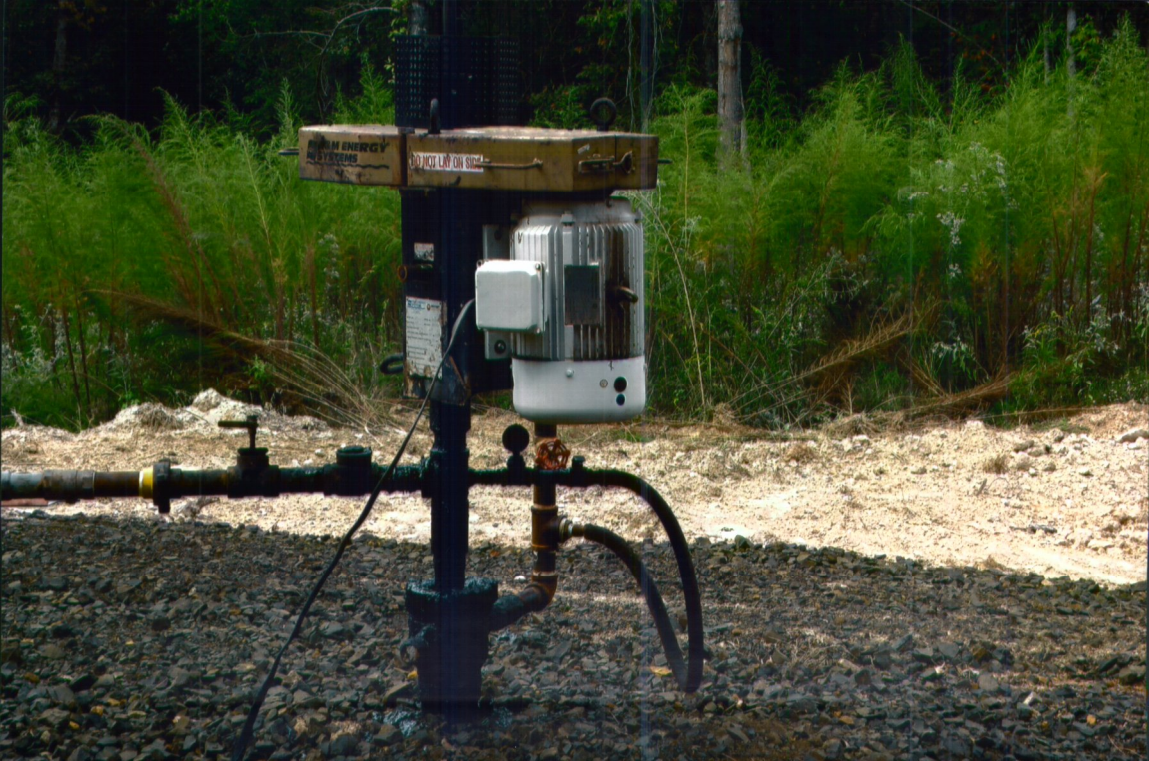
(Photo #14)

T E Ellis #6

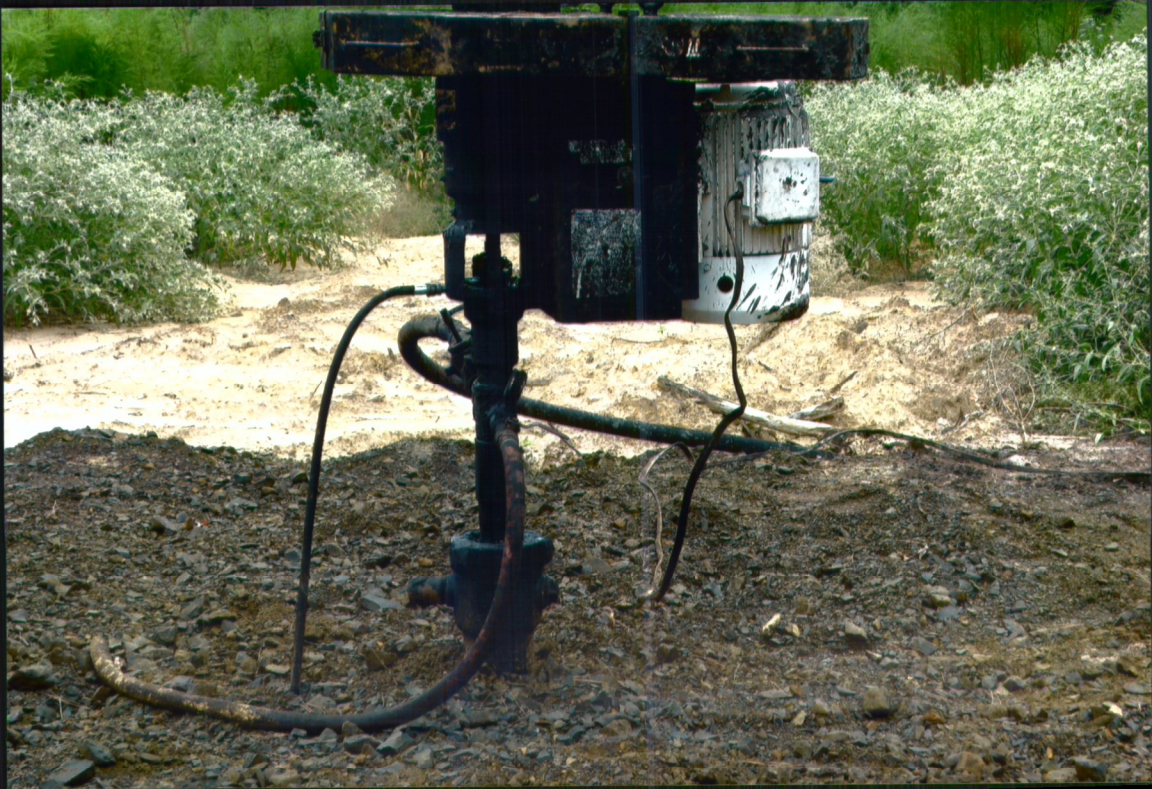
(Photo #15)

T E Ellis #7

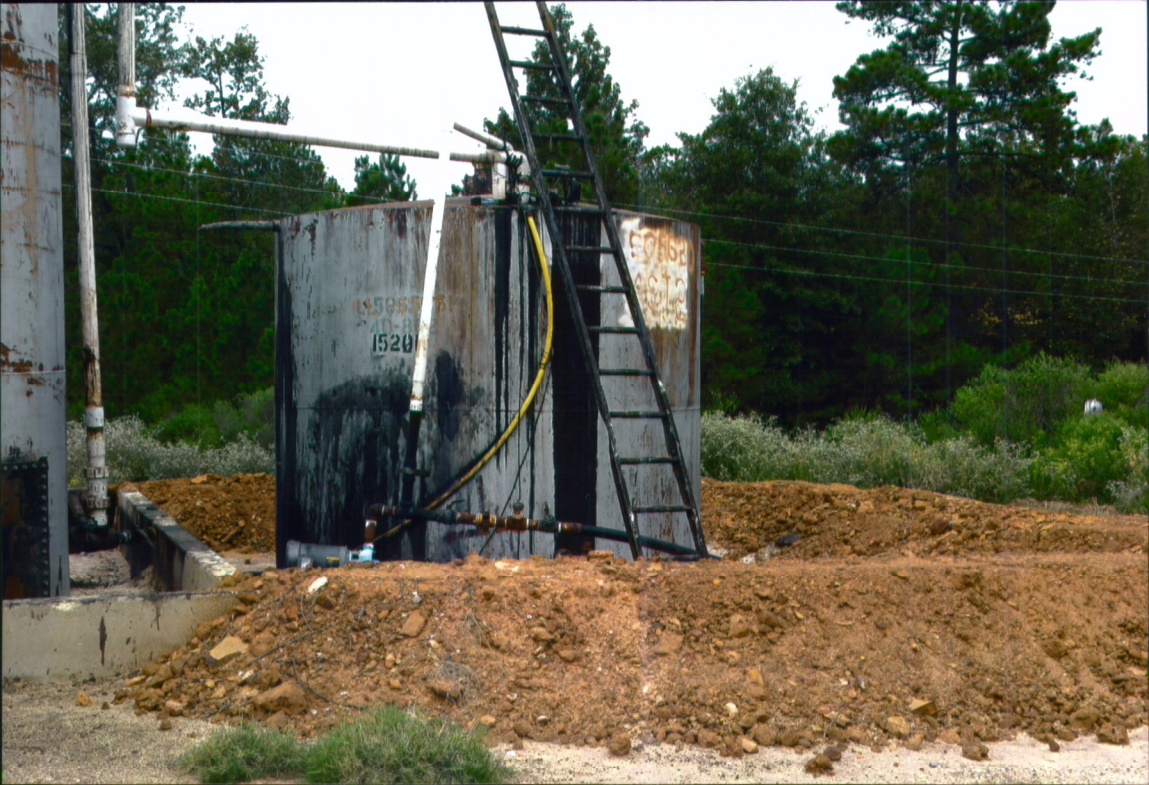
(Photo #16)

Phillips A TB
