RE: Compliance Inspection
AFIN: 88-00562; NPDES Permit No.: ARR00C134 and ARG500061

NPDES Compliance Inspection Report

Capital Quarries Company Inc. – Pocahontas
 632 Johnson Church Rd.
 Pocahontas, AR
 Randolph County

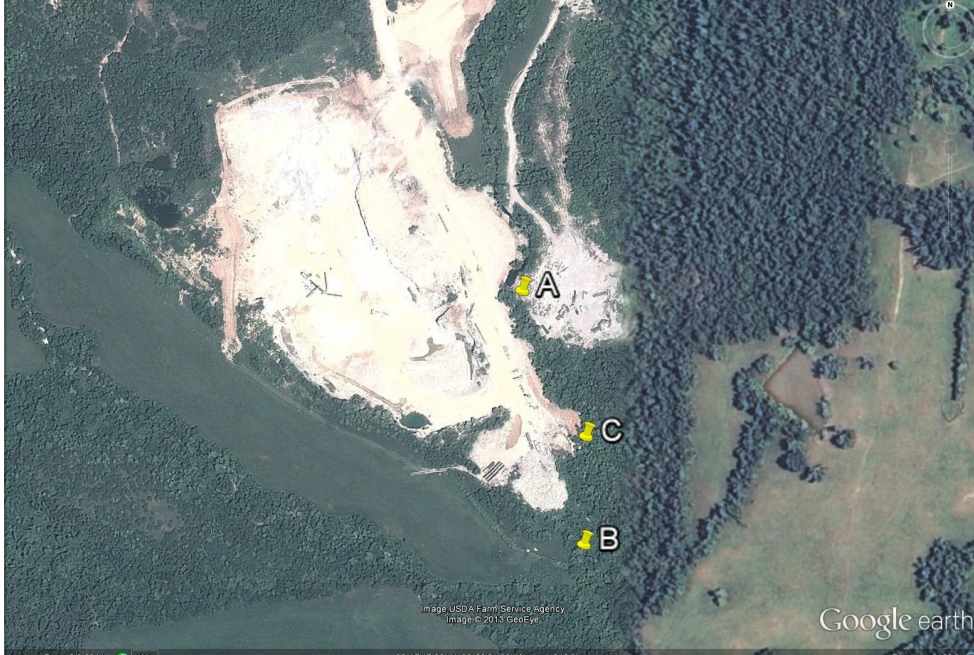
Water Division NPDES Photographic Evidence Sheet									
Location:		Capital Quarries Company Inc. – Pocahontas, AR							
Photographer:		Google Earth Image				Witness:		None	
Photo #	1	Of	5		Date:	N/A	Time:	N/A	
Description:		Overview of the site. Point “A” is the permitted location for Outfall 001. Point “B” is the location identified in the SWPPP for Outfall 001. Point “C” is the actual location of Outfall 001.

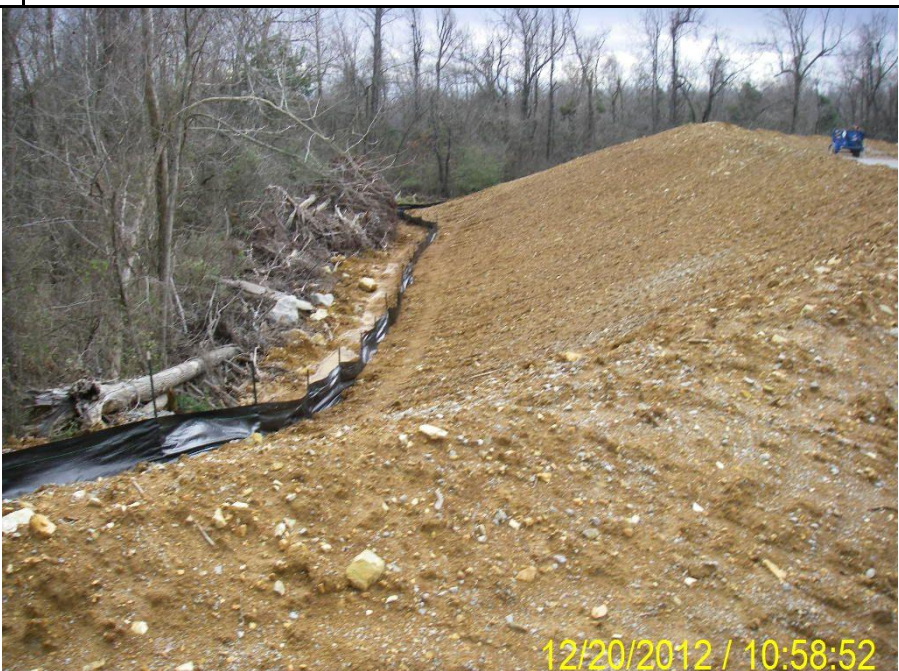
There were unstabilized slopes on the south portion of the site where topsoil was recently stockpiled. This area has the potential to pollute waters of the State and was not identified in the SWPPP.

Photographer:		Michael Greenway				Witness:		None	
Photo #	2	Of	5		Date:	12/20/2012	Time:	10:58	
Description:		View of unstabilized slopes on the south end of the site.

- c. The sediment basin, south berm, and receiving waters were not identified in the SWPPP.
2. A stockpile of topsoil was placed next to a creek along the south portion of the site and was not stabilized. The sediment run-off from this area has the potential to pollute waters of the State. In your response to this letter, please indicate what plans and/or actions have been made to prevent sediment runoff into waters of the state from this particular area.

I will need documentation (photos) when the area has been seeded and mulched. Additional photos of established vegetation will also be required to adequately address the items noted in my inspection report. I will send Mr. Jones a confirmation letter after I receive this documentation.

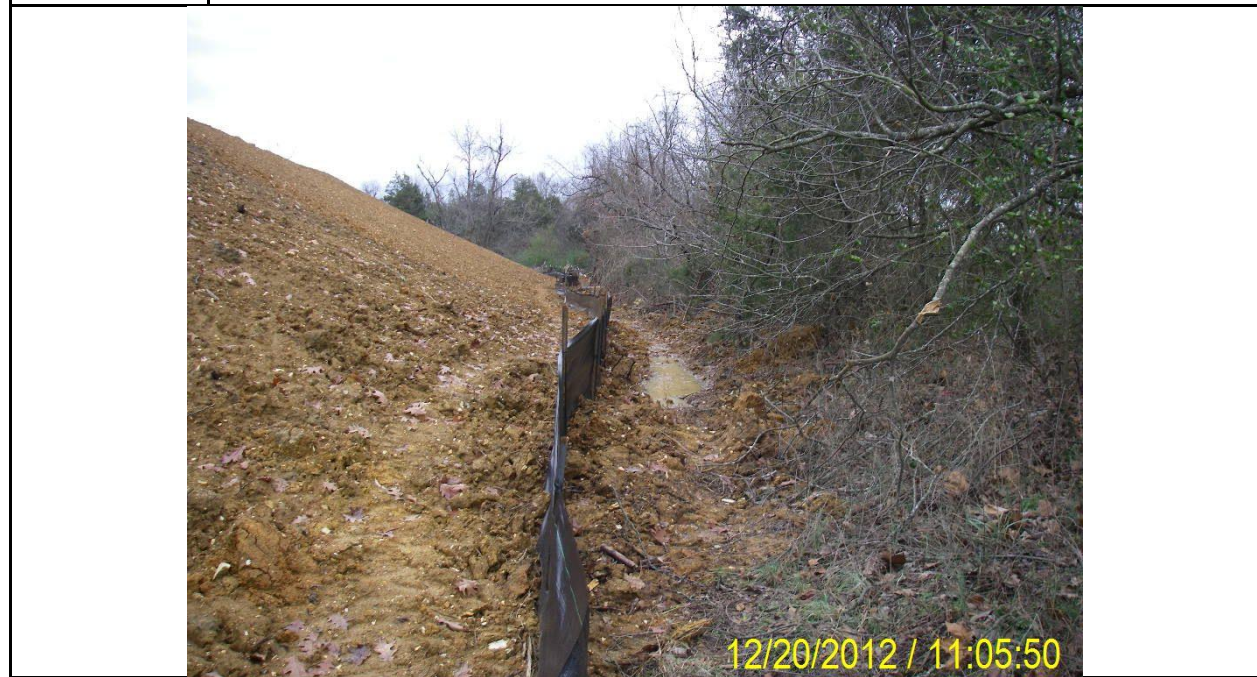
Photo #	3	Of	5	Date:	12/20/2012	Time:	11:05
----------------	---	-----------	---	--------------	------------	--------------	-------

Description:	View of unstabilized slopes on the south end of the site. A creek is located near the right side of this photographed area.						
---------------------	---	--	--	--	--	--	--

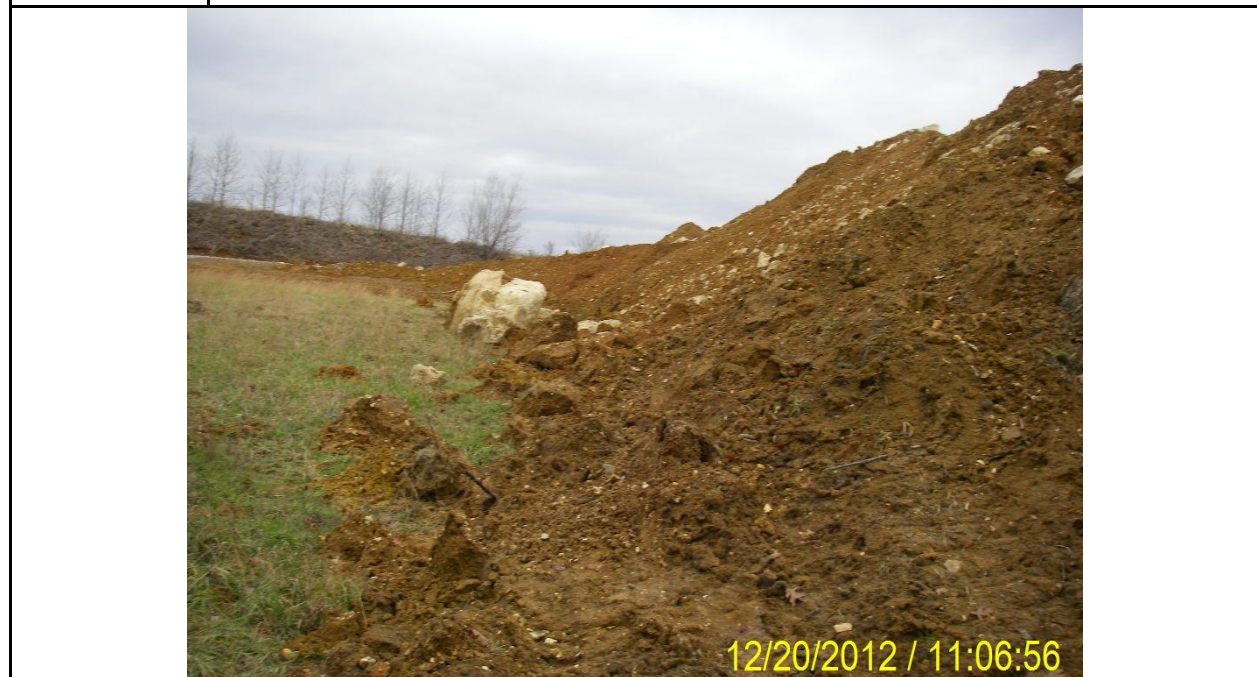
Photo #	4	Of	5	Date:	12/20/2012	Time:	11:06
----------------	---	-----------	---	--------------	------------	--------------	-------

Description:	View of unstabilized slopes on the south end of the site.						
---------------------	---	--	--	--	--	--	--

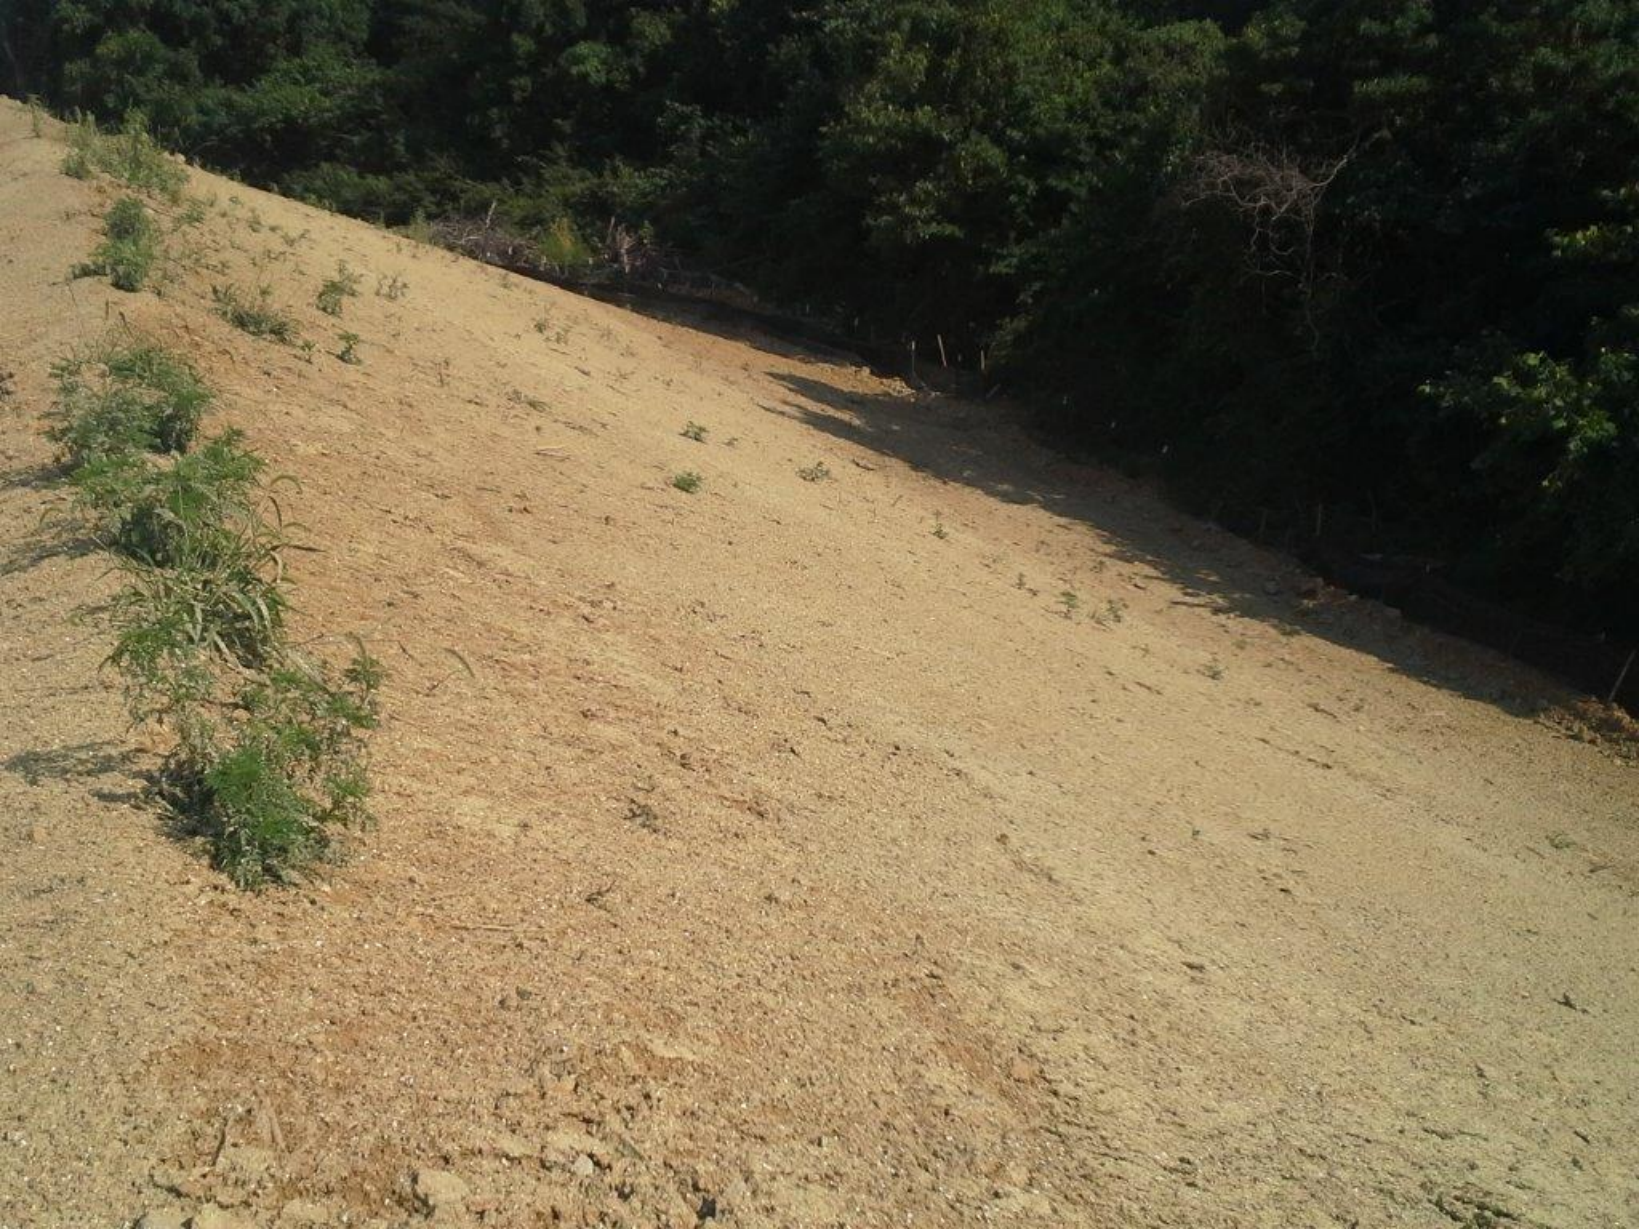
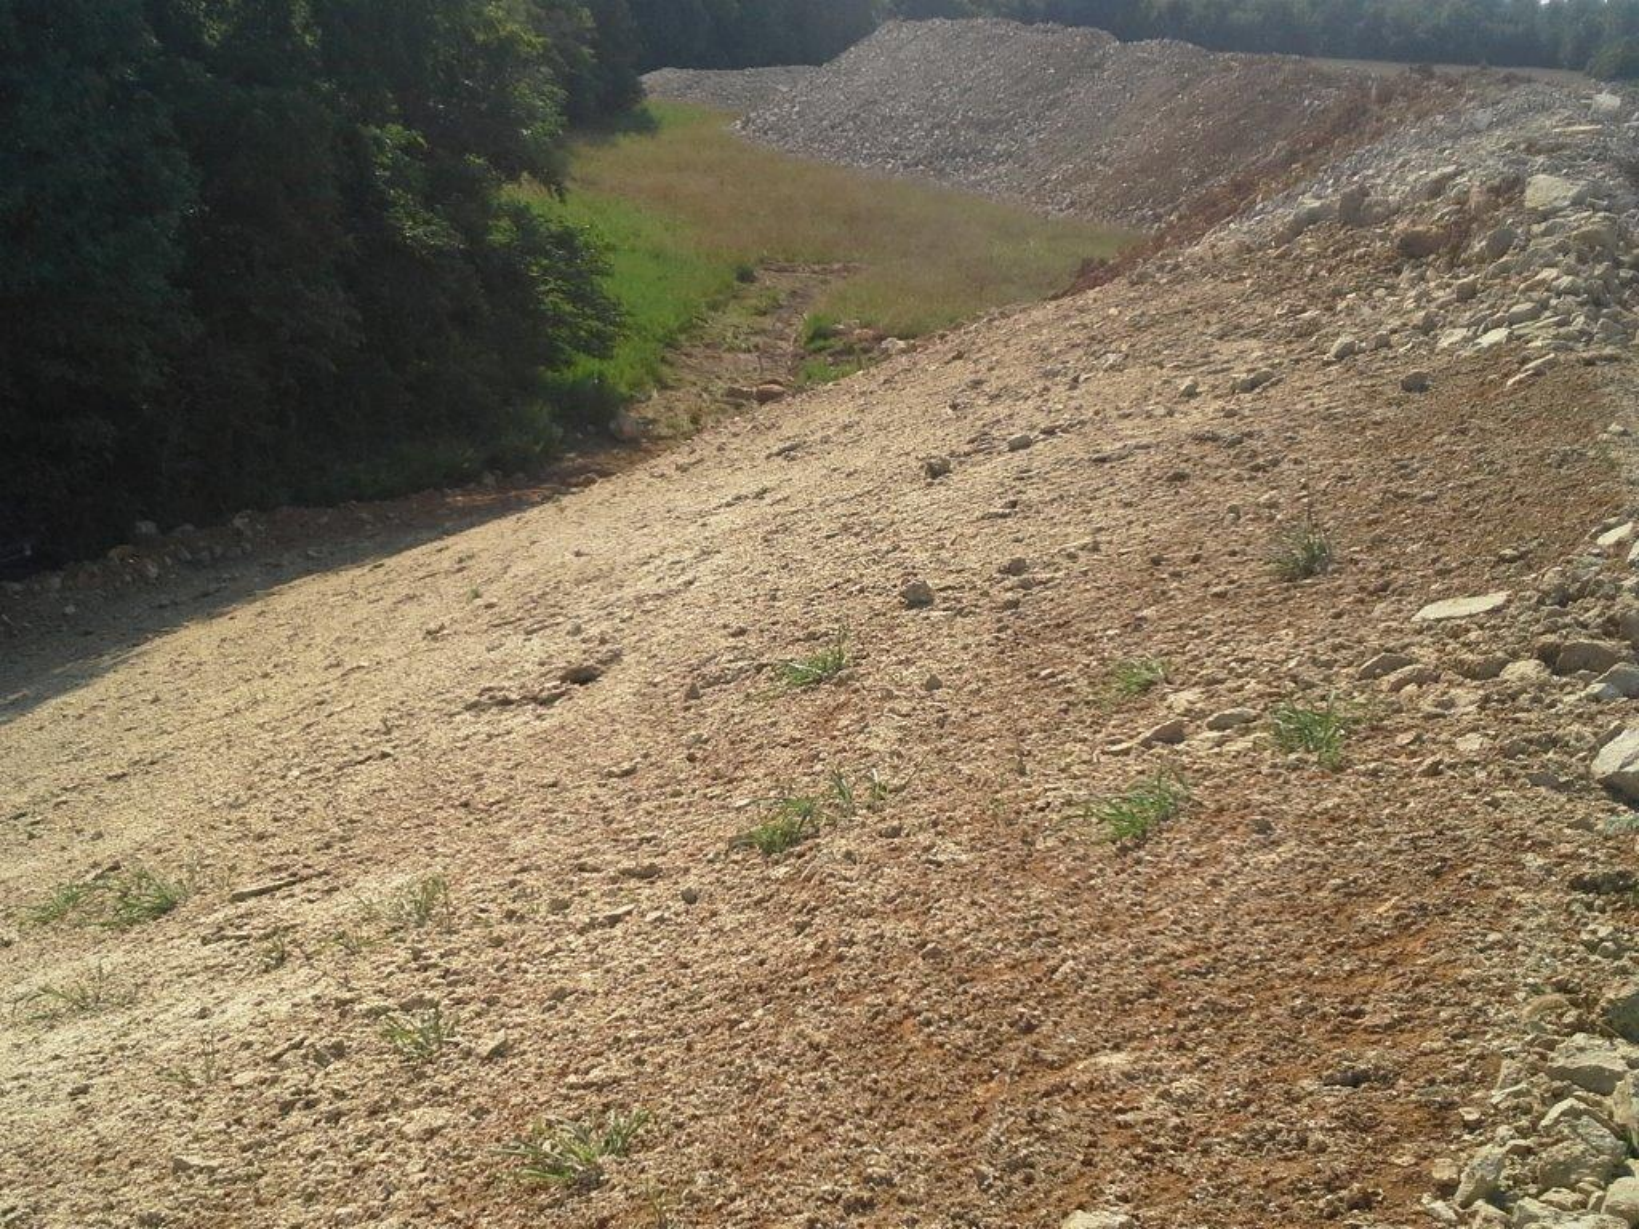
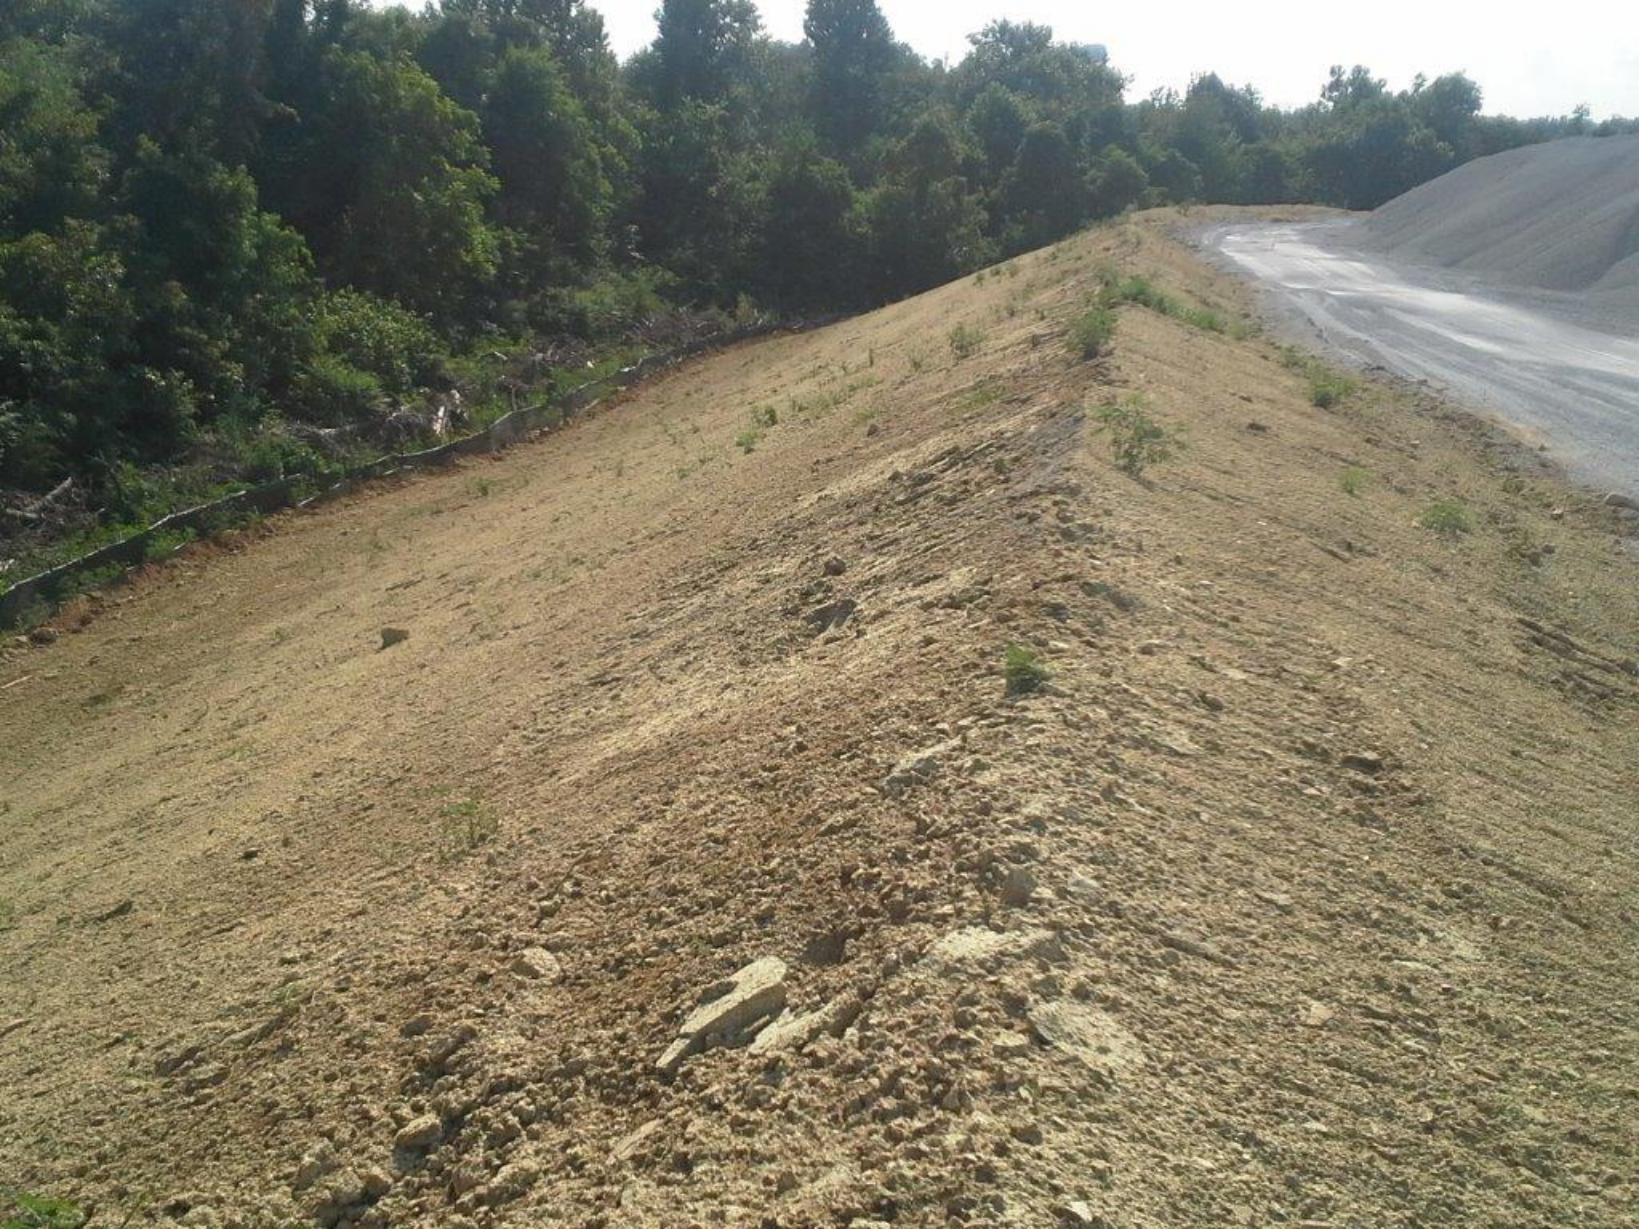
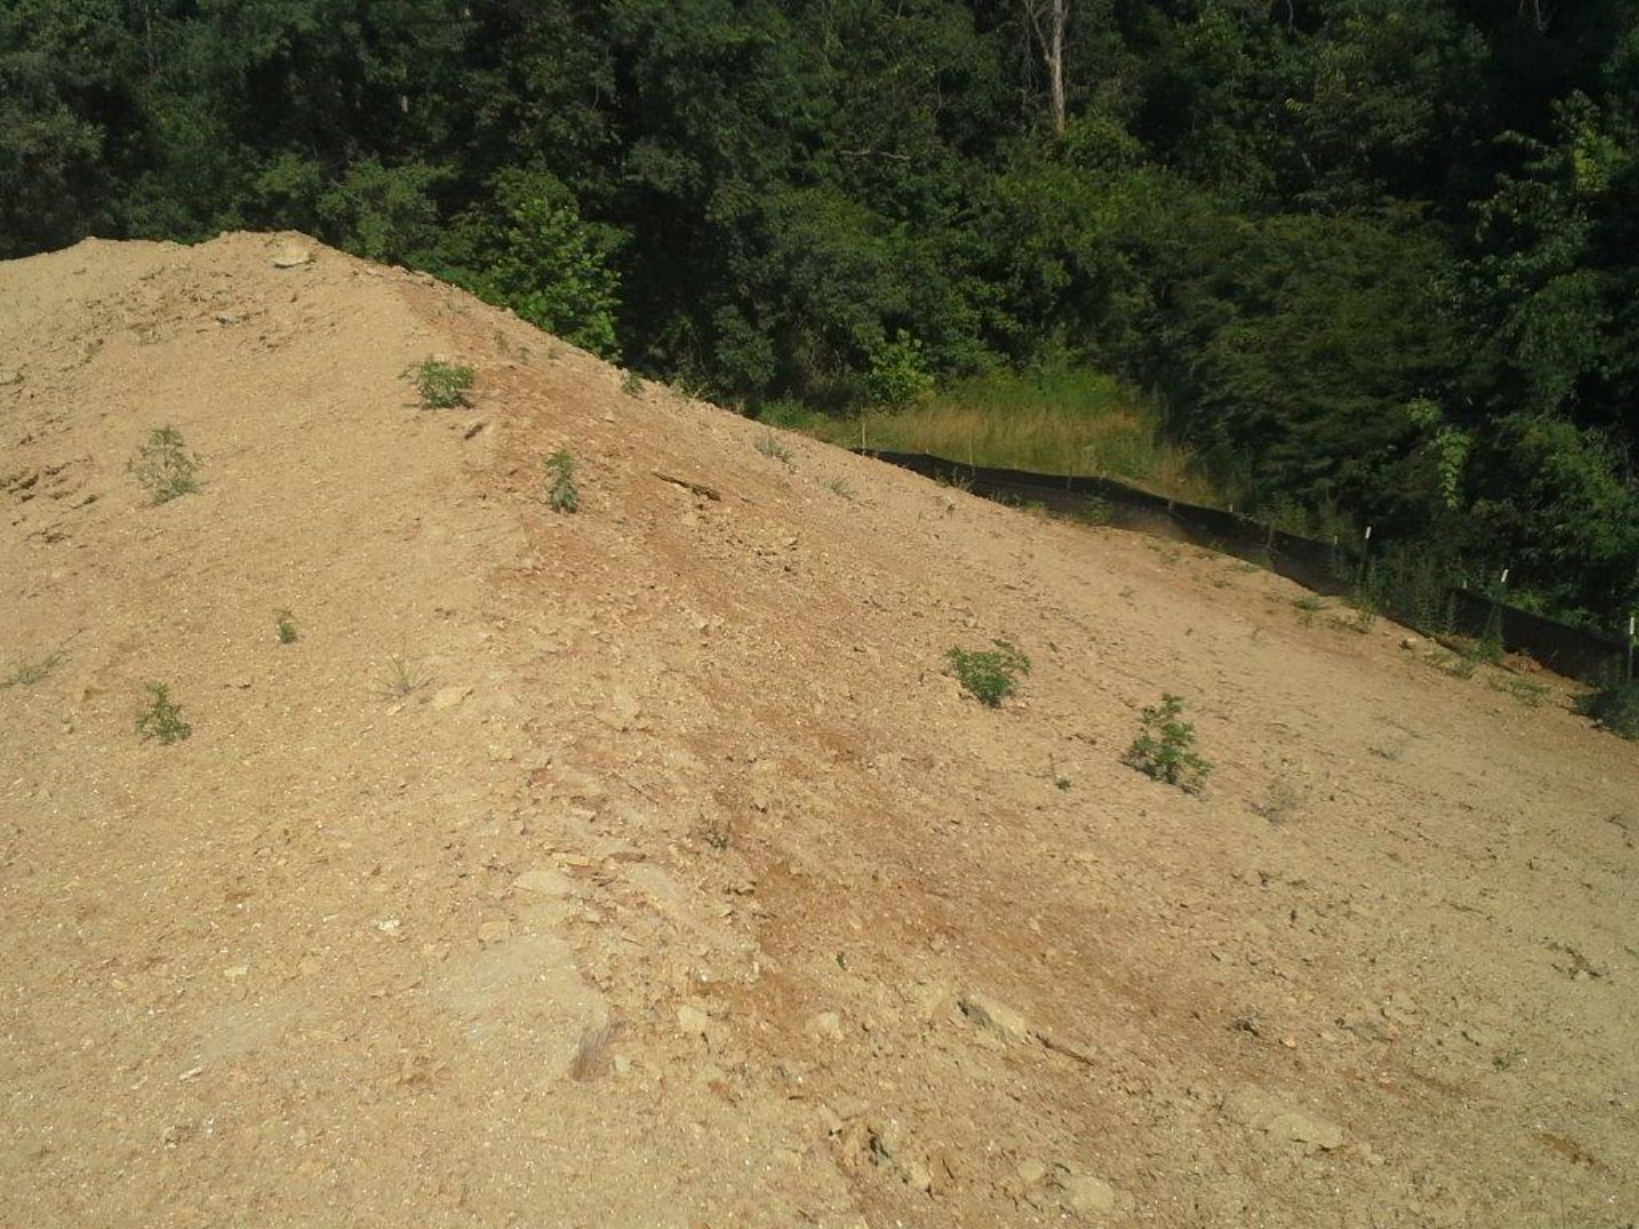
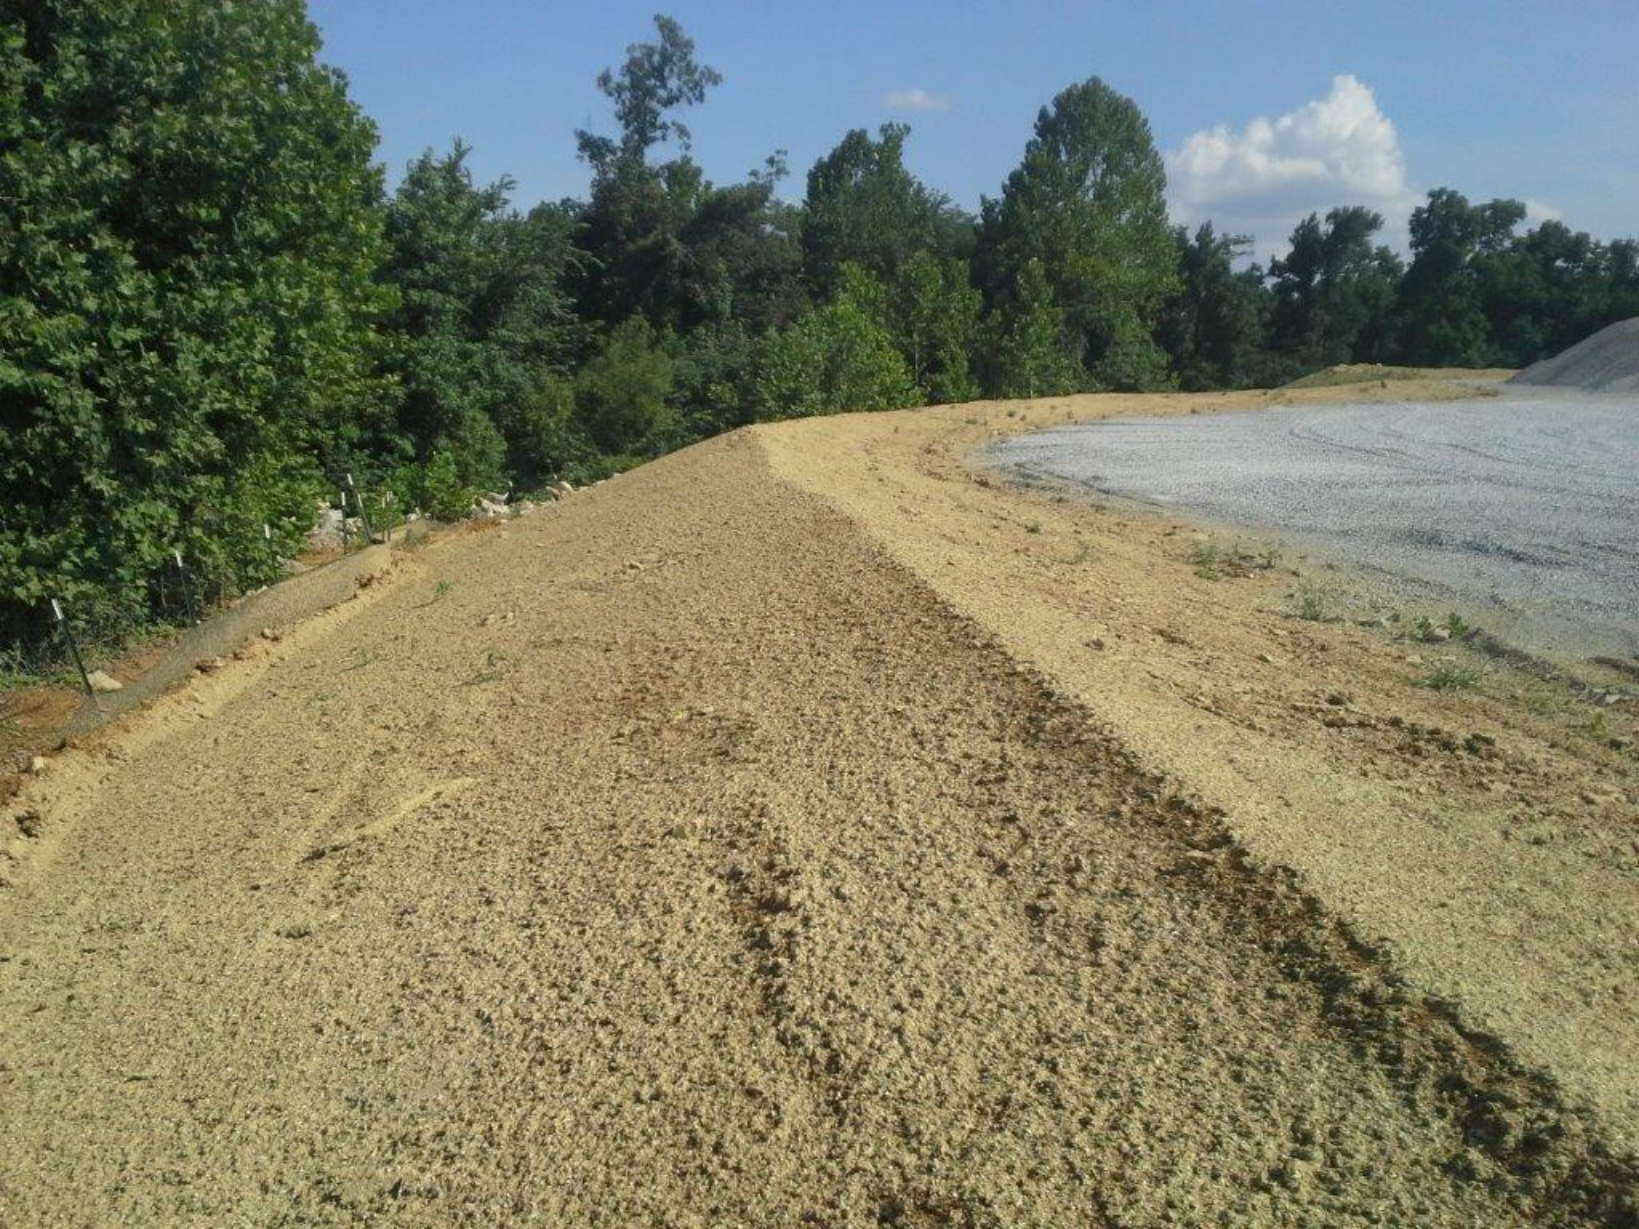
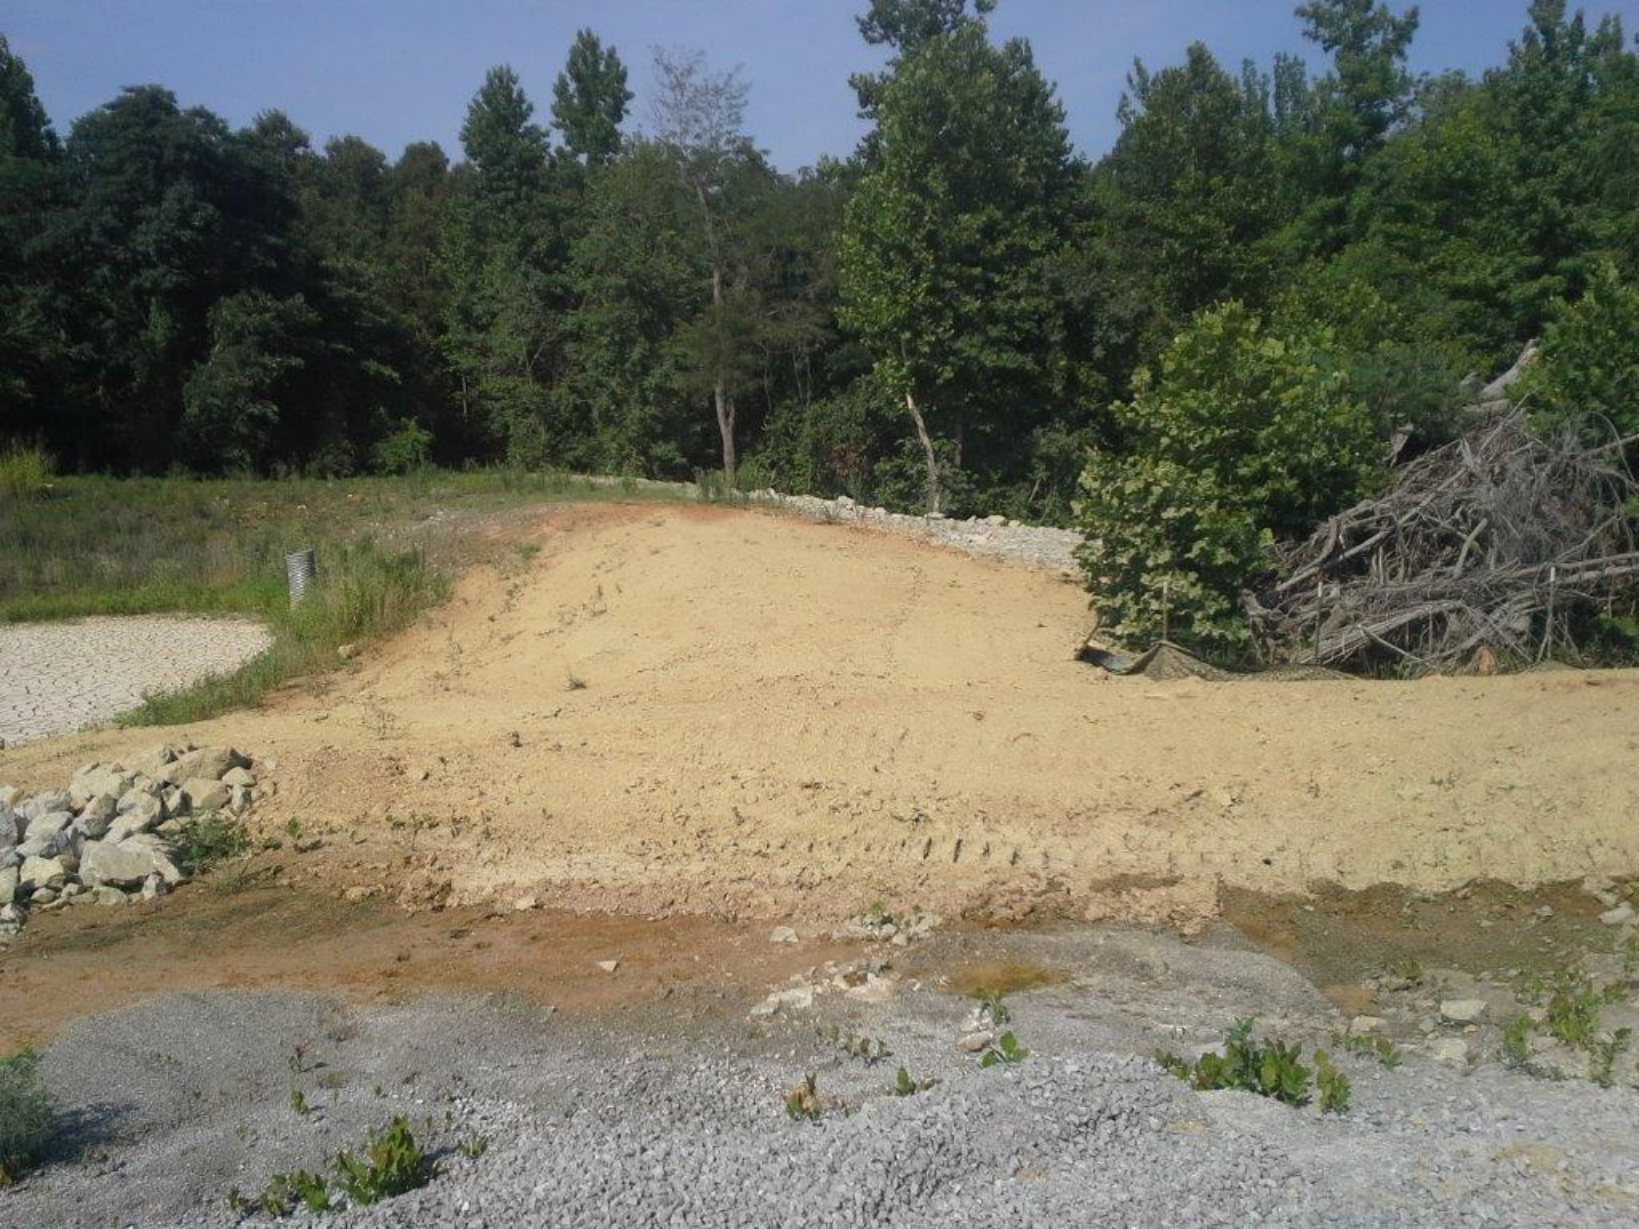
20130708_164916
20130708_164900
20130708_165234
20130708_165228
20130708_165138
20130708_165132
20130708_165240

I am following up on the conditions at the Pocahontas, AR facility. I still need photo documentation of the slopes that were supposed to be stabilized on the south portion of the site. Thanks,
