**Re: Compliance Inspections (Howard Co)**  
**AFIN: 31-00111 State Permit No.: 4289-WR-3**  
**31-00103 4188-WR-3**

**ARKANSAS DEPARTMENT OF ENVIRONMENTAL QUALITY**  
**Agricultural Permit Inspection Report**

<b>Inspection Date</b> 3-11-2014	<b>AFIN Number</b> 31-00111	<b>Permit Number</b> 4289-WR-3	<b>County</b> Howard	<b>Compliance Status</b> <b>OUT</b>
<b>Facility Name and Location</b> Steve Alexander Farm  Hwy 246 north of Athens then east on Goat Ranch Rd. 2.25 miles		<b>Name of Responsible Official</b> Steve Alexander  <b>Phone Number</b> 870 583-7221		<b>Mailing Address</b> 879 Goat Ranch Rd.  Umpire, AR 71971
<b>Legal Description</b> Sec. <u>11</u> Tns. <u>5S</u> Rng. <u>28W</u>		<b>Name of Person Contacted</b> Derek Alexander / 870 557-7220		<b>Title</b> son of owner
<b>Grow or Produce for:</b> Cargill		<b>Design Animal Type and Capacity</b>		
<b>Evaluate the Following Areas: S-Satisfactory M-Marginal U--Unsatisfactory N/A-Not Evaluated</b>				
<b>Part 1 - Operation and Maintenance</b>				
<b>(a) No discharge of wastewater from basins, lagoons, holding pond, and/or pits.</b>				<b>U</b>

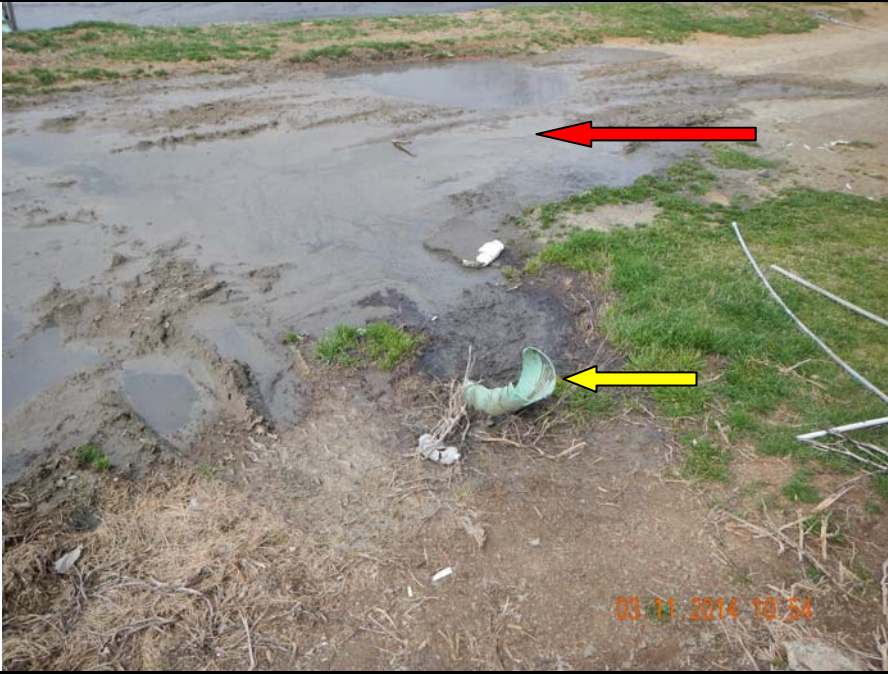
1. A discharge of liquid manure originating from the cleanout was observed on the ground between the barn and the holding pond. This discharge flowed into a nearby freshwater pond located on the property (see Photos 1 – 4). This discharge was not reported as required in Part III, 13. Evidence of an additional older overflow was discovered near the southern-most barn. This was also not reported as required.
2. Only one soil analyses report was made available. The annual report indicates all land application fields were utilized. Soil samples for all fields land applied on, which are required every five (5) years from the effective date of the permit, should be made available. Also, the land application fields should be reported separately on the annual report.

Water Division NPDES Photographic Evidence Sheet									
<b>Location:</b>		Steve Alexander Farm							
<b>Photographer:</b>		Shan Lynch				<b>Witness:</b>		Steve Alexander Farm personnel	
<b>Photo #</b>	1	<b>Of</b>	4		<b>Date:</b>	3-11-2014	<b>Time:</b>	10:54	
<b>Description:</b>		Origin of discharge (yellow arrow). Liquid manure shown (red arrow).

1<sup>st</sup> We took a gasoline pump and pumped off all the liquid we could.

2<sup>nd</sup> We took the backhoe and tractor and ~~scraped~~ scraped all the solids back into the holding pond.

3<sup>rd</sup> We took a tractor tiller and tilled the dirt.

4<sup>th</sup> We then covered the tilled soil with new dirt and gravel.

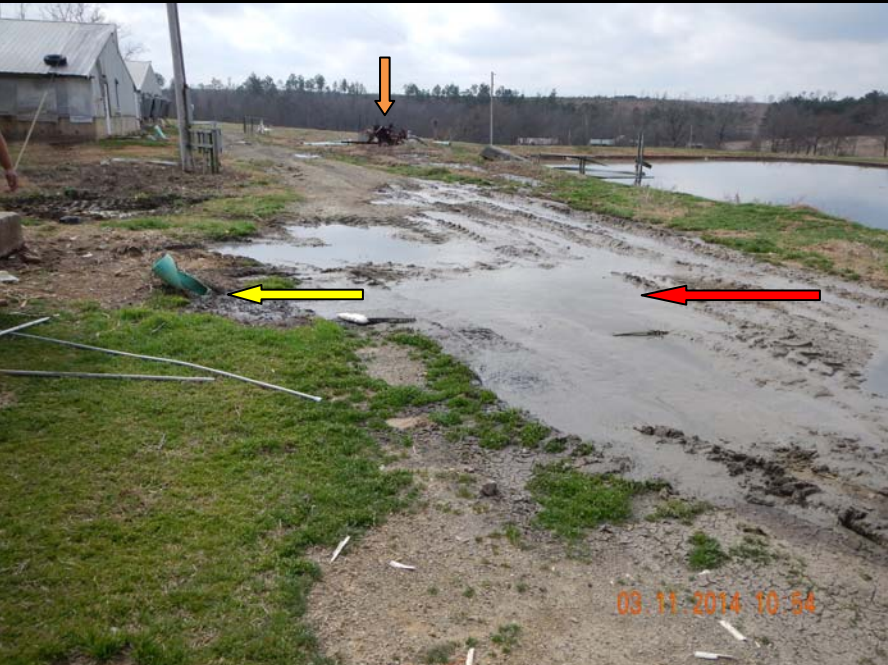
<p>A photograph showing a muddy, brownish-grey area, likely a discharge point. A green pipe is visible in the foreground, and a red arrow points to a pool of liquid manure. A yellow arrow points to the origin of the discharge. The date and time stamp '03.11.2014 10:54' are visible in the bottom right corner.</p>							
<b>Photographer:</b>		Shan Lynch				<b>Witness:</b>		Steve Alexander Farm personnel	
<b>Photo #</b>	2	<b>Of</b>	4		<b>Date:</b>	3-11-2014	<b>Time:</b>	10:54	
<b>Description:</b>		Origin of discharge (yellow arrow). Discharged hog manure (red arrow) with flow toward pump (orange arrow). Liquid manure flowed behind holding pond shown at right.

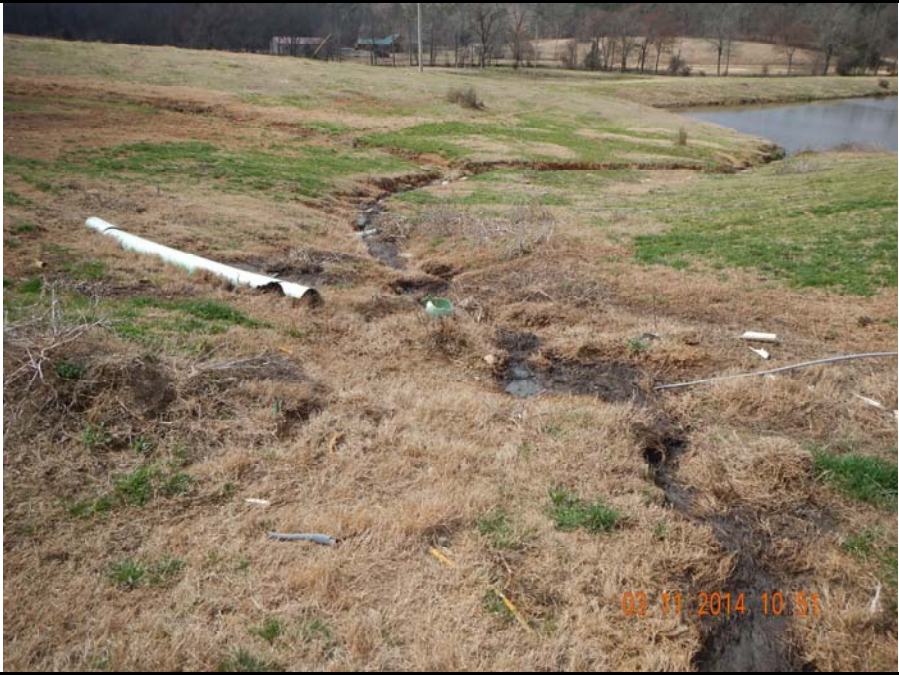
Water Division NPDES Photographic Evidence Sheet									
<b>Location:</b>		Steve Alexander Farm							
<b>Photographer:</b>		Shan Lynch				<b>Witness:</b>		Steve Alexander Farm personnel	
<b>Photo #</b>	3	<b>Of</b>	4		<b>Date:</b>	3-11-2014	<b>Time:</b>	10:51	
<b>Description:</b>		Photo taken near pump shown in previous photo. Note evidence of runoff into freshwater pond.

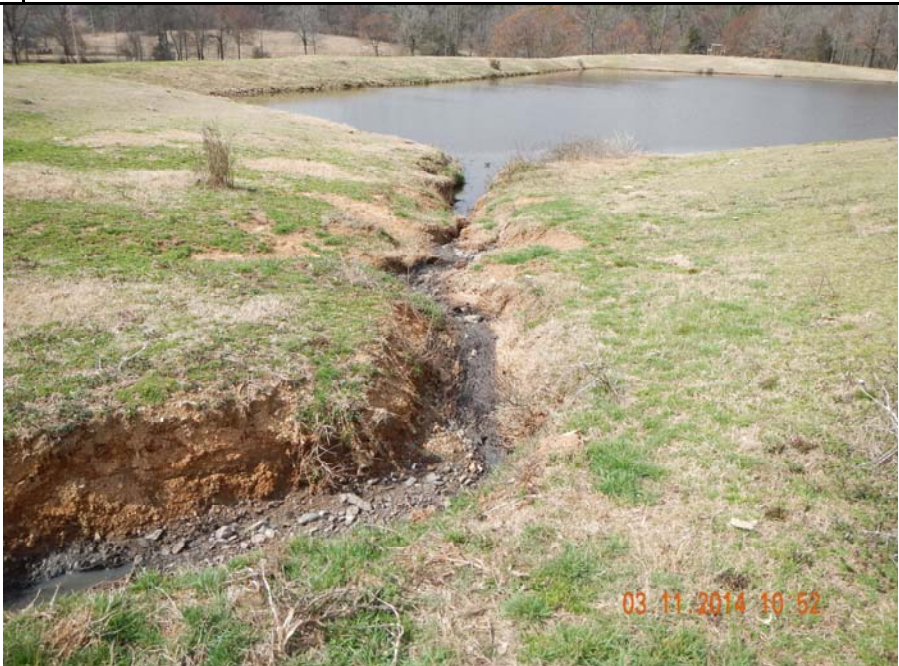
<b>Photographer:</b>		Shan Lynch				<b>Witness:</b>		Steve Alexander Farm personnel	
<b>Photo #</b>	4	<b>Of</b>	4		<b>Date:</b>	3-11-2014	<b>Time:</b>	10:52	
<b>Description:</b>		Same as previous.

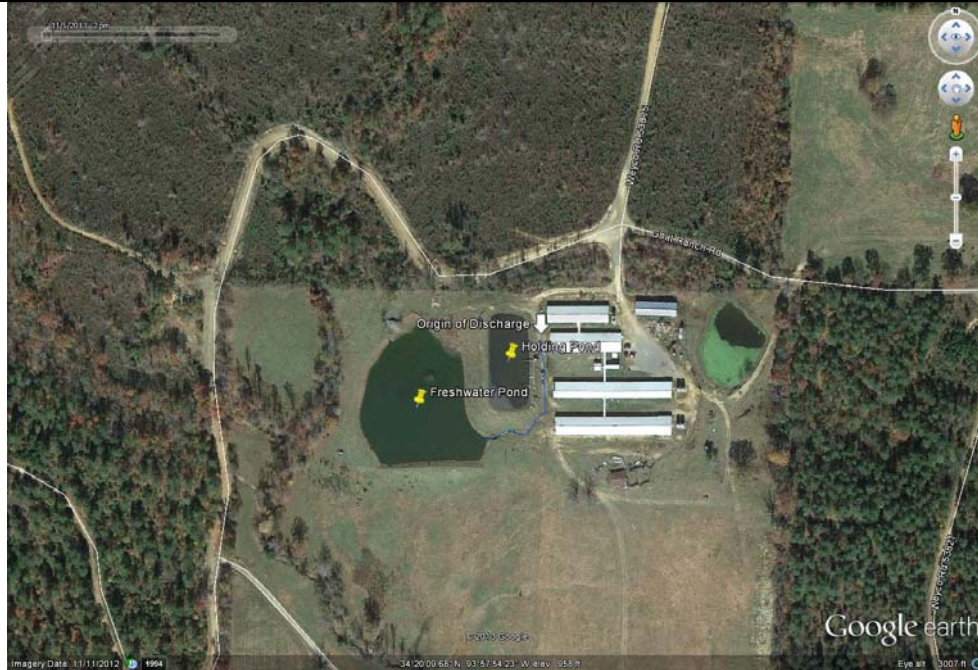
<b>Location:</b>	Steve Alexander Farm					
<b>Photographer:</b>	Shan Lynch			<b>Witness:</b>	N/A	
<b>Photo #</b>		<b>Of</b>		<b>Date:</b>		<b>Time:</b>
<b>Description:</b>	Overview of Steve Alexander Farm and observed discharge from holding pond into the privately-owned pond located on the property.

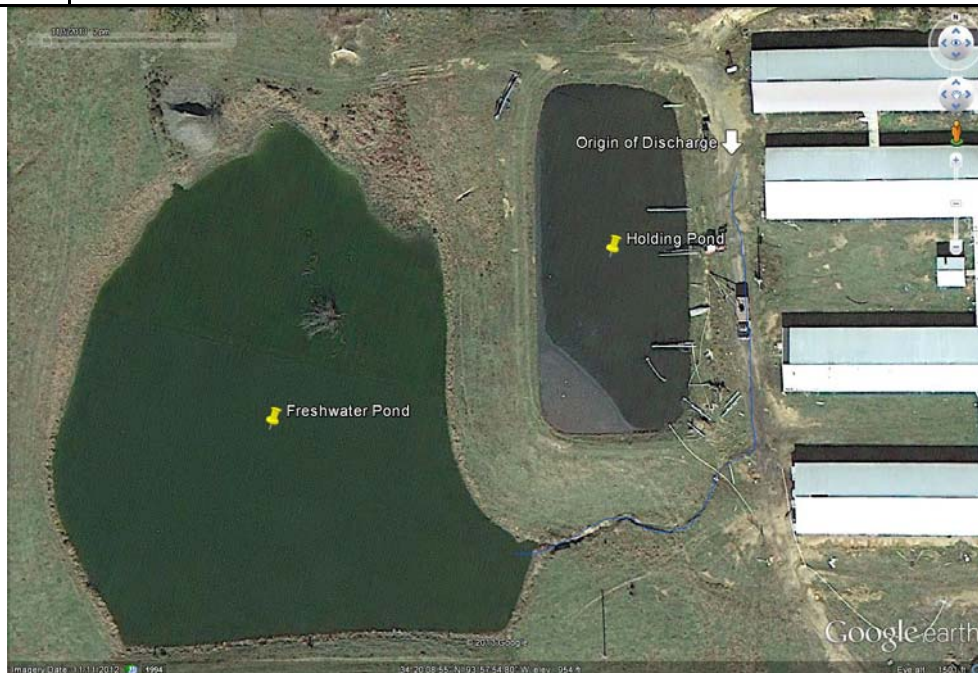
<b>Photographer:</b>	Shan Lynch			<b>Witness:</b>	N/A	
<b>Photo #</b>		<b>Of</b>		<b>Date:</b>		<b>Time:</b>
<b>Description:</b>	Closer view of previous slide.
