UNITED STATES ENVIRONMENTAL PROTECTION AGENCY Washington, D.C. 20460 <h2 style="margin: 0;">NPDES Compliance Inspection Report</h2>	Form Approved OMB No. 2040-0003 Approval Expires 7-31-85
--	---	--

## CONSTRUCTION SITE STORM WATER INSPECTION

Re: Ironwood Estates Construction Site - Permit # ARR151748.

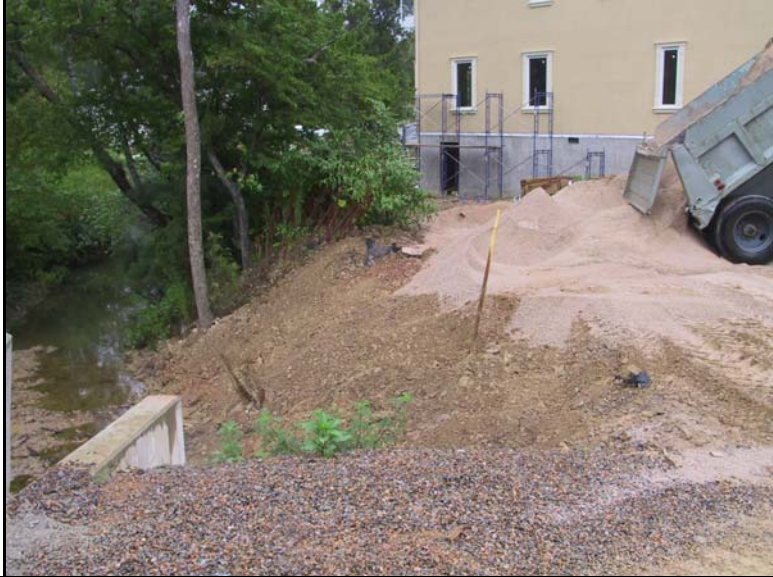
<b>Location:</b>		Ironwood Estates							
<b>Photographer:</b>		Jim McSwain				<b>Witness:</b>		Dennis Benson	
<b>Photo #</b>	1	<b>Of</b>	5			<b>Date:</b>	7/27/06	<b>Time:</b>	1108
<b>Description:</b>		Dumping construction material next to the creek

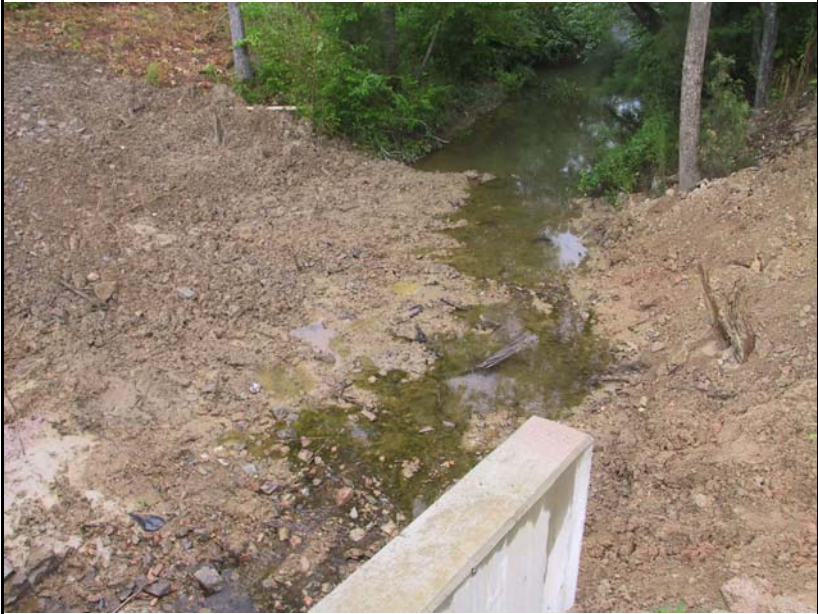
<b>Photographer:</b>		Jim McSwain				<b>Witness:</b>		Dennis Benson	
<b>Photo #</b>	2	<b>Of</b>	5			<b>Date:</b>	7/27/06	<b>Time:</b>	1108
<b>Description:</b>		Area of disturbance along the creek.

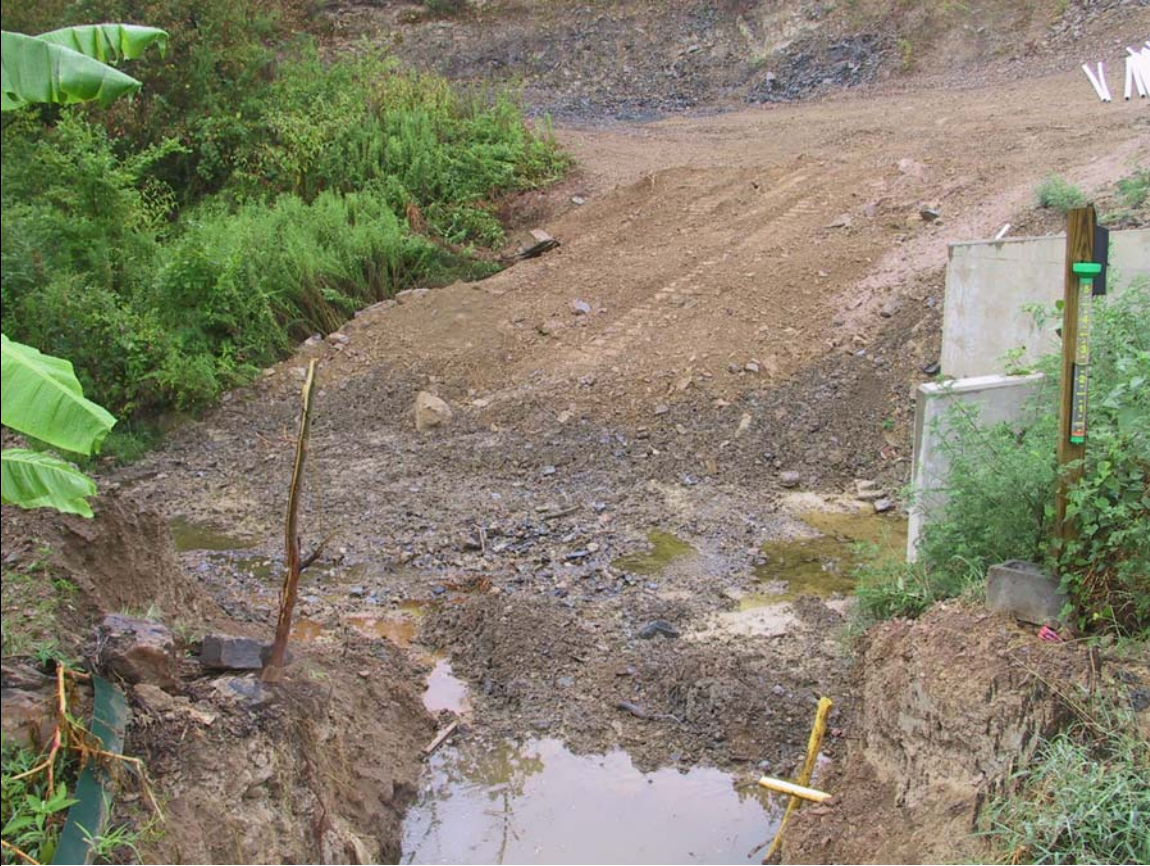
Phase I and Phase II are complete. Phase III is in the process of having roads cut in, as well as, having the utilities installed. Controls that were along the creek were removed by the contractor that is installing the utilities across the creek. There were no effective controls in place during this inspection. In talking Mr. Little, he stated that he is placing controls behind completed areas as they are developed. He stated that there were controls in place, but the utilities contractor removed them. There was a document in the SWPPP box referencing this.

<b>Location:</b>	Ironwood Estates						
<b>Photographer:</b>	Jim McSwain			<b>Witness:</b>	Dennis Benson		
<b>Photo #</b>	3	<b>Of</b>	5	<b>Date:</b>	7/27/06	<b>Time:</b>	1108
<b>Description:</b>	Location where utilities were placed across the creek.

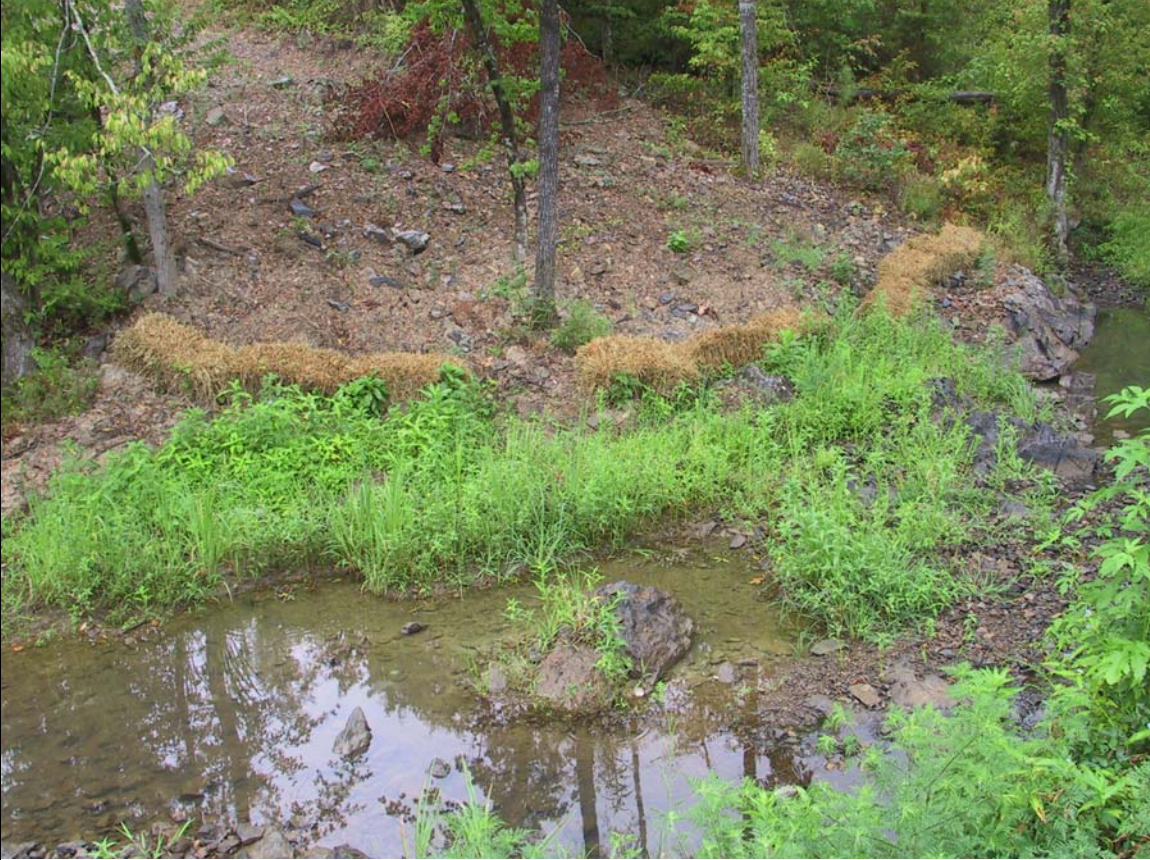
Hay bales, silt fence – both improperly installed. Hay bales were not staked. Silt fence was not buried.

- 1. The construction site posting was placed inside the SWPPP box. The construction site posting must be placed in a prominent location available for public viewing.**
- 2. The Storm Water Pollution Prevention Plan is not being maintained on-site as required in Part II.A.2.a of your ADEQ General Permit.**
- 3. The inspection reports are not adequately addressing all the requirements. Your inspector needs to be inspecting the entire site for compliance. Refer to Part II.4.e of your ADEQ General Permit.**
- 4. The lack of effective sediment controls along the Little Joe Creek has allowed moderate amounts of sediment to enter the waters of the state.**

<b>Location:</b>		Ironwood Estates							
<b>Photographer:</b>		Jim McSwain				<b>Witness:</b>		Dennis Benson	
<b>Photo #</b>	4	<b>Of</b>	5			<b>Date:</b>	7/27/06	<b>Time:</b>	1113
<b>Description:</b>		Sediment that is washing into the waters of the state – unstaked bales

The above items require your immediate attention. Please submit a written response to these findings to the NPDES Enforcement Section of this Department. This response should contain documentation describing the course of action taken to correct each item noted. This corrective action should be completed as soon as possible, and the written response is due by August 20, 2006.
