**Downstream Areas Data  
Assessment Report**

Mayflower Pipeline Incident Response  
Mayflower, Arkansas

January 2014

Revision 4

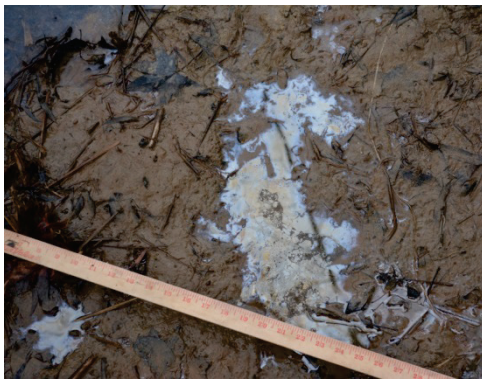
In the A-Main, A-365W, and A-365E drainage ways, brittle and non-brittle sheens of metallic and/or rainbow colors were observed along the banks and on the water surface in the drainage swale (Figure 11-1) between October 21, 2013 and January 5, 2014. Examples of these are shown in the photos below.

**Brittle Rainbow Sheen Cover Observation  
on December 28, 2013 (A-Main)**

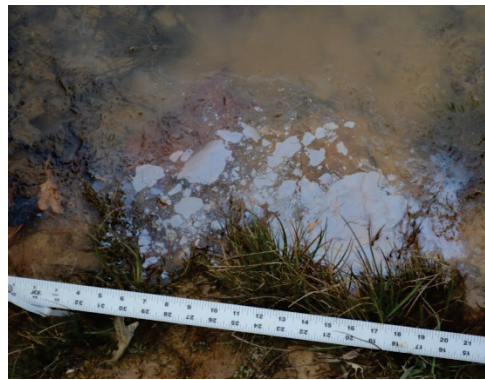
**Brittle Metallic Sheen Patch Observation on  
January 4, 2014 (A-365W)**

Patches observed at a single location in these monitoring areas covered typically less than one square foot. Sheen streamers observed in these areas varied in size from 1 inch to 20 feet. At approximately 9 percent of the sheen locations, various patches and/or streamers covering an area up to 20 feet by 20 feet (up to 70 percent of the water surface) were observed. A summary of sheen observations in the drainage ways is included in the following table.

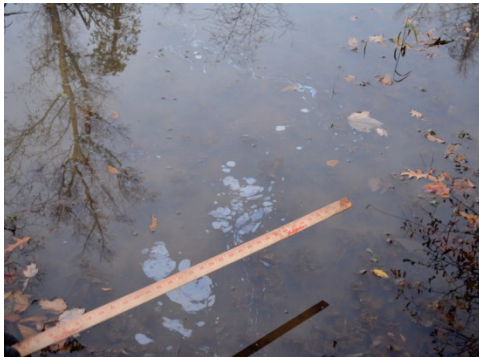
Mainly non-brittle sheens were observed in two monitoring areas of Dawson Cove – Dawson Cove Inlet Channel and Dawson Cove Open Water Area (Figure 11-2) between October 21 2013 and January 5, 2014. Similar numbers of brittle and non-brittle sheens were observed in the B-On Water area. One brittle sheen was observed in the Dawson Cove Outlet. Examples of these are shown in the photos below.

**Brittle Metallic Sheen Patch Observation on  
November 30, 2013  
(Dawson Cove Inlet Channel)**
