**Cove Restoration Planting Plan**

Mayflower Pipeline Incident Response  
Mayflower, Arkansas

Prepared for:  
ExxonMobil Environmental Services  
Company

Prepared by:  
ARCADIS U.S., Inc.  
630 Plaza Drive  
Suite 100  
Highlands Ranch  
Colorado 80129  
Tel 720 344 3500  
Fax 720 344 3535

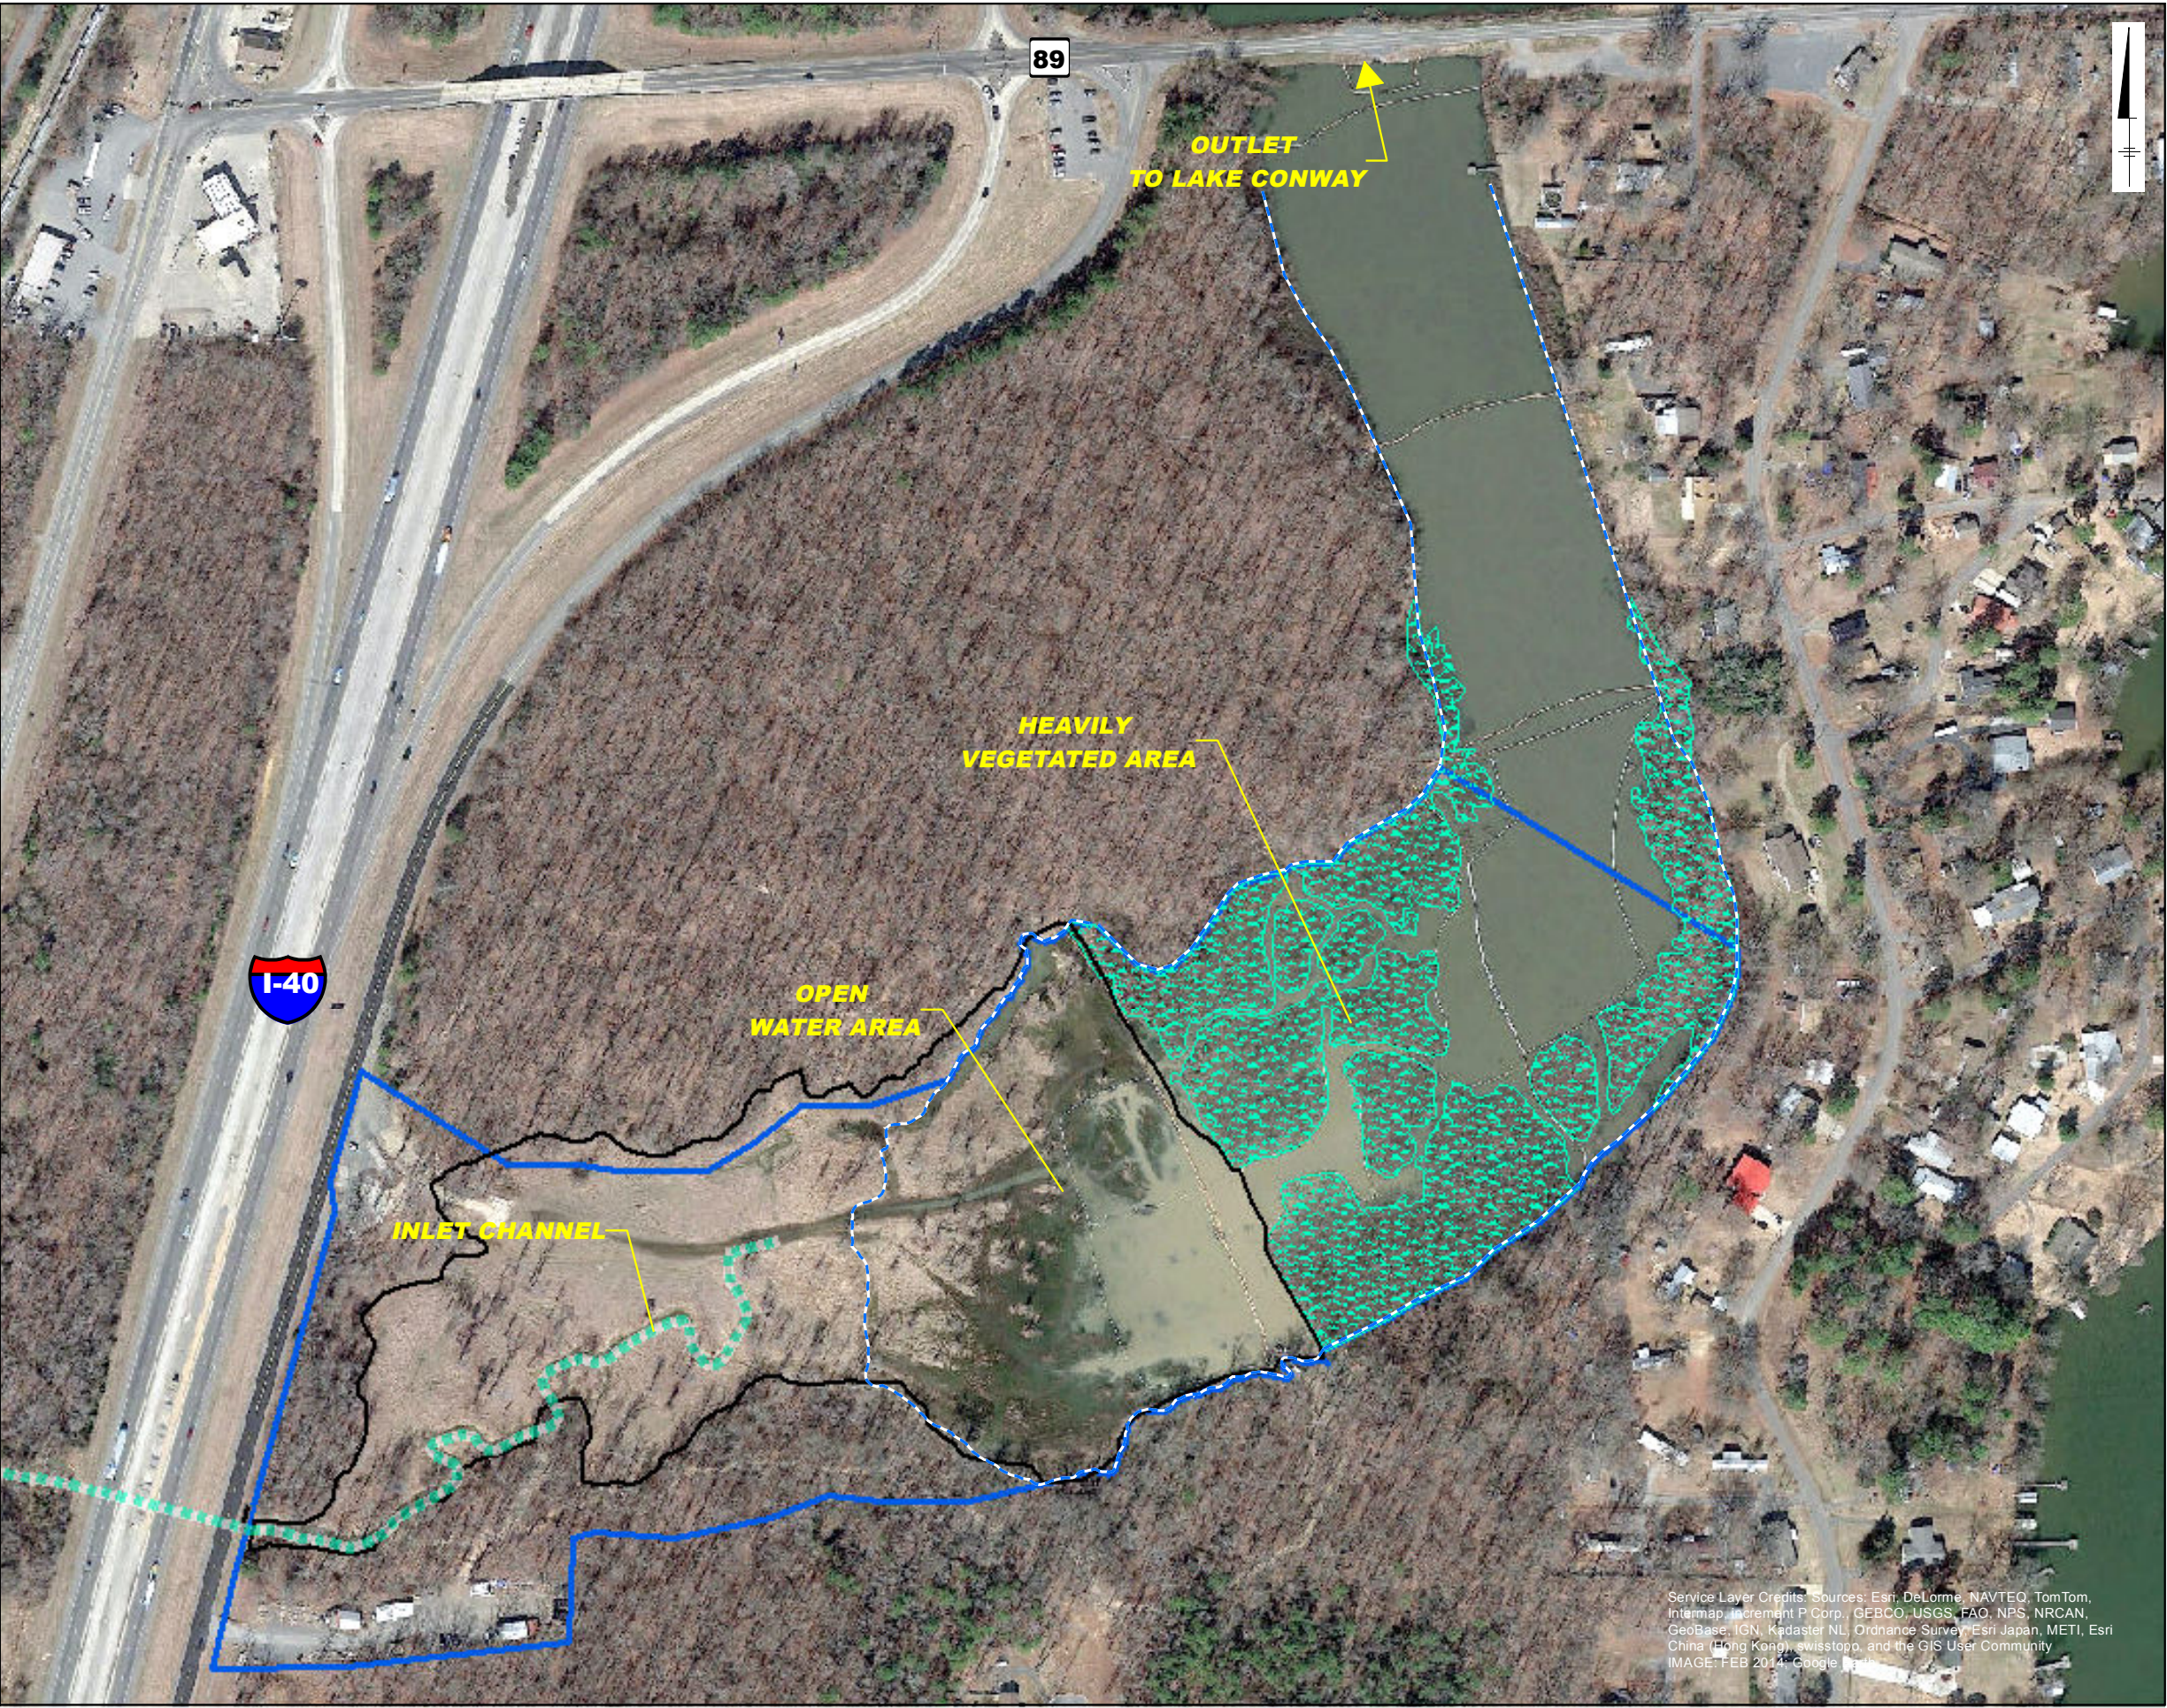
Response action cleanup activities affected approximately 17.1 acres of forested wetlands and approximately 1,300 linear feet of an unnamed stream (referred to as the Inlet Channel) in the cove. Sheen mitigation actions described in the Mitigation Action Plan (ARCADIS 2014a) were completed in November 2014. The remedial action objective was to mitigate surface water sheens related to crude oil from the Pegasus Pipeline, to the extent technologically feasible. The completed mitigation actions in three areas of the cove are summarized below (areas are shown on Figure 2):

- *Inlet Channel.* Targeted removal of sheen-bearing sediment along the bottom of the main channel between Interstate 40 and the Open Water Area. Removal depths varied from 6 to 18 inches. Approximately 750-800 cubic yards of sediment were removed from along approximately 1,300 feet of the Inlet Channel. Excavation areas with depths greater than 6 inches were backfilled with clean material.

- *Open Water Area.* A thin-layer reactive cap was placed over approximately 4.5 acres in the open marsh and water area located between the Inlet Channel and the Heavily Vegetated Area. The reactive cap consisted of an approximate 3- to 6-inch layer of clean sand mixed with organoclay placed directly over the sediment surface. Organoclay is an effective sorptive medium for petroleum hydrocarbons and sheens.

- *Heavily Vegetated Area.* The Heavily Vegetated Area is located downstream of the Open Water Area, extends east, and includes several natural channels. Targeted in-situ amendment in the Heavily Vegetated Area consisted of organoclay placed directly over the sediment, limiting disturbance to the existing vegetation. This vegetation was preserved during the response activities because of its habitat value and the relatively light degree of oiling that occurred in this area.

The outline of disturbed wetlands is shown on Figure 2. This CRPP focuses on restoring the disturbed Inlet Channel and forested wetlands in the cove. The following sections discuss the cove hydrology, the wetland delineation performed in April 2014, and the supplemental wetland assessment performed in September 2014.

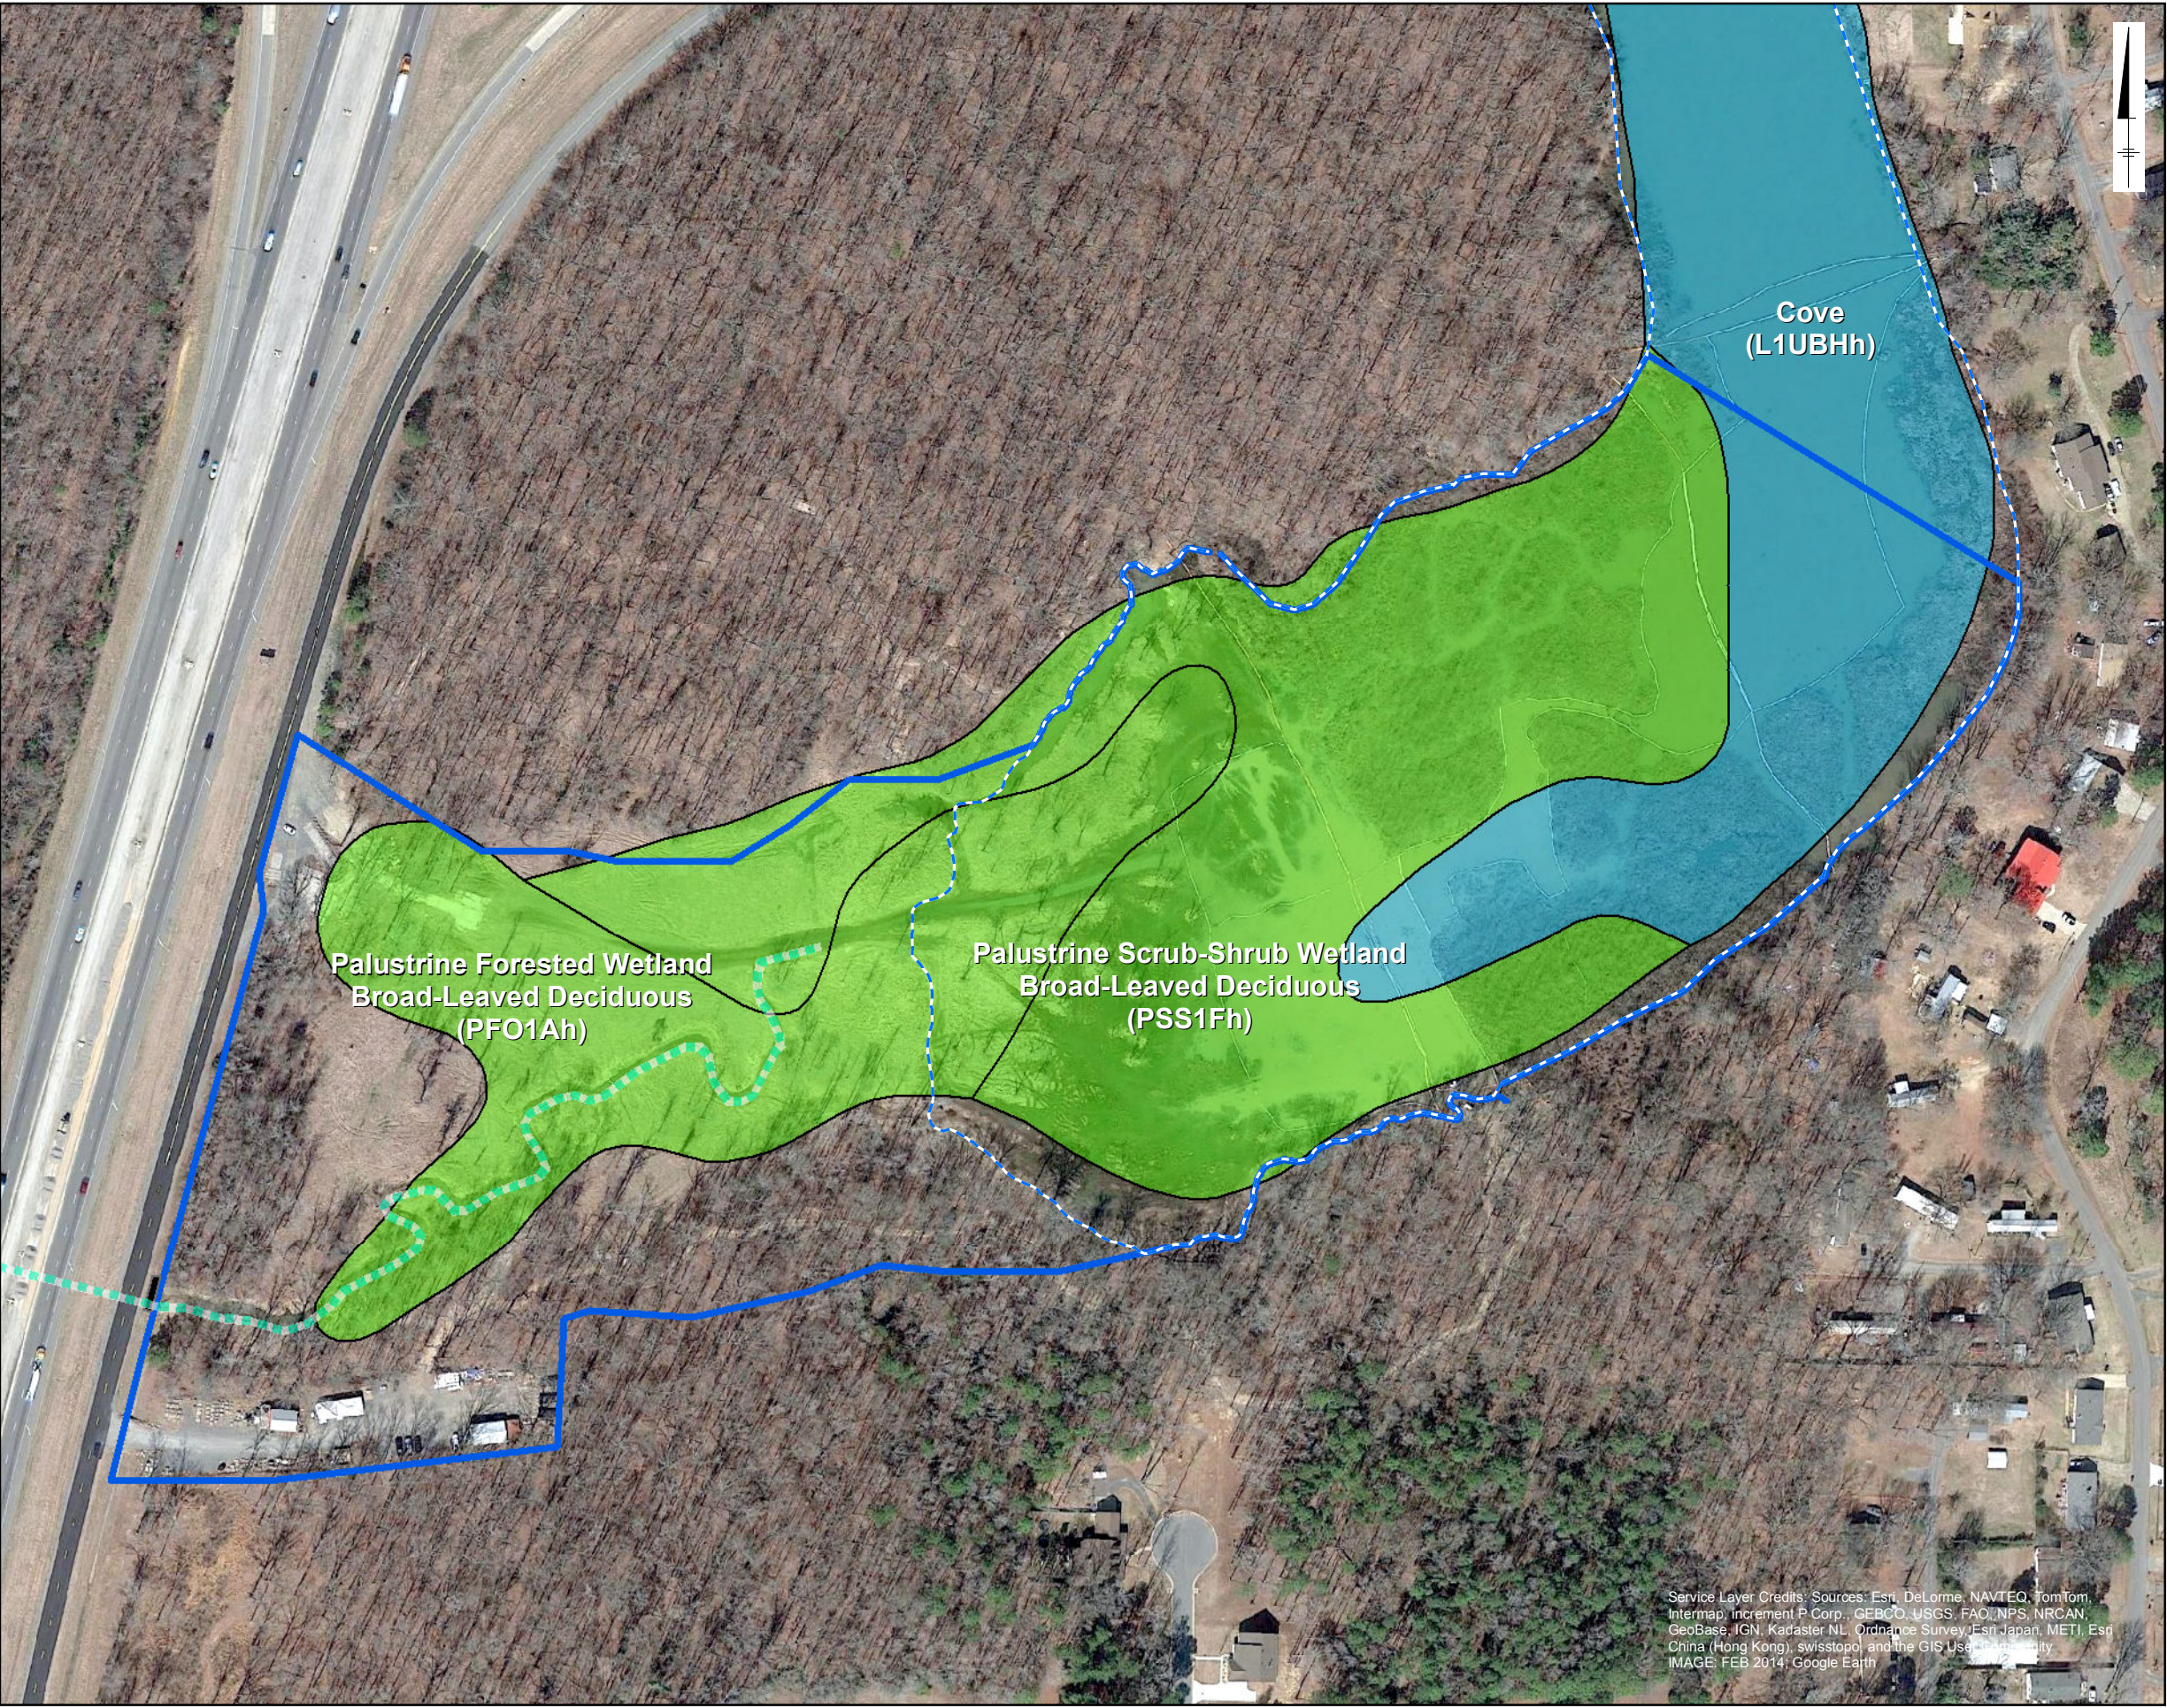
FIGURE  
3

As a result of the seasonal flooding of Lake Conway, portions of the cove are periodically inundated. As shown on the National Wetland Inventory Map (Figure 3), this results in the creation of two vegetation communities:

- Palustrine Forested Broad-Leaved Deciduous (PFO1Ah) with a temporary non-tidal water regime that has been diked/impounded
- Palustrine Scrub-Shrub Broad-leaved Deciduous (PSS1Fh) with a semi-permanent non-tidal regime that has been diked/impounded

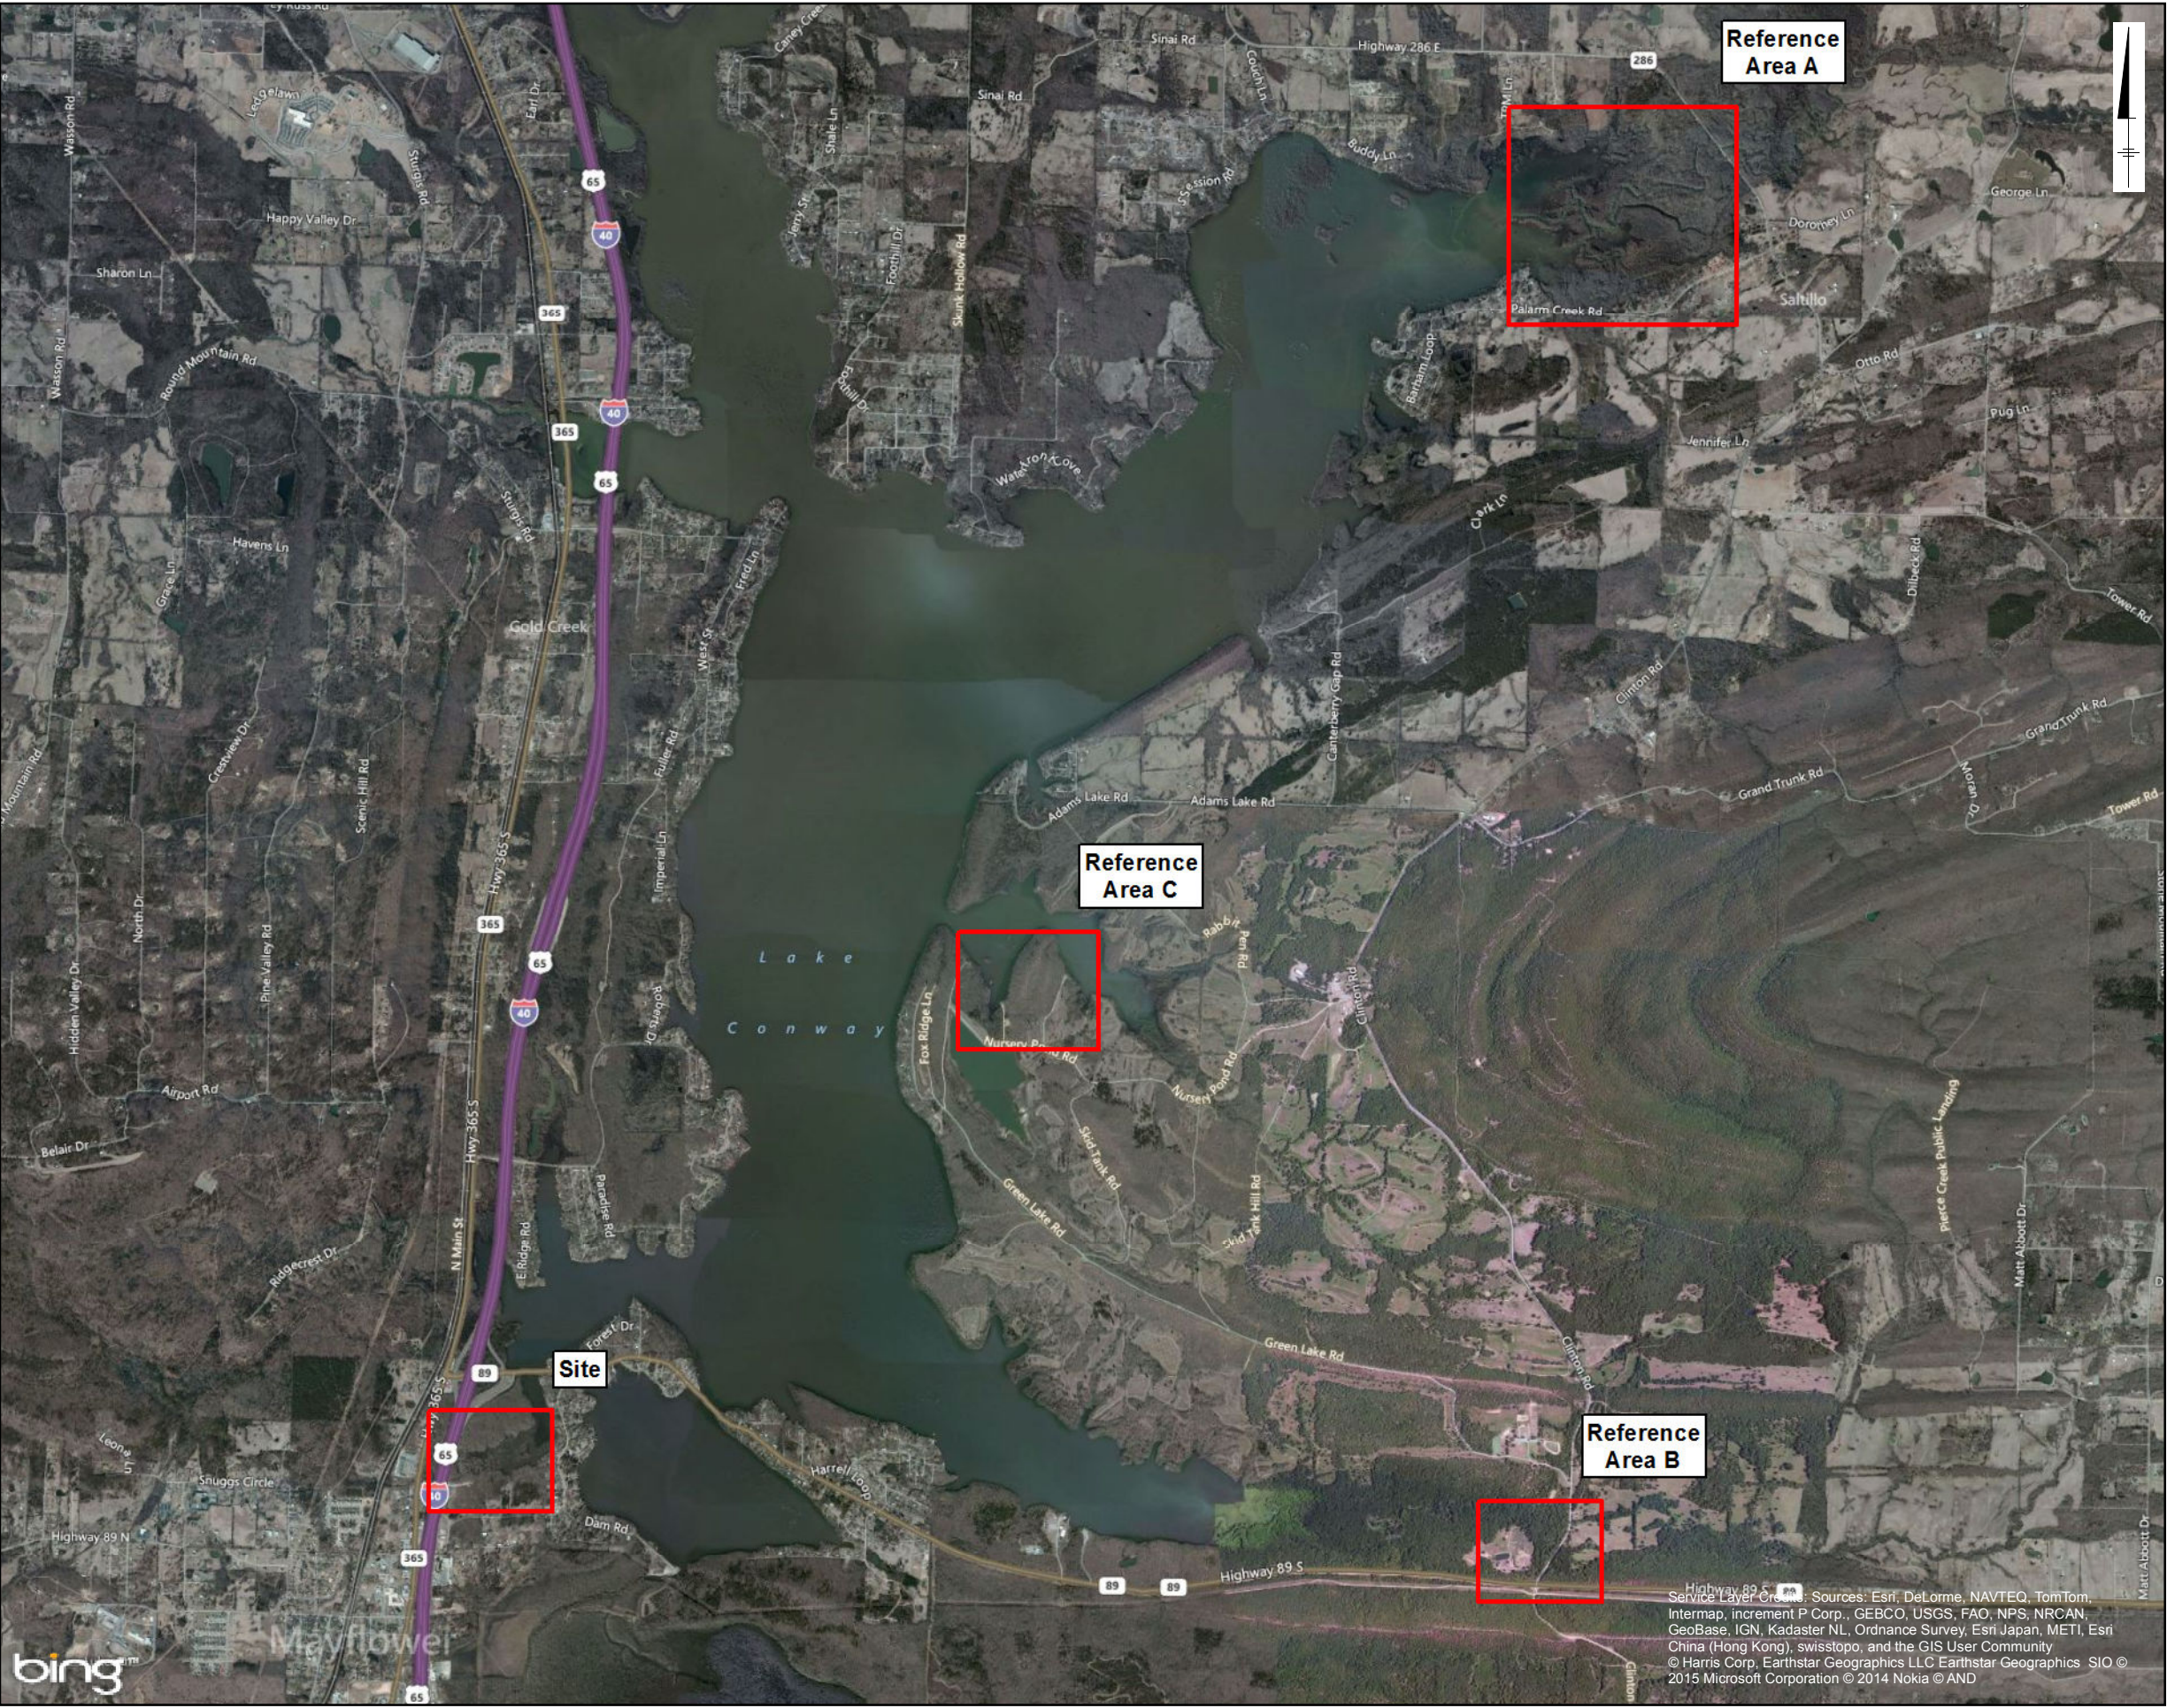
FIGURE  
4

2014 WETLAND ASSESSMENT OVERVIEW

Three nearby wetlands (Figure 4) were assessed to determine which plant species would be proposed in the CRPP. The Hydrogeomorphic Approach, as outlined in “A Regional Guidebook for Conducting Functional Assessments of Forested Wetlands in the Arkansas Valley Region of Arkansas” (USACE 2008b), was used for the assessment, with the following modification. In place of detailed transects recommended in the Hydrogeomorphic Approach, forested wetland habitats around Lake Conway were sampled. This

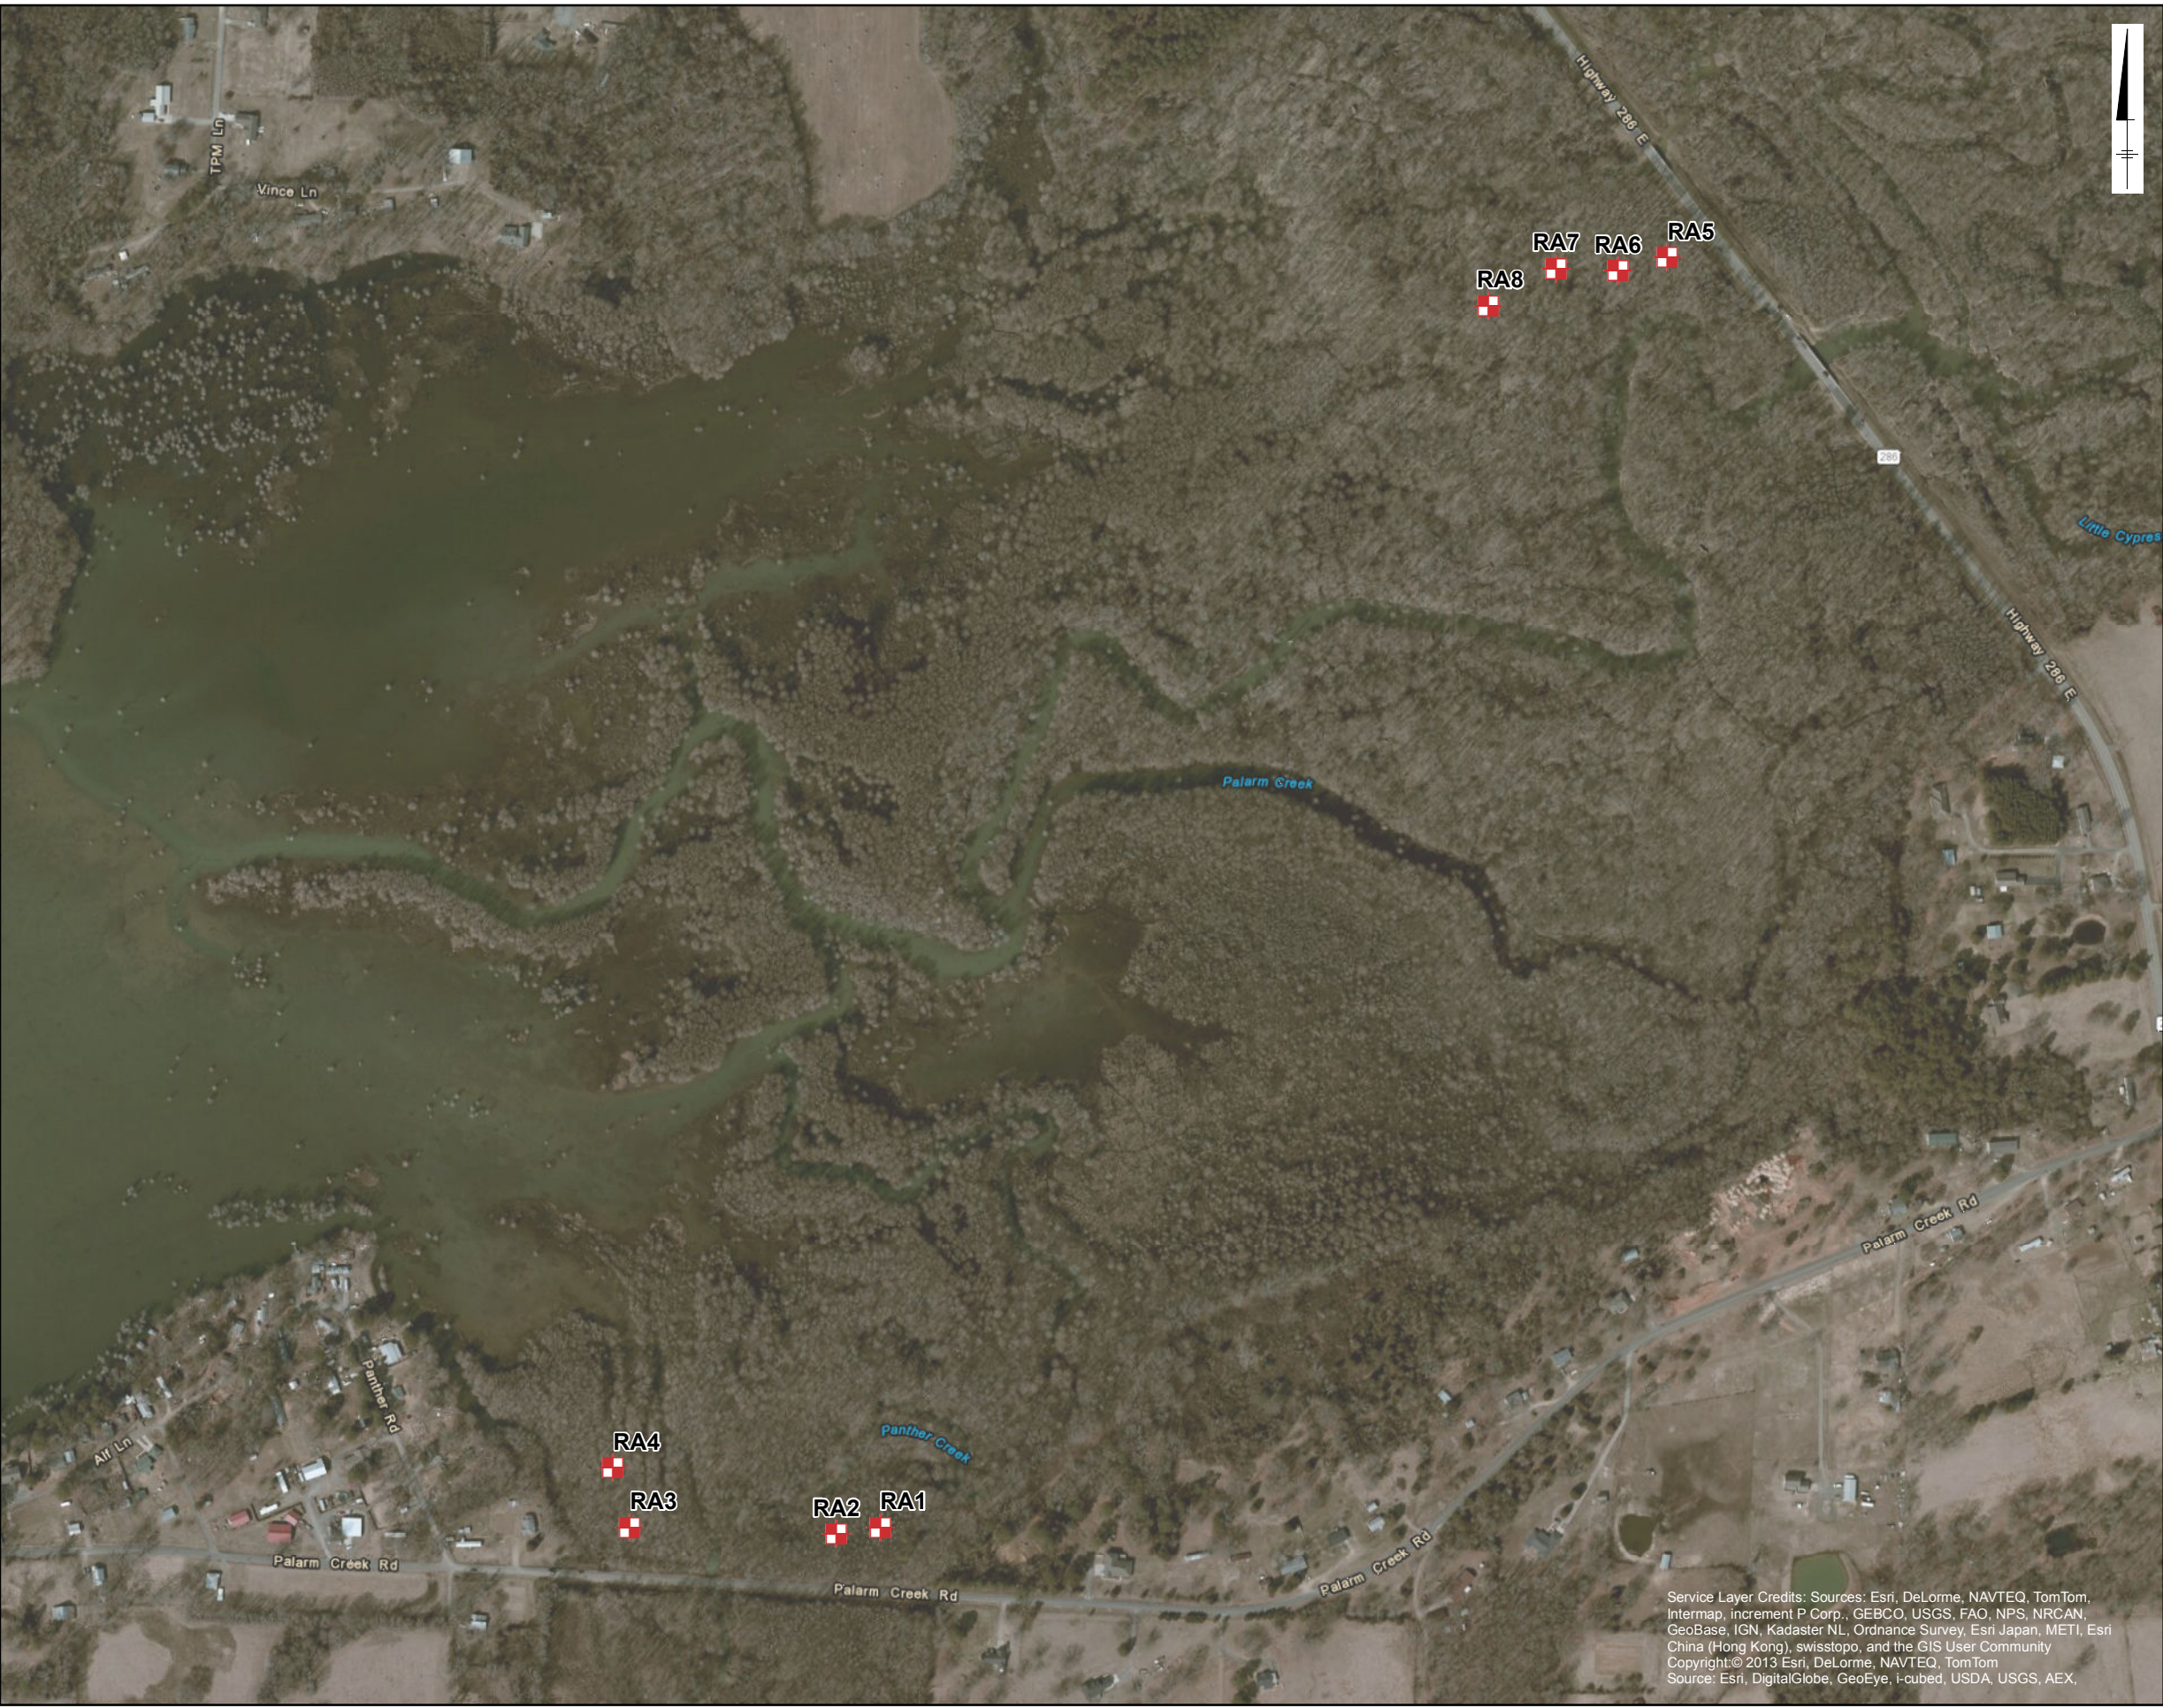
FIGURE  
5

The community located in and adjacent to standing water in the drainage swales of Reference Area A was dominated by a bald cypress (*Taxodium distichum*) and water tupelo (*Nyssa aquatica*). The upper edge was dominated by the sweet gum (*Liquidambar styraciflua*) and red maple (*Acer rubrum*) community. There was an absence of a dense shrub and herbaceous community due to the closed tree canopy. The sampling plots in Reference Area A are shown in Figure 5.

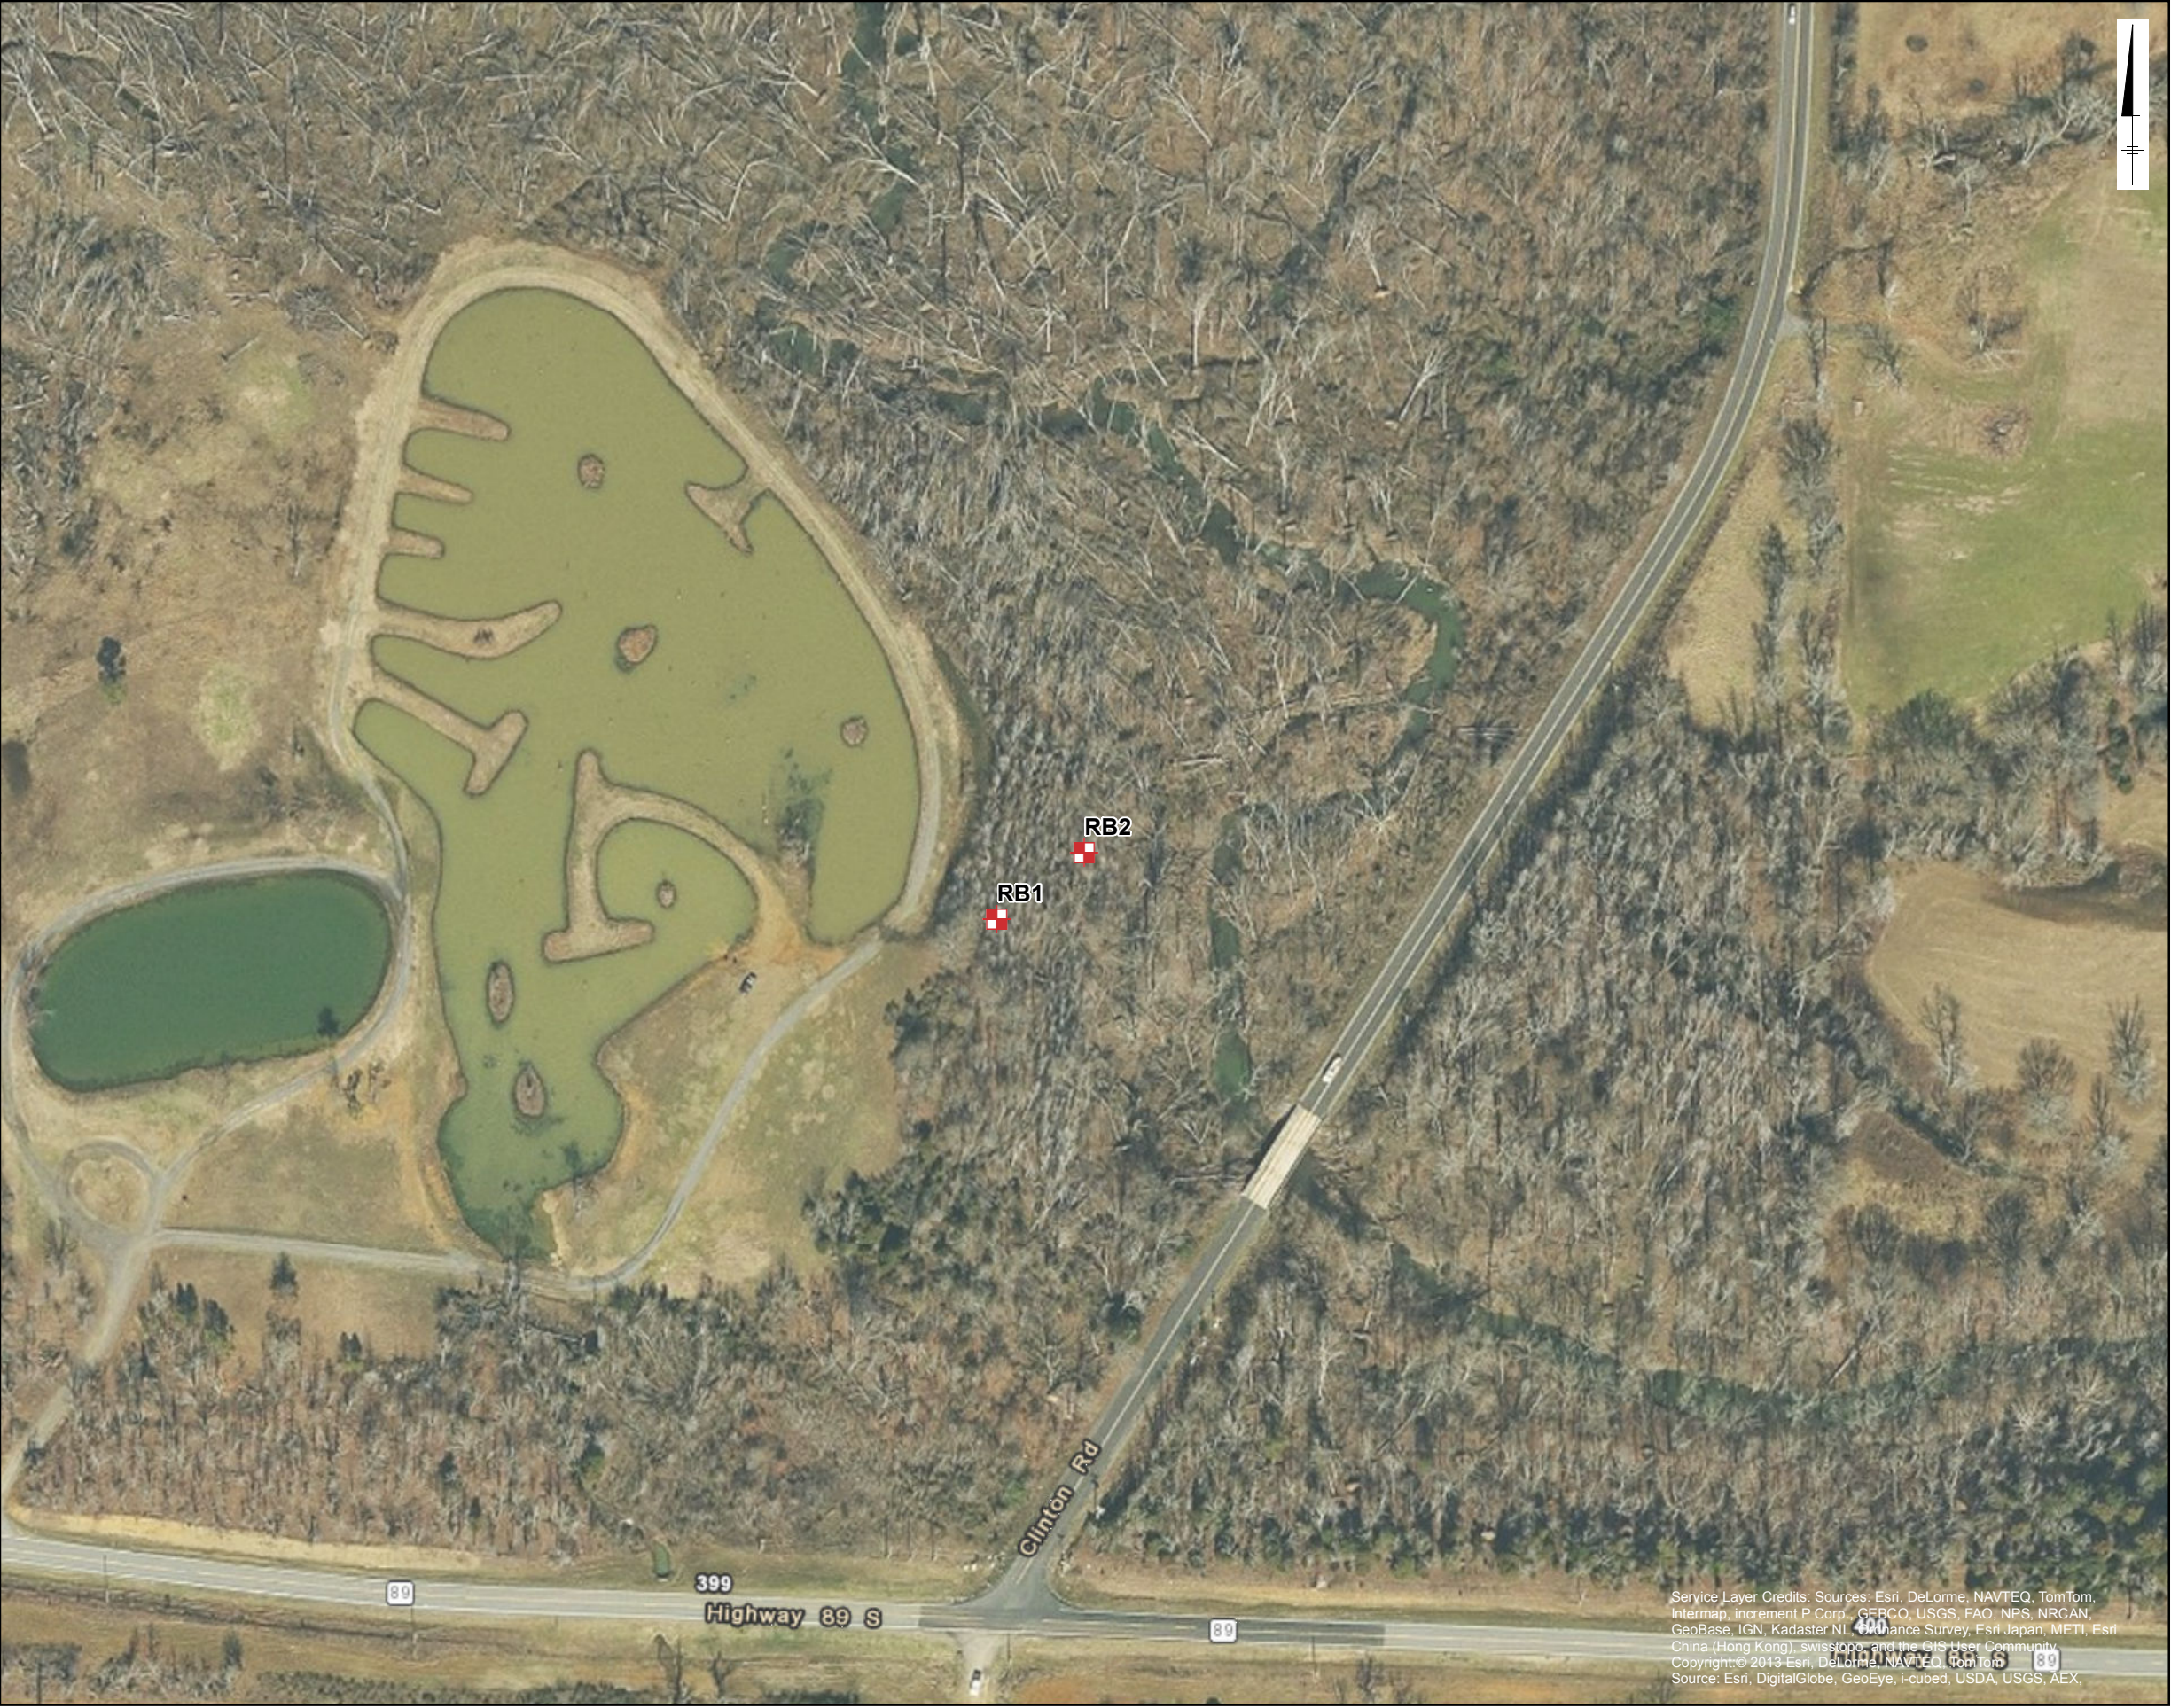
**FIGURE 6**

Reference Area B is an undisturbed young forested wetland, representative of an early successional wetland forest as would be present in the cove. It lies southeast of Lake Conway. This forested wetland consists of a dense stand of small diameter-at-breast height sweet gum trees with little to no shrub community as a result of the closed canopy. Two plots were sampled in Reference Area B (Figure 6).
