**Cove Restoration Planting Plan**

Mayflower Pipeline Incident Response  
Mayflower, Arkansas

Prepared for:  
ExxonMobil Environmental Services  
Company

Prepared by:  
ARCADIS U.S., Inc.  
630 Plaza Drive  
Suite 100  
Highlands Ranch  
Colorado 80129  
Tel 720 344 3500  
Fax 720 344 3535

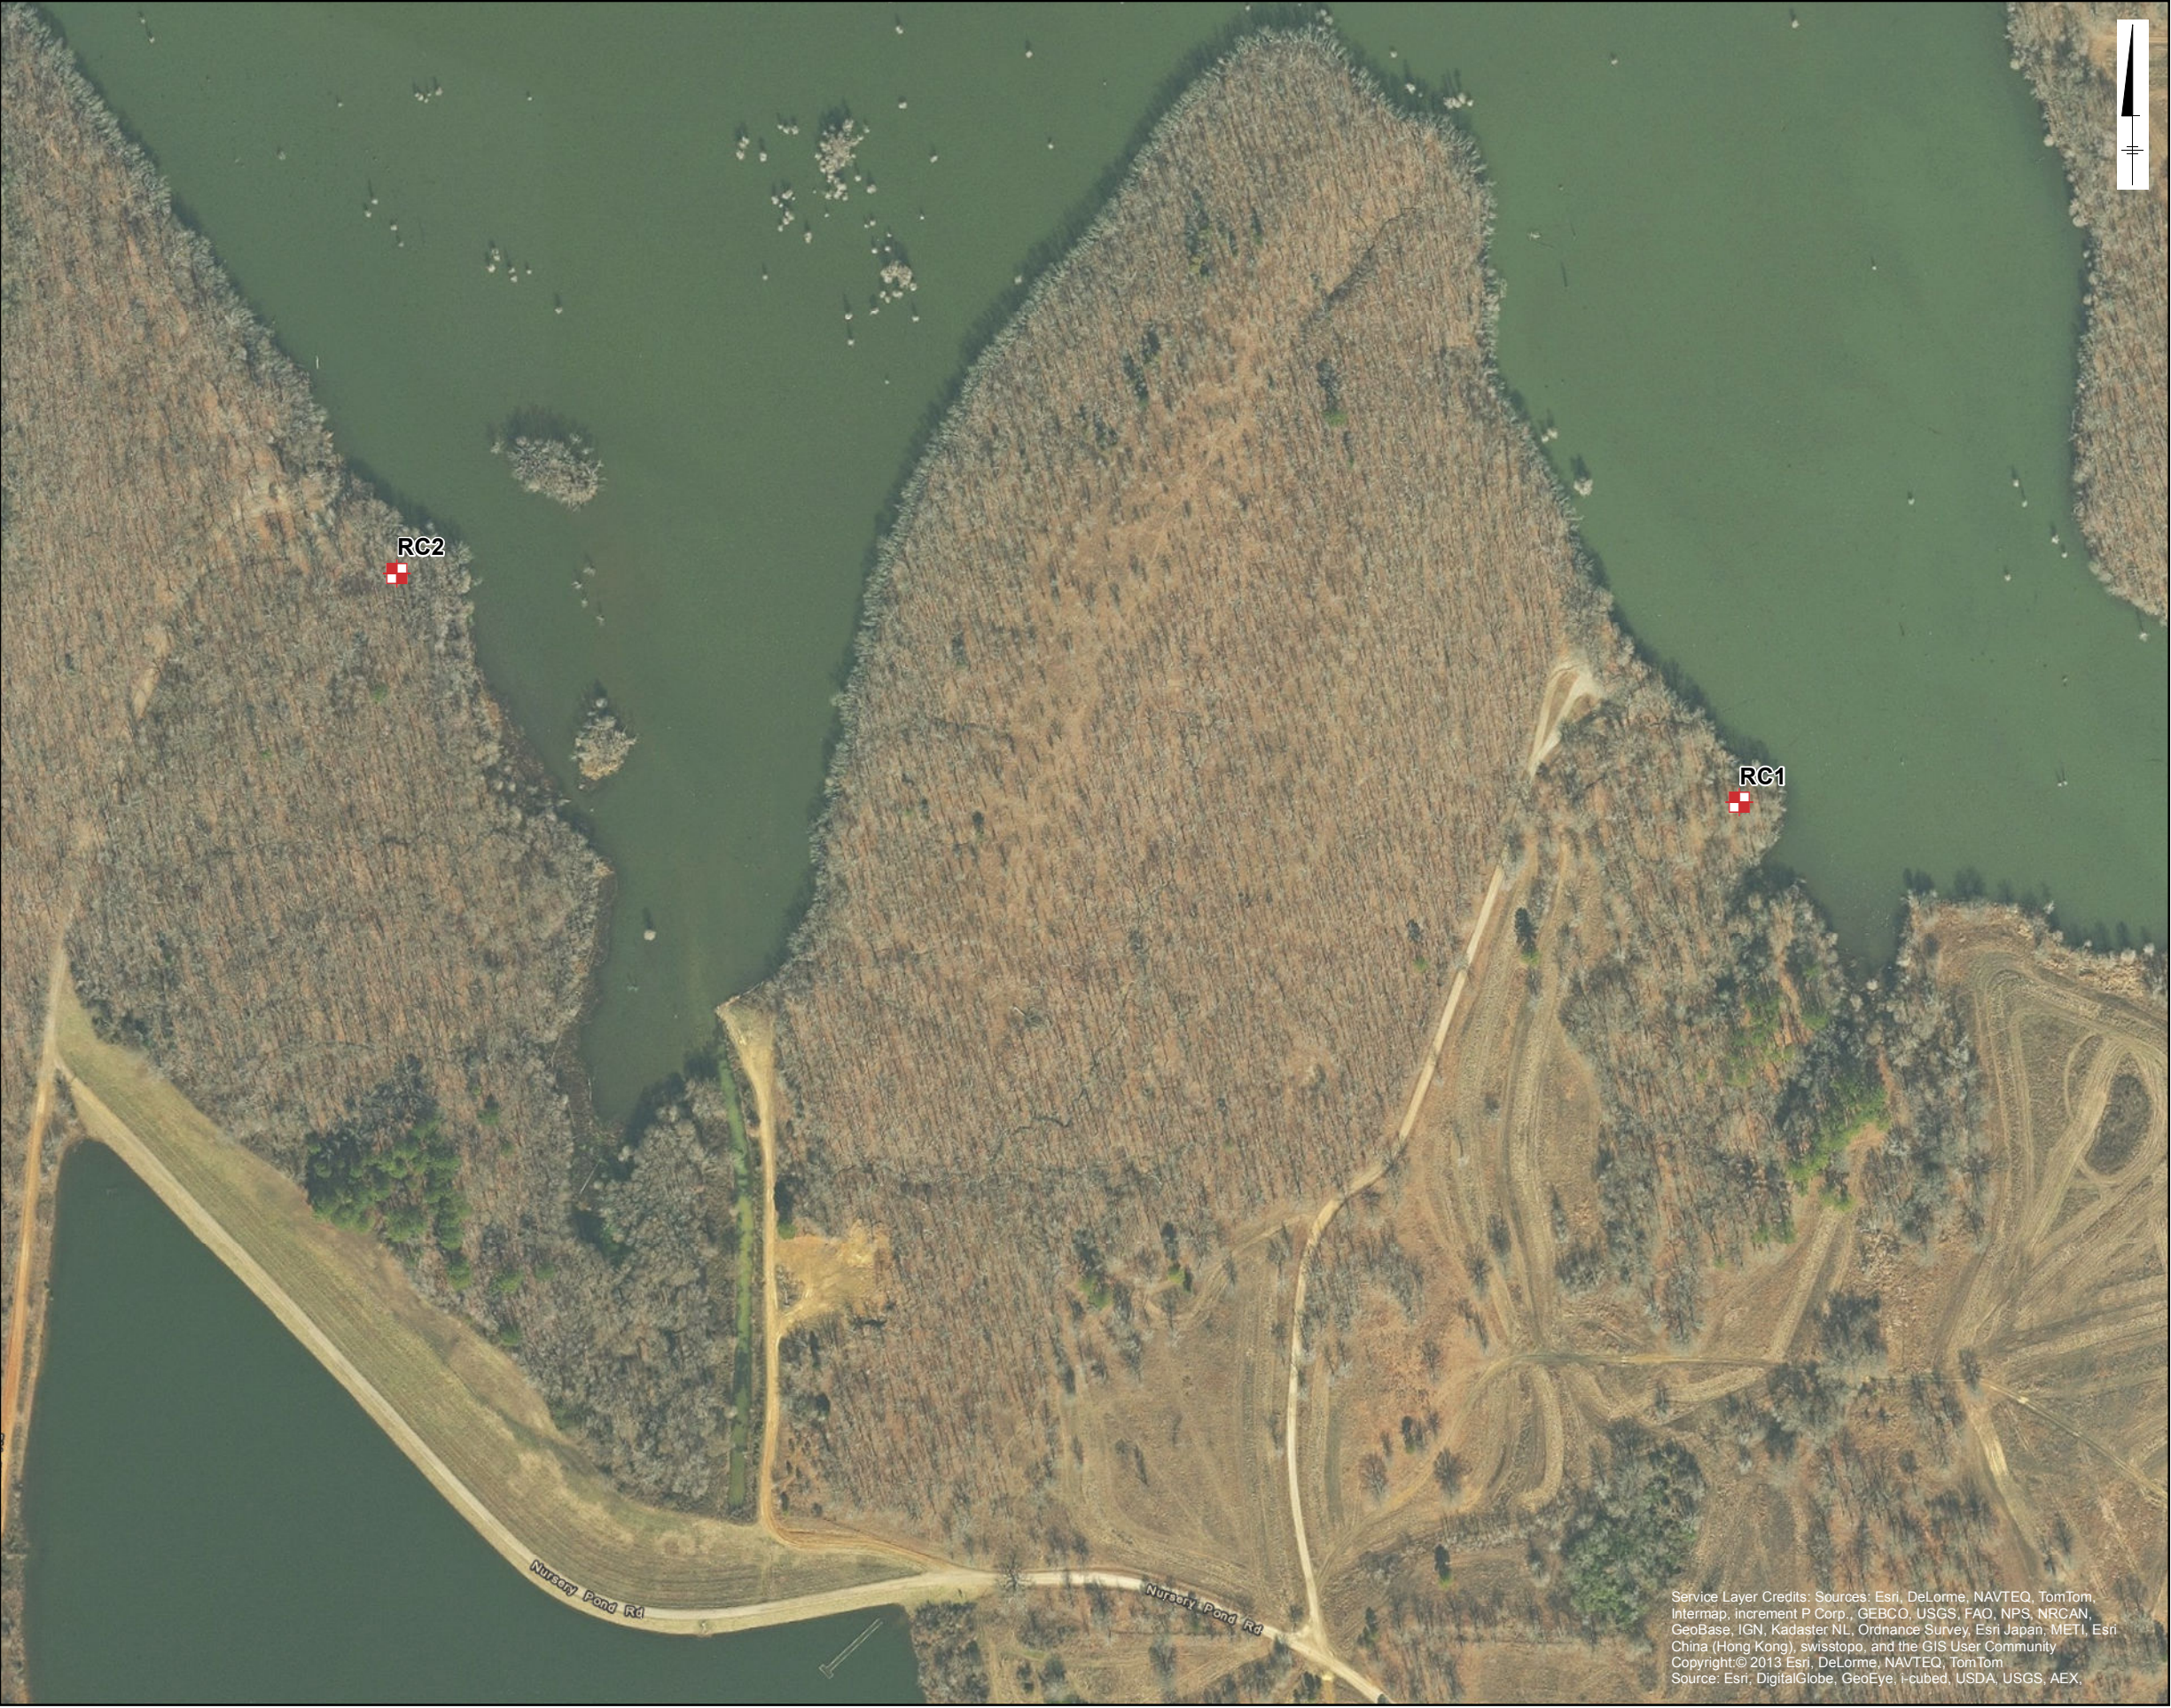
FIGURE  
7

Reference Area C is a mature forest on the fringe of Lake Conway. It is representative of emergent hydrological regimes such as the edges of the cove. Two plots were sampled in this area, along the eastern shore of Lake Conway (Figure 7). In this area, Wetland Fringe and Forested Wetland habitats were observed. Their vegetation community was dominated by bald cypress trees. These were growing in 6 inches of water, with water marks on the trunks approximately 12 inches above the water line, indicating the range of water levels these habitats experience.

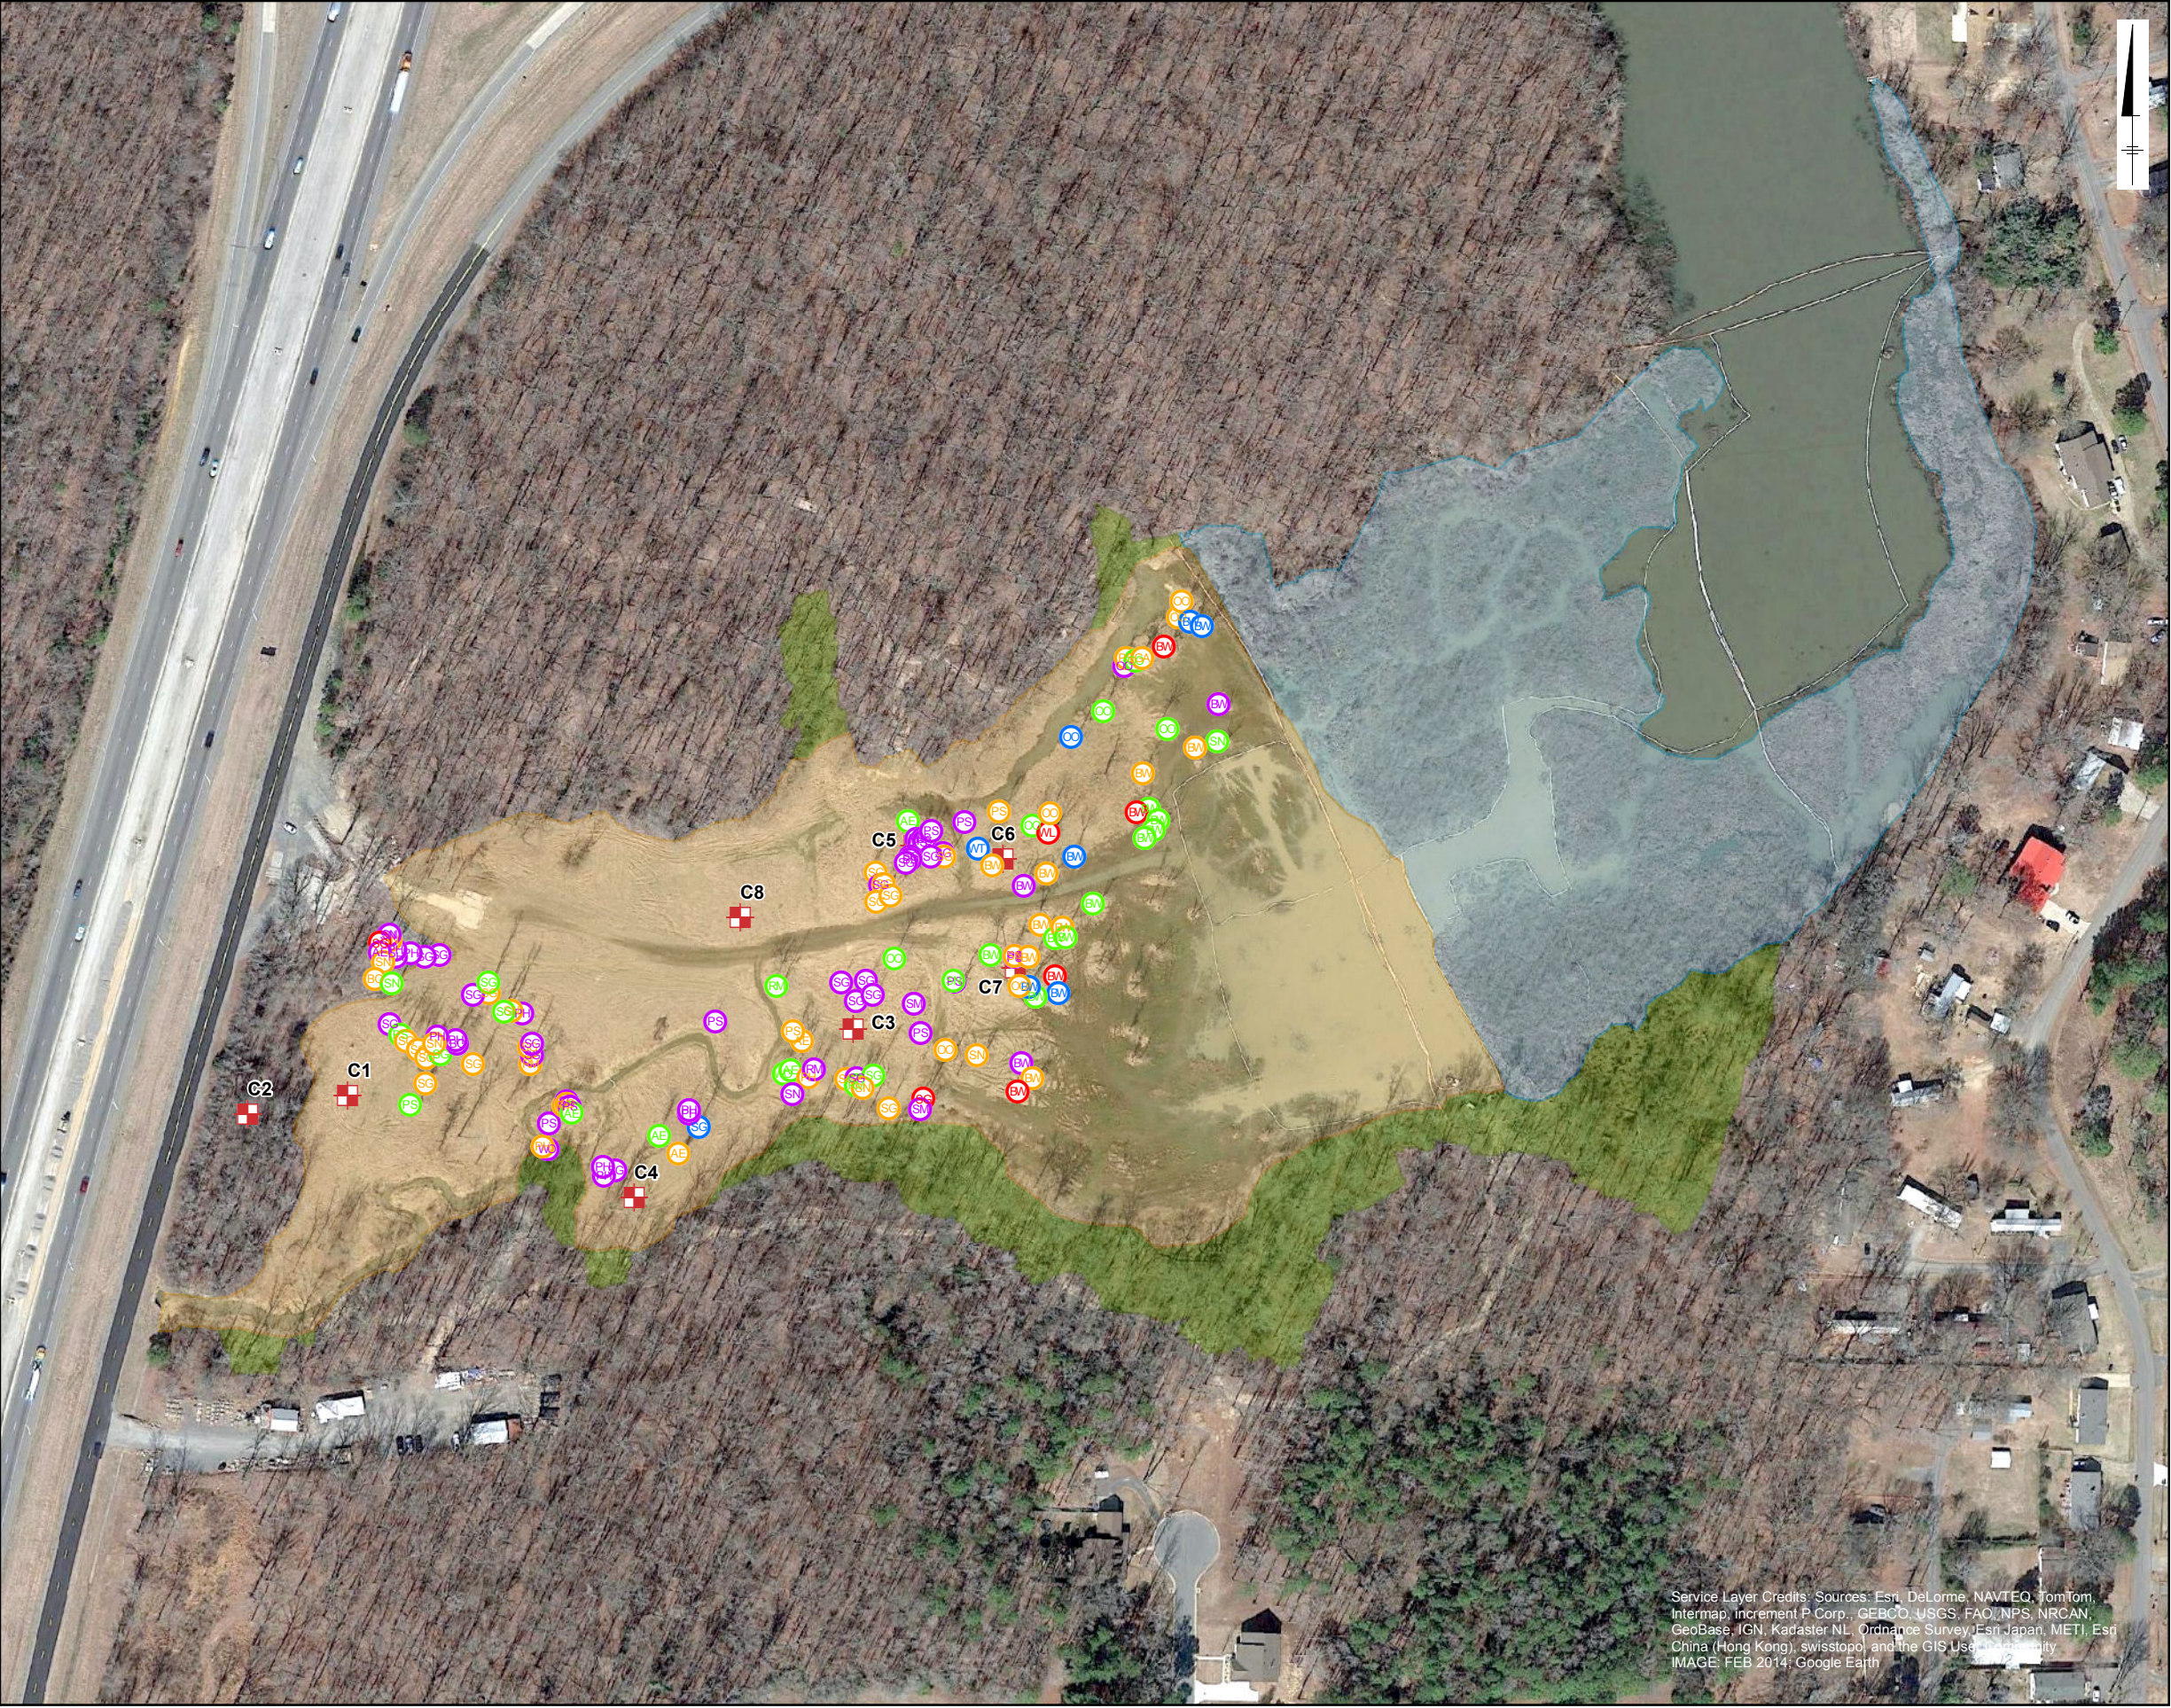
PROJECT AREA FORESTED WETLAND

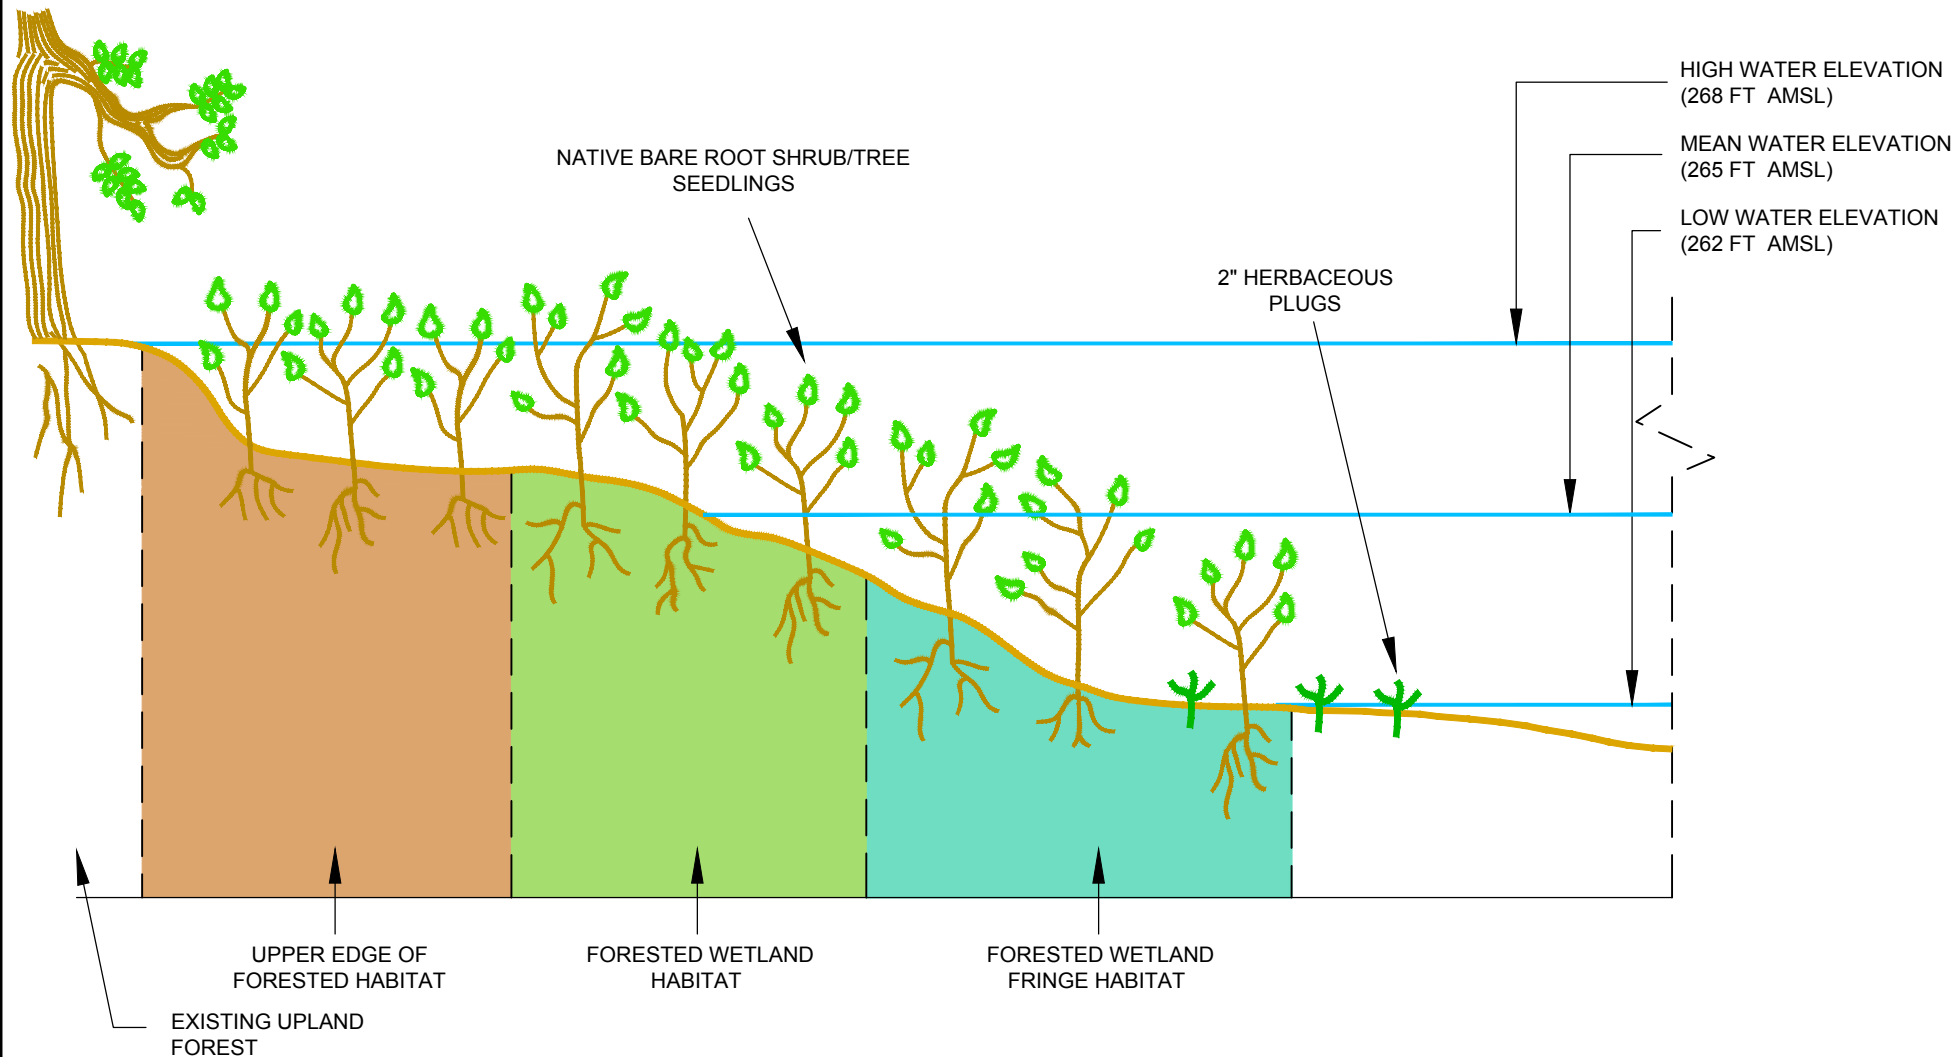
PLANTING PLAN DETAILS

BARE ROOT SEEDLING NOTES:

1. SELECTED SHRUB AND TREE SEEDLING SPECIES BASED ON OBSERVATIONS OF HIGH-VALUE FORESTED WETLAND SYSTEMS ASSOCIATED WITH UNDISTURBED PORTIONS OF LAKE CONWAY CONDUCTED DURING THE SEPTEMBER 2014 WETLAND ASSESSMENT. SPECIES AND THE LOCATION THAT THEY WERE OBSERVED CAN BE FOUND IN TABLE 1.

2. 2" NATIVE HERBACEOUS PLUGS WILL BE PLANTED AS NEEDED IN THE "FORESTED WETLAND FRINGE HABITAT".
3. DURING THE SEPTEMBER 2014 WETLAND ASSESSMENT THE FOLLOWING SPECIES WERE OBSERVED TO BE NATURALLY RECOLONIZING THE PROJECT AREA: BLACK WILLOW, BUTTONBUSH, WATER WILLOW. NO BARE ROOT SEEDLINGS OF THESE SPECIES WILL BE PLANTED DURING THE INITIAL RESTORATION EFFORTS.

Figure 10 shows a conceptual drawing of a cross-section of the proposed planting plan across the range of habitats as well as the species recommended for each hydrological condition. The approximate locations of these habitats are shown on Figure 11. Based on current site conditions and the assessment of other hydrologically comparable forested wetlands associated with Lake Conway, the planned restoration of the cove is as follows:

- *Upper Edge Forested Habitat (3.2 acres)*. The cleared, higher elevations of the cove currently dominated by beggar ticks (*Bidens frondosa*)/water pepper (*Polygonum hydropiper*) community and associated with the Upper Edge Forested Wetland habitats of Lake Conway will be planted with bare root seedlings of sweet gum, red maple and persimmon. The area will be seeded with riparian herbaceous seed mix (NC Piedmont Riparian Mix, ERNMX-307; Table 2) to reduce erosion and stabilize slopes until the seedlings establish root systems.

- *Forested Wetland Habitat (8.4 acres)*. In both the Reference Areas and the cove, a collection of tree species were identified in those areas of the forested wetlands that occurred in areas with seasonal flooding. These species included: overcup oak (*Quercus lyrata*), willow oak (*Quercus phellos*), silver maple (*Acer saccharinum*), and river birch (*Betula nigra*). Bare root seedlings of these species will be planted in the Forested Wetland habitat of the cove in areas of appropriate hydrology. A combination of the Riparian and Wet Meadow seed mixes (NC Piedmont Riparian Mix [ERNMX-307] and NC Piedmont FACW Mix [ERNMX-308]; Table 2) will be applied to the Forested Wetland habitat.

- *Forested Wetland Fringe Habitat (5.5 acres).* The lower elevations of the cove wetlands will be planted with bare root seedlings of bald cypress and water tupelo trees. Historical Lake Conway water elevations will be used to estimate average hydrologic conditions and select seedling placement within the cove. Wetland swales provide ideal hydrology for the development of cypress/water tupelo communities as observed in Reference Area C. A native wet meadow seed mix (NC Piedmont FACW Mix, ERNMX-308; Table 2) will be applied in the saturated soils of the Fringe Forested Wetland habitat to provide species diversity with modifications.

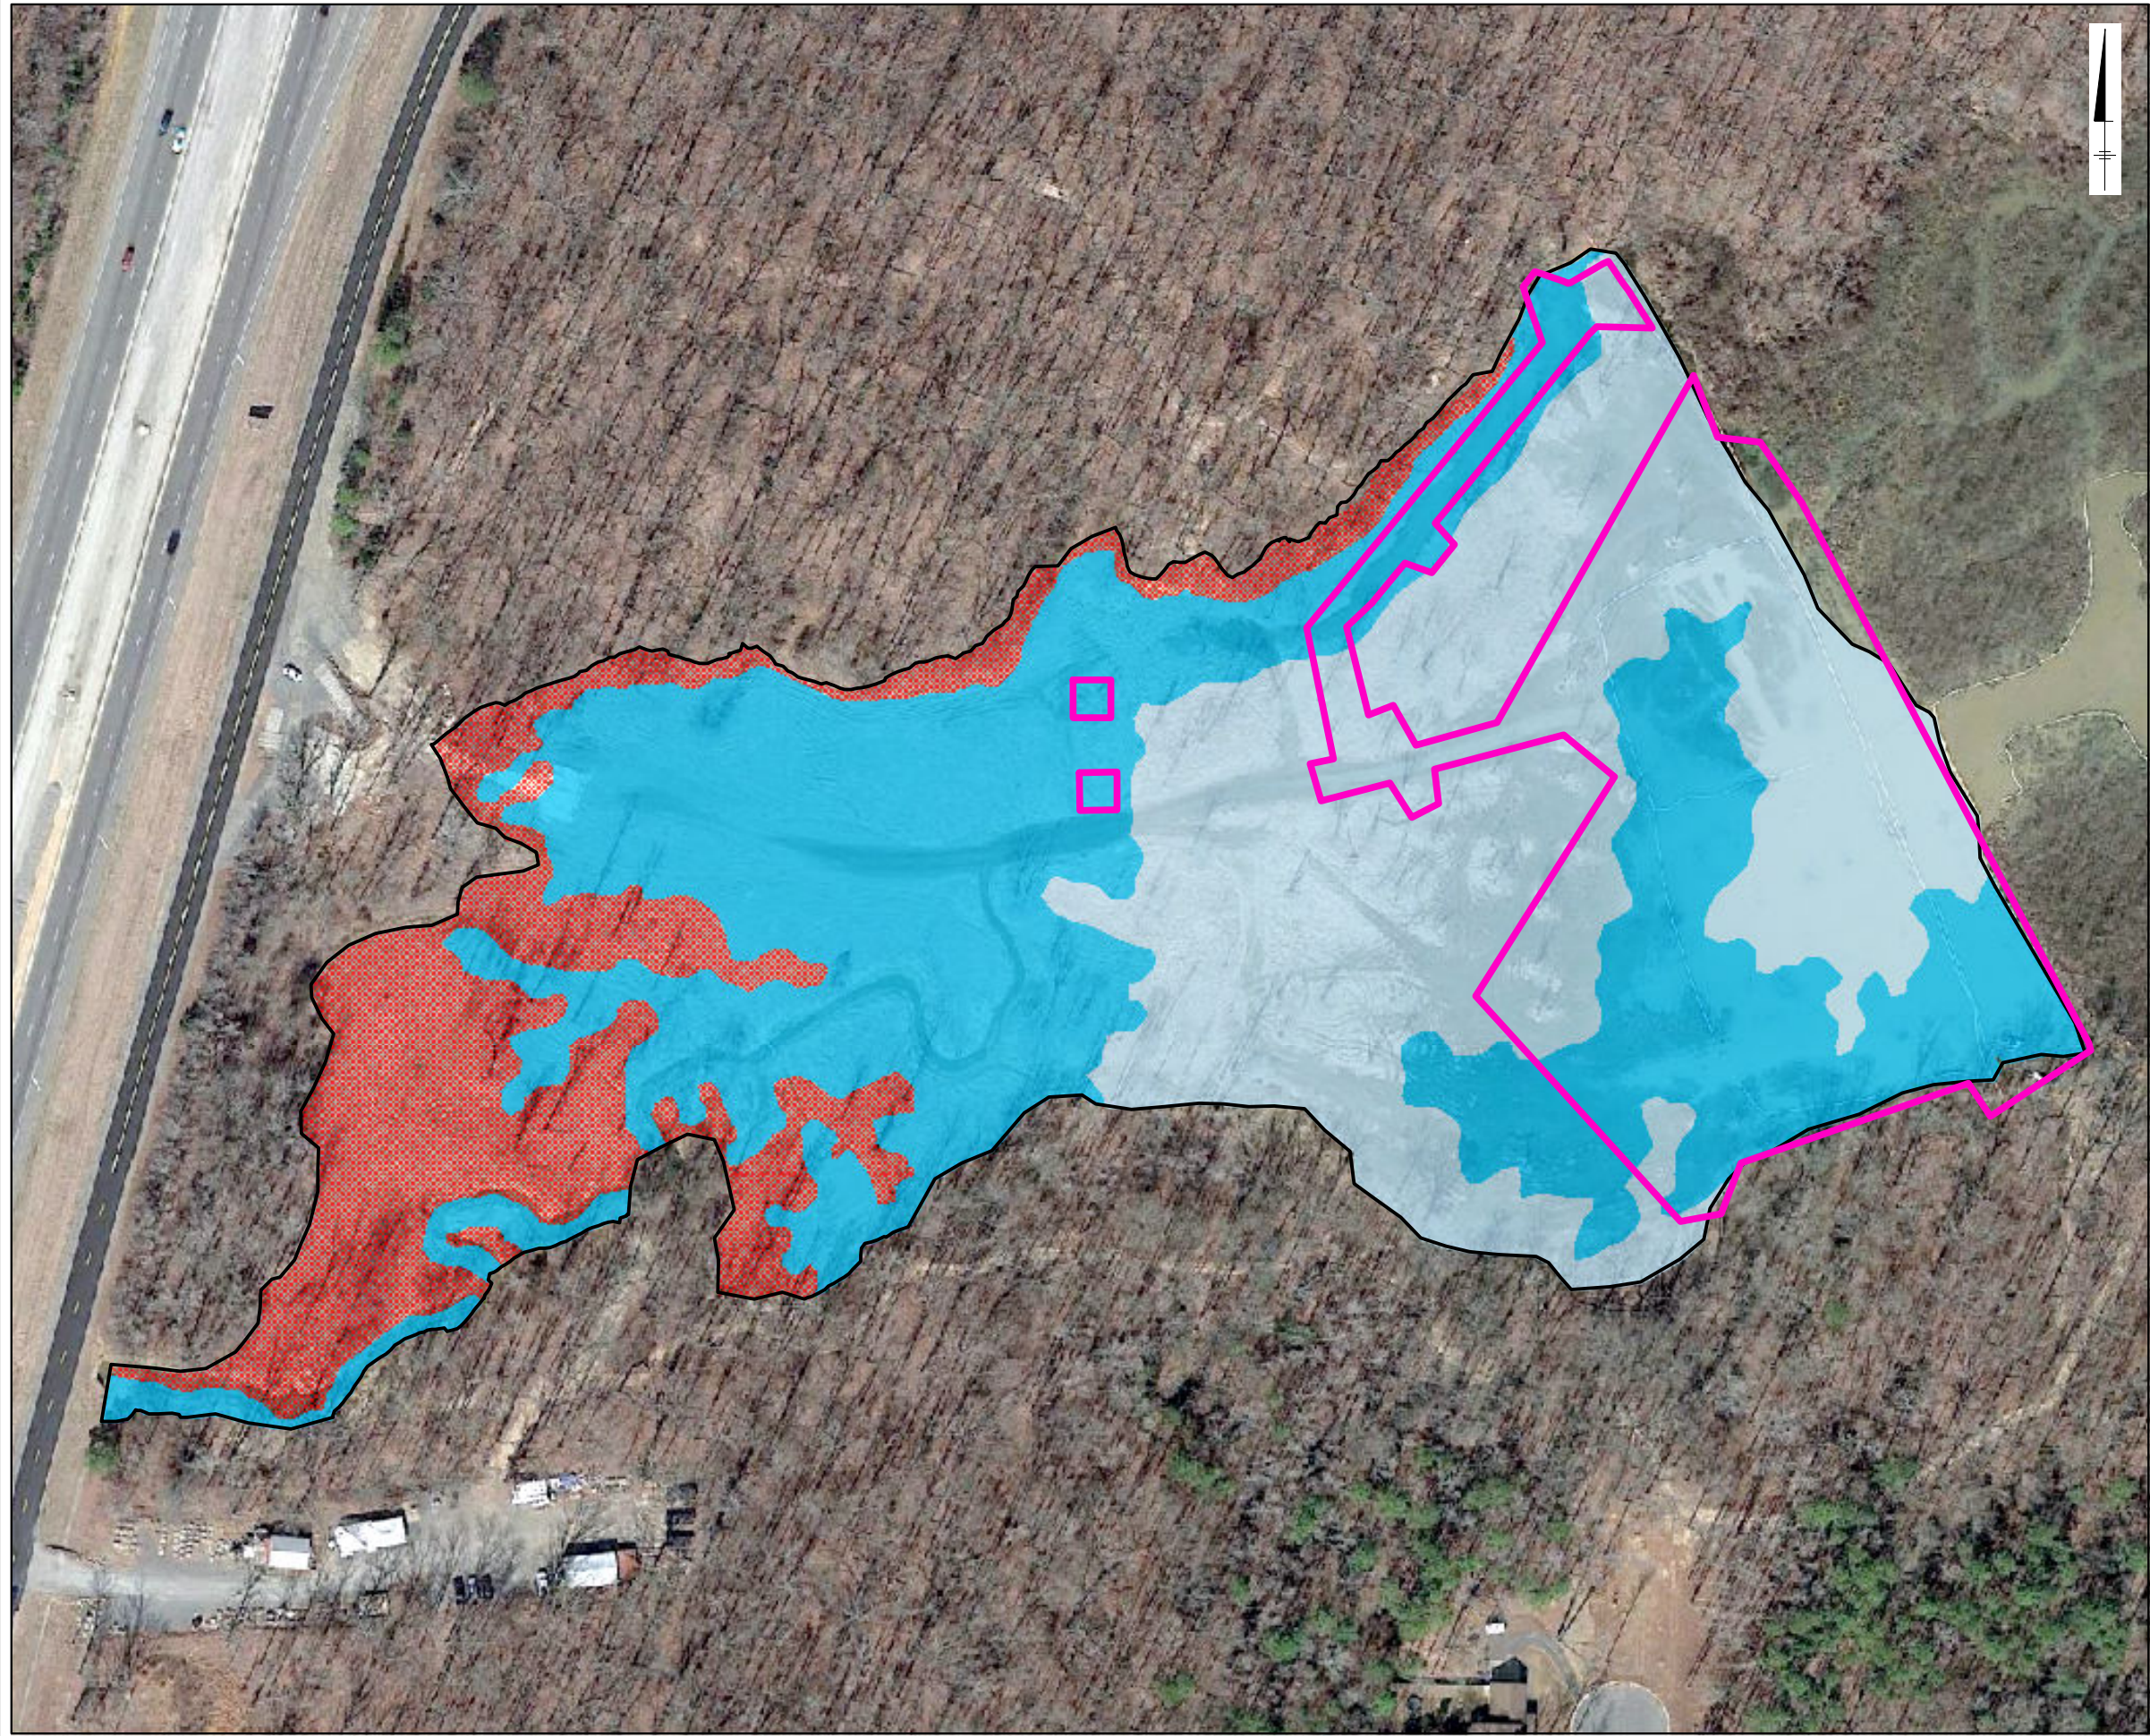
FIGURE  
**11**

The reactive cap was placed in October through November 2014 and portions of the cap cover the three habitat types within the cove. The Site Planting Plan (Figure 11) shows the location and hydrology of the cap and the proposed plant communities to be restored. In these areas with the reactive cap, special measures will be taken to not compromise the cap's integrity with restoration activities. Areas of the cap that can be reached from adjacent uncapped areas will be planted with seedlings and seeded with a Wetland mixes (Obligate Wetland Mix, ERNMX-131; Table 2) will be applied to accessible edges of the cap. For the remainder of the area, methods of access will be used that prevent damage to the cap:

- A shallow-draft small boat (e.g., jon-boat with electric motor) to access submerged areas of the cap
- The use of boards/mats to walk out on the cap and plant seedlings.

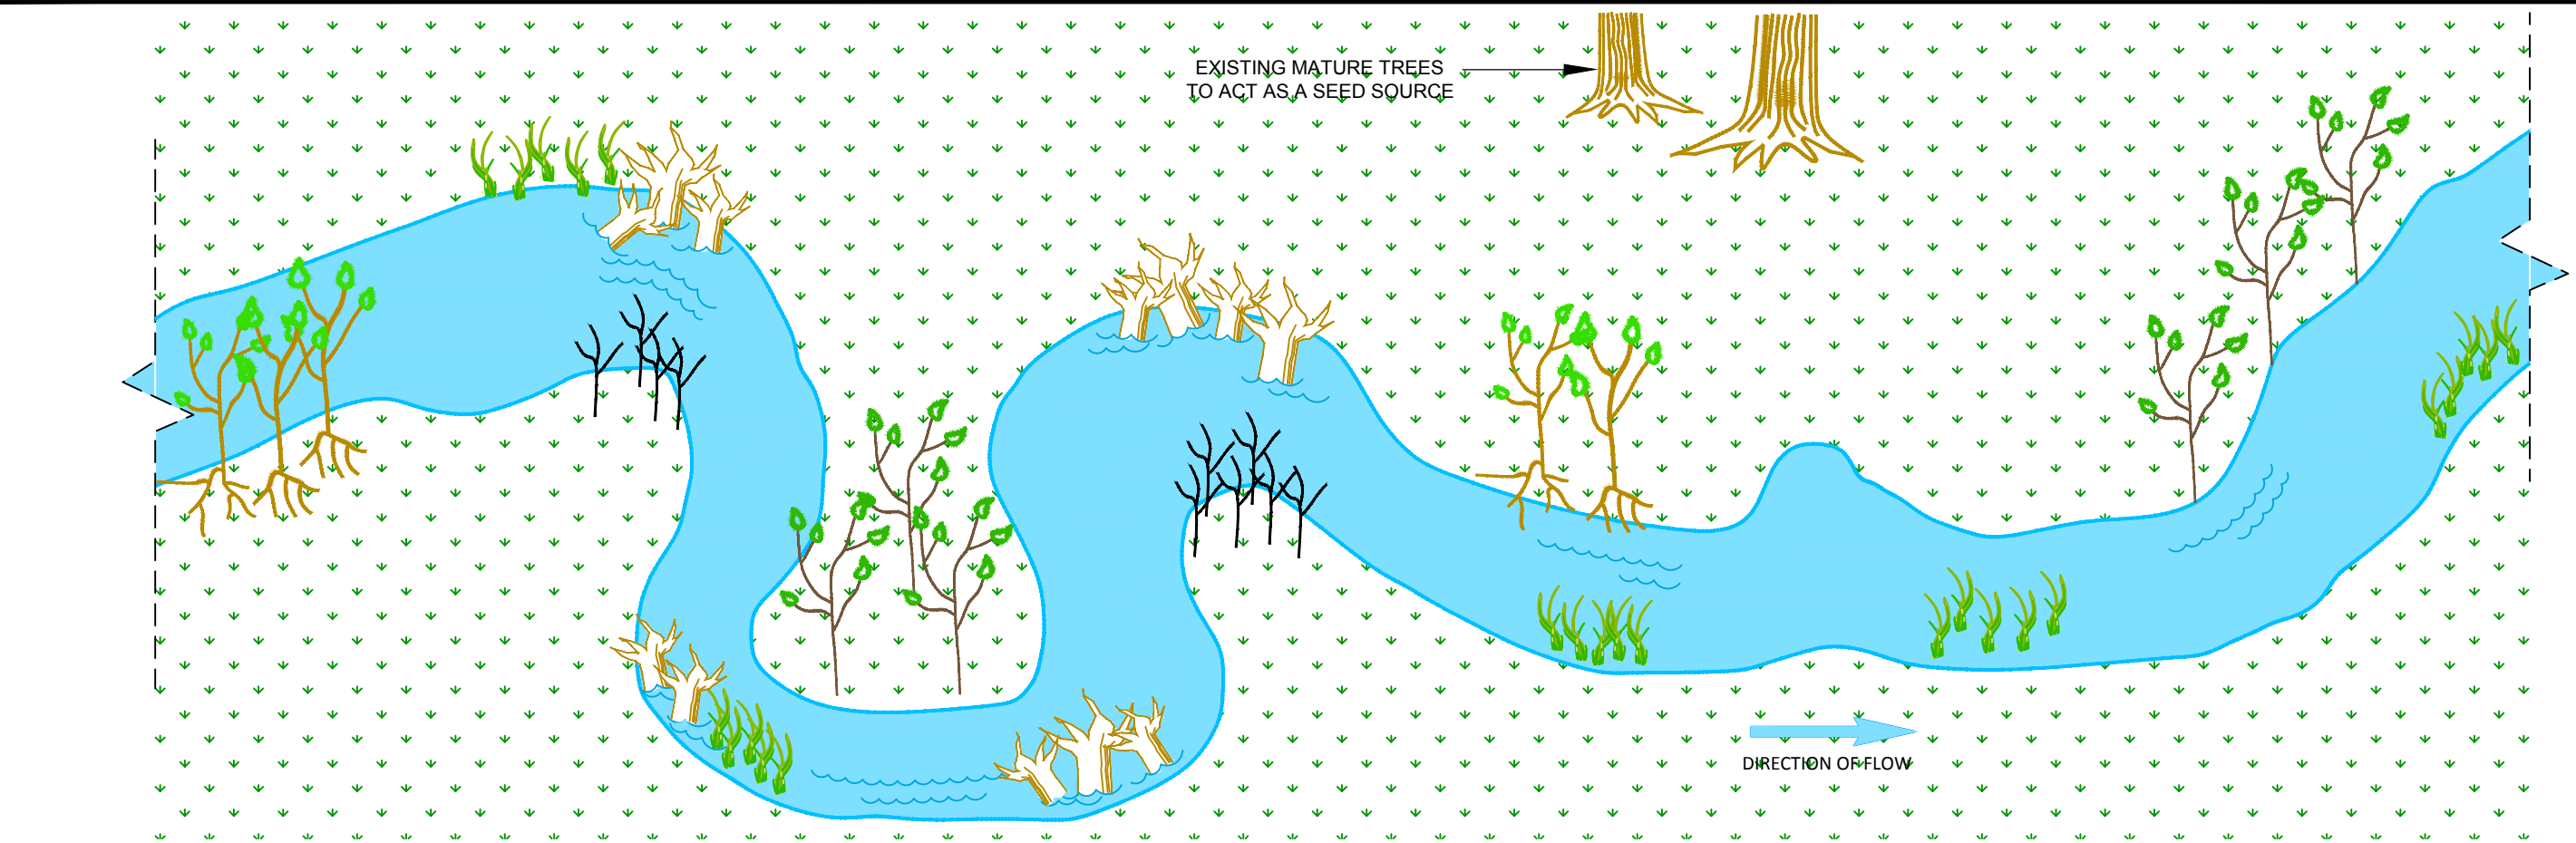
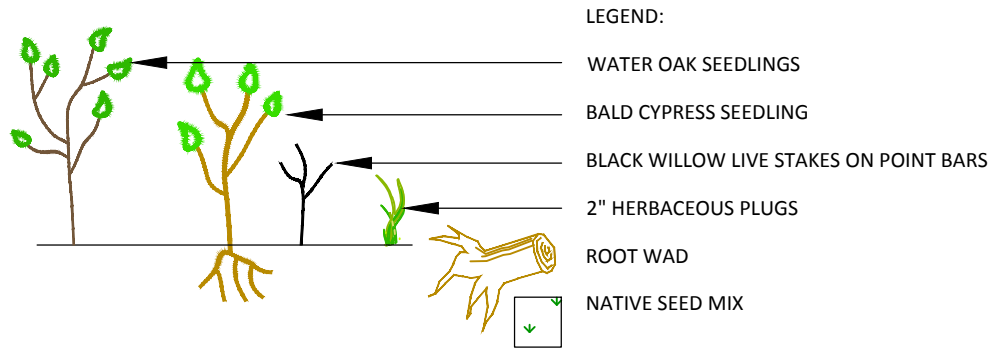
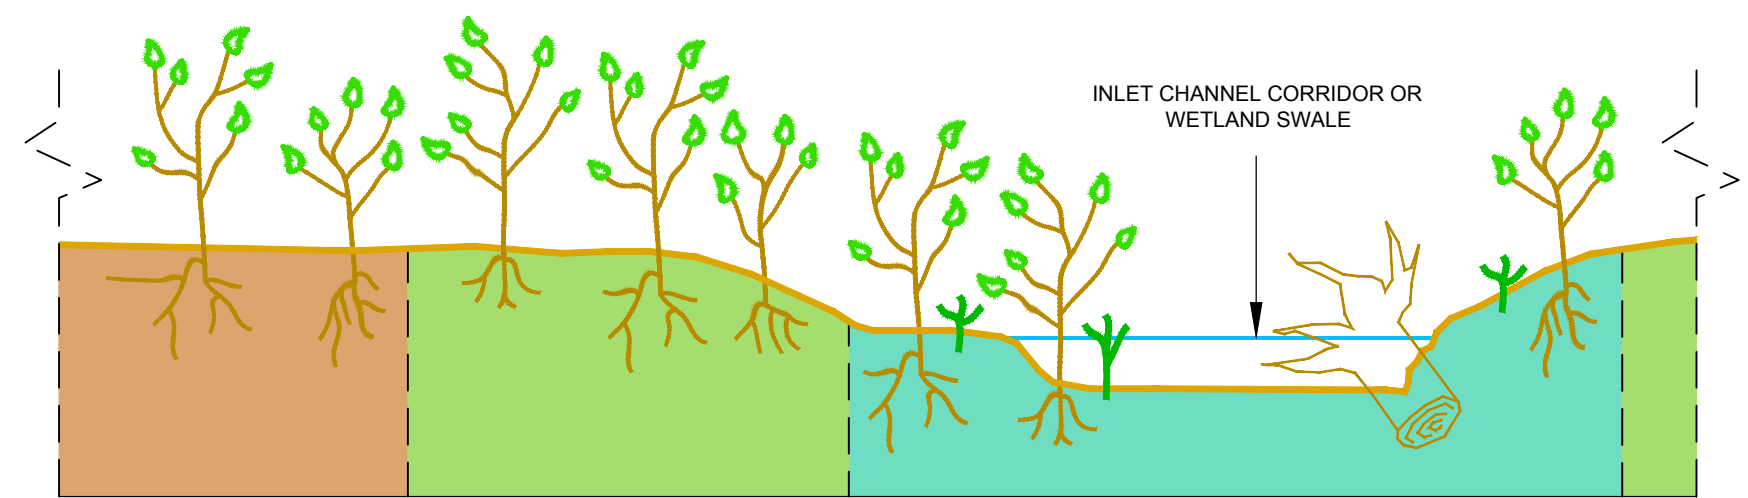
MAYFLOWER PIPELINE INCIDENT RESPONSE EXXONMOBIL ENVIRONMENTAL SERVICES COMPANY COVE PLANTING PLAN	
INLET CHANNEL RESTORATION PLAN	
	FIGURE 12

- NOTES:
1. SELECTED SHRUB AND TREE SEEDLING SPECIES BASED ON OBSERVATIONS OF HIGH VALUE FORESTED WETLAND SYSTEMS ASSOCIATED WITH UNDISTURBED PORTIONS OF LAKE CONWAY CONDUCTED DURING THE SEPTEMBER 2014 WETLAND ASSESSMENT. SPECIES AND THE LOCATION THAT THEY WERE OBSERVED CAN BE FOUND IN TABLE 1.

2. NATIVE SEED MIXES WILL BE APPLIED THROUGHOUT THE RIPARIAN AREA IN ADDITION TO THE PLANTED TREES AND SHRUBS. THE SPECIES INCLUDED IN THE SEED MIXES ARE LISTED IN TABLE 2. RIPARIAN SEED MIX (NC PIEDMONT RIPARIAN MIX, ERNMX-307) WILL BE APPLIED TO THE INLET CHANNEL BANKS AND ADJACENT FLOODPLAIN. WET MEADOW AND WETLAND SEED MIX (NC PIEDMONT FACW MIX, ERNMX-308) WILL BE APPLIED TO PORTIONS OF THE INLET CHANNEL CORRIDOR EXHIBITING APPROPRIATE HYDROLOGIC CONDITIONS.

5. SHRUB AND TREE SEEDLING SPECIES WILL BE PLANTED AS AVAILABLE.
  6. LOCATIONS OF THE FEATURES SHOWN HAVE BEEN APPROXIMATED. ACTUAL PLANT PLACEMENT WILL BE SELECTED BY AN ECOLOGIST IN THE FIELD.

7. ROOT WADS WILL BE PLACED THROUGHOUT THE CORRIDOR TO PROVIDE WILDLIFE HABITAT AND ARMOR INLET CHANNEL BANKS.

CROSS SECTION VIEW

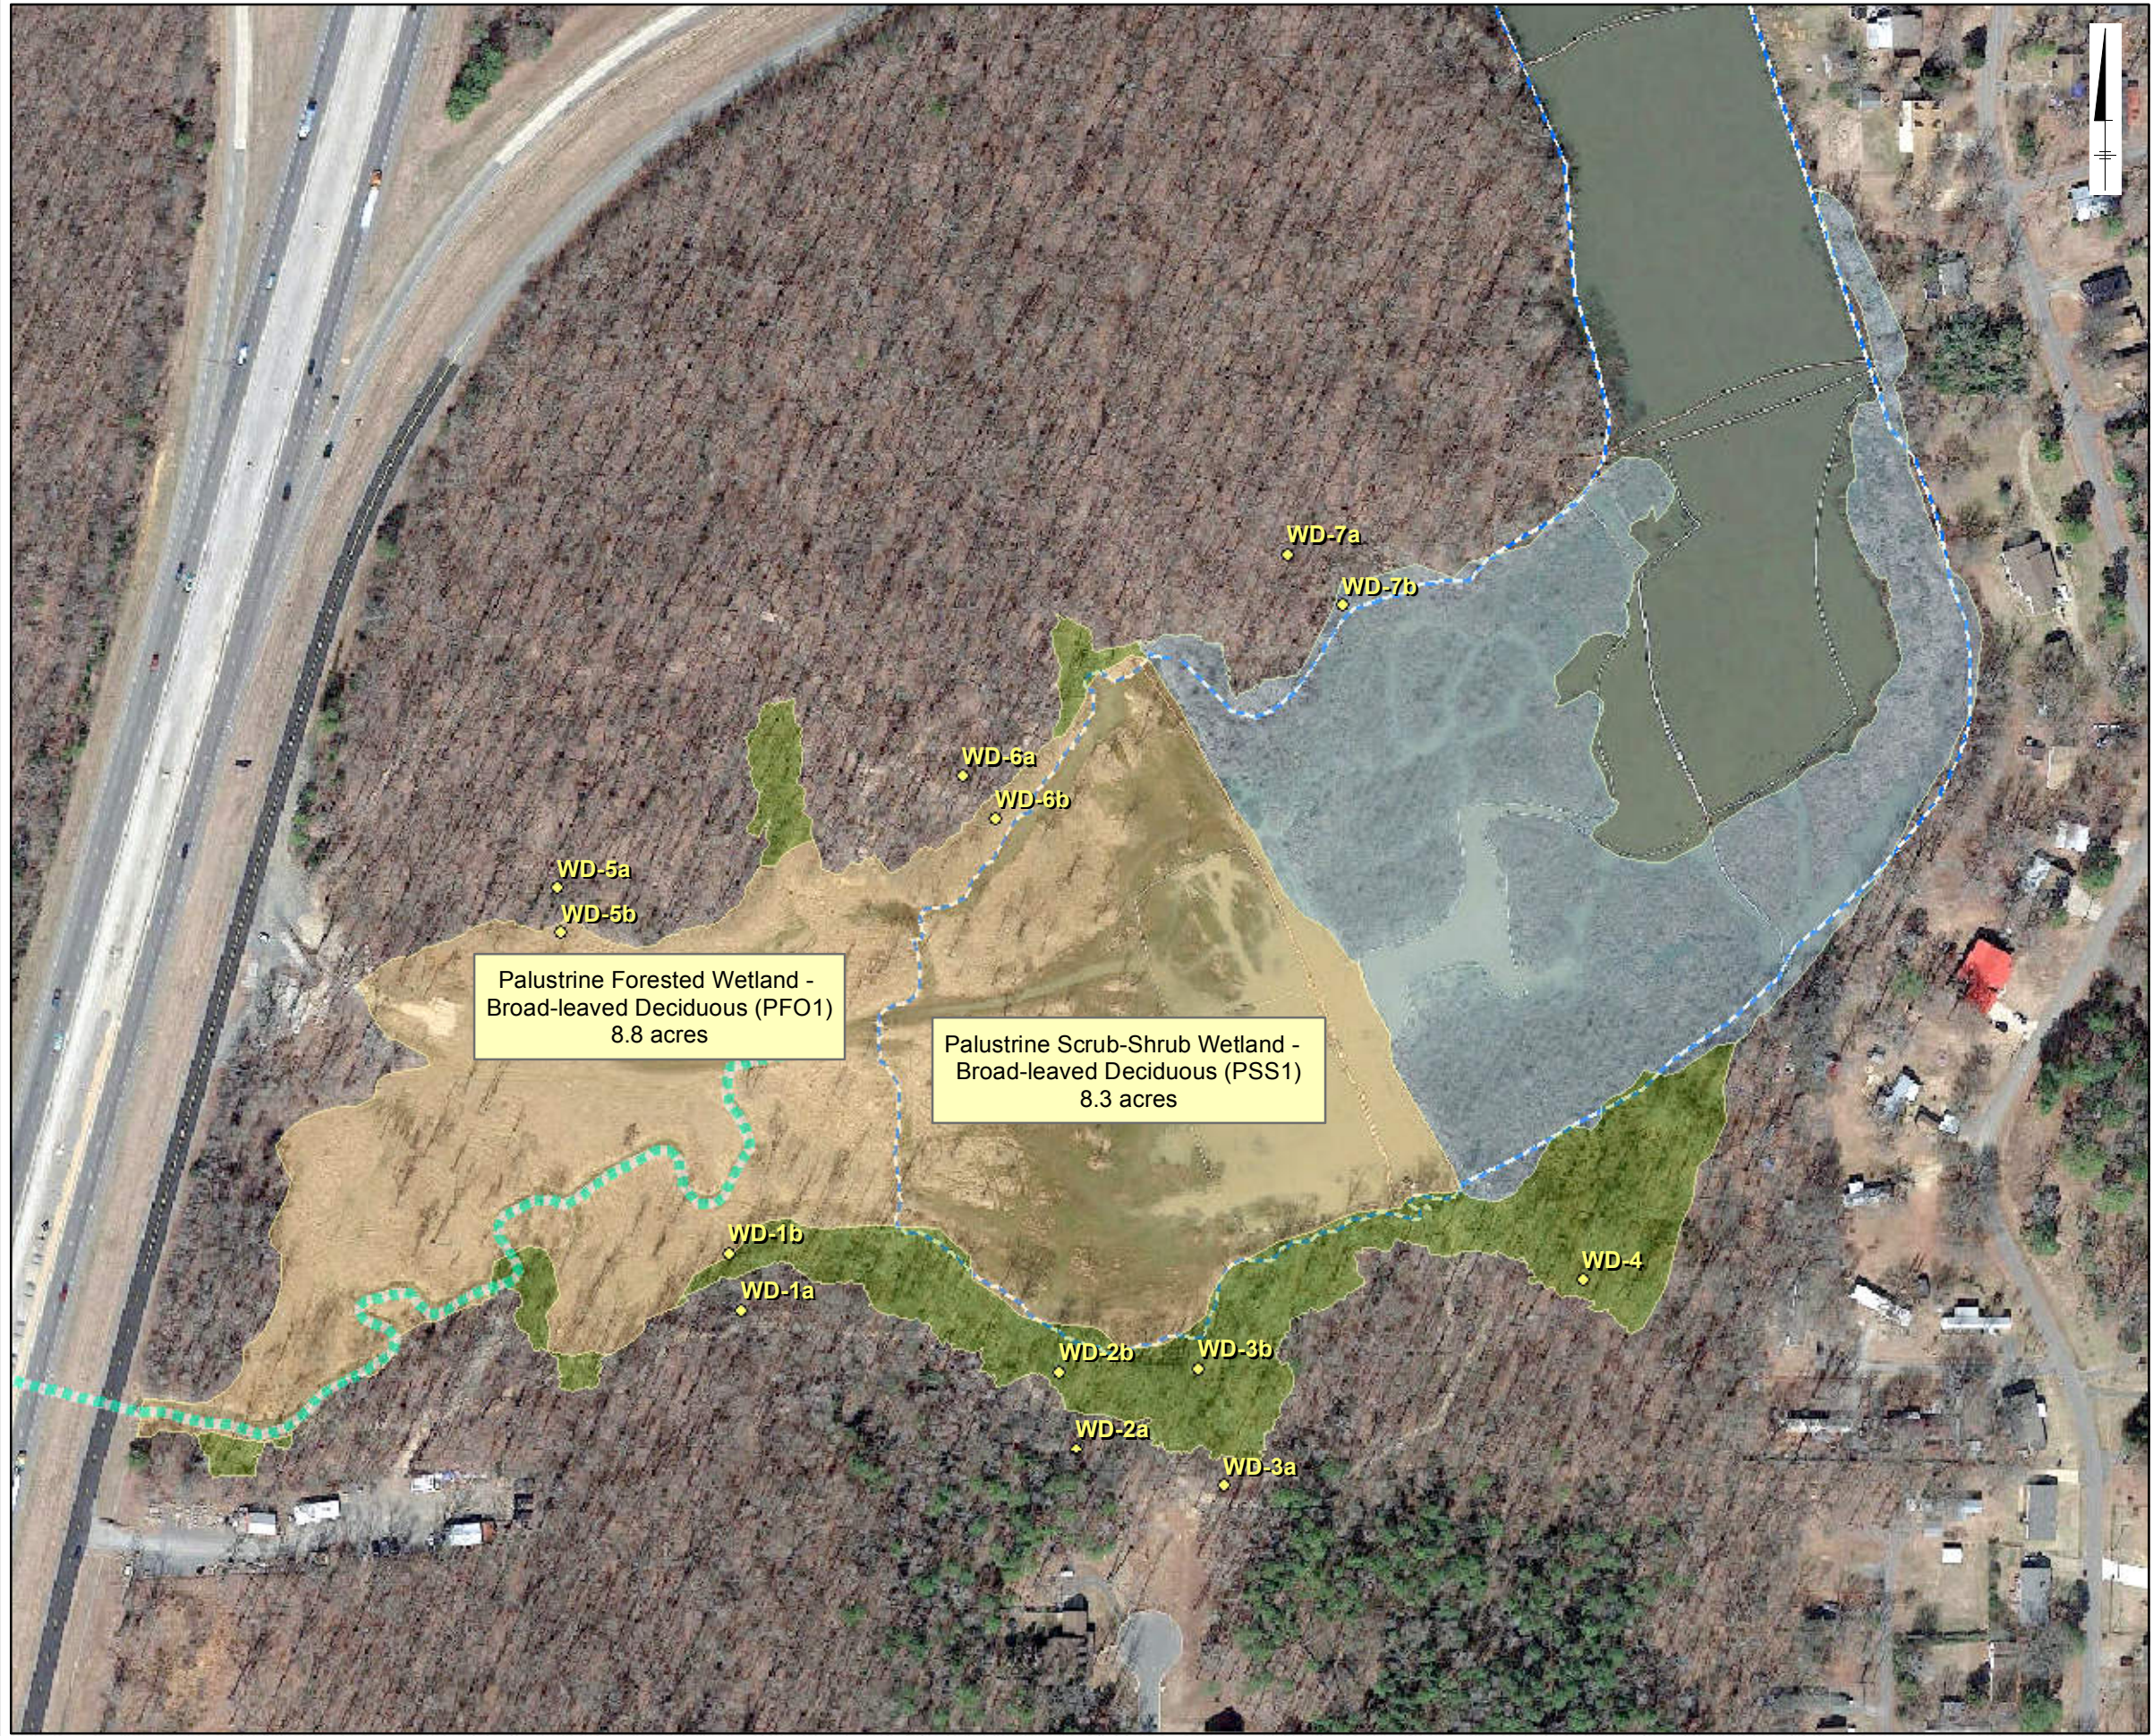
- Wetland Delineation Points
- Drainage Path
- Approximate Waters Edge
- Existing Forested Wetlands (4.4 acres)
- Existing Vegetated Wetlands (10.3 acres)
- Disturbed Wetlands (17.1 acres)

Notes:  
1. Conastoga-Rovers & Associates conducted a wetland delineation in April 2014 using the methodology outlined in the 1987 USACE Wetland Delineation Manual, including the Atlantic and Gulf Coast Regional Supplement, and Regulatory Guidance Letter 08-02.  
2. The vegetated area shown in this plan was digitized based on the February 2014 aerial photo that was acquired via Google Enterprise Geo Master License  
3. The water's edge changes based on season and recent rainfall. The approximate water's edge is based on conditions during the pre-design study in April 2014.  
4. Vegetation was not cleared from the areas labeled "Existing Forested Wetland" and "Existing Vegetated".

The wetlands delineation classified the 17.1 acres of disturbed wetlands as 8.8 acres as Palustrine Forested Wetland – Broad-leaved Deciduous (PFO1) and 8.3 acres as Palustrine Scrub-Shrub Wetland – Broad-leaved Deciduous (PSS1). A summary figure is provided Appendix B.

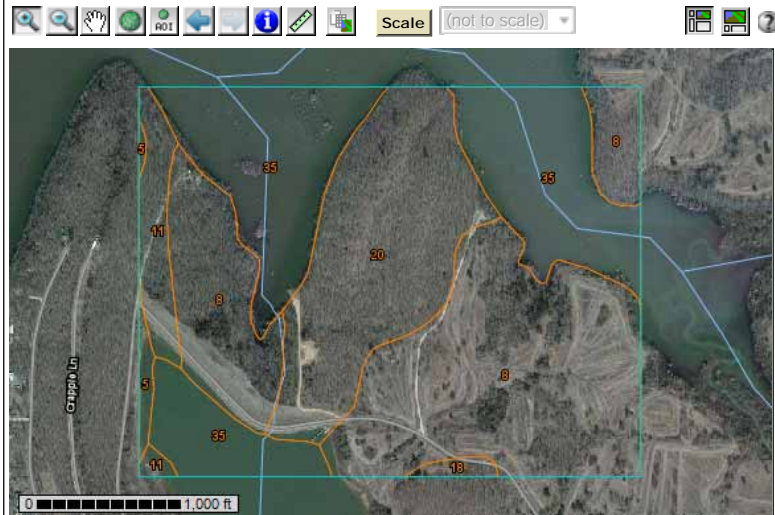
**Warning: Soil Map may not be valid at this scale.**

You have zoomed in beyond the scale at which the soil map for this area is intended to be used. Mapping of soils is done at a particular scale. The soil surveys that comprise your AOI were mapped at 1:20,000. The design of map units and the level of detail shown in the resulting soil map are dependent on that map scale.
