# Mayflower Pipeline Incident Response

## Post-Construction Sheen Monitoring Monthly Report #1: April 2015

Mayflower, Arkansas

**Period:** 04/06/2015 through 04/30/2015

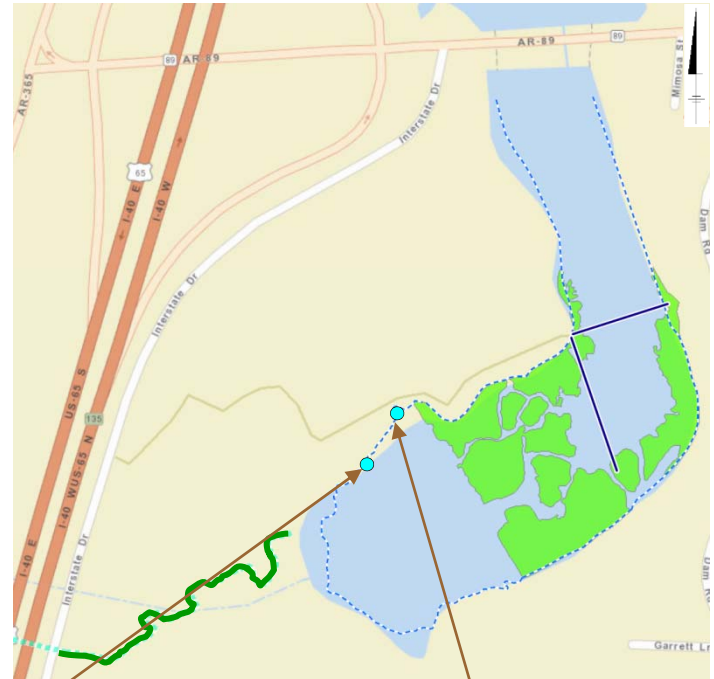
**Cove (Summary of Observations from April 2015)**

- Two brittle sheens observed, one silver gray and one rainbow/silver gray, in Open Water Area.
- No sheen observed in Heavily Vegetated Area.
- No sheen observed downstream of Heavily Vegetated Area.

Mitigation: None needed

Path Forward for May 2015: Continue biweekly sheen monitoring in cove.
