Appendix B

Bench-Scale Test Results

**Bench-scale Test
Mayflower Pipeline Incident Response, Mayflower, Arkansas**

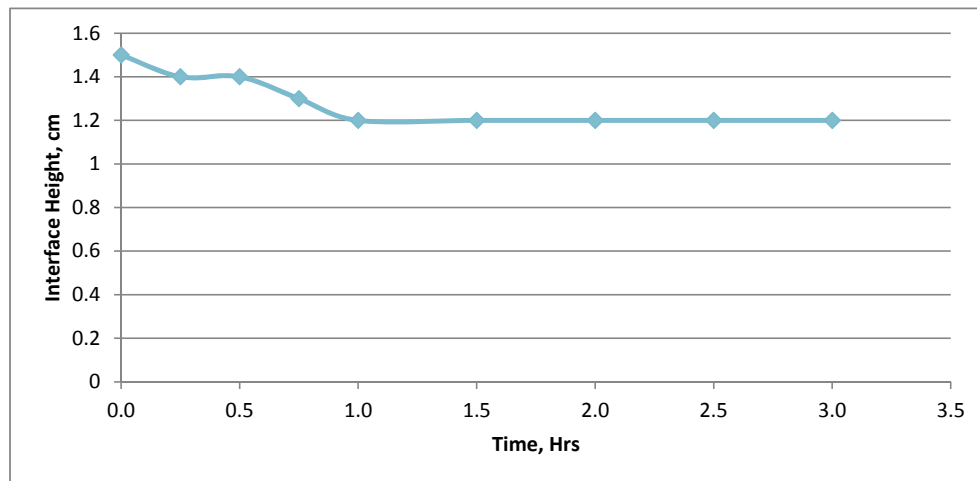
Test Material: **PM-199** Tested By: Ricky Sams
 Test Start Date: 4/21/2014 Checked By: Dave Liles

Date	Time	Elapsed Time, min	Elapsed Time, hrs	Water/Solids Interface Height, (cm)	Comments
4/21/2014	12:00 PM	0	0.00	1.5	Media added over the course of 7 minutes
4/21/2014	12:15 PM	15	0.25	1.4	~80% of media settled
4/21/2014	12:30 PM	30	0.50	1.4	
4/21/2014	12:45 PM	45	0.75	1.3	Still settling slowly
4/21/2014	1:00 PM	60	1.00	1.2	~10% of media remains on surface; still settling slowly
4/21/2014	1:30 PM	90	1.50	1.2	Media still slowly settling; small air bubbles are causing residual floating particles
4/21/2014	2:00 PM	120	2.00	1.2	Media still slowly settling; small air bubbles are causing residual floating particles
4/21/2014	2:30 PM	150	2.50	1.2	
4/21/2014	3:00 PM	180	3.00	1.2	Small amount of residual floating particles caused by small air bubbles; solution agitated to allow for even settling

Comparing the two types of organoclay products, PM-199 and PMFI, results show that PMFI settles at a slightly faster rate (0.01 centimeters per minute [cm/min]) than PM-199 (0.005 cm/min). Upon adding PMFI to the potable water in the graduated cylinder, approximately 90% of the material settled to the bottom in 15 minutes. Within 35 to 40 minutes of application, PMFI finished settling, although residual material continued to float for the remainder of the test (up to 180 minutes after initial application). Upon adding PM-199 to the potable water in the graduated cylinder, approximately 80% of the material settled to the bottom in 15 minutes. PM-199 slowly settled for up to 120 minutes after application, although a majority (90%) of material settled after 60 minutes of initial application. Residual floating material persisted through the duration of the test (up to 180 minutes after initial application).

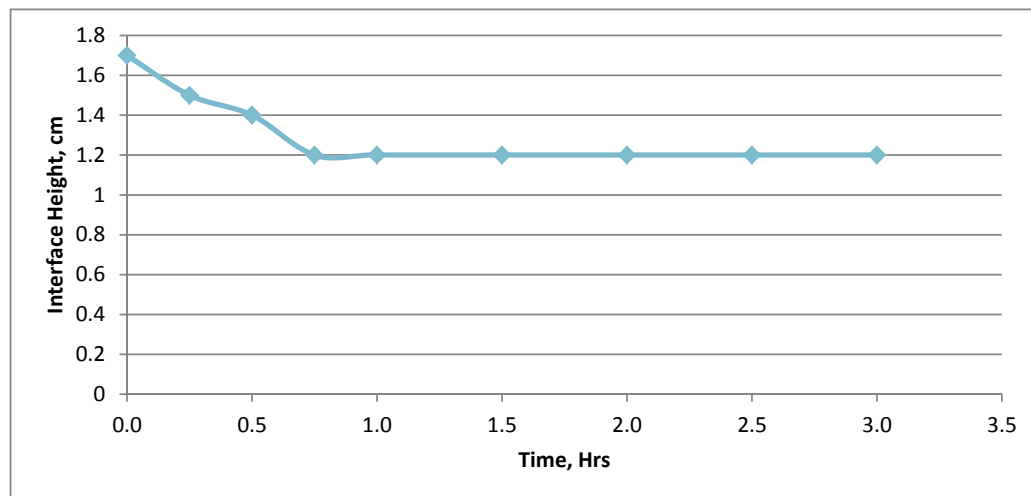
Test Material: **PMFI** Tested By: Ricky Sams
 Test Start Date: 4/21/2014 Checked By: Dave Liles

Date	Time	Elapsed Time, min	Elapsed Time, hrs	Water/Solids Interface Height, (cm)	Comments
4/21/2014	12:00 PM	0	0.00	1.7	Media added over the course of 7 minutes
4/21/2014	12:15 PM	15	0.25	1.5	~90% of media has settled to bottom
4/21/2014	12:30 PM	30	0.50	1.4	
4/21/2014	12:45 PM	45	0.75	1.2	Media finished settling at 35 to 40 minutes
4/21/2014	1:00 PM	60	1.00	1.2	Residual floating media on surface, done settling
4/21/2014	1:30 PM	90	1.50	1.2	Residual floating particles; media done settling
4/21/2014	2:00 PM	120	2.00	1.2	Floating, white "fuzzy" looking particles appear
4/21/2014	2:30 PM	150	2.50	1.2	
4/21/2014	3:00 PM	180	3.00	1.2	Residual floating material; solution agitated to allow for even settling

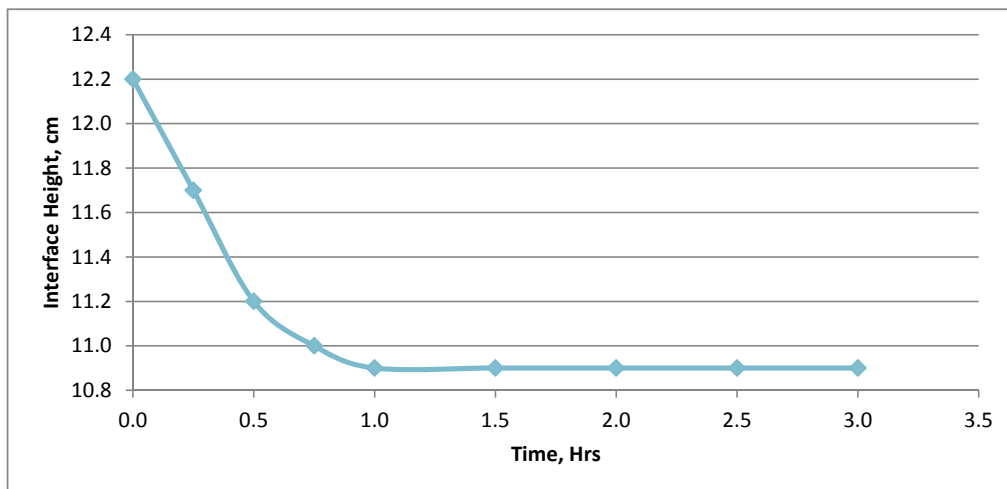
Test Material: **90% Sand / 10% PM-199** Tested By: Ricky Sams
 Test Start Date: 4/22/2014 Checked By: Dave Liles

Date	Time	Elapsed Time, min	Elapsed Time, hrs	Water/Solids Interface Height, (cm)	Comments
4/22/2014	3:05 PM	0	0.00	12.2	Media settled immediately; foaming on surface caused residual floating particles
4/22/2014	3:20 PM	15	0.25	11.7	Fines still settling out
4/22/2014	3:35 PM	30	0.50	11.2	Distinct layer of fines on surface of Sand/Organoclay mixture
4/22/2014	3:50 PM	45	0.75	11.0	Fines still settling; foaming on surface has not changed; turbidity decreasing
4/22/2014	4:05 PM	60	1.00	10.9	Foaming on surface has not changed; turbidity decreasing
4/22/2014	4:35 PM	90	1.50	10.9	Foaming still persists
4/22/2014	5:05 PM	120	2.00	10.9	Foaming still persists
4/22/2014	5:35 PM	150	2.50	10.9	
4/22/2014	6:05 PM	180	3.00	10.9

For both organoclay-sand mixtures, material immediately settled to the bottom of the graduated cylinder upon initial application; however, foaming on the surface caused residual floating particles, which took longer to settle. For 45 to 60 minutes after initial application, the fine particles in both mixtures continued to settle, creating a distinct layer of fines on the surface of the organoclay-sand mixture. During this time, turbidity slowly decreased, although foaming persisted at the surface. For the PM-199-sand mixture, a majority of material finished settling after 60 minutes following initial application, whereas a majority of the PMFI-sand mixture finished settling after 120 minutes.

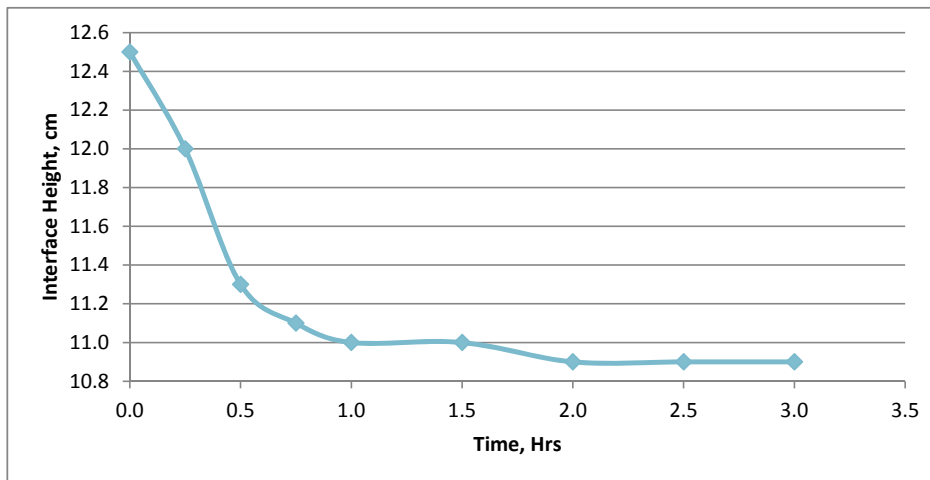
Test Material: **90% Sand - 10% PMFI** Tested By: Ricky Sams
 Test Start Date: 4/22/2014 Checked By: Dave Liles

Date	Time	Elapsed Time, min	Elapsed Time, hrs	Water/Solids Interface Height, (cm)	Comments
4/22/2014	3:05 PM	0	0.00	12.5	Media settled rapidly; residual floating particles due to excessive foaming
4/22/2014	3:20 PM	15	0.25	12.0	Foaming persists; fine particles still settling; fines beginning to make distinct layer on bottom
4/22/2014	3:35 PM	30	0.50	11.3	Foaming persists; fines still settling
4/22/2014	3:50 PM	45	0.75	11.1	Fines still settling; turbidity decreasing
4/22/2014	4:05 PM	60	1.00	11.0	Turbidity decreasing; foaming still persists
4/22/2014	4:35 PM	90	1.50	11.0	Foaming still persists on surface
4/22/2014	5:05 PM	120	2.00	10.9	Foaming still persists on surface
4/22/2014	5:35 PM	150	2.50	10.9	Foaming still persists on surface
4/22/2014	6:05 PM	180	3.00	10.9	Foaming still persists on surface

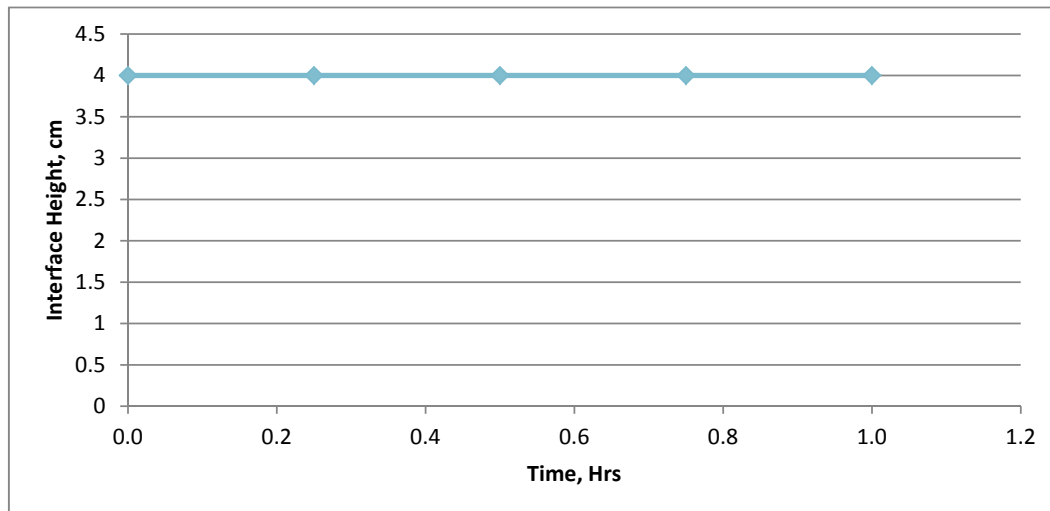
Test Material: **AquaGate**
Test Start Date: 4/22/2014

Date	Time	Elapsed Time, min	Elapsed Time, hrs	Water/Solids Interface Height, cm	Comments
4/22/2014	1:20 PM	0	0.00	4	Media settled immediately; residual floating material on surface
4/22/2014	1:35 PM	15	0.25	4	No change
4/22/2014	1:50 PM	30	0.50	4	No change
4/22/2014	2:05 PM	45	0.75	4	No change
4/22/2014	2:20 PM	60	1.00	4	No change

1. Test stopped after 1 hour because media settled immediately.

During the AquaGate settling test, the material settled immediately after application with some residual floating material on the surface. Settling conditions remained unchanged for the remainder of the test (up to 180 minutes after initial application).

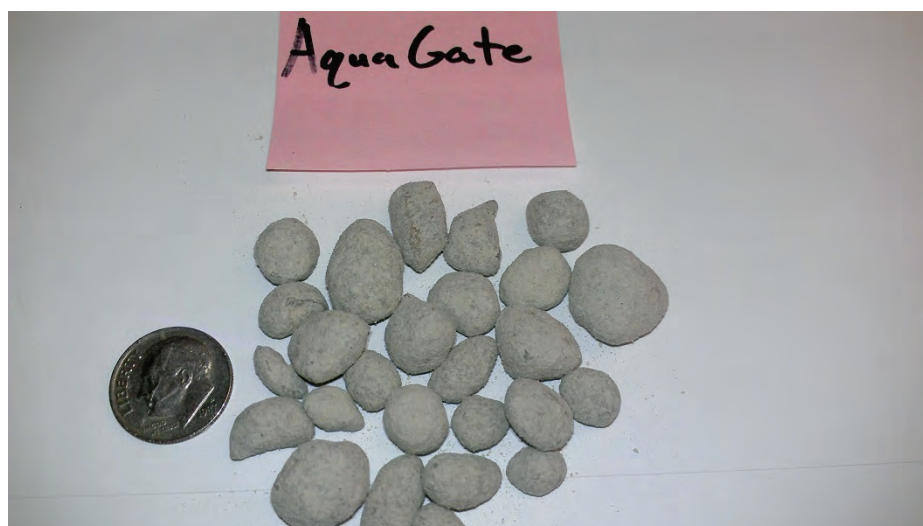
Photograph 3
AquaGate

Organoclay Product Materials

The main objective of the Reactive Media Bench-Scale Settling Test is to evaluate the settling rate and characteristics of organoclay products (PM-199, PMFI, and AquaGate) and organoclay-sand mixtures (90% Sand – 10% PM-199 and 90% Sand – 10% PMFI). Data collected during each settling test are presented in Test Data Sheets and photolog.

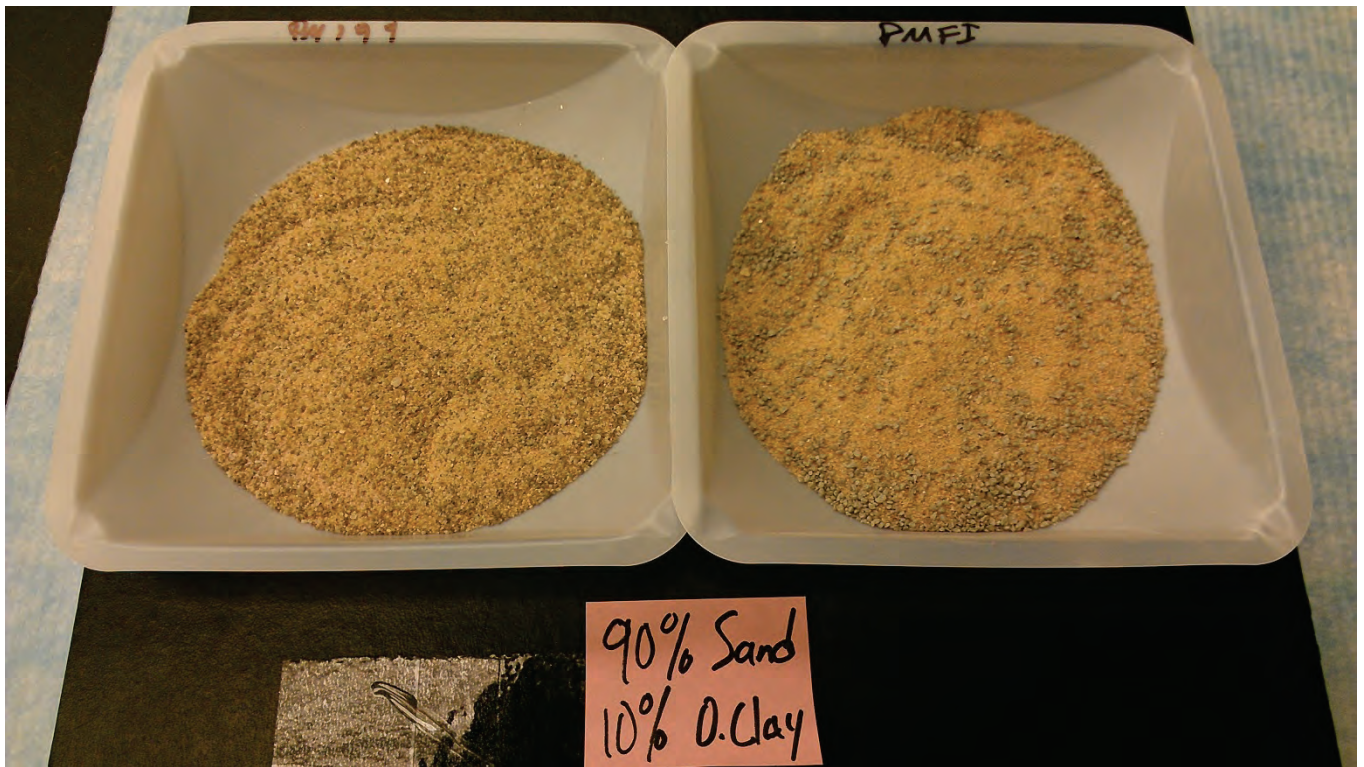
Photograph 4

Left: 90% Sand mixed with 10% PM-199 (Organoclay); Right: 90% Sand mixed with 10% PMFI (Organoclay)

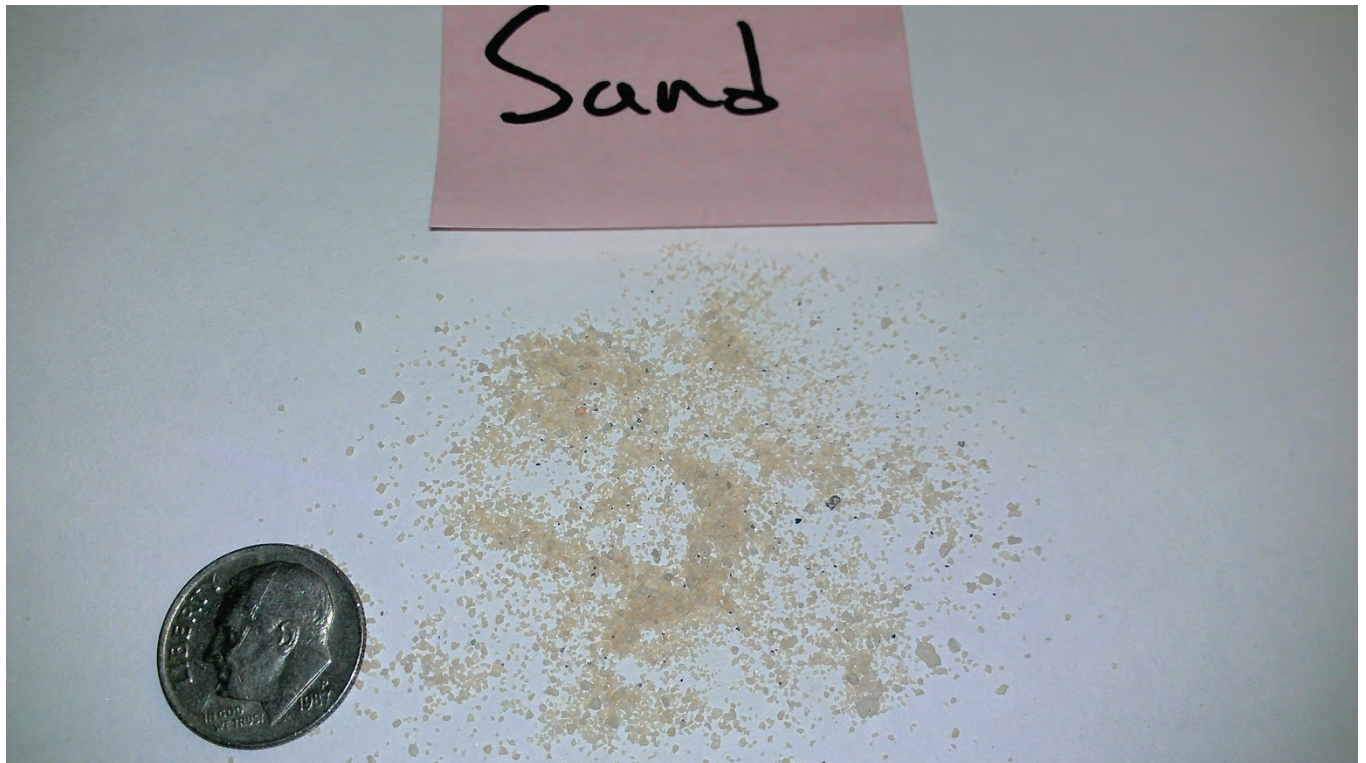
Photograph 5

Sand

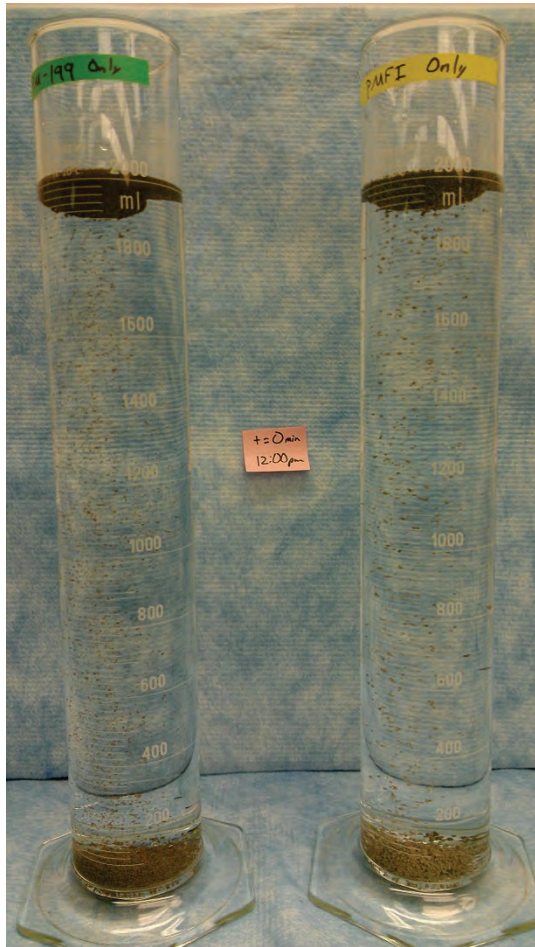
Photograph 6

Elapsed Time: 0 minutes

PM-199 Thickness (left): 1.5 cm

PMFI Thickness (right): 1.7 cm

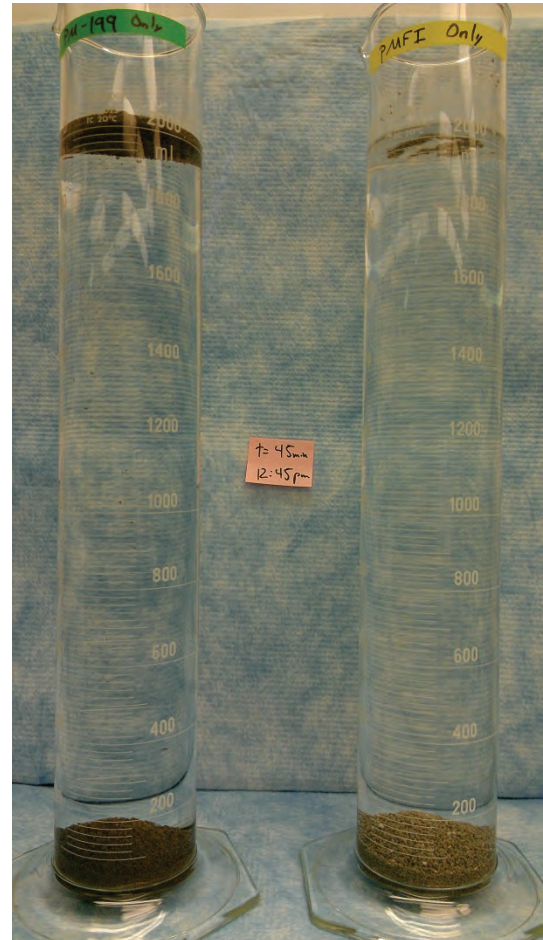
Photograph 7

Elapsed Time: 45 minutes

PM-199 Thickness (left): 1.3 cm

PMFI Thickness (right): 1.2 cm

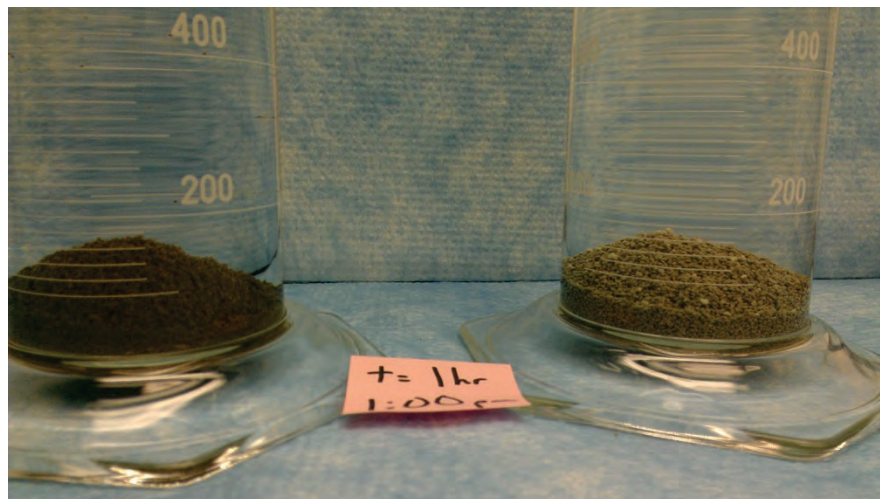
Photograph 8

Elapsed Time: 60 minutes

PM-199 Thickness (left): 1.2 cm

PMFI Thickness (right): 1.2 cm

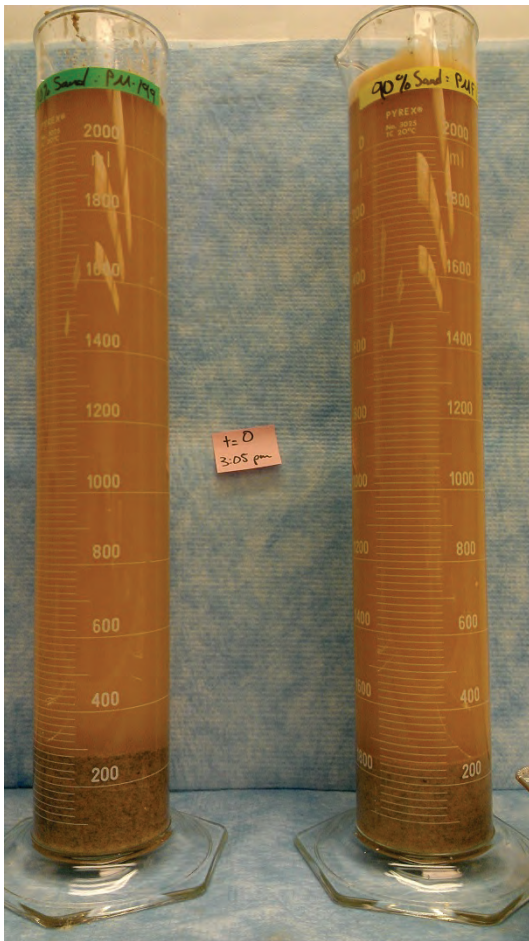
Photograph 9

Elapsed Time: 0 minutes

90% Sand – 10% PM-199 Thickness (left): 12.2 cm

90% Sand – 10% PMFI Thickness (right): 12.5 cm

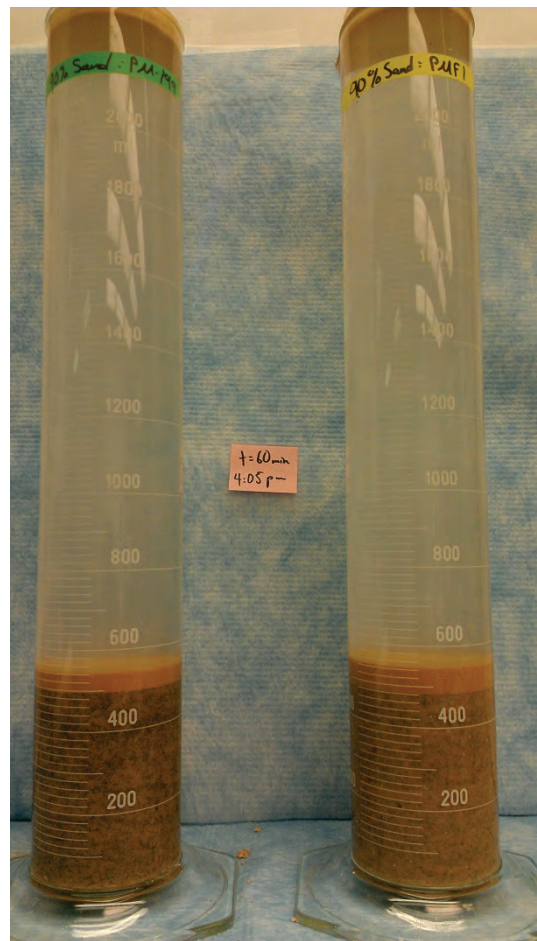
Photograph 10

Elapsed Time: 60 minutes

90% Sand – 10% PM-199 Thickness (left): 10.9 cm

90% Sand – 10% PMFI Thickness (right): 11.0 cm

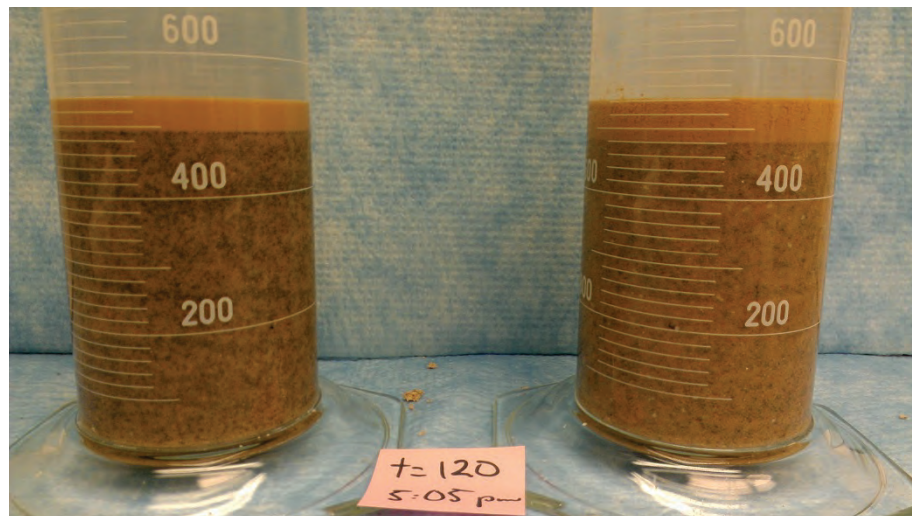
Photograph 11

Elapsed Time: 120 minutes

90% Sand – 10% PM-199 Thickness (left): 10.9 cm

90% Sand – 10% PMFI Thickness (right): 10.9 cm

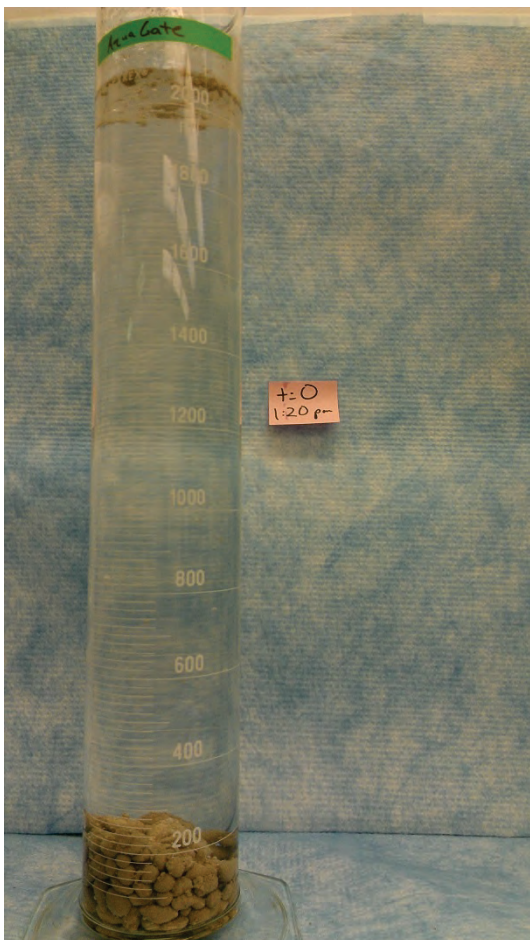
Photograph 12

Elapsed Time: 0 minutes

AquaGate Thickness: 4 cm

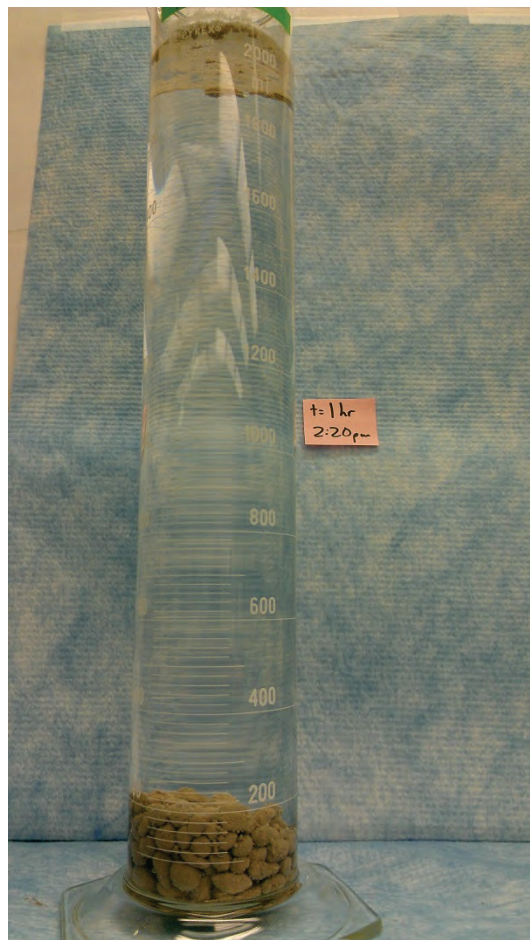
Photograph 13

Elapsed Time: 60 minutes

AquaGate Thickness: 4 cm

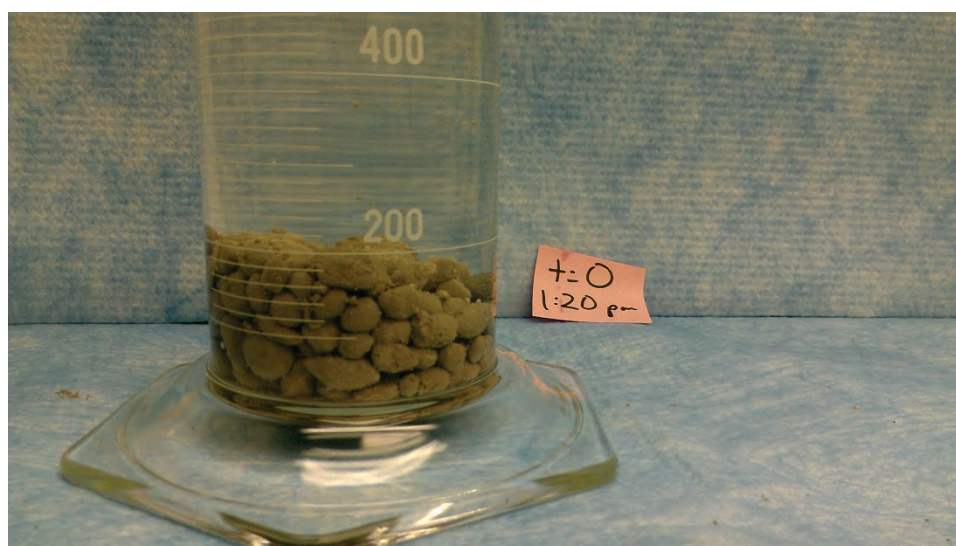
Photograph 14

Elapsed Time: 0 minutes

AquaGate Thickness: 4 cm

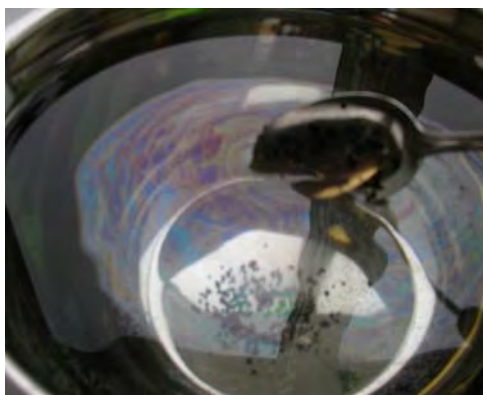
15. If no sheen is observed, using latex- or nitrile-gloved hands, transfer the material into hand. Break the mixed OC/water/NAPL material apart at the surface of the water in the stainless steel bowl.
16. Note if NAPL or sheen is present on the surface of the water. Photograph water surface. Record qualitative observations of sheen using the same "Description" terms used in the field (as summarized in the table below from National Oceanic and Atmospheric Administration 2007).

Code	Description	Layer-Thickness Interval	
		microns (μm)	inches (in.)
S	Sheen (silver/gray)	0.04 - 0.30	1.6×10^{-6} – 1.2×10^{-5}
R	Rainbow	0.30 – 5.0	1.2×10^{-5} - 2.0×10^{-4}
M	Metallic	5.0 – 50	2.0×10^{-4} – 2.0×10^{-3}
T	Transitional Dark (or True) Color	50 – 200	2.0×10^{-3} – 8×10^{-3}
D	Dark (or True) Color	>200	> 8×10^{-3}

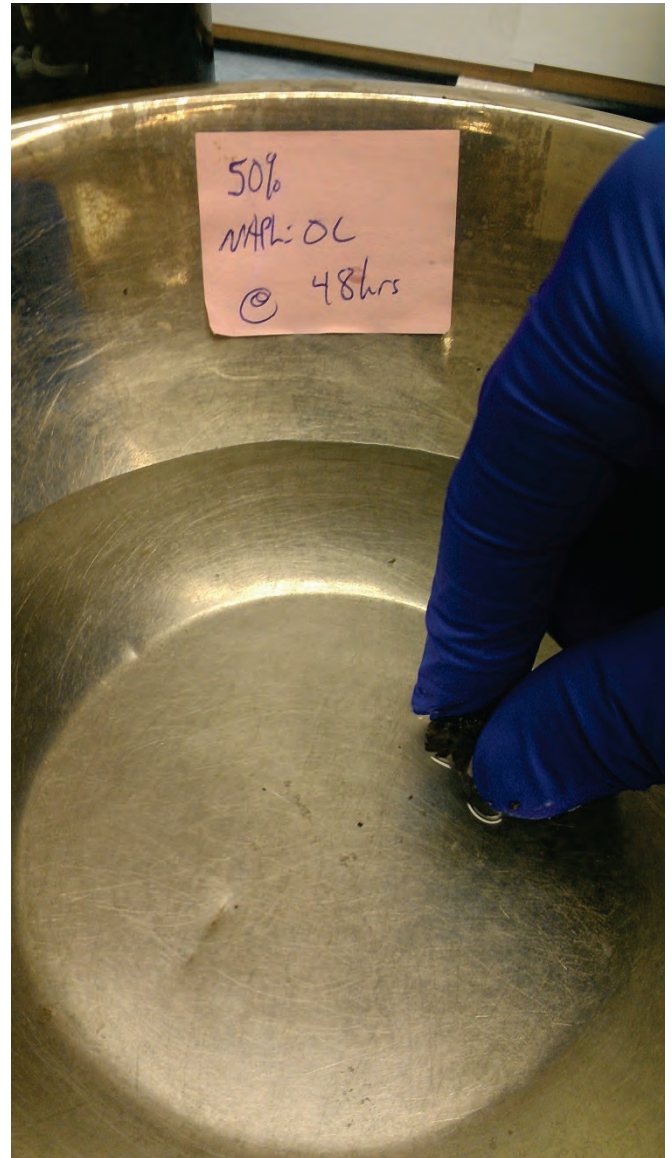
Photograph 2

Elapsed Time: 48 hours

Surface Water Sheen Observed?

- Hand Dipped – No
- Broken Up By Hand - No

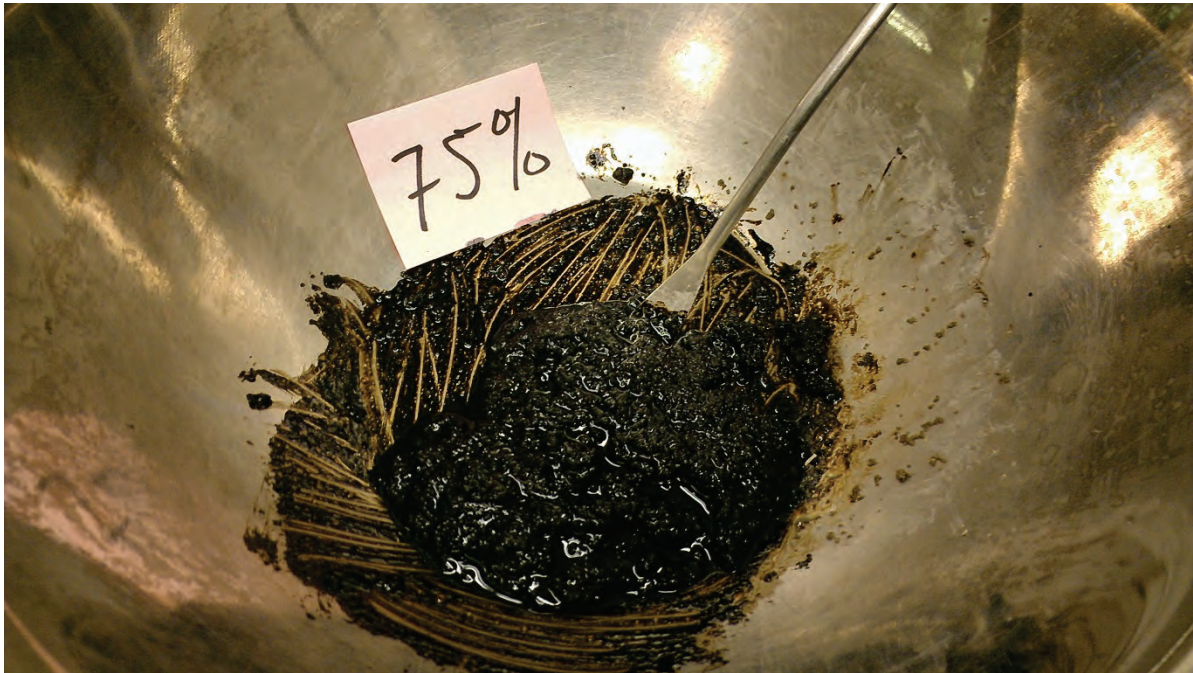
Photograph 5

Elapsed Time: 0 minutes

Homogenized Sample Composition:

- 20 g OC
- 15 g NAPL
- 10.89 ml water

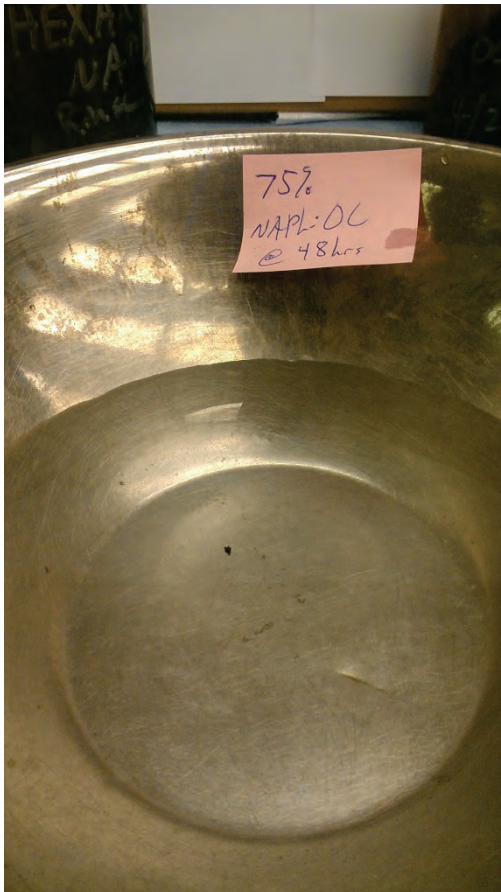
Photograph 6

Elapsed Time: 48 hours

Surface Water Sheen Observed?

- Hand Dipped – No
- Broken Up By Hand - No

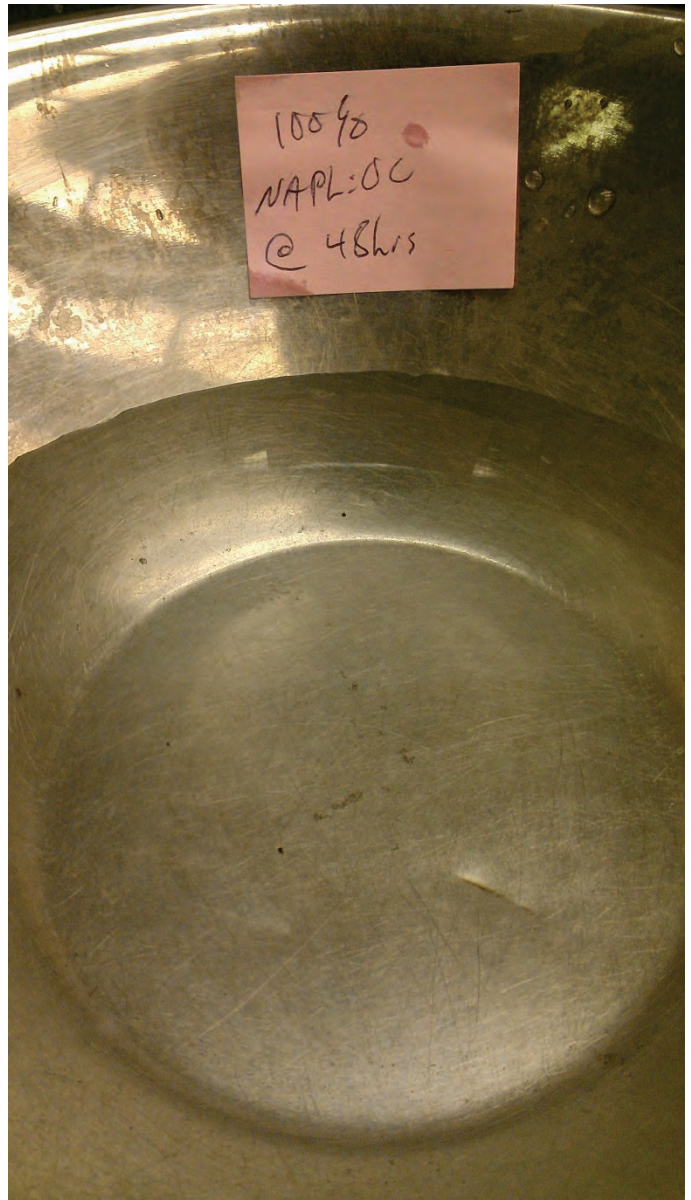
Photograph 8

Elapsed Time: 48 hours

Surface Water Sheen Observed?

- Hand Dipped – No
- Broken Up By Hand - No

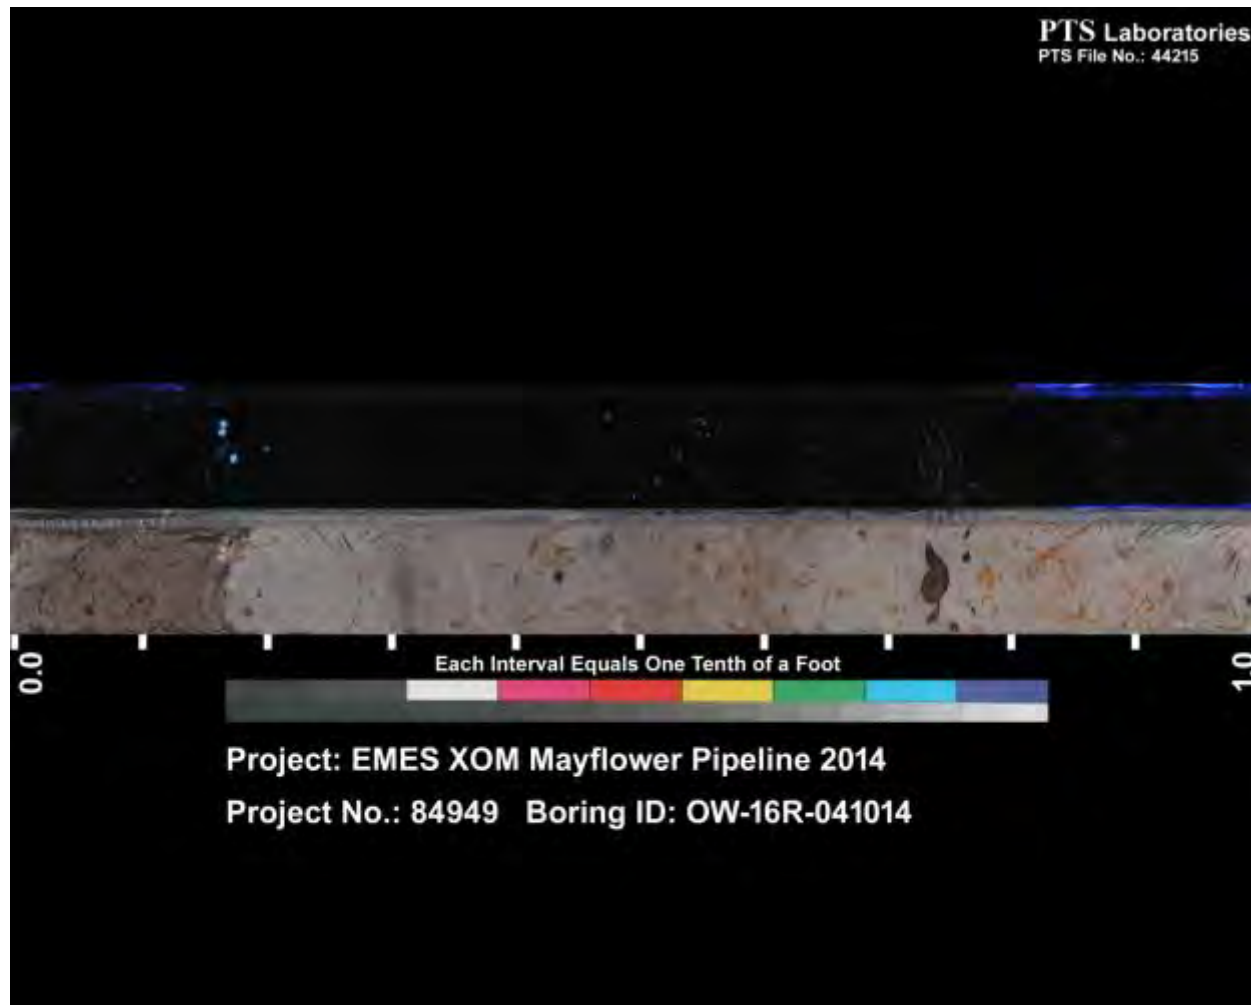
FIGURE 1

Boring ID: OW-16R-041014	
Sampling Depth (inches)	Qualitative Sheening Amount
0 - 6	Medium Sheen
6 - 12	Lighter Sheen

PTS indicated based on their evaluation of the cores that there was little or no physical evidence of hydrocarbon saturation presence based on the following observations: 1) UV fluorescence appears to be from mineral or organic material, 2) no presence of hydrocarbon odor, only organic odor, 3) no visual presence of hydrocarbon or NAPL, 4) the core material consists of very fine grained sediments and/or organic material which may yield false-positive oil (NAPL) saturation results. PTS core photography and laboratory report are enclosed as Attachments.

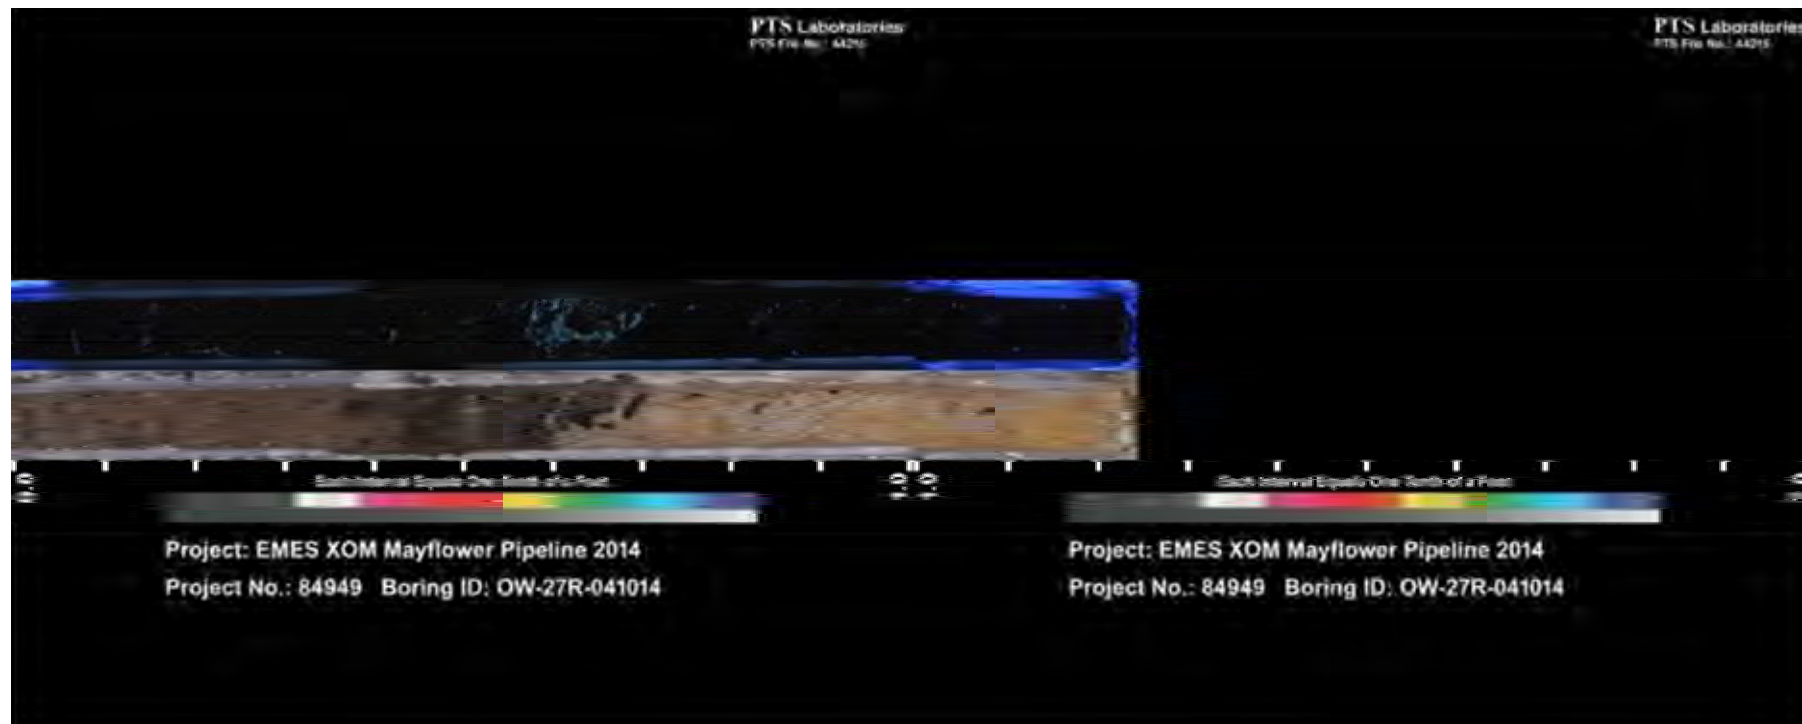
FIGURE
2

Boring ID: OW-27R-041014	
Sampling Depth (inches)	Qualitative Sheening Amount
0 - 6	Heavier Sheen
6 – 12 *	Lighter Sheen
