COMPLAINT REPORT

5225 Planters Road, Fort Smith- back side of the facility at Outfall 001

Arkansas Department of Environmental Quality (ADEQ)
Official Photograph Sheet

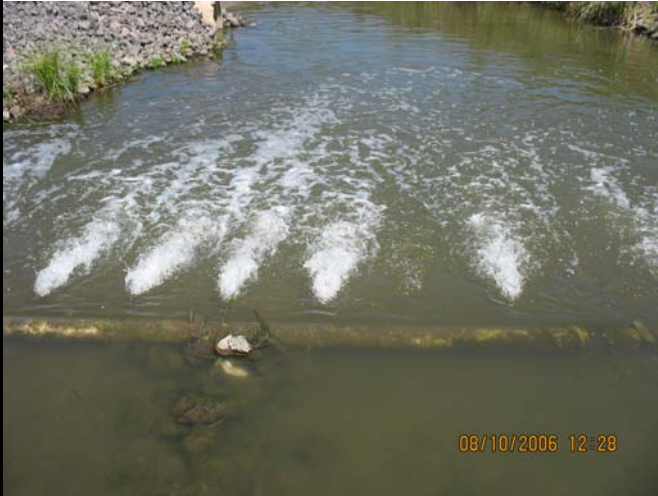
Location:		Quanex- MacSteel-5225 Planters Road in Fort Smith							
Photographer:		Jeff Tyler				Witness:		N/A	
Photo #	1	Of	10			Date:	08-10-06	Time:	1228
Description:		This is the 6" pipe that is located approximately 600' upstream from outfall 001, water mixed with sulfuric acid is re-introduced to the waste stream at 430 gallons per minute in this location to help control the pH value.

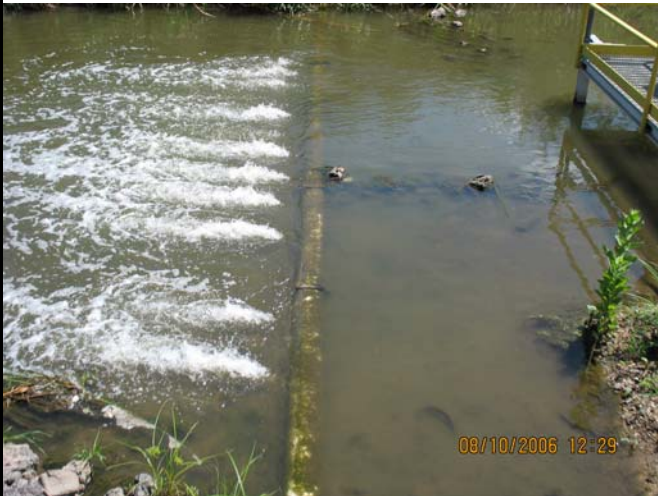
Photographer:		Jeff Tyler				Witness:		N/A	
Photo #	2	Of	10			Date:	08-10-06	Time:	1229
Description:		Pipe located approximately 600' upstream from outfall 001 where water mixed with sulfuric acid is re-introduced to the waste stream at 430 gallons per minute. Same pipe as above photo.

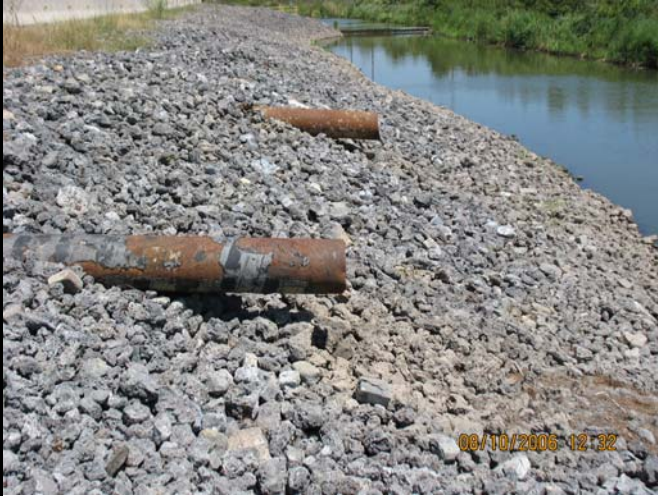
Location:	Quanex-Mac Steel-5225 Planters Road in Fort Smith						
Photographer:	Jeff Tyler				Witness:	N/A	
Photo #	3	Of	10		Date:	08-10-06	Time: 1232
Description:	Two pipes which discharge storm water from underneath the truck scales at the facility.

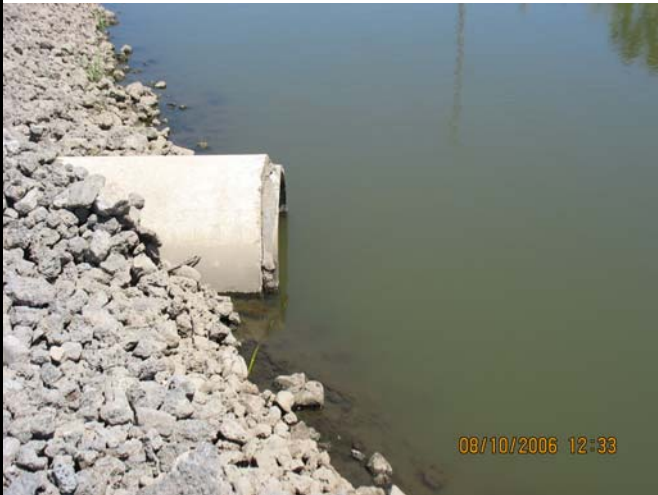
Photographer:	Jeff Tyler				Witness:	N/A	
Photo #	4	Of	10		Date:	08-10-06	Time: 1233
Description:	Concrete pipe which discharges storm water from roof top guttering system at the facility.

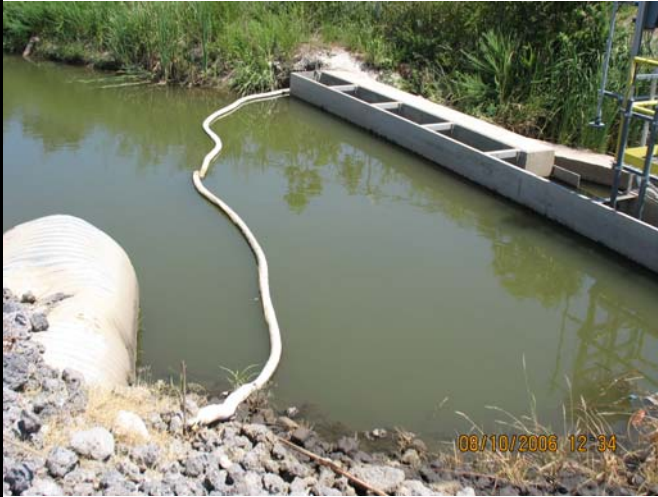
Location:	Quanex-MacSteel, 5225 Planters Road in Fort Smith						
Photographer:	Jeff Tyler				Witness:	N/A	
Photo #	5	Of	10		Date:	08-10-06	Time: 1234
Description:	A concrete pipe which discharges storm water from the south side of the property, also an absorbent barrier utilized to help control any pollutants in the waste stream above the outfall.

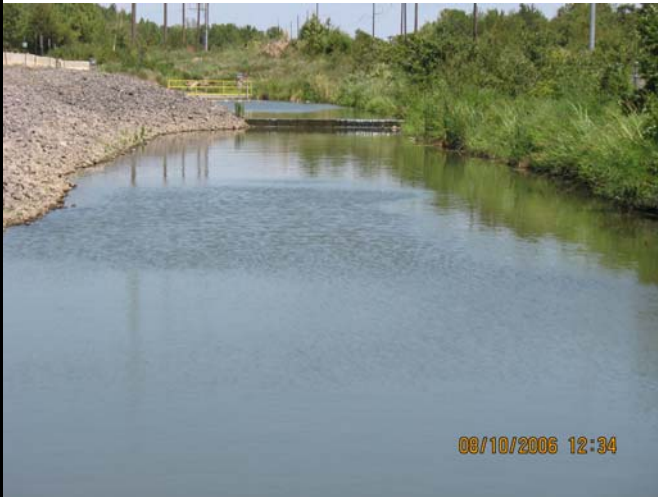
Inspection conducted on 08-10-06, I met with Warren Taff, Environmental Engineer, and discussed the complaint. Inspection revealed that the area at outfall 001 was free of excessive trash; photos were taken to confirm these findings. I took a sample at the outfall and it revealed that the pH was 7.11s.u. at 32°C. Mr. Taff confirmed that all processed wastewater discharges to the Ft. Smith public sewer. See inspection and photos from 08-10-06 for details.

Photographer:	Jeff Tyler				Witness:	N/A	
Photo #	6	Of	10		Date:	08-10-06	Time: 1234
Description:	General view of the storm water ditch taken from the outfall location, free of any trash or other debris.

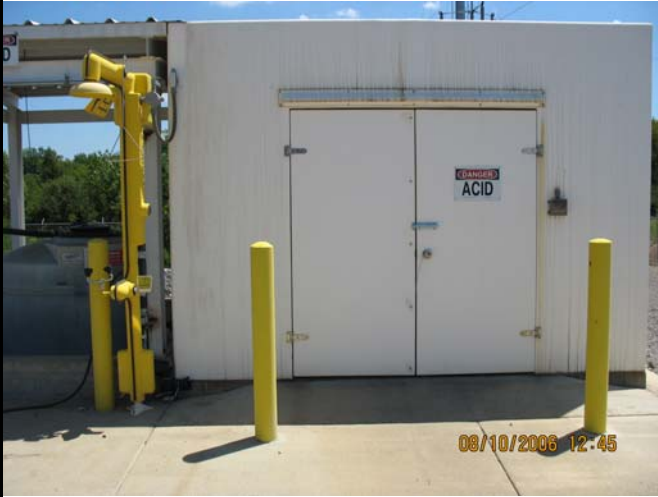
Location:		Quanex-MacSteel-5225 Planters Road in Fort Smith							
Photographer:		Jeff Tyler				Witness:		N/A	
Photo #	7	Of	10			Date:	08-10-06	Time:	1245
Description:		Building which contains the sulfuric acid and equipment which the facility maintains to control the pH of the discharge.

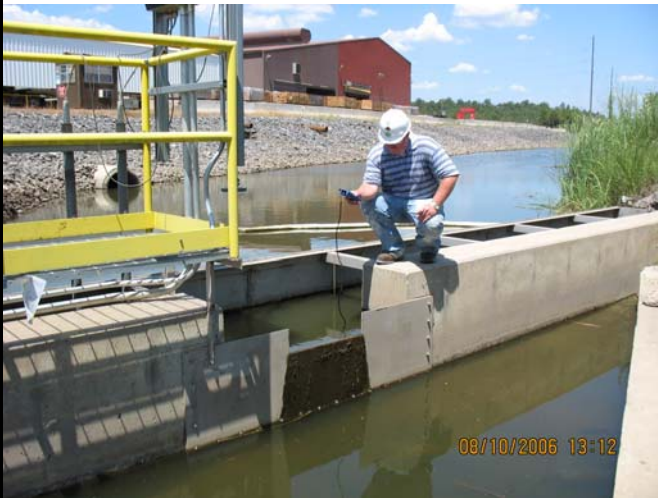
Photographer:		Warren Taff				Witness:			
Photo #	8	Of	10			Date:	08-10-06	Time:	1312
Description:		Field Inspector, Jeff Tyler monitoring the pH at outfall 001.

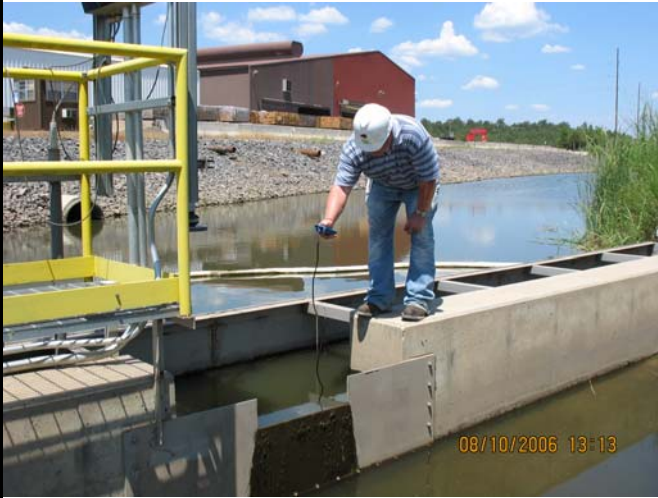
Location:		Quanex-MacSteel-5225 Planters Road in Fort Smith							
Photographer:		Warren Taff				Witness:		N/A	
Photo #	9	Of	10			Date:	08-10-06	Time:	1313
Description:		Field Inspector Jeff Tyler monitoring pH at outfall 001.
