RE: Complaint Investigation of XTO Energy's Ballew #1-22H Reserve Pit in

Pangburn, AR (Cleburne Co.); reserve pit discharge from Nov 2011 &

improper reserve pit closure

Water Division Photographic Evidence Sheet										
<b>Location:</b>	Bal	Ballew #1-22H from Hwy 16 off Price Ford Rd about 6.6 miles WxSW of Pangburn, AR								
Photographer:		Kerri McCabe			Witness:		Lance B.			
Photo #	1	Of	4		Date:	(	04-03-12	Time:	1134	
<b>Description:</b> Site Identification

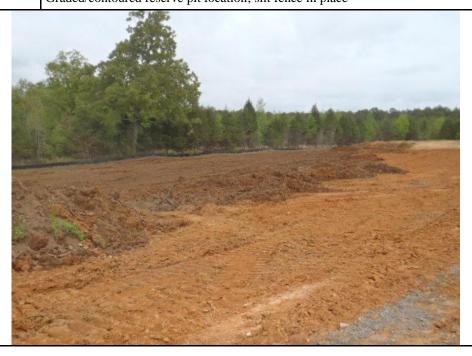
I arrived onsite later in the day & the pit was still being graded/contoured. I spoke with Mr. Lance B. while onsite. He informed me that the liner was being taken to Rolling Meadows Landfill in Hazen, AR. He said that JM Oilfield Services had hauled the reserve pit contents (location unknown at this time). Silt fence was installed around the former reserve pit area. Ms. Brooke Shaw with XTO Energy informed me that the reserve pit contained shallow groundwater & stormwater. XTO Energy did not use the reserve pit during a Frac Flowback Reuse program. Also, I inspected the lease road (separate report). I did not investigate the original route because that activity occurred on private property & I could not see any indication of the activity from the production pad or pipeline ROW.

Photographer:	Kerri McCabe			Witness:		Lance B.			
Photo #	2	Of	4		Date:		04-03-12	Time:	1143
<b>Description:</b> Graded/contoured reserve pit location: silt fence in place

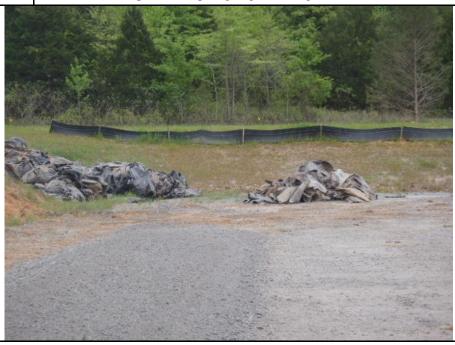
Water Division Photographic Evidence Sheet										
Location:	Bal	Ballew #1-22H from Hwy 16 off Price Ford Rd about 6.6 miles WxSW of Pangburn, AR								
Photographer:	•	Kerri McCabe			Witness:		Lance B.			
Photo #	3	Of	Of 4			<b>Date:</b> 04-03-12 <b>Time:</b> 1143			1143	
<b>Description:</b> Removed liner on production pad; going to Rolling Meadows Landfill (Hazen, AR)							ı, AR)

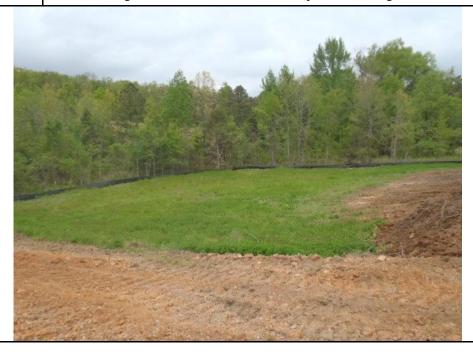
Photographer:		Keri	ri McCab	e	Witness: Lance B.				
Photo #	4	Of	4		Date:	04-03-12		Time:	1144
<b>Description:</b>		Silt fence along intermittent stream near reserve pit location; vegetation establishing							lishing
