## WATER DIVISION COMPLAINT REPORT

COMPLAINANT NAME: <b>Donald P. Norman</b>	COMPLAINT AGAINST: <b>City of Mountain View</b>
RESPONSE REQUESTED BY COMPLAINANT: <b>Yes</b>	SITE ADDRESS: <b>South-side of Oak St.</b>
MAILING ADDRESS: <b>903 Oak St.</b>	MAILING ADDRESS: <b>P.O. Box 360</b>
CITY, STATE, ZIP: <b>Mountain View, AR</b>	CITY, STATE, ZIP: <b>Mountain View AR 72560</b>
PHONE & EXT: <b>870-615-9097</b> FAX:	PHONE & EXT: <b>870-269-3293</b> FAX:
EMAIL:	EMAIL:

**Water Division Photographic Evidence Sheet**

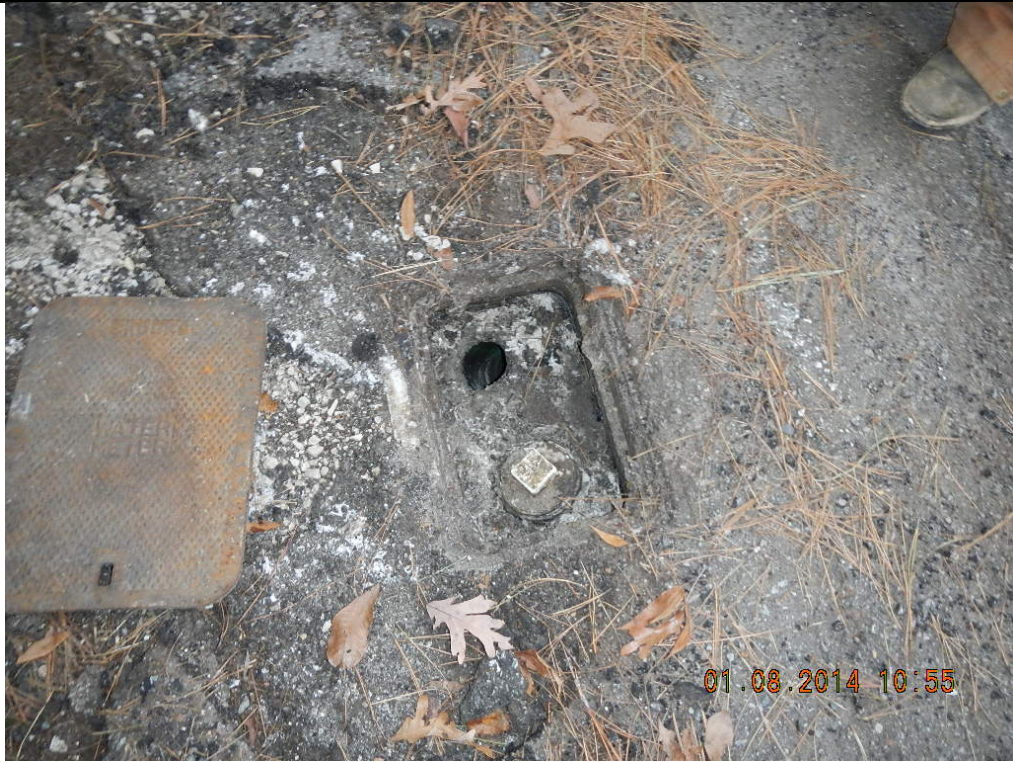
Location:	<b>City of Mountain View;</b>		
Photographer:	<b>Sean Saunders</b>	Date:	<b>1/8/2014</b>
Witness:	<b>Richard Gonzales</b>	Time:	<b>10:55</b>
		Photo #:	<b>1</b>
Description:	<b>Two sewer line cleanouts. The one missing the cap is the one that overflowed. The box is full of sediment and sewer debris.</b>

**On January 8, 2014, I spoke with J.R. Henderson the Water and Sewer Superintendent. He stated that his office had received the complaint on 1/2/2014 and that he had a work order showing that it had been fixed on 1/3/2014. I then went to the location of the overflow. The overflow occurred at a sewer line cleanout; and at the time of the inspection, an overflow was not occurring. The cap to the clean out was missing and the area around the clean out had not been sanitized. A letter will be sent.**

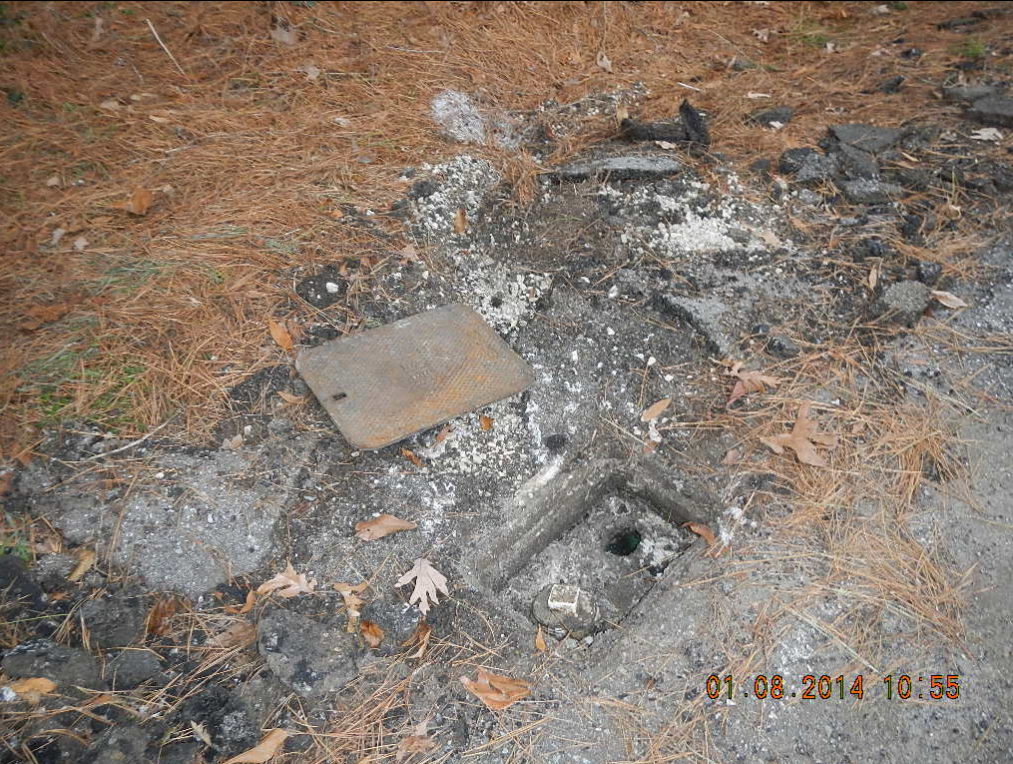
Photographer:	<b>Sean Saunders</b>	Date:	<b>1/8/2014</b>
Witness:	<b>Richard Gonzales</b>	Time:	<b>10:55</b>
		Photo #:	<b>2</b>
Description:	<b>The cleanouts and where the overflow ran into the ditch.</b>
