## Memo

Re: March 18, 2017 fish kill in Whitewater Creek in Mountain View, AR

Water Division Fish Kill Photographic Evidence Sheet

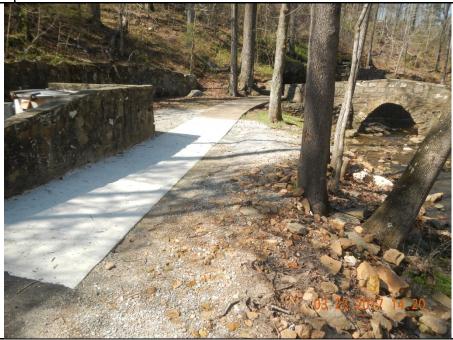
Photo # 1 Of 4 Date: 3/23/2017 Time: 1420

Description: Lift station on the left and Whitewater Creek on the right.

On March 23, 2017, ADEQ Inspector Skyler Schlick investigated the fish kill. There were no dead fish observed in a 300 foot section of Whitewater Creek. The water was fairly clear and no visual abnormalities were noted in the water. There was a lift station within approximately 25 feet of Whitewater Creek. There was toilet paper that was observed on the concrete pad of the lift station. Additionally, there appeared to be an erosive path on the bank of Whitewater Creek where the sanitary sewer overflow (SSO) entered the creek. The City of Mountain View was contacted view phone on March 24, 2017. Debbie Walker confirmed that there was a SSO of approximately 3,000 gallons at this location.

The reported fish kill was likely caused by the SSO that reached Whitewater Creek.

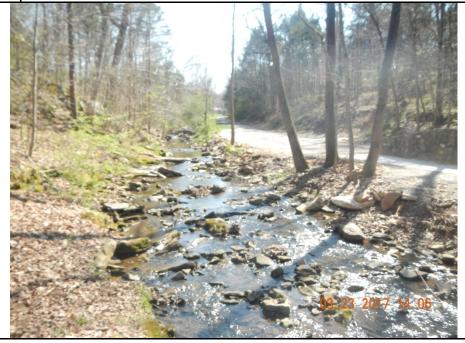
Photo #
2
Of
4
Date:
3/23/2017
Time:
1406

**Description:** Whitewater Creek.
