ARKANSAS  
Department of Environmental Quality

RE: AFIN: 61-00055

NPDES Permit No.: AR0034835

**Arkansas Department of Environmental Quality (ADEQ)  
Official Photograph Sheet**

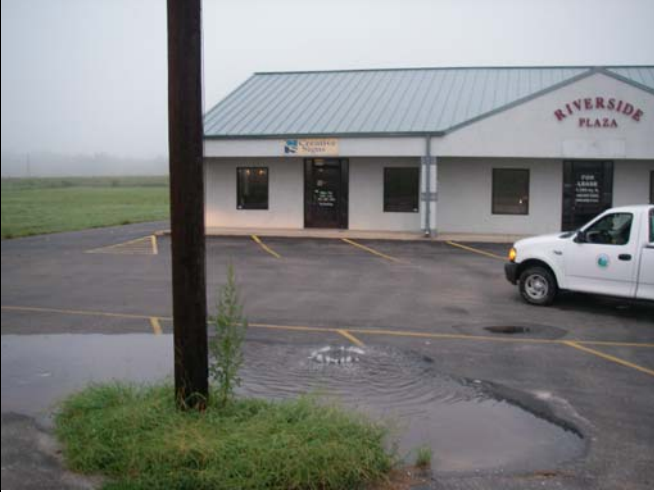
- 1. On the morning of August 28, a manhole was observed overflowing on Old County Rd. in front of Riverside Plaza. Local law enforcement officials had observed the overflow on the night of August 27. This violates Part II Section B:1.a. of the permit requiring proper operation and maintenance. This is also considered an unpermitted discharge.**
- 2. The overflow was not reported on the Tabular SSO (Sanitary Sewer Overflow) Report accompanying the August 2006 DMR. This violates Part III Item 6 of the permit.**

<b>Location:</b>		Riverside Plaza, Old County Rd., Pocahontas							
<b>Photographer:</b>		Brent Walker			<b>Witness:</b>		None		
<b>Photo #</b>	1	<b>Of</b>	4			<b>Date:</b>	08/28/2006	<b>Time:</b>	0630
<b>Description:</b>		Overflowing manhole

The above items require your immediate attention. Please submit a written response to these findings to the NPDES Enforcement Section of this Department. This response should contain documentation describing the course of action taken to correct the items noted. This corrective action should be completed as soon as possible, and the written response is due by October 27, 2006.

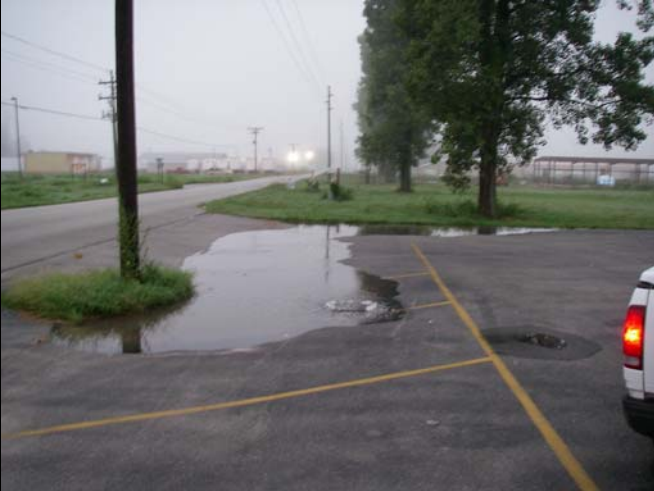
<b>Photographer:</b>		Brent Walker			<b>Witness:</b>		None		
<b>Photo #</b>	2	<b>Of</b>	4			<b>Date:</b>	08/28/2006	<b>Time:</b>	0631
<b>Description:</b>		Overflowing manhole

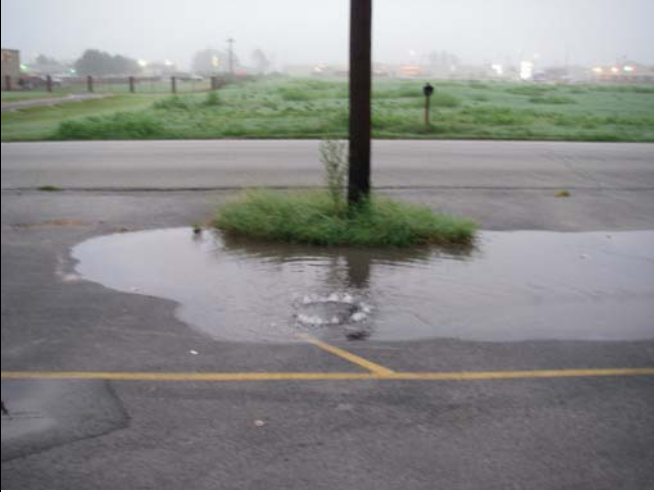
<b>Location:</b>		Riverside Plaza, Old County Rd., Pocahontas						
<b>Photographer:</b>		Brent Walker			<b>Witness:</b>		None	
<b>Photo #</b>	3	<b>Of</b>	4	<b>Date:</b>		08/28/2006	<b>Time:</b>	0631
<b>Description:</b>		Overflowing manhole
