# NPDES Compliance Inspection Report

Name and Location of Facility Inspected ( <i>For industrial users discharging to POTW, also include POTW name and NPDES permit number</i> ) <b>City of Pocahontas WWTP ~1 mile south of Black River Bridge off Old County Rd. Pocahontas, AR Randolph County</b>	Entry Time/Date <b>0750 3/9/2007</b>	Permit Effective Date <b>February 1, 2004</b>
	Exit Time/Date <b>0810 3/9/2007</b>	Permit Expiration Date <b>January 31, 2009</b>
Name(s) of On-Site Representative(s)/Title(s)/Phone and Fax Number(s) <b>None</b>	Other Facility Data	
Name, Address of Responsible Official/Title/Phone and Fax Number <b>William Daniel/Manager/870-892-3222 Pocahontas Water and Sewer Systems 207 Hwy 67 South Pocahontas, AR 72455</b>	Contacted Yes <input type="checkbox"/> No <input checked="" type="checkbox"/>

This reconnaissance inspection was conducted as a follow-up to monitor the status of stopping the overflow from lagoon 1 and bringing the water level in lagoons 1 & 2 back down to normal operating levels.

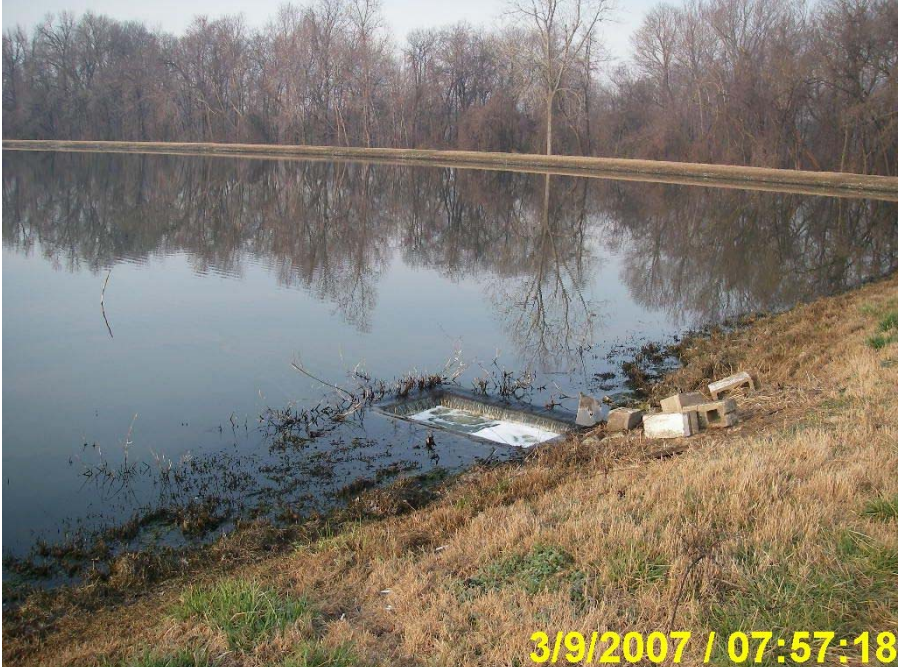
The water level in lagoon 2 was approximately 2 inches above the top of the outlet structure which is still several inches above the designed operating level.

<b>Location:</b>	Pocahontas WWTP						
<b>Photographer:</b>	Brent Walker			<b>Witness:</b>	None		
<b>Photo #</b>	1	<b>Of</b>	4	<b>Date:</b>	03/09/2007	<b>Time:</b>	0757
<b>Description:</b>	Outfall box for Lagoon #2 with grating removed to allow unobstructed discharge into lagoon #3.

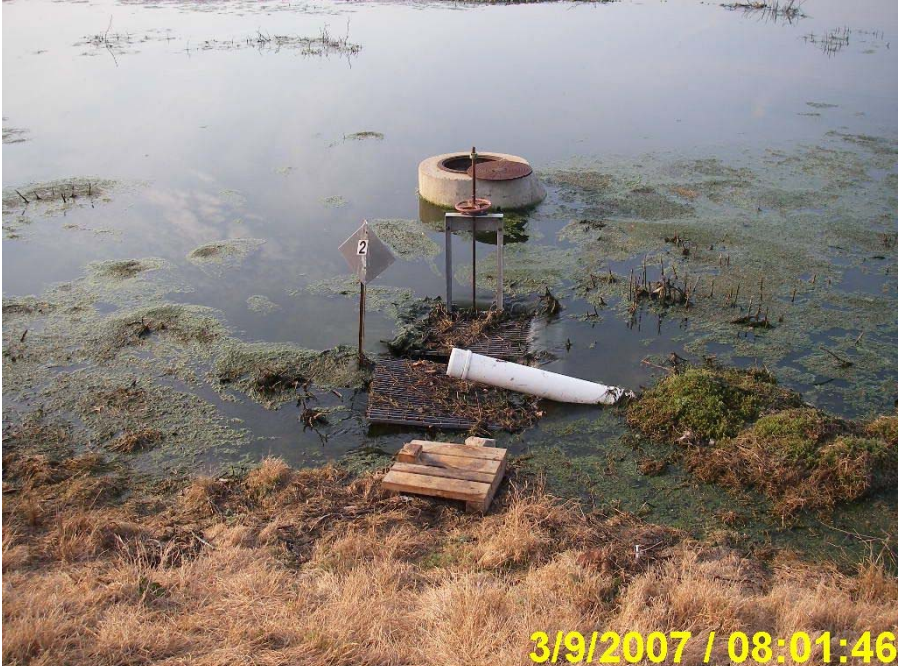
The rock filters were still submerged and thus being bypassed by a majority of the effluent.

<b>Location:</b>	Pocahontas WWTP						
<b>Photographer:</b>	Brent Walker			<b>Witness:</b>	None		
<b>Photo #</b>	3	<b>Of</b>	4	<b>Date:</b>	03/09/2007	<b>Time:</b>	0801
<b>Description:</b>	Submerged rock filter with overflow grating removed.
