# NPDES Compliance Inspection Report

Name and Location of Facility Inspected (For industrial users discharging to POTW, also include POTW name and NPDES permit number) <b>City of Pocahontas WWTP ~1 mile south of Black River Bridge off Old County Rd. Pocahontas, AR Randolph County</b>	Entry Time/Date <b>1015 3/22/2007</b>	Permit Effective Date <b>February 1, 2004</b>
	Exit Time/Date <b>1035 3/22/2007</b>	Permit Expiration Date <b>January 31, 2009</b>
Name(s) of On-Site Representative(s)/Title(s)/Phone and Fax Number(s) <b>None</b>	Other Facility Data	
Name, Address of Responsible Official/Title/Phone and Fax Number <b>William Daniel/Manager/870-892-3222 Pocahontas Water and Sewer Systems 207 Hwy 67 South Pocahontas, AR 72455</b>	Contacted Yes <input type="checkbox"/> No <input checked="" type="checkbox"/>

## Photographic Evidence Sheet

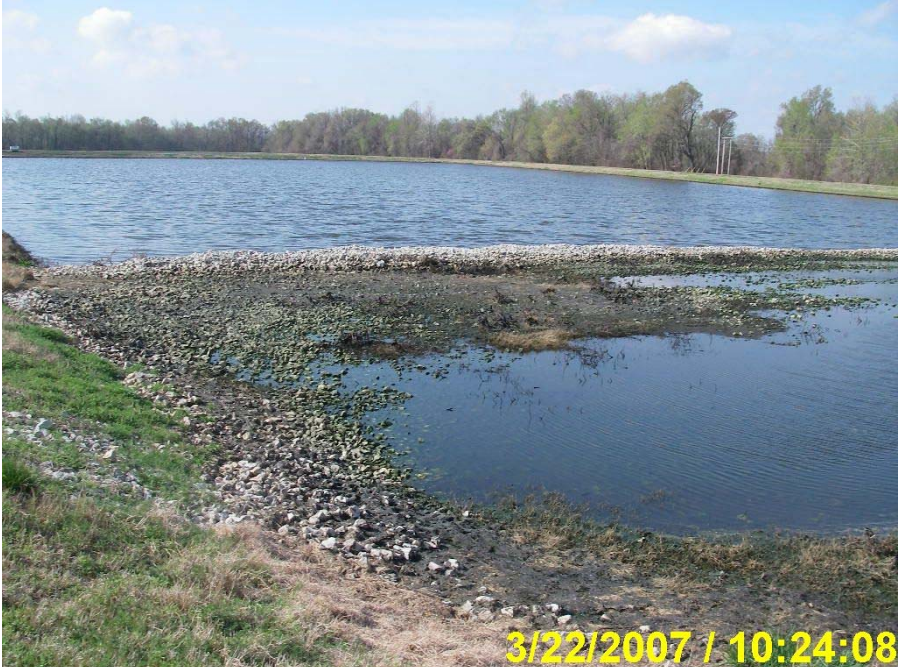
<b>Location:</b>	Pocahontas WWTP						
<b>Photographer:</b>	Brent Walker			<b>Witness:</b>	None		
<b>Photo #</b>	1	<b>Of</b>	4	<b>Date:</b>	3/22/07	<b>Time:</b>	1024
<b>Description:</b>	Water level in lagoon 3 lowered thus exposing rock filter.

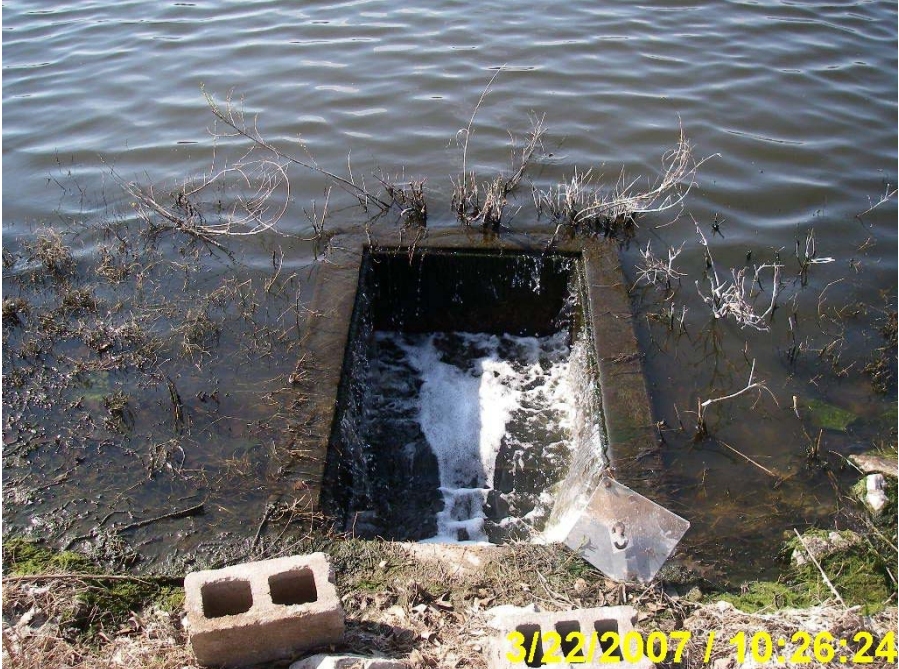
<b>Location:</b>	Pocahontas WWTP						
<b>Photographer:</b>	Brent Walker			<b>Witness:</b>	None		
<b>Photo #</b>	3	<b>Of</b>	4	<b>Date:</b>	3/22/07	<b>Time:</b>	1026
<b>Description:</b>	Outlet box in lagoon 2; less ~0.5" of flow over top of outlet box.
