# NPDES Compliance Inspection Report

Name and Location of Facility Inspected (For industrial users discharging to POTW, also include POTW name and NPDES permit number) <b>City of Pocahontas WWTP ~1 mile south of Black River Bridge off Old County Rd. Pocahontas, AR Randolph County</b>	Entry Time/Date <b>1715 4/20/2007</b>	Permit Effective Date <b>February 1, 2004</b>
	Exit Time/Date <b>1735 4/20/2007</b>	Permit Expiration Date <b>January 31, 2009</b>
Name(s) of On-Site Representative(s)/Title(s)/Phone and Fax Number(s) <b>None</b>	Other Facility Data	
Name, Address of Responsible Official/Title/Phone and Fax Number <b>William Daniel/Manager/870-892-3222 Pocahontas Water and Sewer Systems 207 Hwy 67 South Pocahontas, AR 72455</b>	Contacted Yes <input type="checkbox"/> No <input checked="" type="checkbox"/>

## Photographic Evidence Sheet

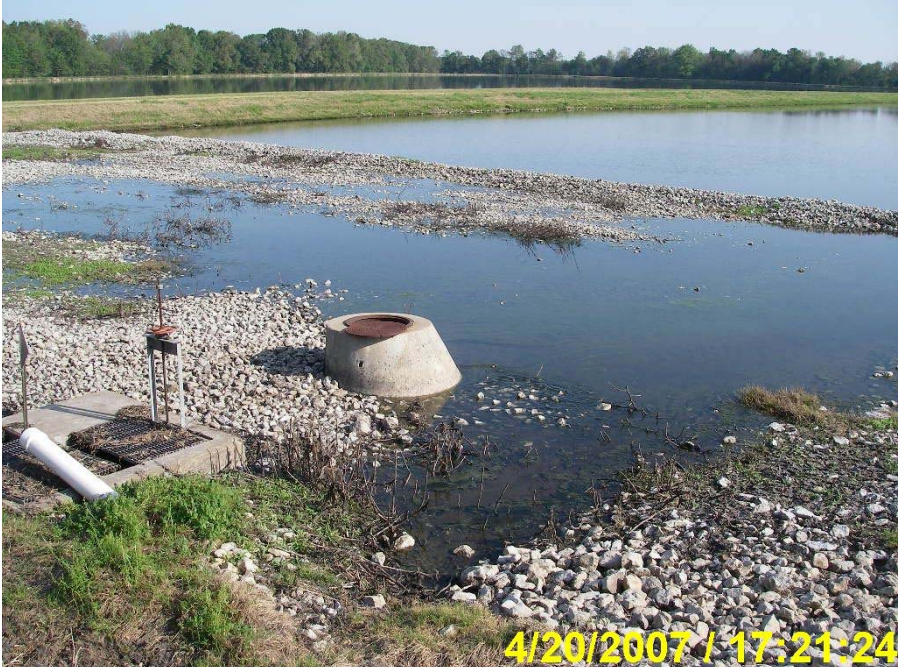
The rock filter is still partially submerged and there is evidence that the majority of the flow is bypassing the filter.

<b>Location:</b>	Pocahontas WWTP						
<b>Photographer:</b>	Brent Walker			<b>Witness:</b>	None		
<b>Photo #</b>	1	<b>Of</b>	4	<b>Date:</b>	4/20/2007	<b>Time:</b>	1721
<b>Description:</b>	Rock filter partially submerged.

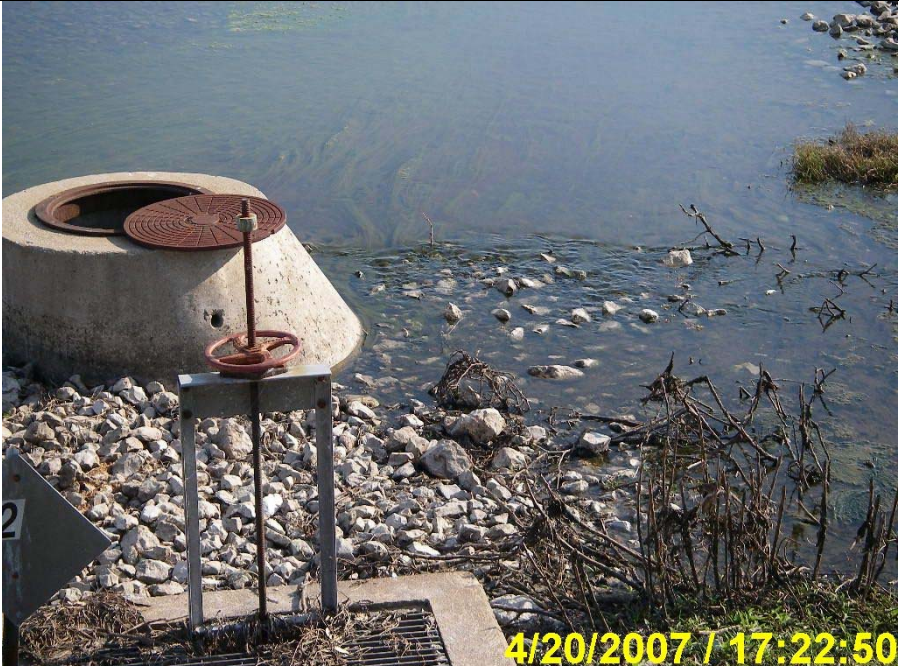
<b>Photographer:</b>	Brent Walker			<b>Witness:</b>	None		
<b>Photo #</b>	2	<b>Of</b>	4	<b>Date:</b>	4/20/2007	<b>Time:</b>	1722
<b>Description:</b>	Flow bypassing rock filter.

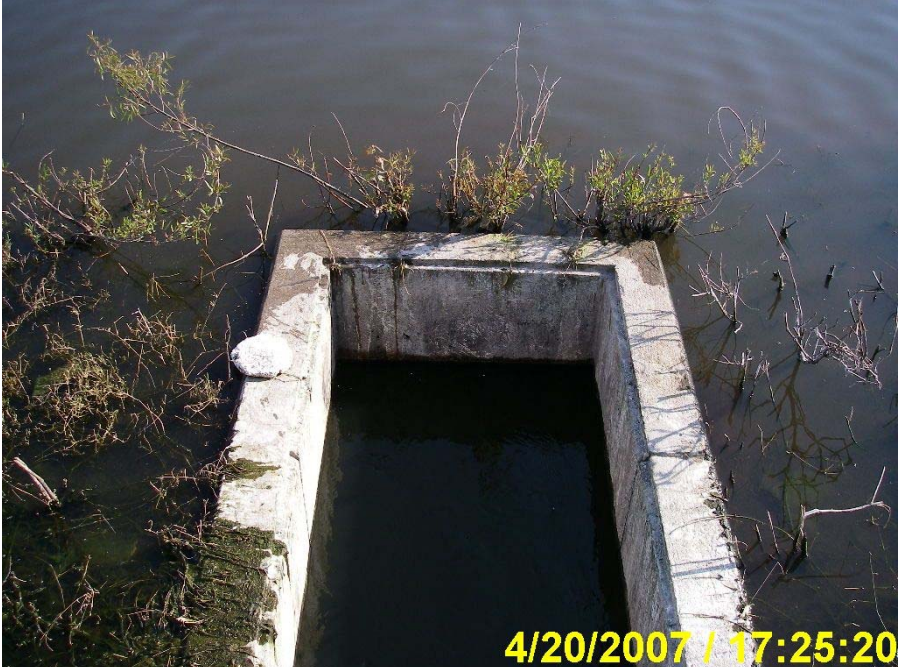
The first and second lagoons are both above normal designed operating levels.

<b>Location:</b>	Pocahontas WWTP							
<b>Photographer:</b>	Brent Walker				<b>Witness:</b>	None		
<b>Photo #</b>	3	<b>Of</b>	4		<b>Date:</b>	4/20/2007	<b>Time:</b>	1725
<b>Description:</b>	Water level near the top of the outlet structure for lagoon #2.
