<p>UNITED STATES ENVIRONMENTAL PROTECTION AGENCY Washington, D.C. 20460</p> <h2 style="margin: 0;">NPDES Compliance Inspection Report</h2>	Form Approved OMB No. 2040-0003
--	------------------------------------

Name and Location of Facility Inspected (<i>For industrial users discharging to POTW, also include POTW name and NPDES permit number</i>) Pocahontas Wastewater Treatment Plant 2 miles down Swan Cove Road off Old County Rd. (South along Black River) Pocahontas, AR Randolph Co.	Entry Time/Date 0935 3/31/2008	Permit Effective Date February 1, 2004
Name(s) of On-Site Representative(s)/Title(s)/Phone and Fax Number(s) William G. Daniel/Manager Pocahontas Water and Sewer/870-892-3222	Other Facility Data	
Name, Address of Responsible Official/Title/Phone and Fax Number William G. Daniel / Manager/870-892-3222 Pocahontas Water and Sewer 207 Highway #67 South Pocahontas, AR 72455	Contacted Yes <input checked="" type="checkbox"/> No <input type="checkbox"/>

Water Division NPDES Photographic Evidence Sheet

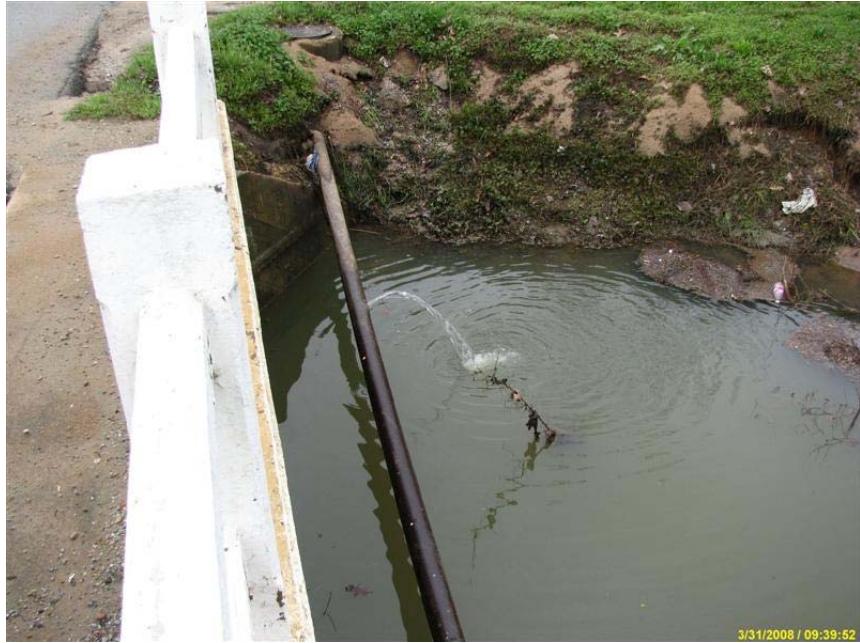
The sewer line servicing the City of Pocahontas Street Department Shop was observed to have developed a split and was spraying into Marr Creek at the Cedar St. Bridge. Waster and Sewer Manager Bill Daniel was notified and advised to correct the problem immediately. The leak was later observed by Dale Washam (Water Division Inspector Supervisor) who also informed Mr. Daniel that the leak should be corrected immediately. The leak was finally corrected at ~1330.

Location:		Cedar St. Bridge over Marr Creek, Pocahontas, AR						
Photographer:		Brent Walker			Witness:		Dean VanDerhoff	
Photo #	1	Of	2	Date:		3/31/2008	Time:	0939
Description:		Leak from sewer line crossing Marr Creek.

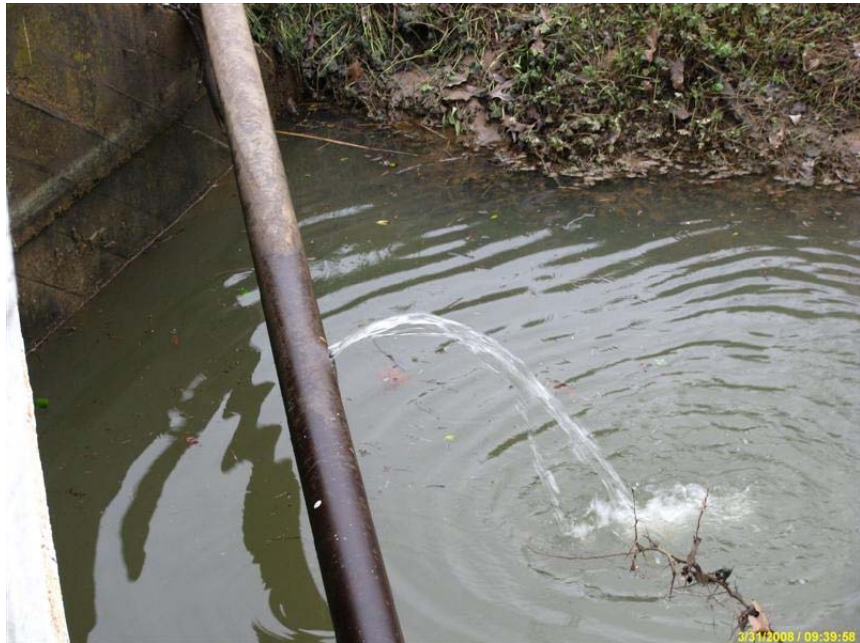
Photographer:		Brent Walker			Witness:		Dean VanDerhoff	
Photo #	2	Of	2	Date:		3/21/2008	Time:	0939
Description:		Leak from sewer line crossing Marr Creek.
