NPDES Compliance Inspection Report

Name and Location of Facility Inspected (<i>For industrial users discharging to POTW, also include POTW name and NPDES permit number</i>) City of Decatur POTW (Collection System) 985 Austin St. Decatur Arkansas	Entry Time/Date 0755 / 10-09-09	Permit Effective Date June 1, 2009
	Exit Time/Date 0840 / 10-09-09	Permit Expiration Date May 31, 2014
Name(s) of On-Site Representative(s)/Title(s)/Phone and Fax Number(s) N/A	Other Facility Data	
Name, Address of Responsible Official/Title/Phone and Fax Number James Boston, Public Works Director City of Decatur P.O. Box 247 Decatur, Arkansas 72722 479-752-3912, 479-752-8336	Contacted Yes <input type="checkbox"/> No <input checked="" type="checkbox"/>

NPDES Compliance Inspection Report Further Explanation

City of Decatur October 9 – 14, 2009 Overflow/Discharge Locations

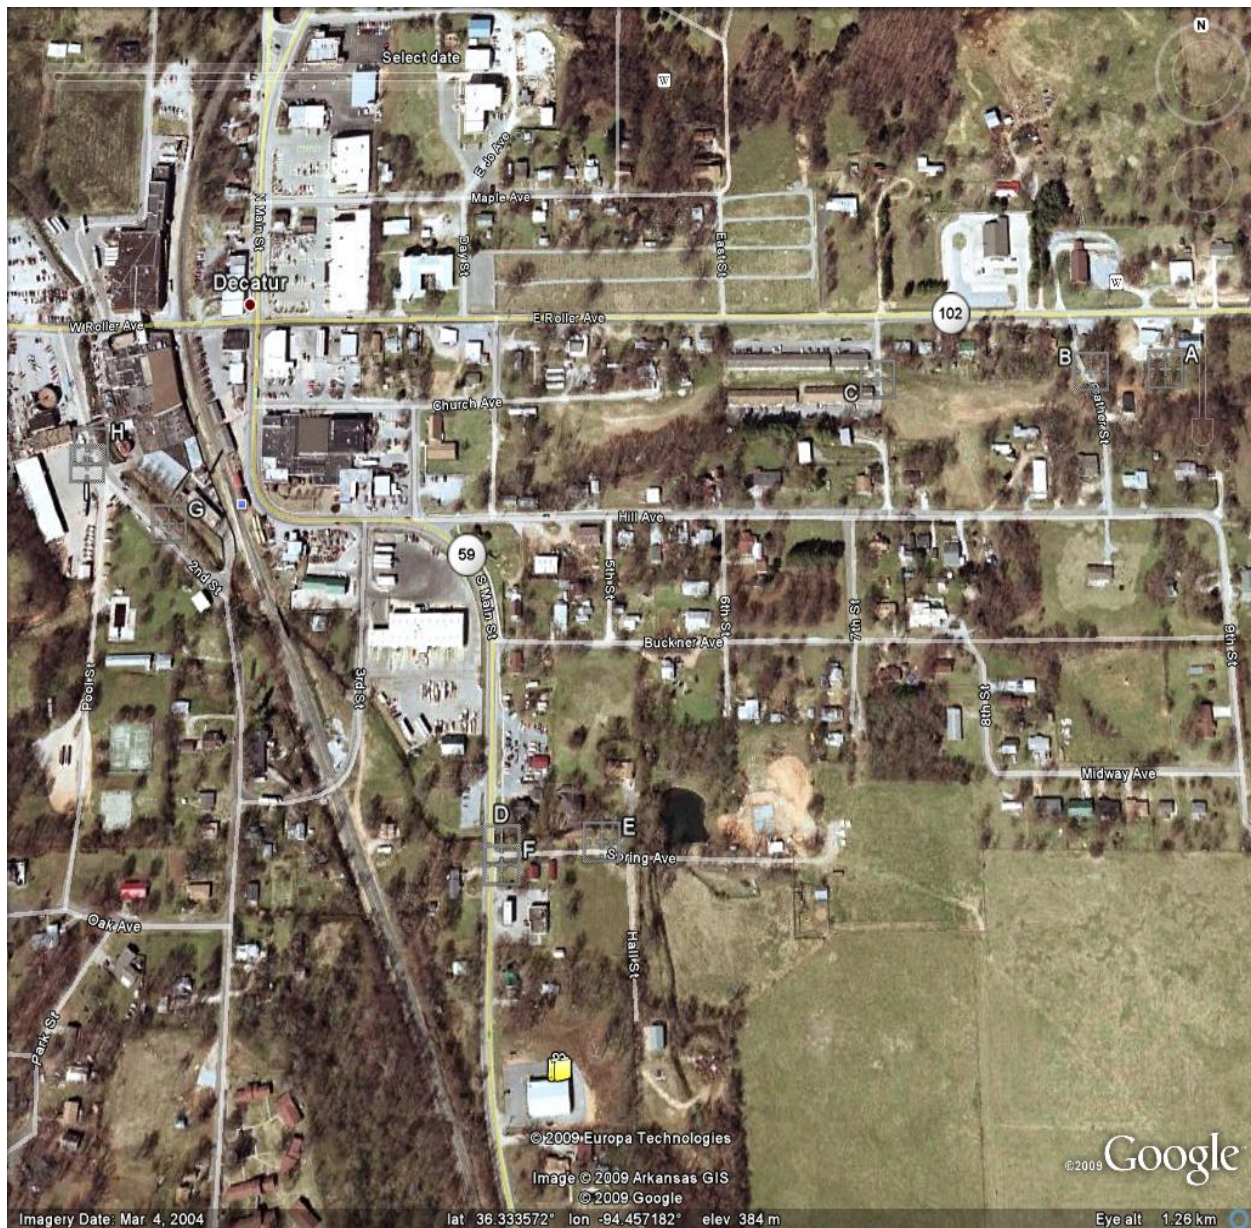
A, B: Manholes behind Wellness Secrets restaurant on Hwy 102.

C: Manhole at apartment complex on Hwy 102.

D, E, F: F is manhole in James Beemer's yard at Spring St. and Hwy 59. E is manhole next to Columbia Hollow Creek (tributary to Spavinaw) on Spring St. D is Cleanout opened by City to allow for discharge to creek.

G, H, I: G is manhole above Columbia Hollow Creek bank adjacent to 2nd St. at Simmon's Foods. H is manhole on 2nd St. at Simmons Foods. I is stormwater grate that discharges to sanitary sewer along 2nd St.

(Locations are approximate.)

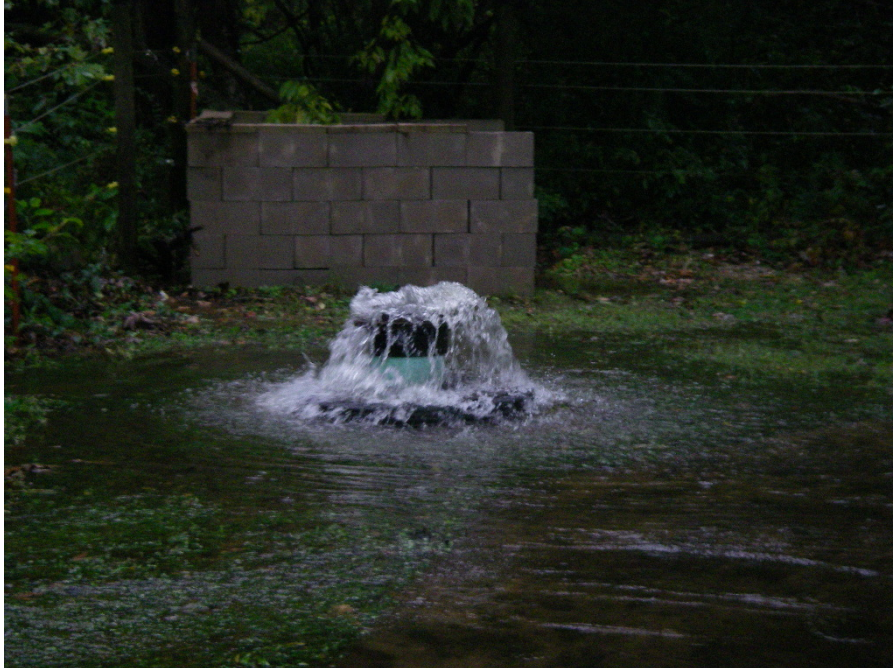
Location:	City of Decatur Collection System						
Photographer:	John Fazio			Witness:	None		
Photo #	1	Of	7	Date:	10/09/09	Time:	0800
Description:	1 of 2 overflows behind Wellness Secrets business on Hwy 102. Looking south.

- a. Two manholes located behind the Wellness Secrets business, located on Hwy 102. The Department received a complaint by an employee of this business on October 9, 2009. The complainant stated that she had reported the overflows to the City of Decatur on this date, and that within thirty minutes of her call to the City, City staff arrived at the site. These overflows were not reported to the Department until October 15, 2009.

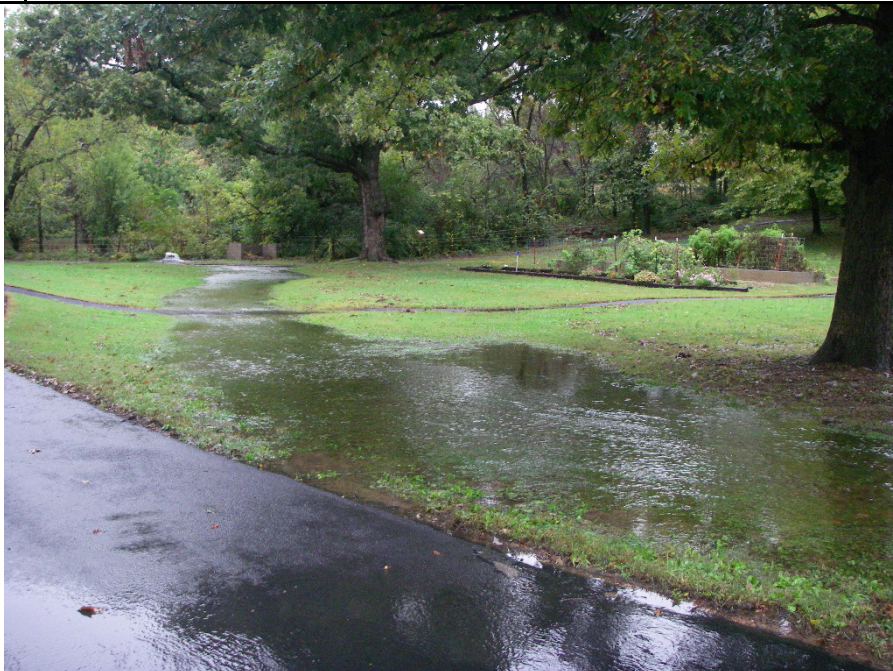
Photographer:	John Fazio			Witness:	None		
Photo #	2	Of	7	Date:	10/09/09	Time:	0802
Description:	Same overflow as above. Looking ~ east. Note garden to upper right.

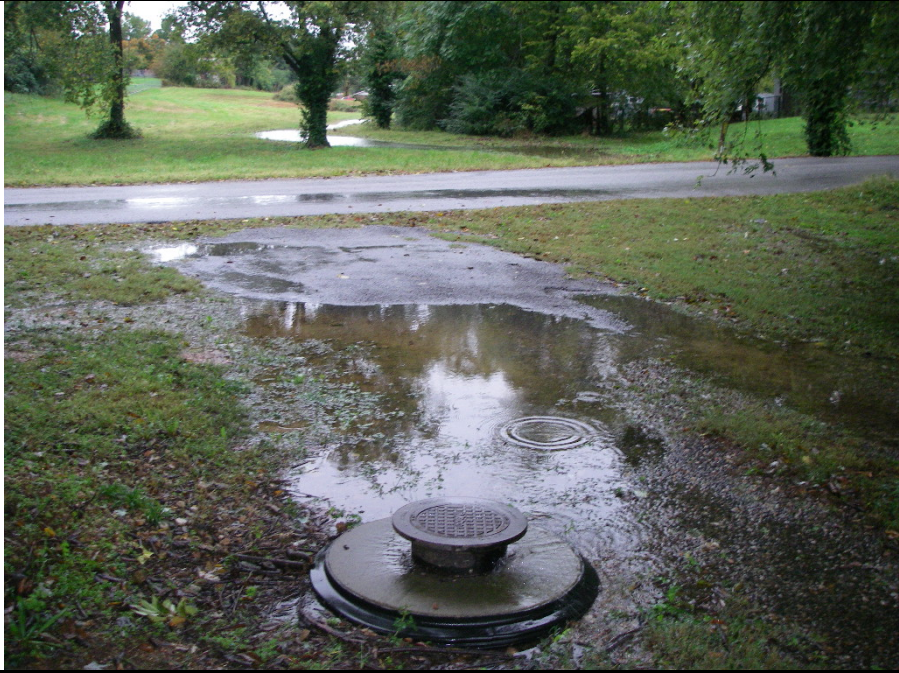
Photo # 3 **Of** 7 **Date:** 10/09/09 **Time:** 0803

Description: Looking ~ west from 2nd overflow behind Wellness Secrets. Flow toward Apt Complex in next photo.

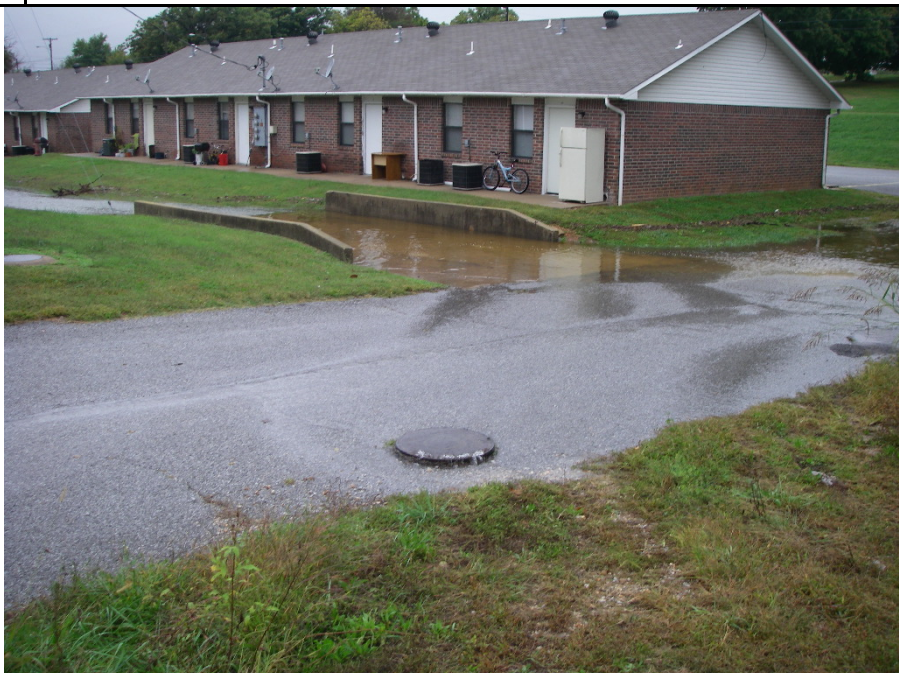
Photo # 4 **Of** 7 **Date:** 10/09/09 **Time:** 0810

Description: Looking ~ west from overflow at apartment complex south of Hwy 102 and west of Wellness Secrets. Flow from this location and Wellness Secrets eventually discharges into Columbia Hollow Creek.

- b. A manhole located at the apartment complex on Hwy 102, located immediately west and downgradient from Wellness Secrets. I made Mr. Boston aware of this overflow during our meeting on October 14, 2009. To date, the Department has no record of a report of this overflow from the City.

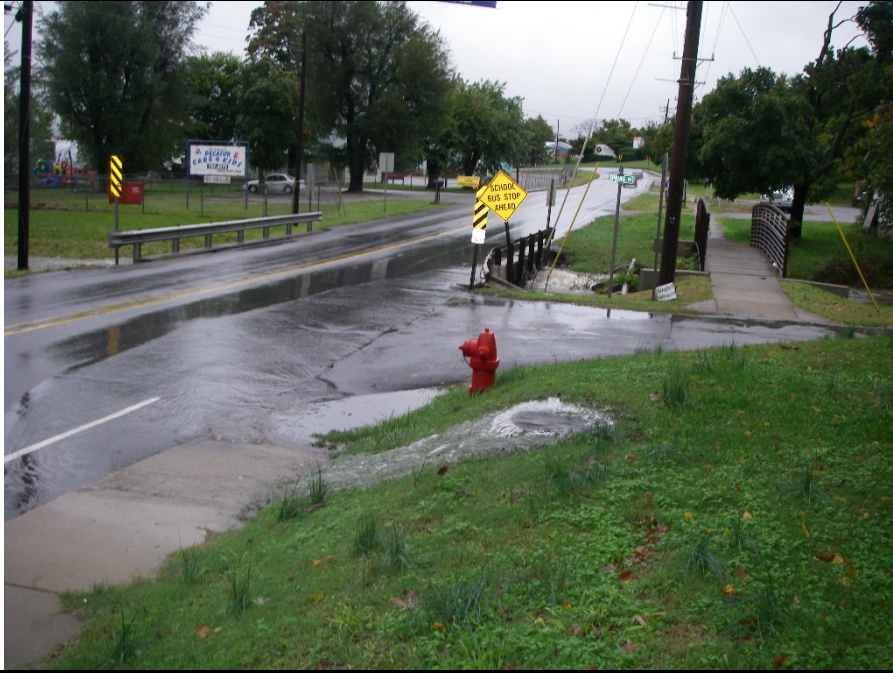
Location:	City of Decatur Collection System						
Photographer:	John Fazio			Witness:	None		
Photo #	5	Of	7	Date:	10/09/09	Time:	0815
Description:	Overflow from Beemer residence (Hwy 59 & Spring St) flowing into Columbia Hollow Creek (background). Looking north.

- c. The manhole located in James Beemer's yard at the intersection of Hwy 59 and Spring St. A report of this overflow was received by the Department on October 9, 2009.

3. Failure to remove and dispose of the solids associated with some of these overflows in accordance with the requirements of Part II.5 of the permit. On October 12, 2009, the Department received a complaint from a resident who stated that his dogs had rolled in the solids that had overflowed from the manhole in Mr. Beemer's yard and the manhole at 404 Spring St. In addition, on October 15, 2009, the Department observed waste (condoms) from the Simmons overflow on top of the vented manhole. Photographs of this same waste were taken by the Department on October 9, 2009. As Mr. Boston and I discussed during our meeting on October 14, 2009, it is necessary to clean up all solids associated with an overflow, and to lime the affected areas as soon as the overflow ceases. These solids are an endangerment to health and the environment.

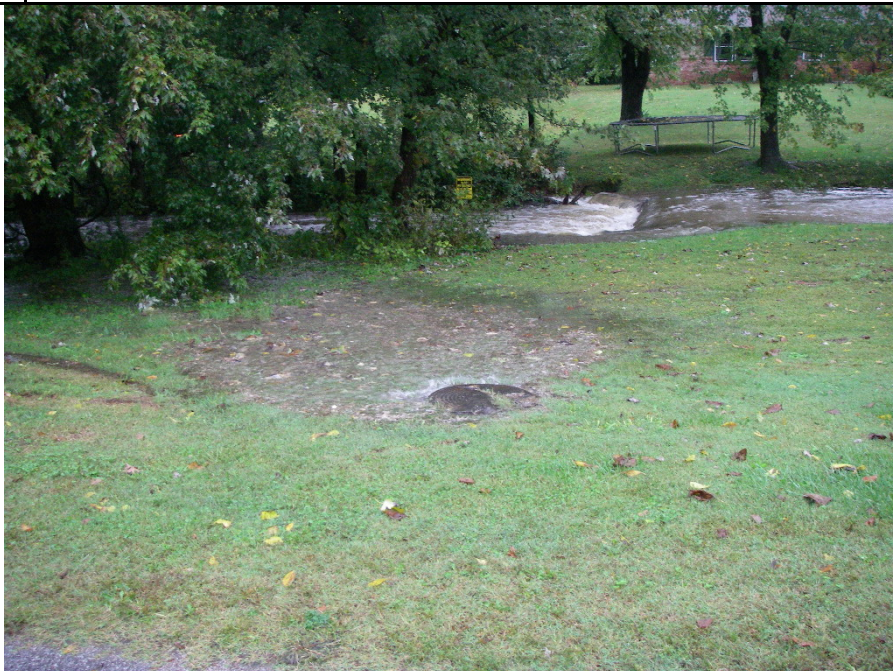
Photographer:	John Fazio			Witness:	None		
Photo #	6	Of	7	Date:	10/09/09	Time:	0817
Description:	Overflow at 404 Spring St. discharging into Columbia Hollow Creek. Looking north.

- d. The manhole located at 404 Spring St. After the inspection, Mr. Beemer stated that he reported both Spring St. overflows to the City on October 9, 2009. The Spring St. sewer main drains east to west, and the Hwy 59 sewer main drains south to north. The manhole in Mr. Beemer's yard is located along the Hwy 59 main just south of where the Spring St. main tees into the Hwy 59 main from the east. During our meeting on October 14, 2009, Mr. Boston stated that inflow and infiltration (I & I) problems in the Hwy 59 main south of the tee causes flow to backup in the Spring St. main that results in manhole overflows along Spring St. Mr. Boston also stated that the City initially thought the I & I problems were along the Spring St. main because of periodic overflows from the Spring St. manholes. The manhole at 404 Spring St. is at a lower elevation than the manhole located in Mr. Beemer's yard. Based on the conditions described above, if an overflow is occurring at the manhole on Mr. Beemer's property, it is likely that an overflow is occurring at the 404 Spring St. manhole as well. I discussed this overflow with Mr. Boston on October 14, 2009. The City did not report the overflow to the Department until October 14, 2009.

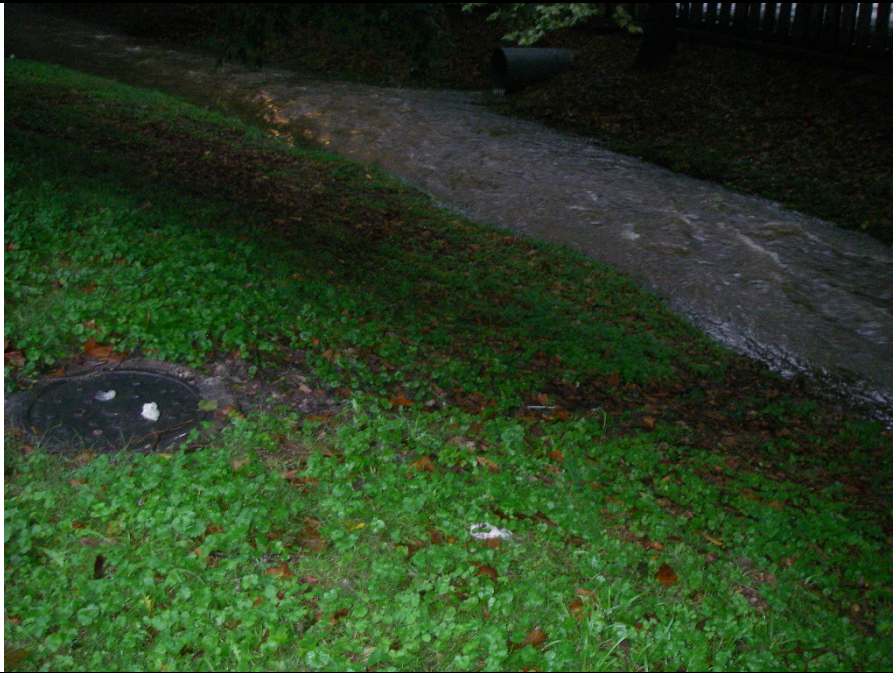
Photo # 7 **Of** 7 **Date:** 10/09/09 **Time:** 0833

Description: Overflow behind Simmons Plant (2nd St) discharging in Columbia Hollow Creek (note condoms on vented manhole).

- e. The manhole located on the west bank of the creek and 2nd St (behind Simmons Foods). I made Mr. Boston aware of this overflow on October 14, 2009. To date, the Department has no record of a report of this overflow from the City.
