# NPDES Compliance Inspection Report

| Name and Location of Facility Inspected ( <i>For industrial users discharging to POTW, also include POTW name and NPDES permit number</i> )<br><b>City of Decatur POTW (Collection System)</b><br><b>985 Austin St.</b><br><b>Decatur Arkansas</b> | Entry Time/Date<br><b>1310 / 10-14-09</b> | Permit Effective Date<br><b>June 1, 2009</b> |

## City of Decatur October 9 – 14, 2009 Overflow/Discharge Locations

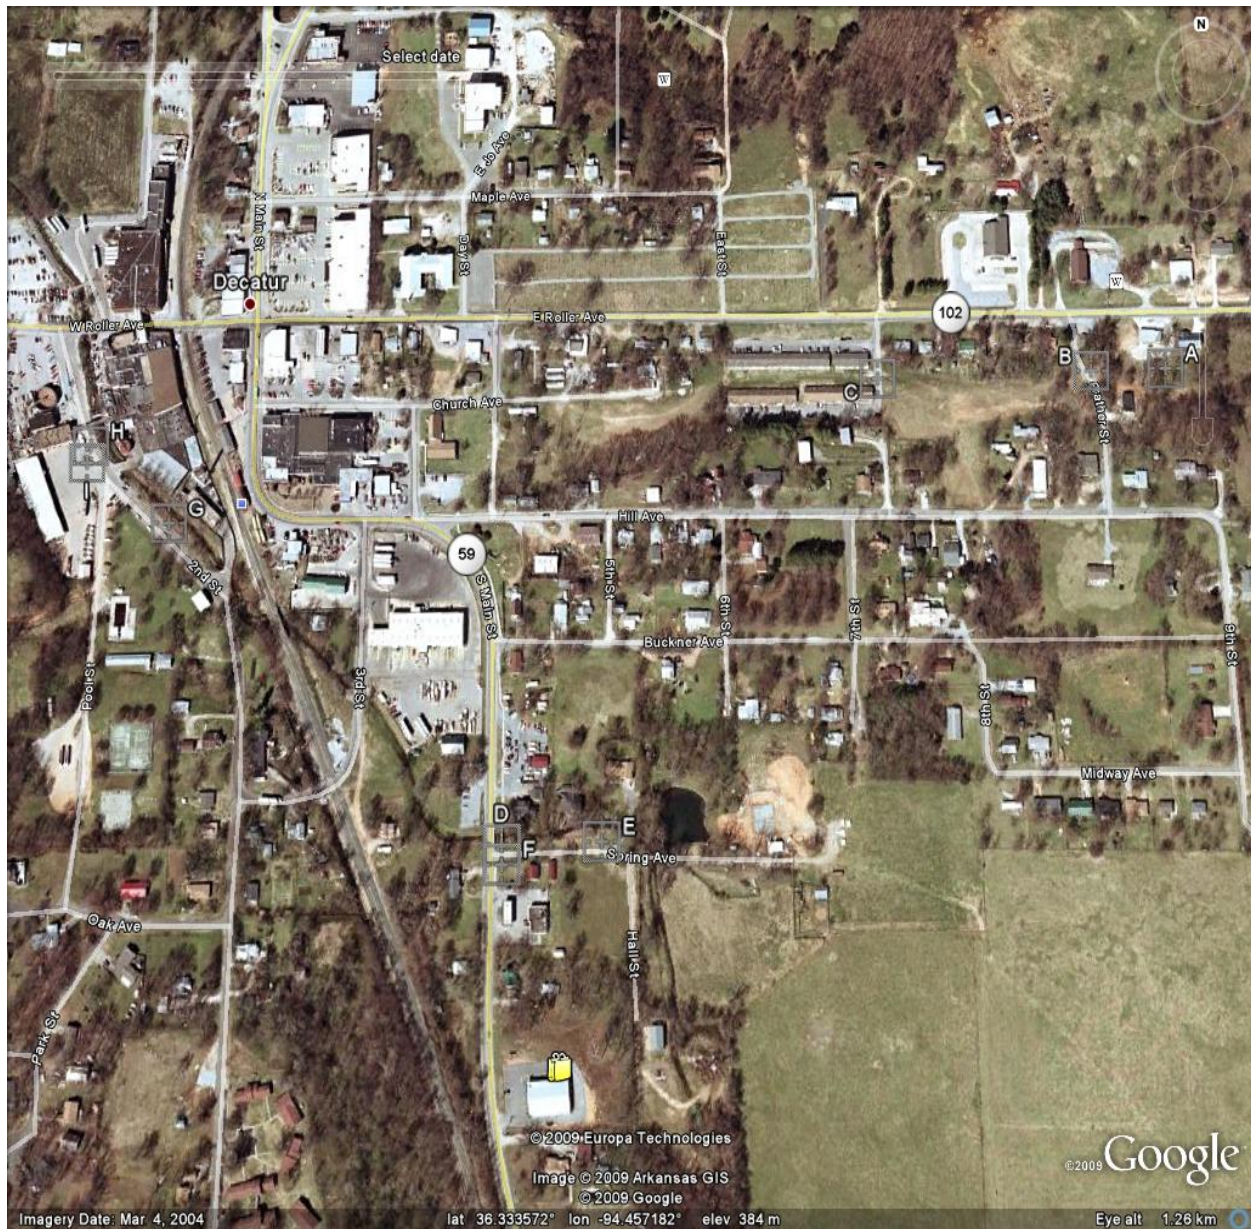
A, B: Manholes behind Wellness Secrets restaurant on Hwy 102.

C: Manhole at apartment complex on Hwy 102.

D, E, F: F is manhole in James Beemer's yard at Spring St. and Hwy 59. E is manhole next to Columbia Hollow Creek (tributary to Spavinaw) on Spring St. D is Cleanout opened by City to allow for discharge to creek.

G, H, I: G is manhole above Columbia Hollow Creek bank adjacent to 2<sup>nd</sup> St. at Simon's Foods. H is manhole on 2<sup>nd</sup> St. at Simmons Foods. I is stormwater grate that discharges to sanitary sewer along 2<sup>nd</sup> St.

(Locations are approximate.)

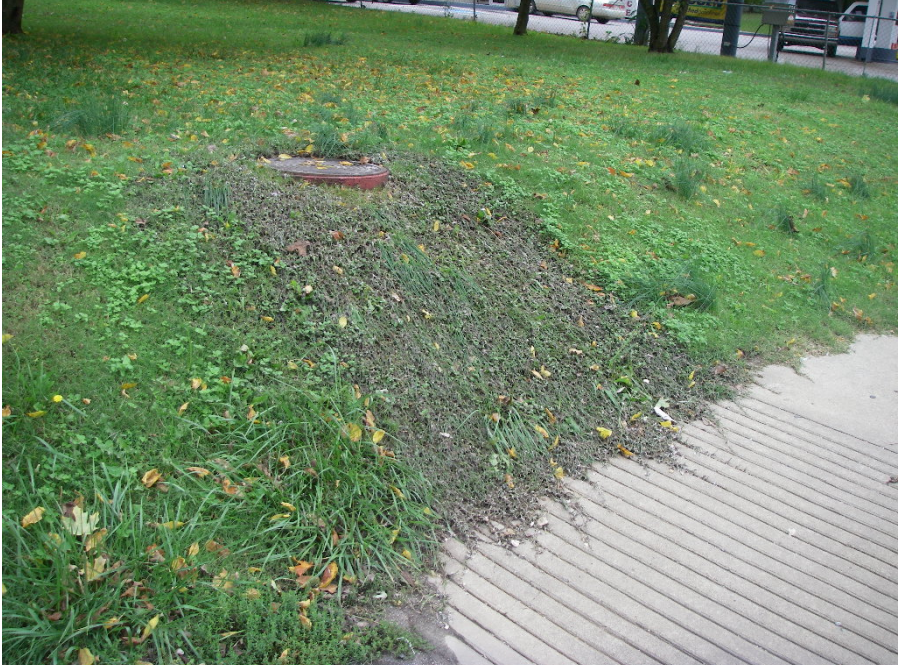
| Water Division NPDES Photographic Evidence Sheet | | | | | | | | |
|---|---|--|---|---|---|---|---|---|
| <b>Photo #</b> | 1 | <b>Of</b> | 8 | <b>Date:</b> | | 10/14/09 | <b>Time:</b> | 1314 |

| Water Division NPDES Photographic Evidence Sheet | | | | | | | | |
|---|---|--|---|---|---|---|---|---|
| <b>Description:</b> | | Solids from overflow at Mr. Beemer's residence. Looking S. Hwy 59 to right of photo. | | | | | | |

4. Failure to remove and dispose of the solids associated with this cleanout discharge and manhole overflows in accordance with the requirements of Part II.5 of the permit. On October 18, 2009, the Department received a complaint that the solids around the cleanout and at the manholes on Mr. Beemer's property and 404 Spring St. had not been removed, and that the areas had not been limed. The complainant included photographs with his complaint to support his claim. In addition, the Department observed solids at the cleanout and at the manholes during this inspection and during the subsequent inspection. Mr. Boston indicated in his October 15, 2009 overflow report that there were no visible signs of debris.

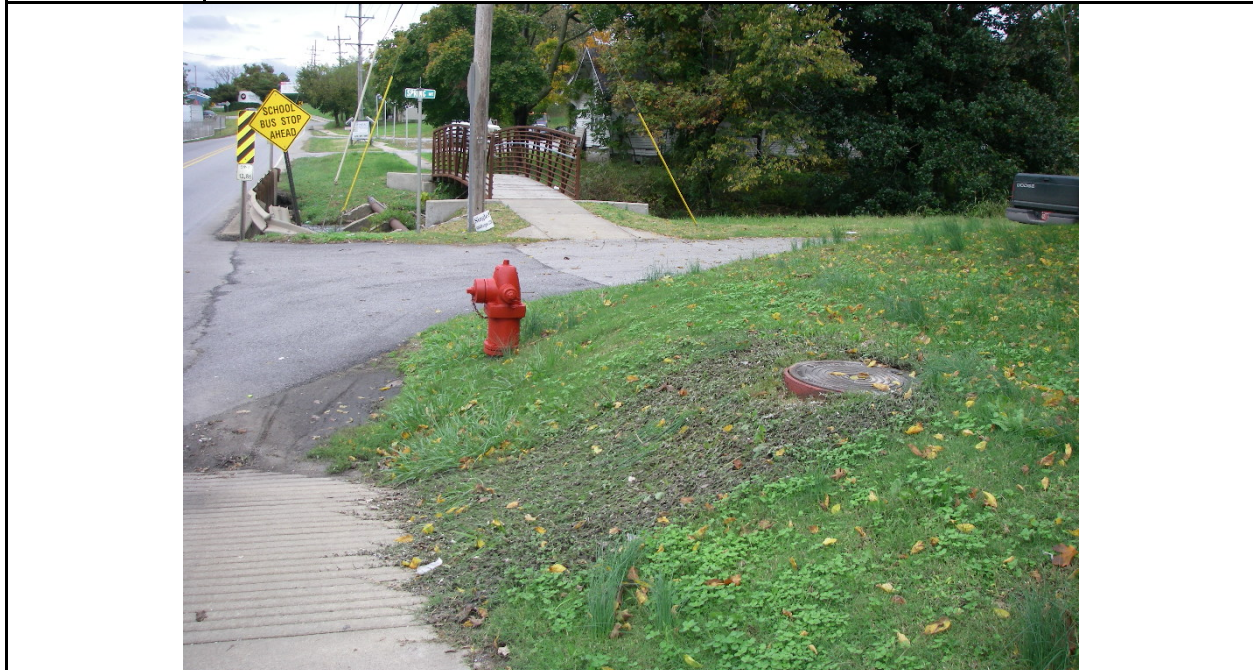
| <b>Photo #</b> | 2 | <b>Of</b> | 8 | <b>Date:</b> | | 10/14/09 | <b>Time:</b> | 1314 |

| <b>Description:</b> | | Manhole on Beemer yard. Cleanout behind utility pole across Spring St. Looking N. Hwy 59 at left in photo. | | | | | | |

- b. Mr. Boston stated that an overflow from the manhole on Mr. Beemer's property on the morning of October 13, 2009 prompted the City to open this cleanout as a safety precaution because the manhole overflow was entering Hwy 59 and causing a traffic problem. According to Mr. Boston's report and his statements during our October 14, 2009 meeting, the overflow from this manhole entered the creek until the cleanout cap was removed by the City.

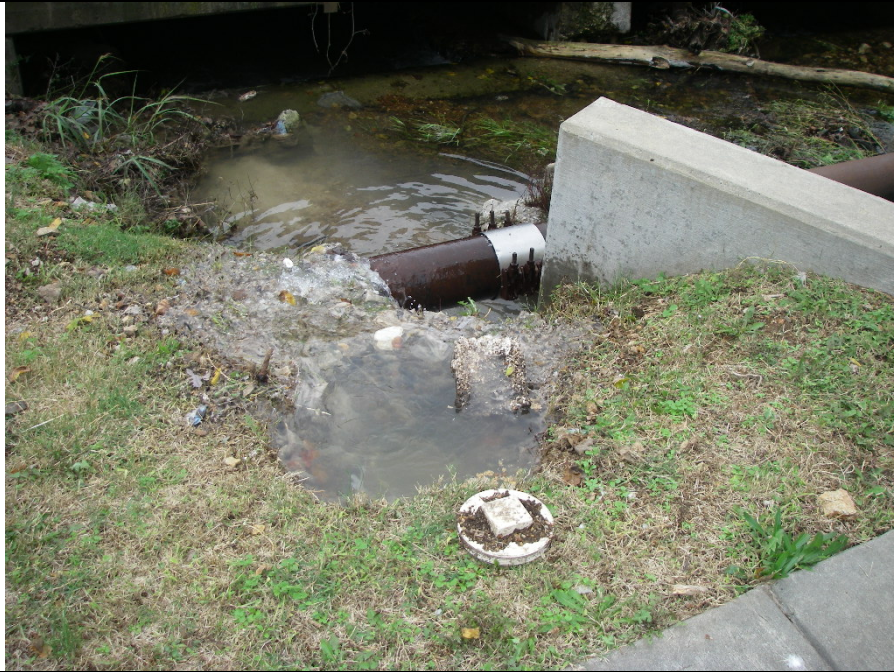
**Photo #** 3 **Of** 8 **Date:** 10/14/09 **Time:** 1314

**Description:** Overflow from cleanout into Columbia Hollow Creek. Removed cap in foreground. Looking NW.

- a. The sewer main cleanout cap was deliberately removed from the City on the morning of October 13, 2009. Direct discharge from the cleanout into the creek began at this time and continued until the Department advised Mr. Boston to cap the cleanout mid-afternoon on October 14, 2009.

3. The City's deliberate removal of the sewer main cleanout cap to allow for direct discharge of raw sewage into the waters of the State is in violation of Regulation 6.106(C) and Part III.D.2 of the permit. Reg.6.106(C) states that no person shall construct, install or operate any building plant, works, establishment or facility or any extension or modification thereto, the operation of which would result in discharge of any wastes into the waters of the State or would otherwise alter the physical, chemical, or biological properties of any waters of the State in any manner not already lawfully authorized. Part III.D.2 of the permit states that the permittee shall give advance notice to the Director of any planned changes in the permitted facility or activity which may result in noncompliance with permit requirements. During our October 14, 2009 meeting, Mr. Boston stated that the City had opened this sewer main cleanout in the past as well, usually during winter months, as a measure to prevent overflows from the manhole in Mr. Beemer's yard from entering the street and causing traffic or safety hazards.

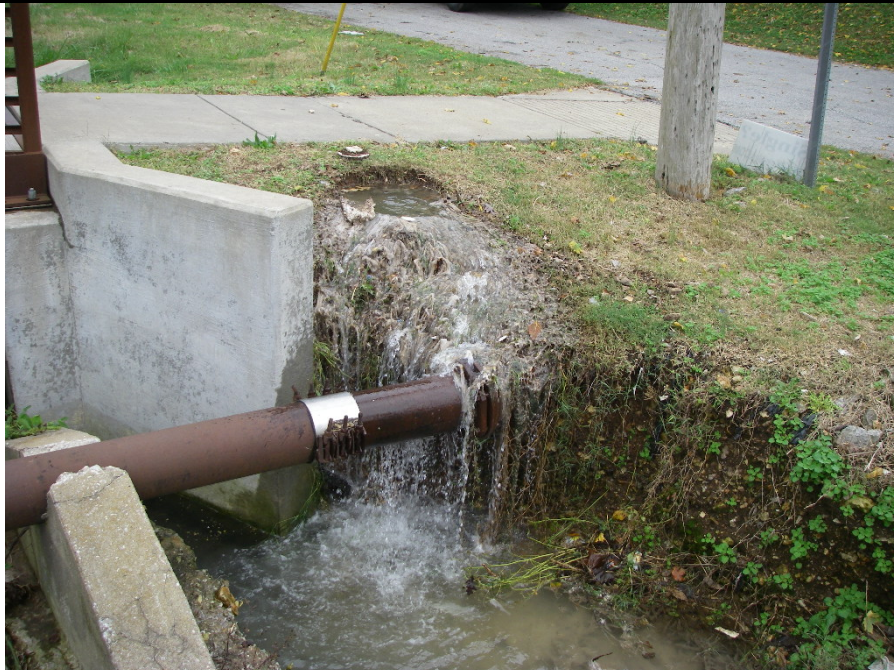
**Photo #** 4 **Of** 8 **Date:** 10/14/09 **Time:** 1314

**Description:** Overflow from cleanout discharging into Columbia Hollow Creek. Looking ~ E. Solids visible.

1. Discharges of sewage from your collection system causing pollution to the waters of the State. This is in violation of the Arkansas Water and Air Pollution Control Act, Ark. Code Ann. §8-4-217(a)(1). The manhole overflows and the sewer main cleanout release discharged directly into Columbia Hollow Creek (may be referred to as Cave Springs Branch).

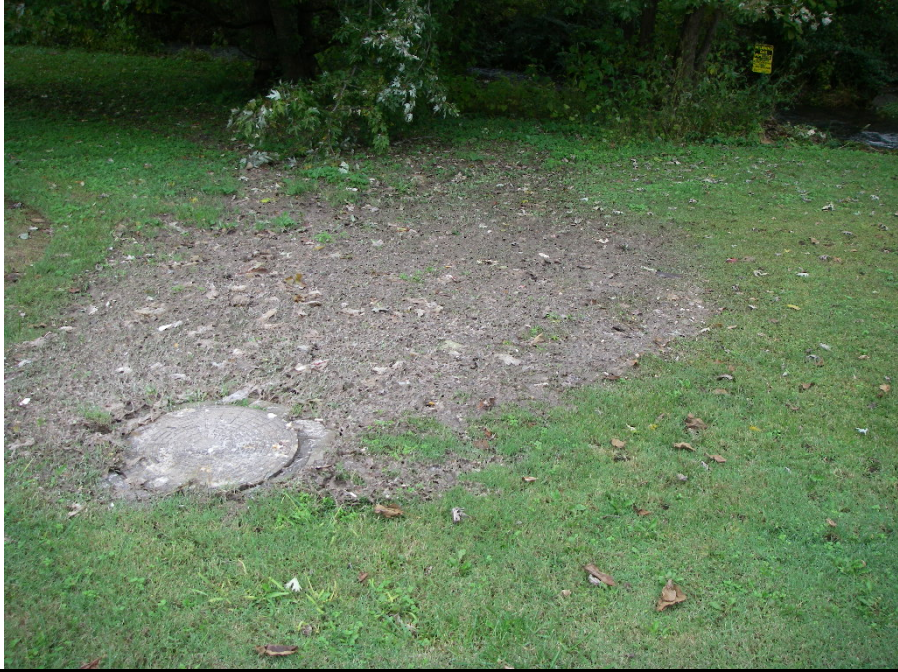
**Photo #** 5    **Of** 8      **Date:** 10/14/09    **Time:** 1319

**Description:** Solids at 404 Spring St. from 10/09/09 & 10/13/09 overflows.

- c. Overflow from the manhole at 404 Spring St. into the creek. On the morning of October 13, 2009, an overflow occurred at this manhole and continued until the cleanout cap was removed. When the cleanout was capped mid-afternoon on October 14, 2009, the manhole at 404 Spring St. began to overflow again and continued until I & I receded.

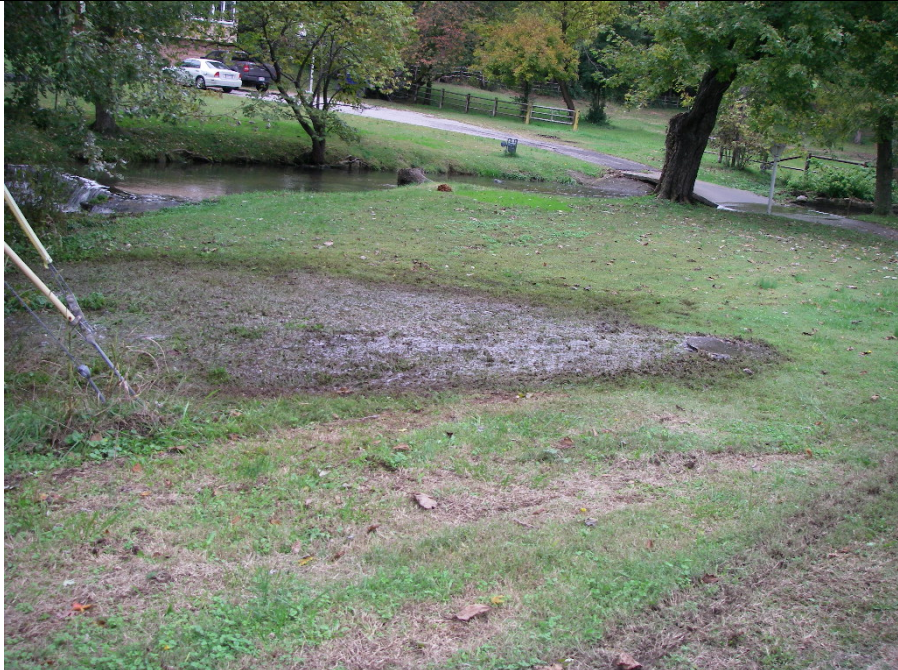
**Photo #** 6    **Of** 8      **Date:** 10/14/09    **Time:** 1500

**Description:** 404 Spring St. manhole area after solids cleaned by City. However, overflowing again after cleanout was capped. (See photo 8 below).

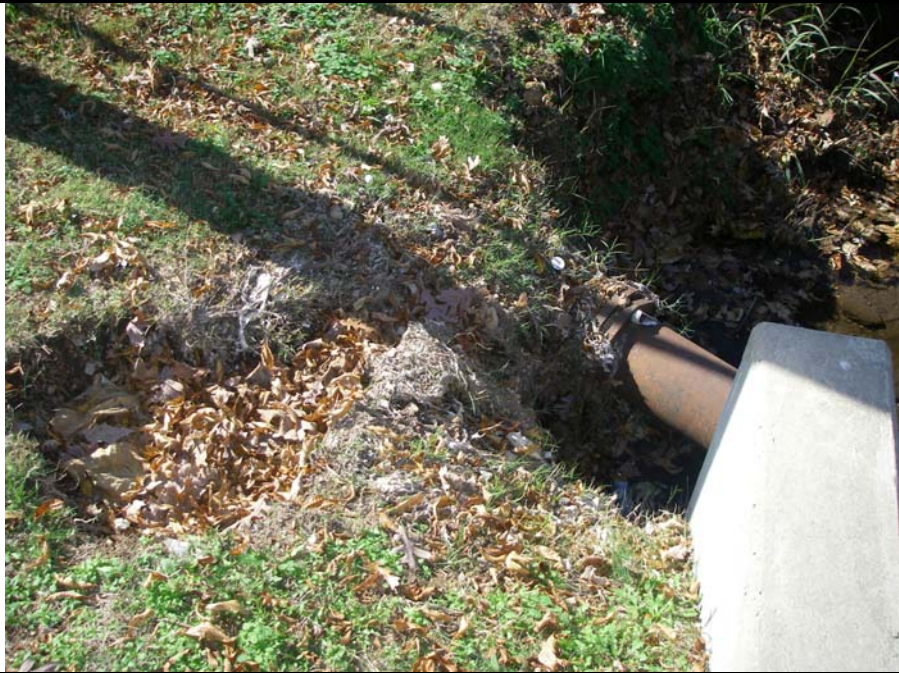
**Photo #** 7    **Of** 8      **Date:** 11/03/09    **Time:** 1224

**Description:** 11/03/09: Solids from 10/13/09 – 10/14/09 cleanout discharge not removed. Area not limed. Cleanout visible at lower left. Creek to right.

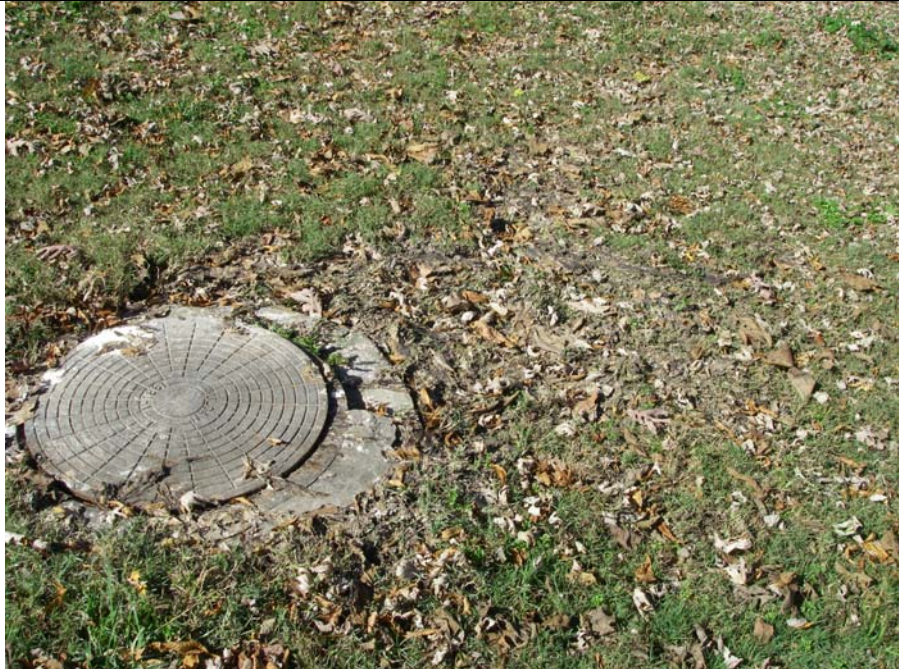
**Photo #** 8    **Of** 8      **Date:** 11/03/09    **Time:** 1227

**Description:** 11/03/09: 404 Spring St. manhole. Solids from overflow that began after cleanout capped on 10/14/09 not cleaned up. Area not limed.
