ARKANSAS
Department of Environmental Quality

RE: Sanitary Sewer Overflow Reporting
AFIN: 04-00052 NPDES Permit No.: AR0022292

<p style="text-align: center;">UNITED STATES ENVIRONMENTAL PROTECTION AGENCY Washington, D.C. 20460</p> <h2 style="text-align: center;">NPDES Compliance Inspection Report</h2>	Form Approved OMB No. 2040-0003
----------------------------------------------------------------------------------------------------------------------------------------------------------------------------------------------------------------------------------------------------------------------	------------------------------------

**Arkansas Department of Environmental Quality (ADEQ)
Official Photograph Sheet**

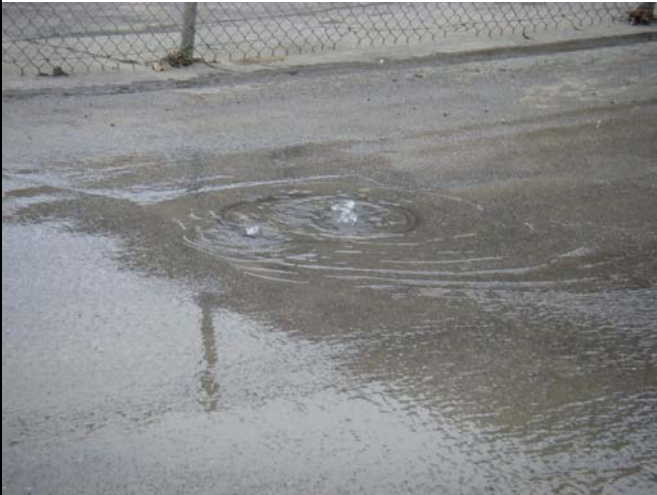
Location:		Second St. near Simmons scale house.						
Photographer:		Alison West			Witness:		John Fazio	
Photo #	1	Of	3		Date:	10-15-2009	Time:	2:16 p.m.
Description:		IMGP3684. Sanitary sewer overflow in Second St. near Simmons scale house.

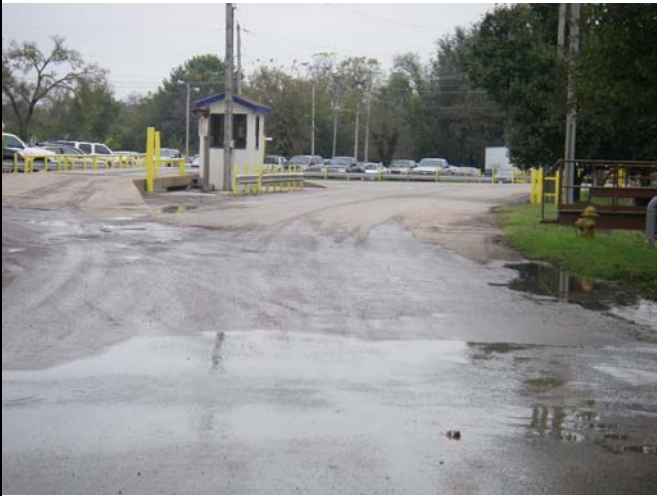
Photographer:		Alison West			Witness:		John Fazio	
Photo #	2	Of	3		Date:	10-15-2009	Time:	2:16 p.m.
Description:		IMGP3685. Sanitary sewer crosses Second St.

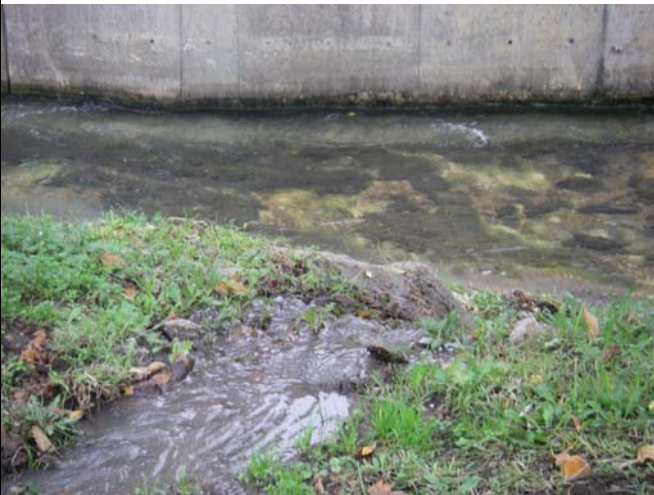
Location:		Second St. near Simmons scale house.						
Photographer:		Alison West			Witness:		John Fazio	
Photo #	3	Of	3		Date:	10-15-2009	Time:	2:16 p.m.
Description:		IMGP3687. Sanitary sewer entering Cave Springs Branch.
