ARKANSAS
Department of Environmental Quality

RE: Sanitary Sewer Overflow Inspection

NPDES Permit No.: AR0022039

NPDES Compliance Inspection Report

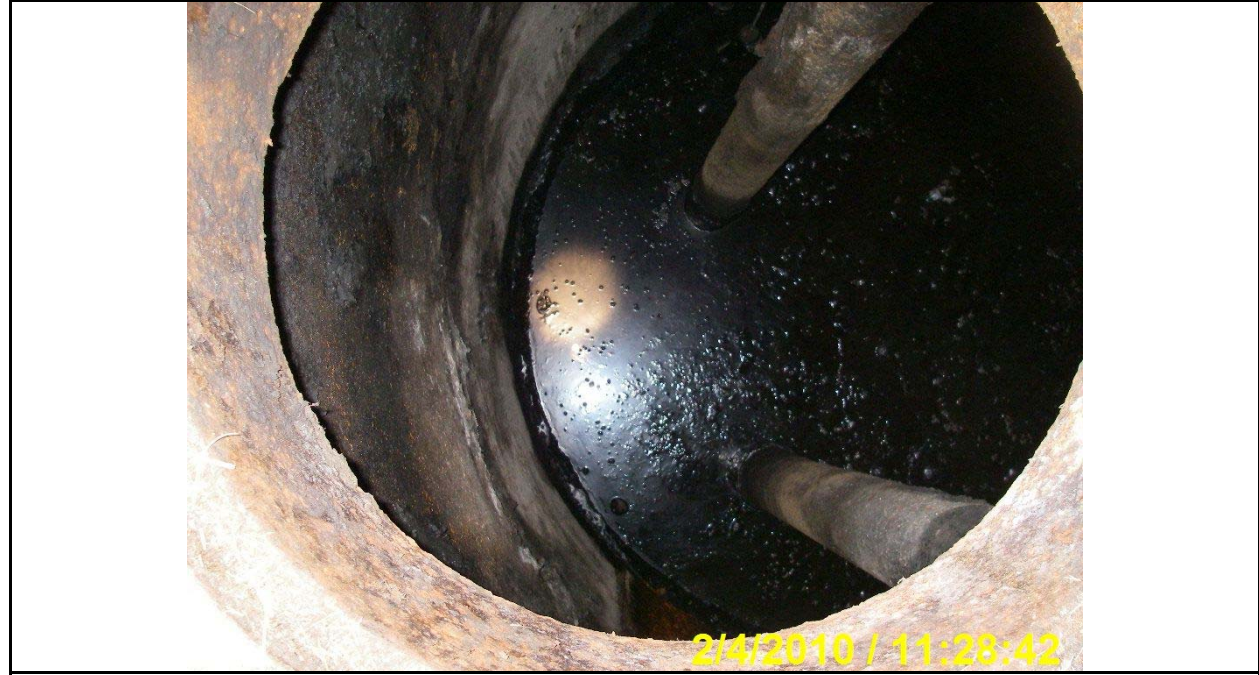
- a. There was a large volume of what appeared to be petroleum oil in the wet well.**
- b. The electrical wiring and connections for the float switches were exposed.**
- c. The safety guards for the drive belts between the motors and pumps had been removed.**
- d. Only one of the two pumps was operational at the time of the inspection.**

Description: Petroleum oil visible in wet well.

1. Pump Station-25 (Mound City Road)
 - a. The wet well was cleaned on April 26, 2010 by Jim's Tank Service. As of this date there is no sign of petroleum oil in the wet well. The cause was found to be a business located close to the pump station.
 - b. The electrical wiring and connections for the float switches has been covered up.
 - c. The safety guards for the drive belts between the motors and pumps have been put in place.
 - d. The suction line on one of the pumps was bad and it was replaced. Both pumps are operational at this time.

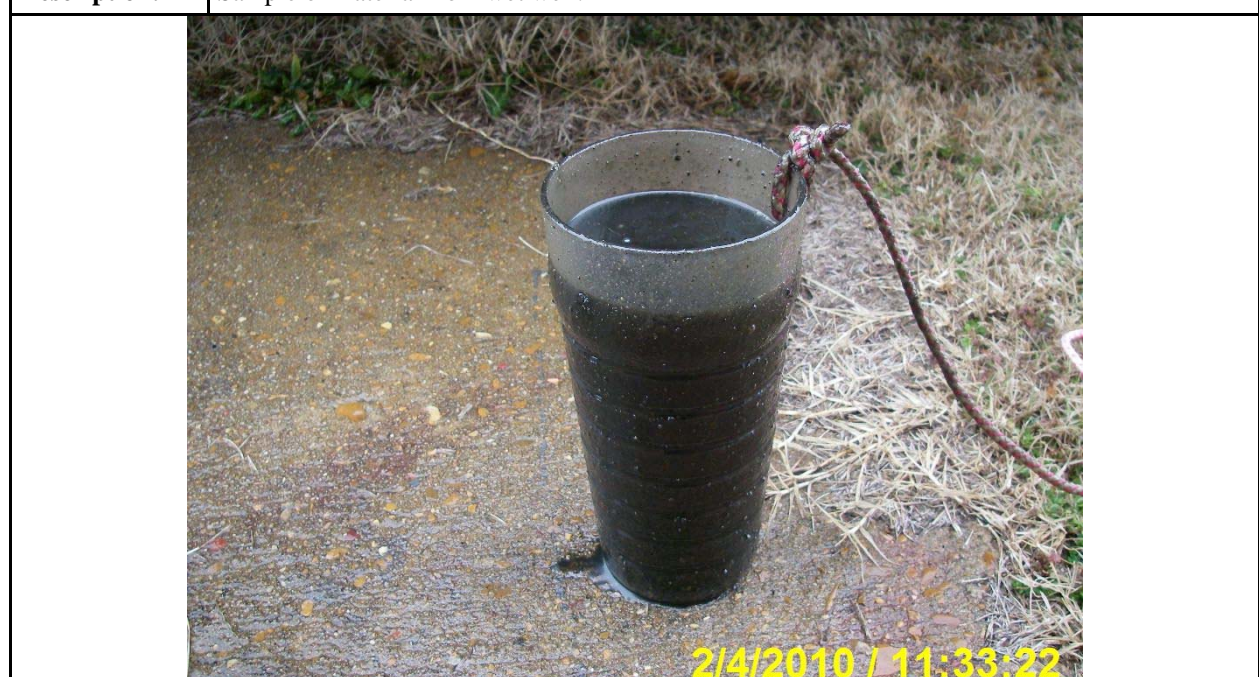
Photo # 2 **Of** 34 **Date:** 2/4/2010 **Time:** 1133

Description: Sample of material from wet well.

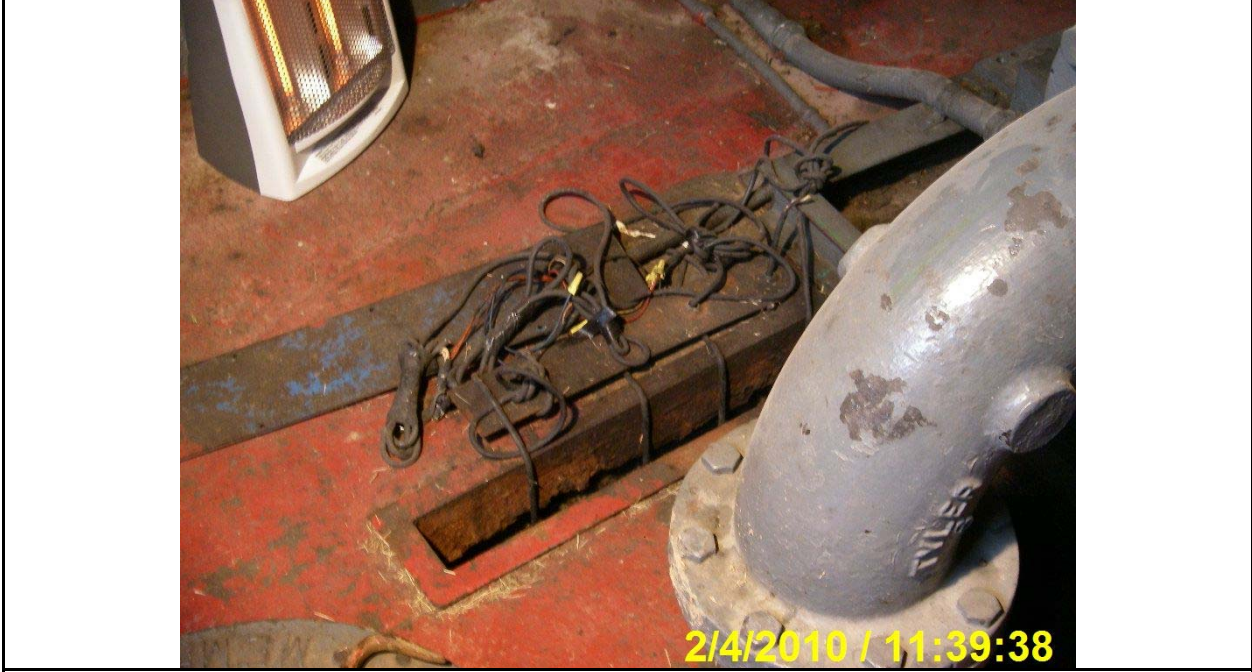
Description:	Exposed wiring for floats.						
---------------------	----------------------------	--	--	--	--	--	--

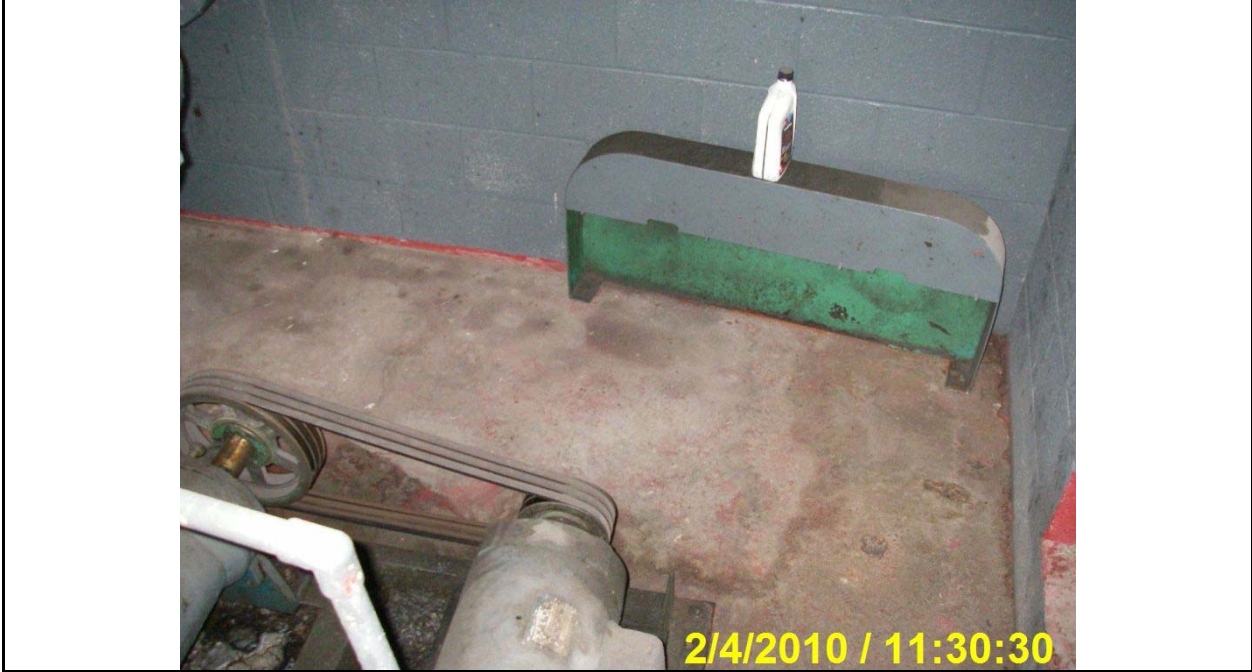
Photo #	4	Of	34	Date:	2/4/2010	Time:	1130
----------------	---	-----------	----	--------------	----------	--------------	------

Description:	Guard removed from belts.						
---------------------	---------------------------	--	--	--	--	--	--

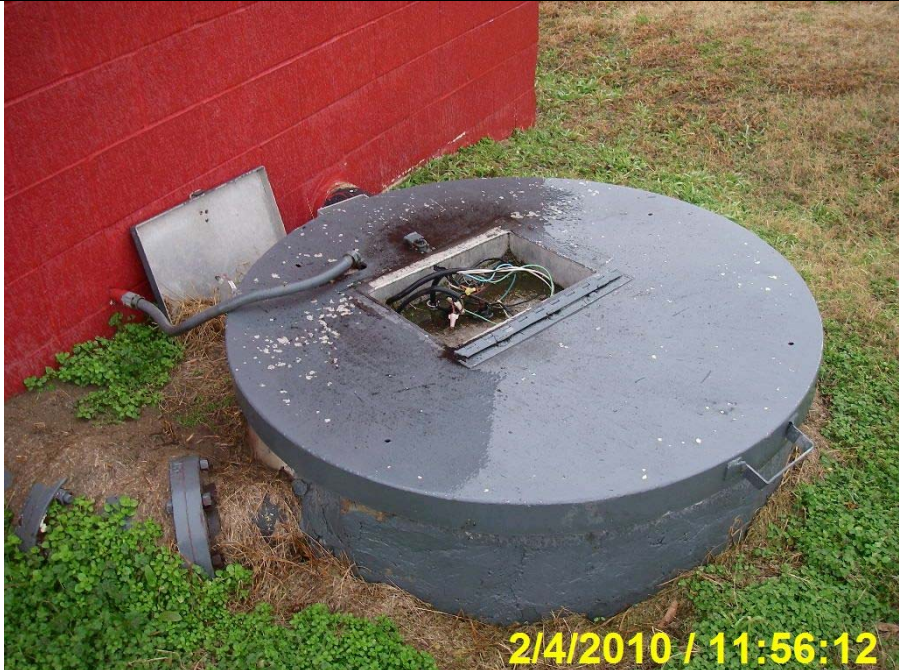
Description: Exposed wiring on outside of station.

2. Pump Station-13 (Club Road)
 - a. The wet well was cleaned on April 27, 2010 by Jim's Tank Service. As of this date there is no sign of petroleum oil in the wet well.
 - b. The exposed wiring and connections for the float switches on the outside of the pump stations have been covered up and locked.
 - c. At the time of the inspection there was evidence of an overflow from an adjacent manhole. There was a problem with this manhole and it has been repaired.
 - d. Both pumps are operational at this time.

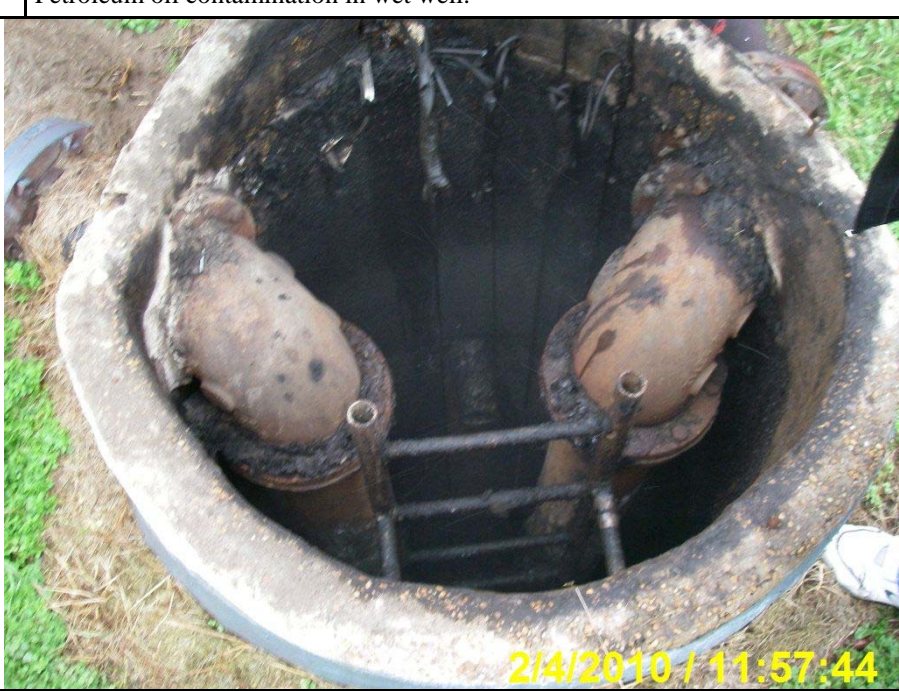
Photo # 6 **Of** 34 **Date:** 2/4/2010 **Time:** 1157

Description: Petroleum oil contamination in wet well.

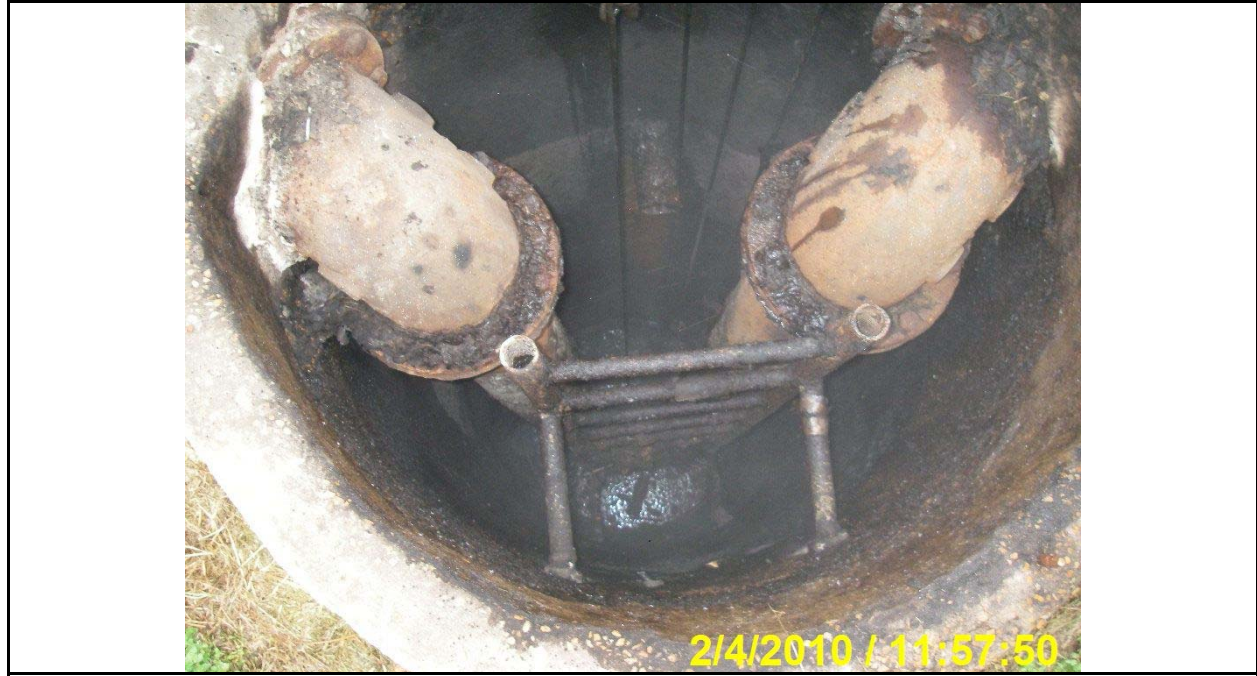
Description: Petroleum oil in wet well.

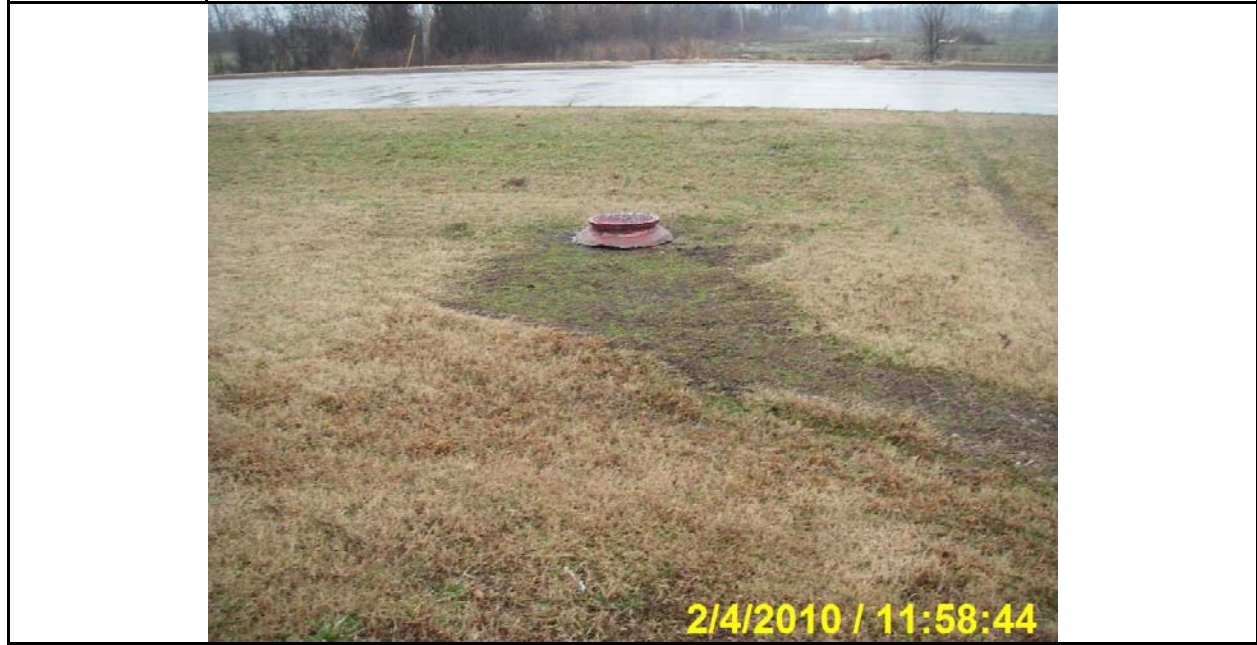
Photo # 8 **Of** 34 **Date:** 2/4/2010 **Time:** 1158

Description: Evidence of recent overflow from adjacent manhole indicated by the difference in the thickness, height and color of vegetation.

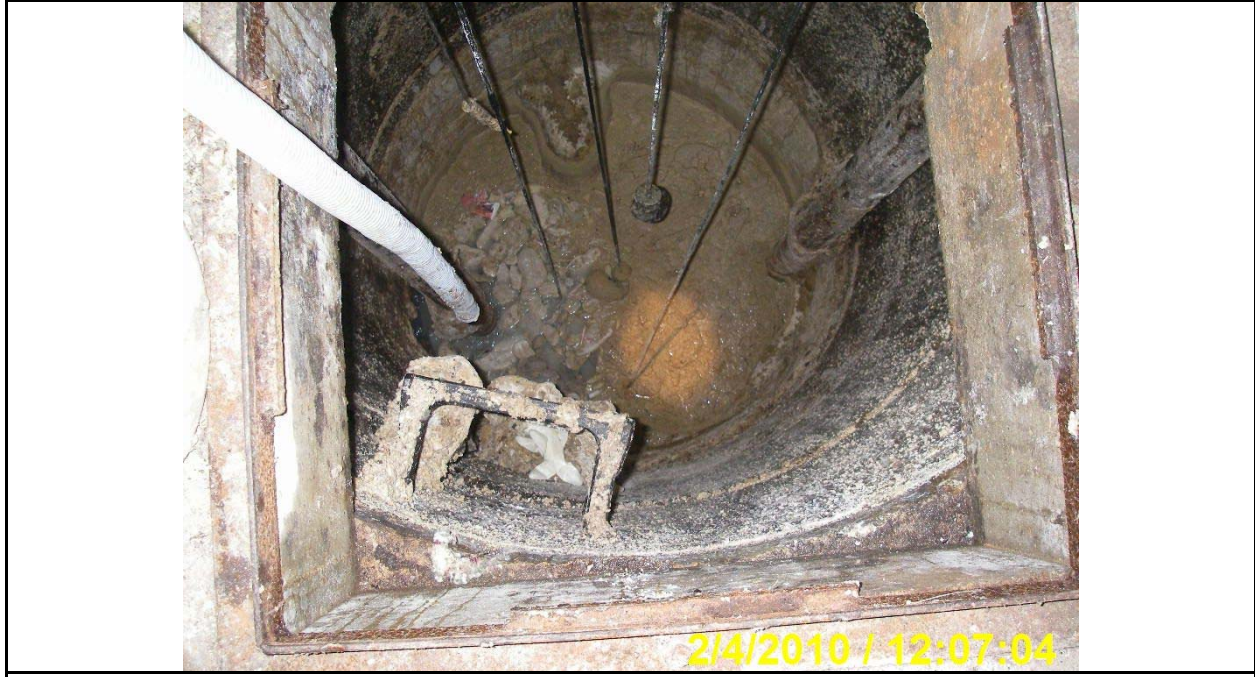
Description:	Excessive grease in wet well.						
---------------------	-------------------------------	--	--	--	--	--	--

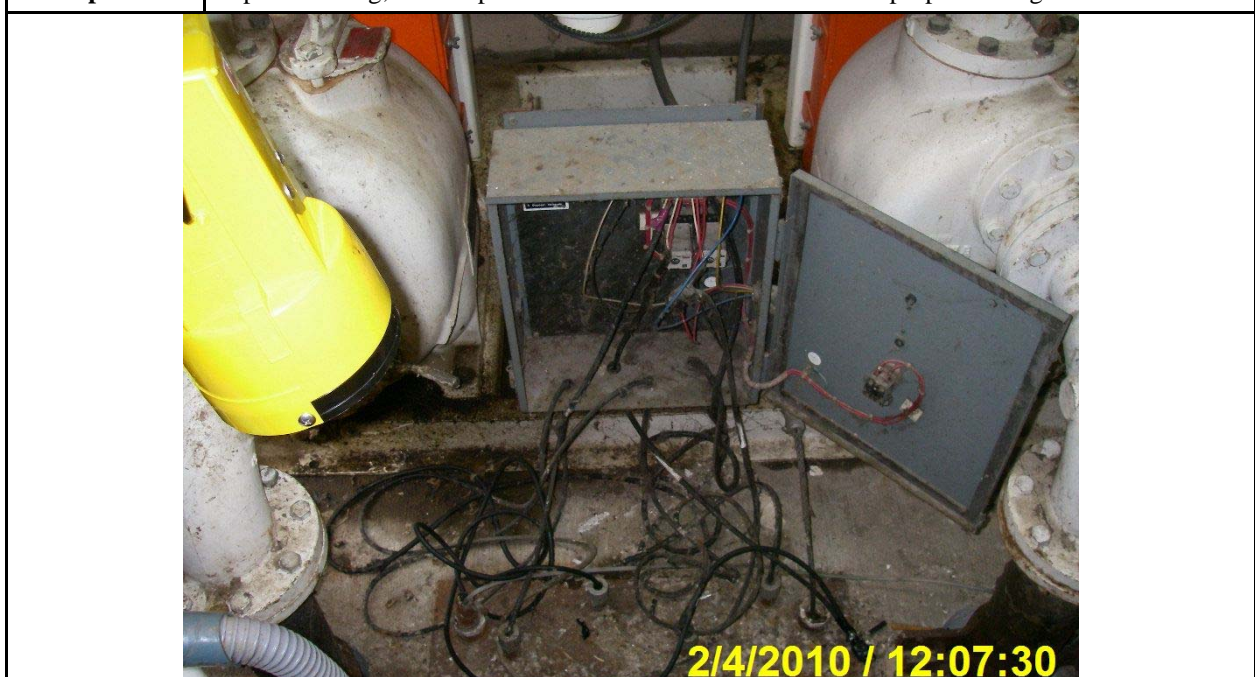
Photo #	10	Of	34	Date:	2/4/2010	Time:	1207
----------------	----	-----------	----	--------------	----------	--------------	------

Description:	Exposed wiring; control panel door can not be closed due to improper routing of wires.						
---------------------	--	--	--	--	--	--	--

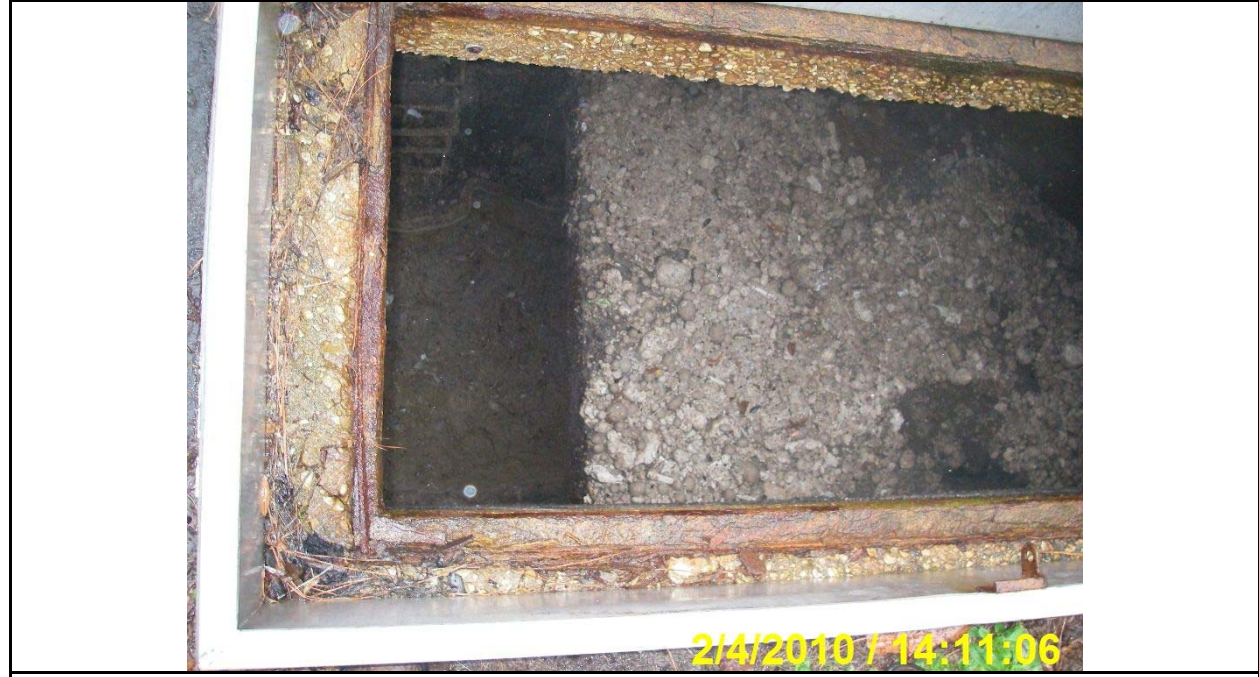
Description:	Excessive grease in wet well.						
---------------------	-------------------------------	--	--	--	--	--	--

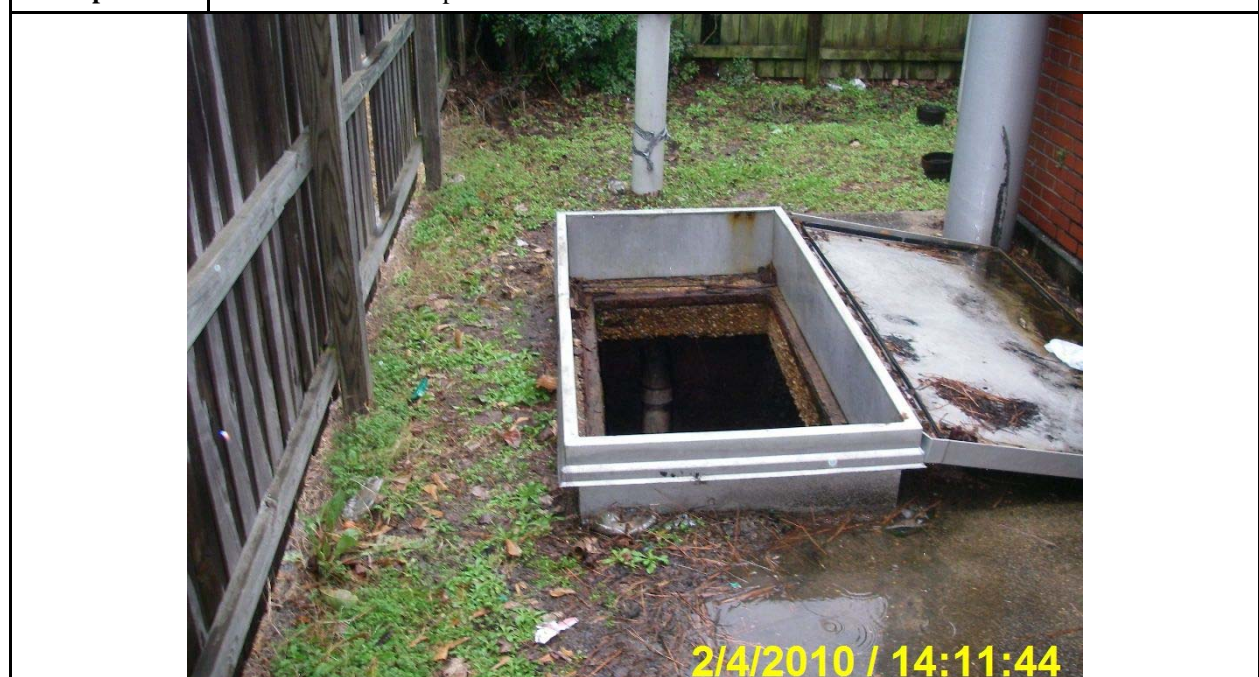
Photo #	12	Of	34	Date:	2/4/2010	Time:	1411
----------------	----	-----------	----	--------------	----------	--------------	------

Description:	Wet well cover left open.						
---------------------	---------------------------	--	--	--	--	--	--

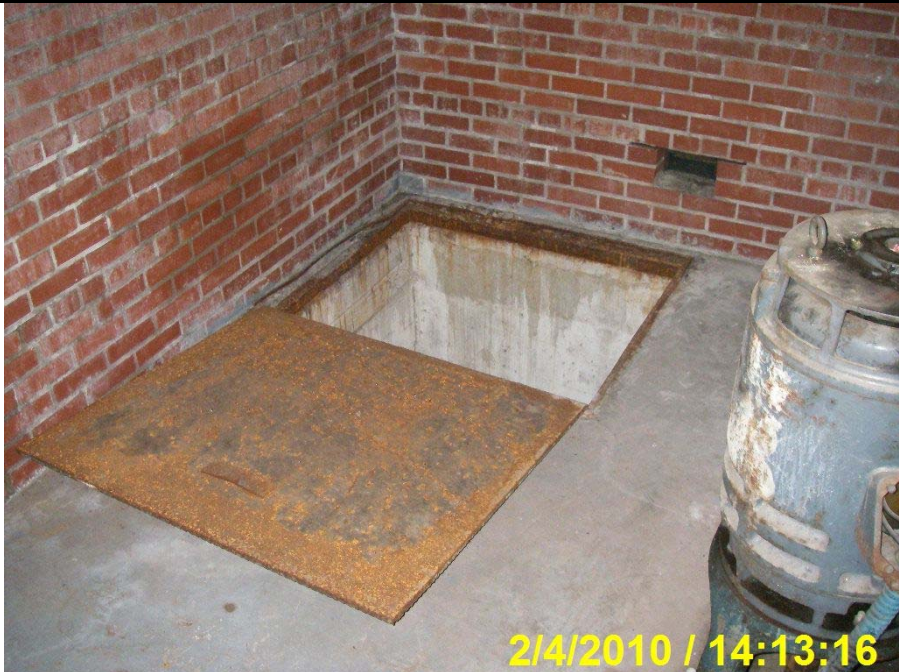
Location:	City of West Memphis – Station #6						
Photographer:	Brent Walker			Witness:	None		
Photo #	13	Of	34	Date:	2/4/2010	Time:	1413
Description:	Hatch left open.

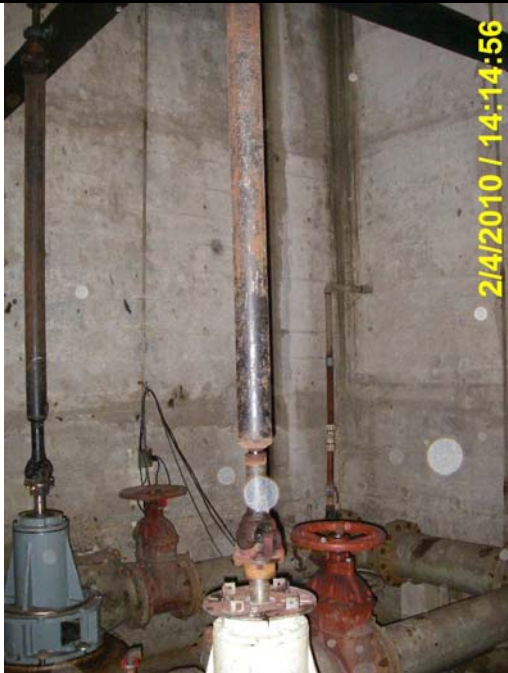
Photographer:	Brent Walker			Witness:	None		
Photo #	14	Of	34	Date:	2/4/2010	Time:	1414
Description:	Pump shafts with guards removed.

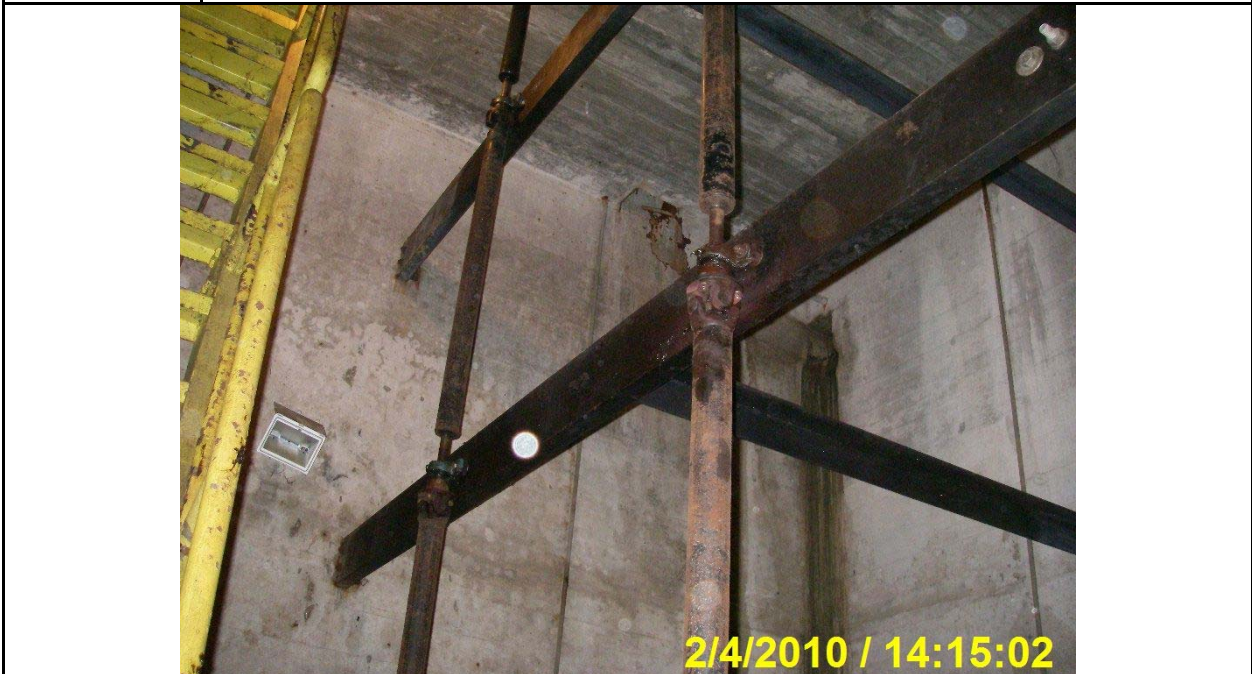
Description: Pump shafts with guards removed.

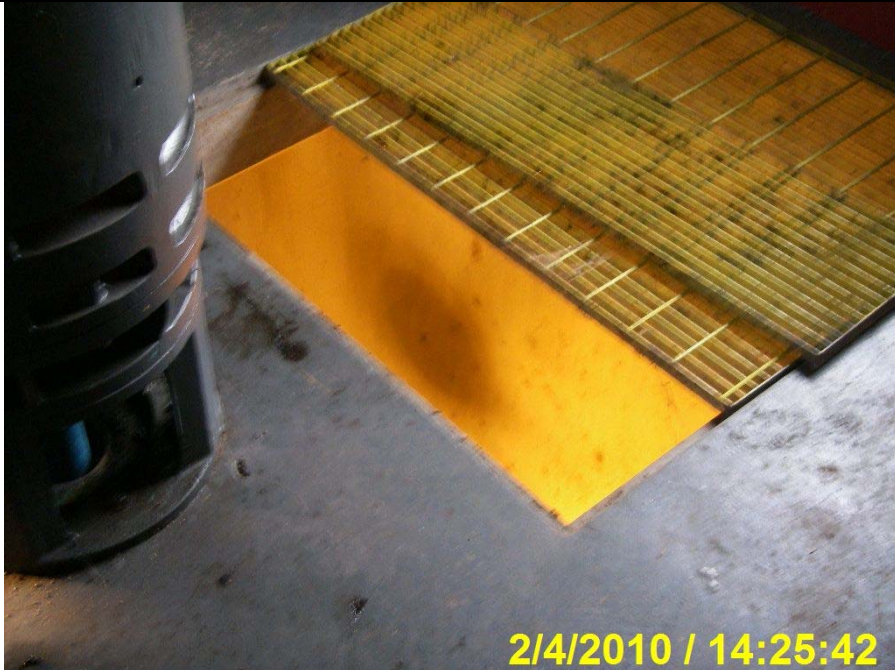
Description: Open grating.

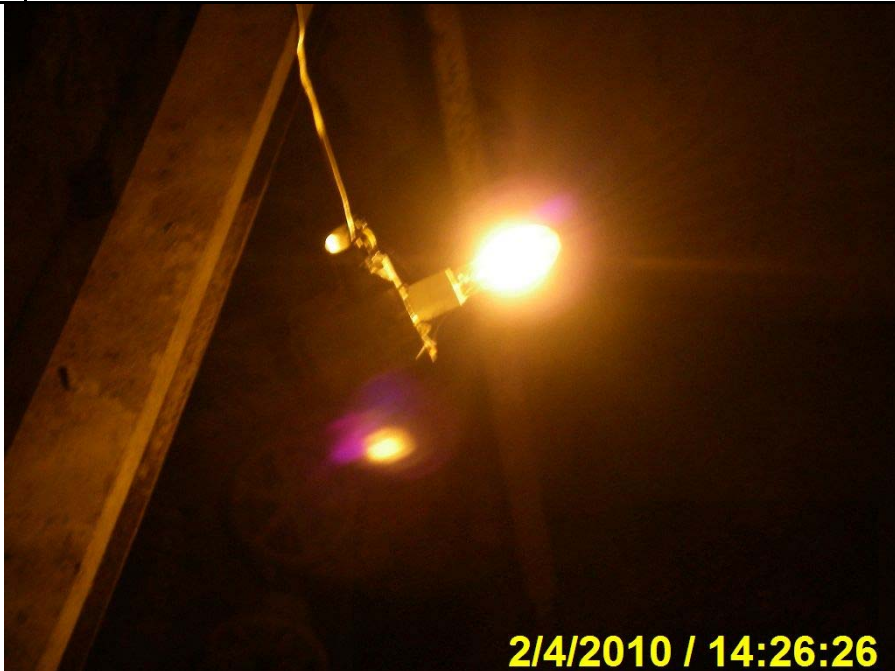
Description: Light hanging from wire.

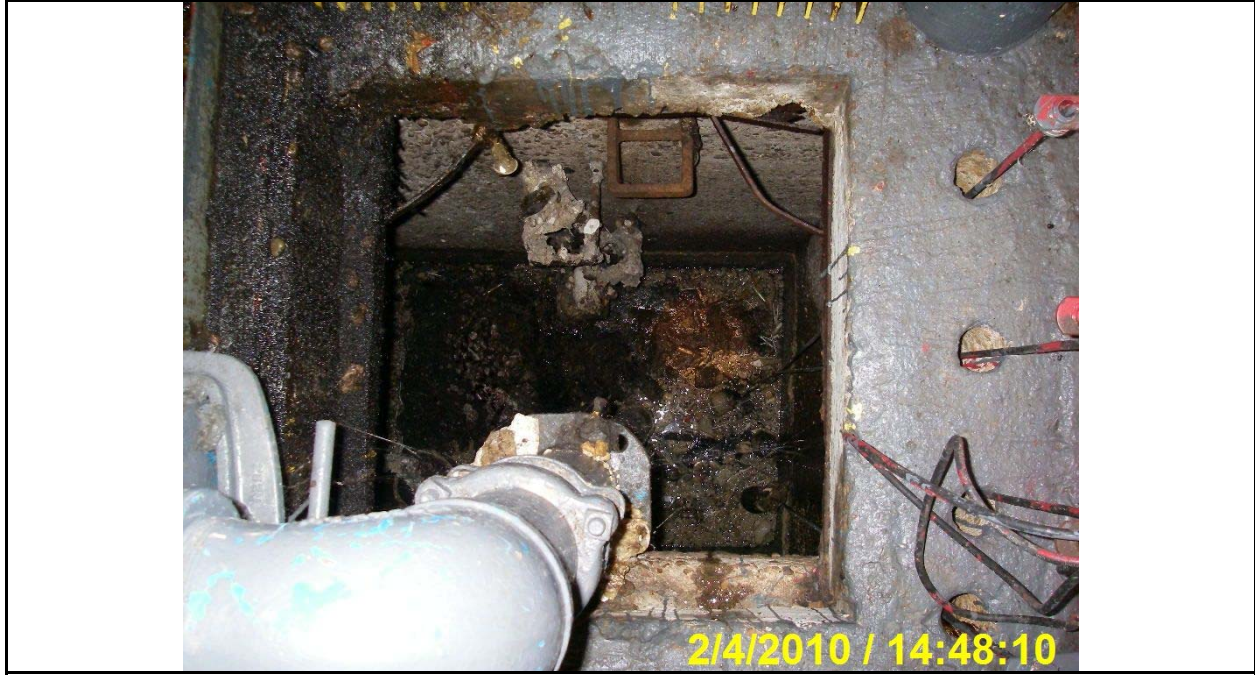
Description:	Excessive grease in wet well.						
---------------------	-------------------------------	--	--	--	--	--	--

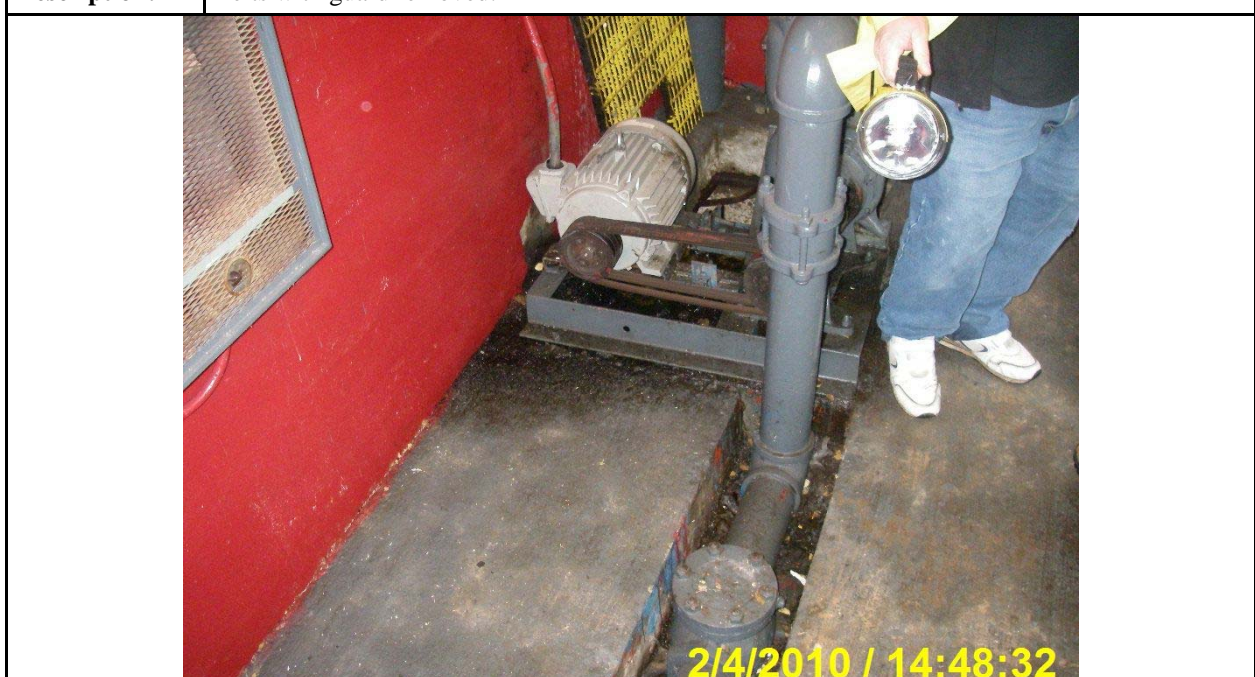
Photo #	22	Of	34	Date:	2/4/2010	Time:	1448
----------------	----	-----------	----	--------------	----------	--------------	------

Description:	Belts with guard removed.						
---------------------	---------------------------	--	--	--	--	--	--

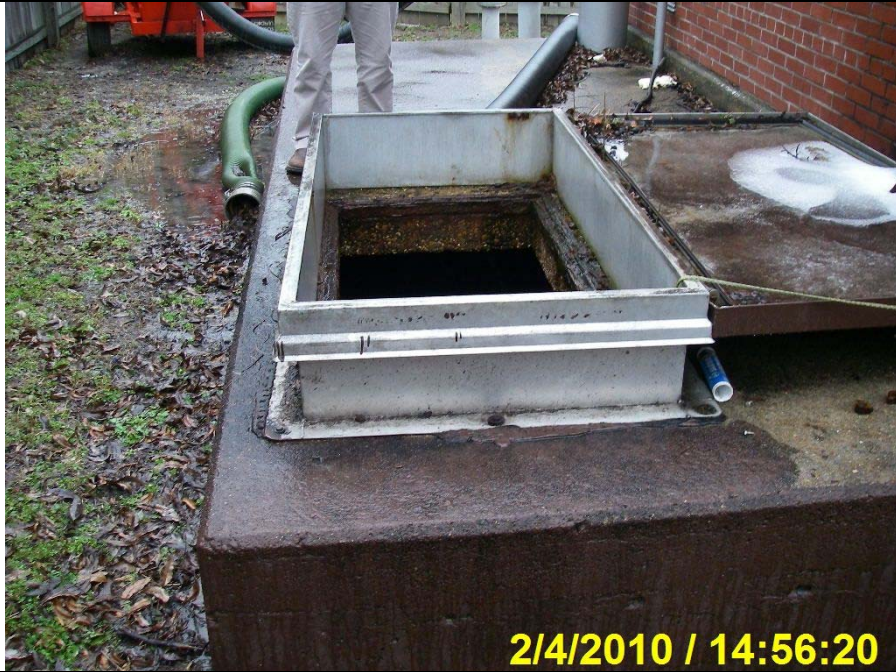
Description: Wet well cover open.

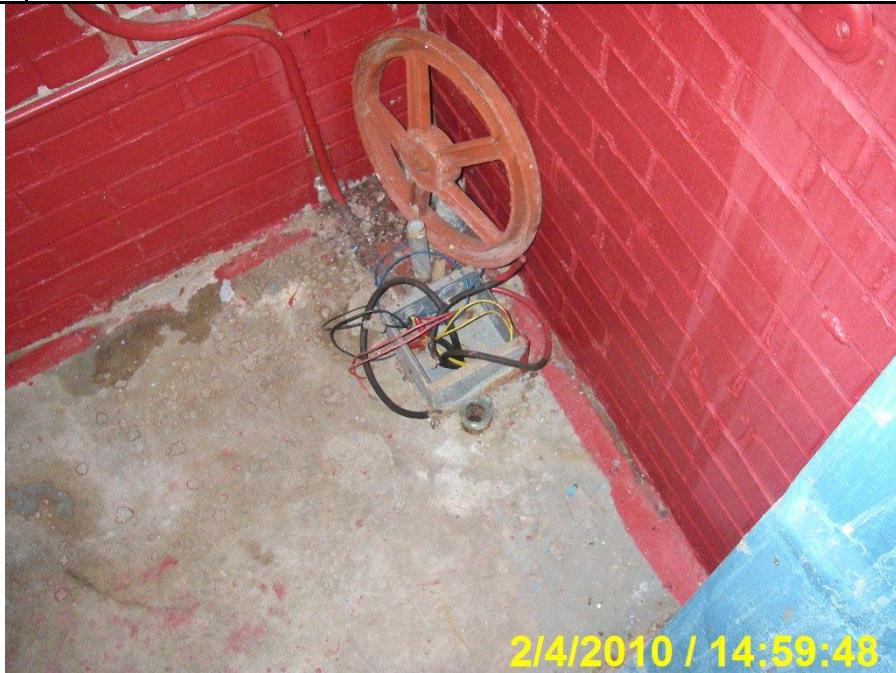
Photo # 24 **Of** 34 **Date:** 2/4/2010 **Time:** 1459

Description: Exposed wiring.

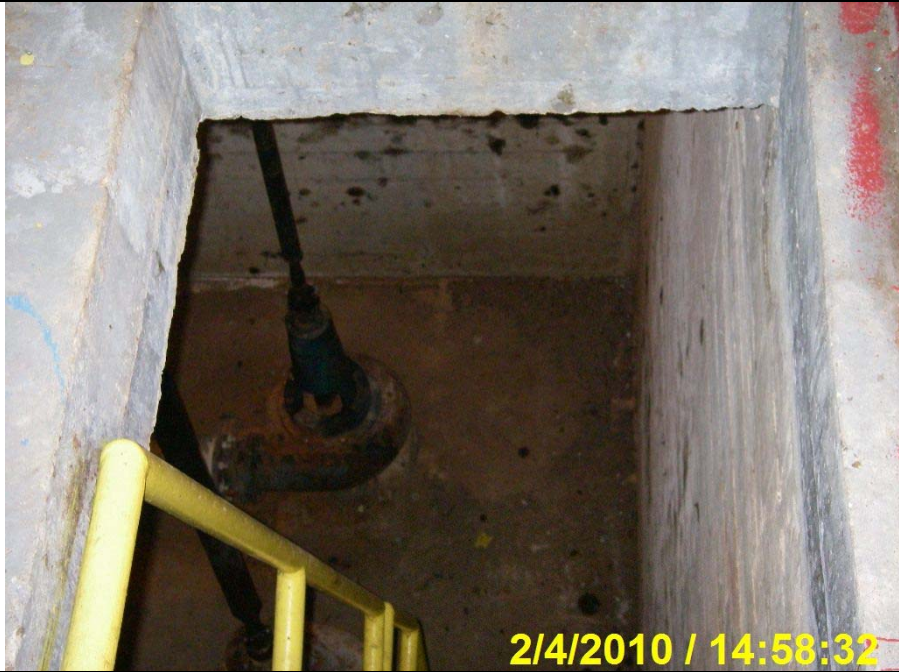
Description:	Pump shaft with guard removed.						
---------------------	--------------------------------	--	--	--	--	--	--

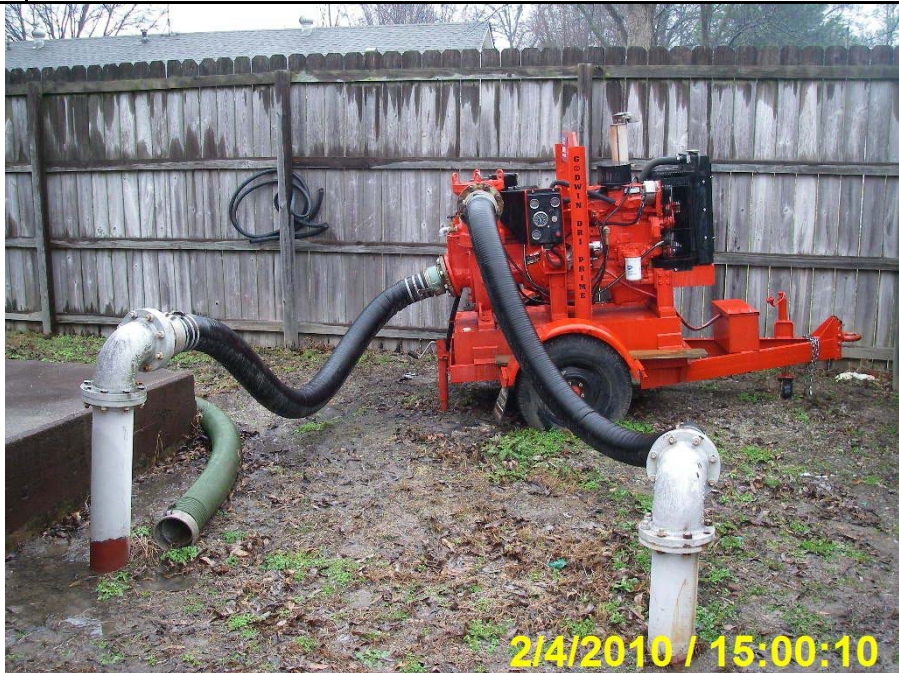
Photo #	26	Of	34	Date:	2/4/2010	Time:	1500
----------------	----	-----------	----	--------------	----------	--------------	------

Description:	Auxiliary pump used for high flows.						
---------------------	-------------------------------------	--	--	--	--	--	--

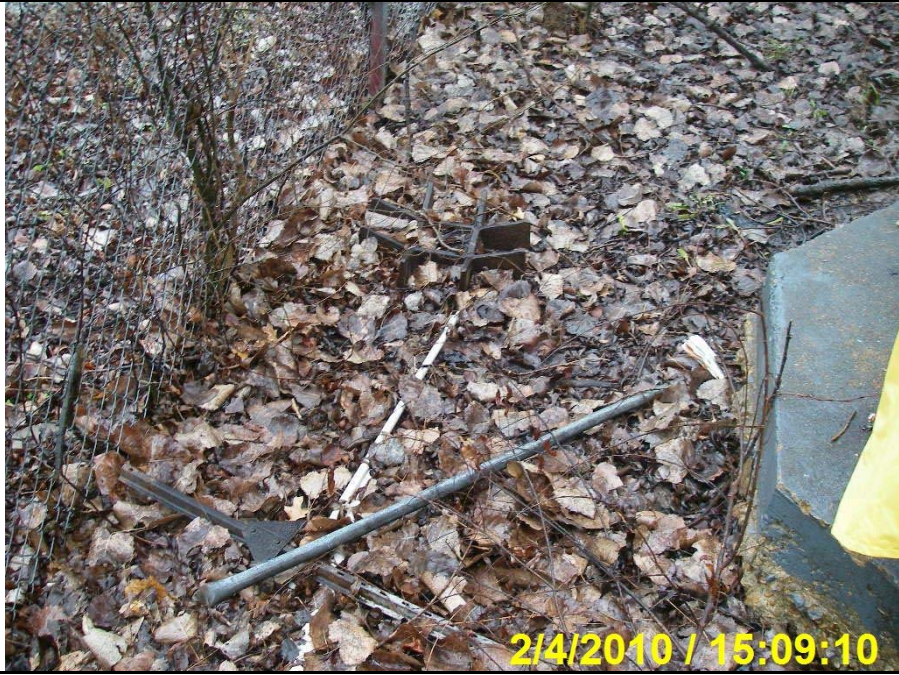
Description: Manhole cover off wet well and upside down in leaves.

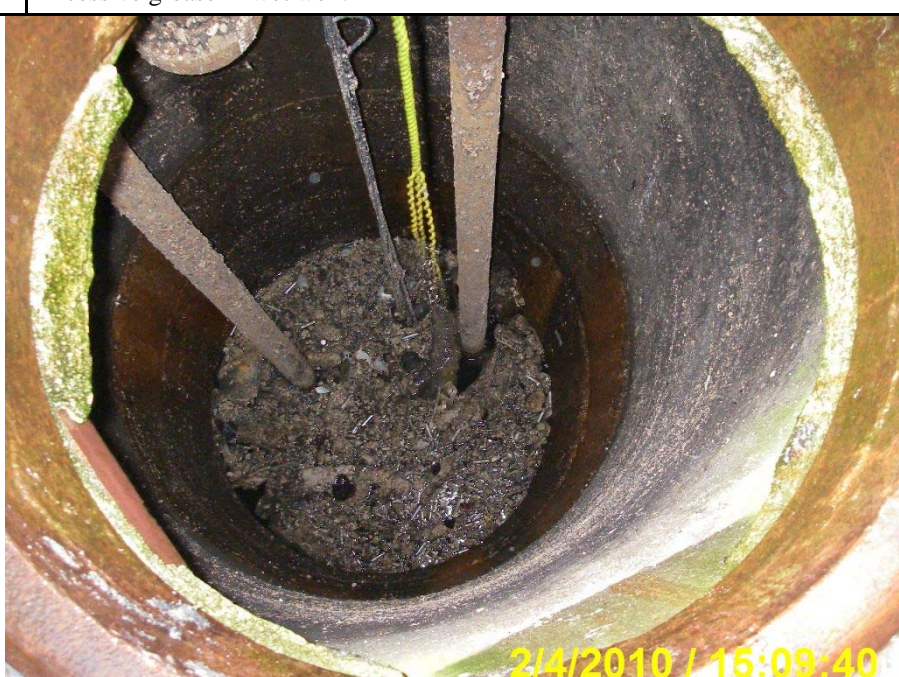
Photo # 28 **Of** 34 **Date:** 2/4/2010 **Time:** 1509

Description: Excessive grease in wet well.

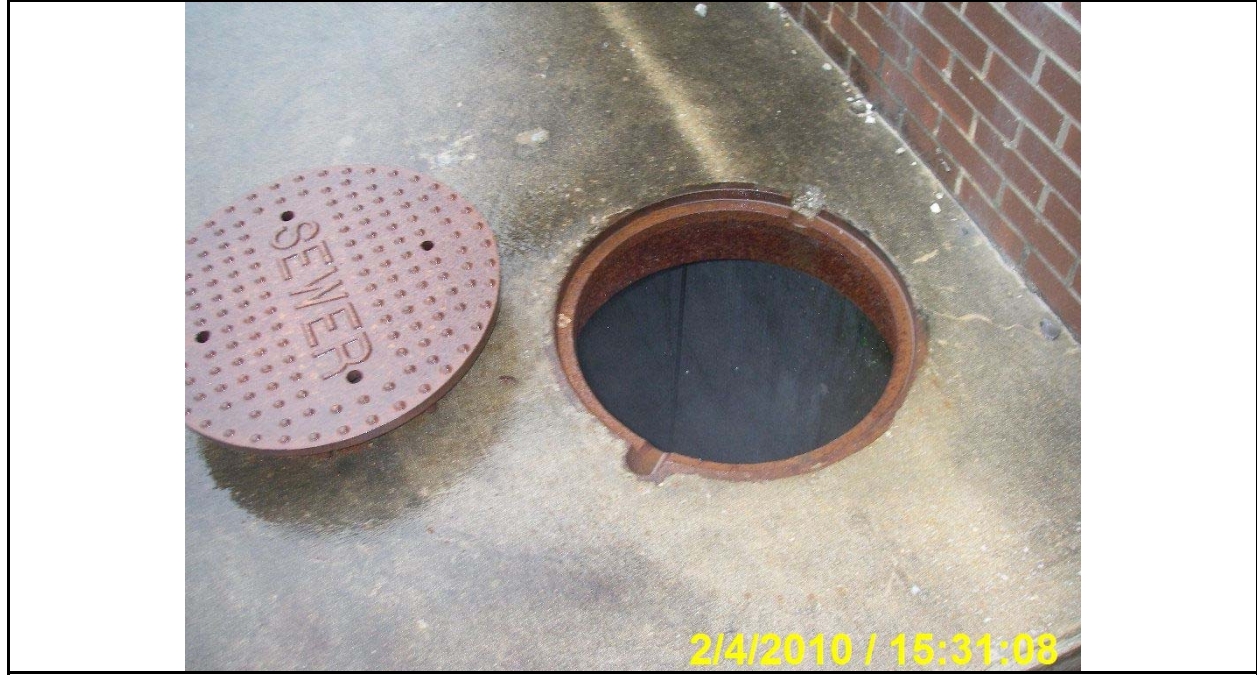
Description: Manhole cover off wet well.

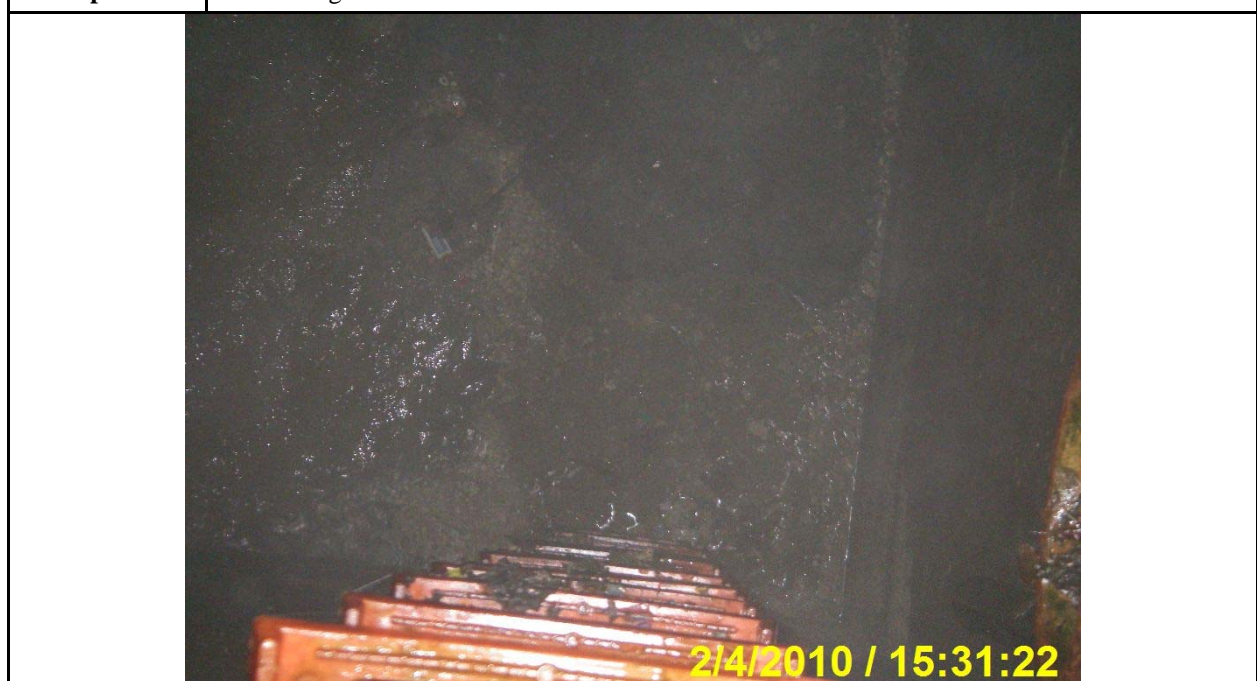
Description: Excessive grease in wet well.

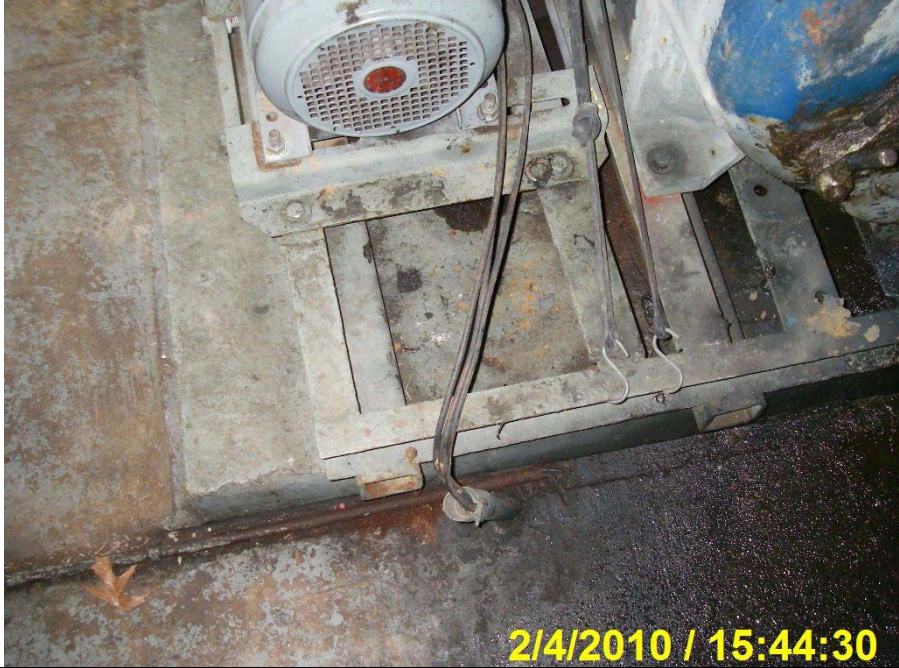
Description:	Exposed wiring.						
---------------------	-----------------	--	--	--	--	--	--

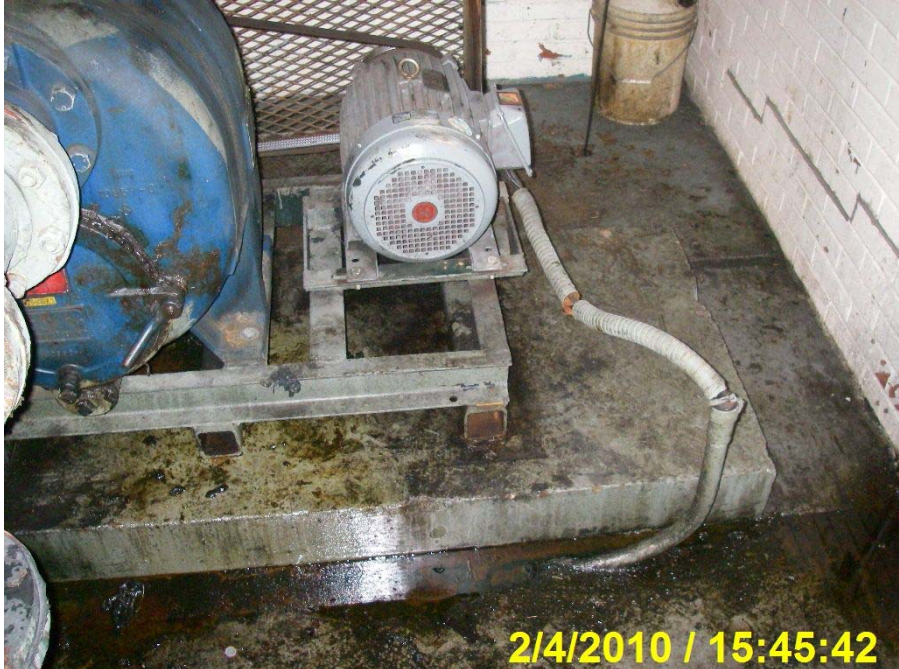
Description:	Broken conduit/exposed wiring.						
---------------------	--------------------------------	--	--	--	--	--	--

- d. The guards/covers for the drive shaft for the pumps are in place.
11. Pump Station-20 (603 North 7th)
- a. The conduit leading to the electric motors for the pumps has been replaced.

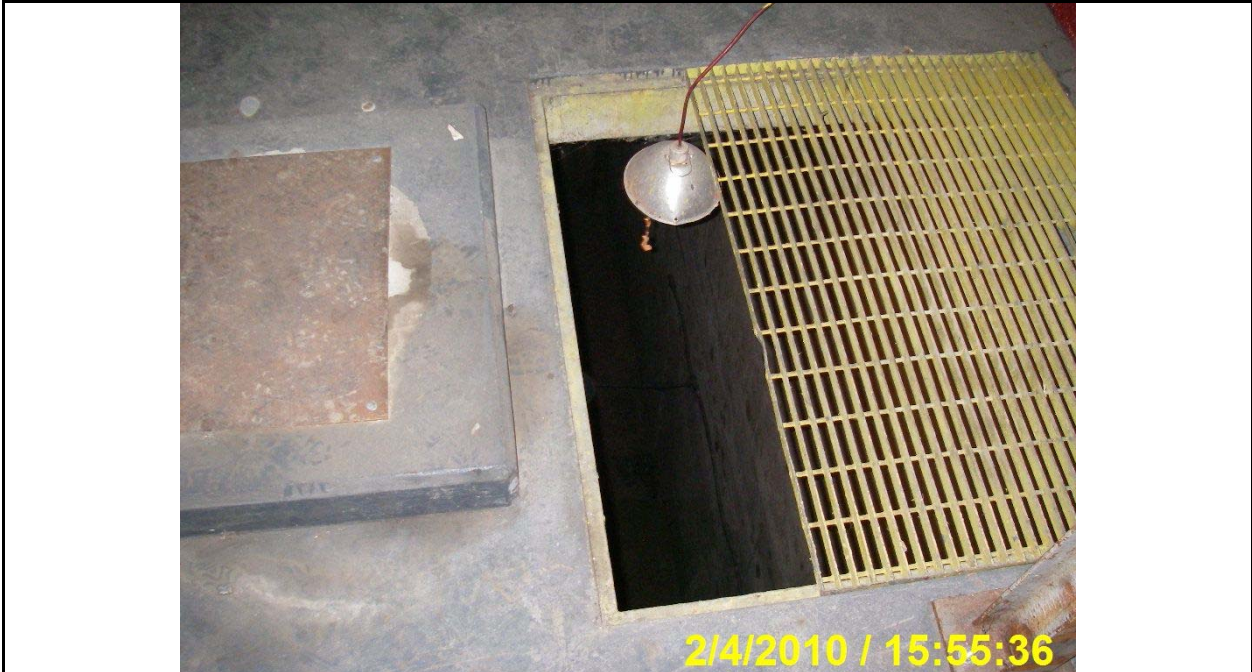
Description:	Open grate with drop light.						
---------------------	-----------------------------	--	--	--	--	--	--
