ARKANSAS
Department of Environmental Quality

RE: Sanitary Sewer Overflow Inspection

NPDES Permit No.: AR0022039

NPDES Compliance Inspection Report

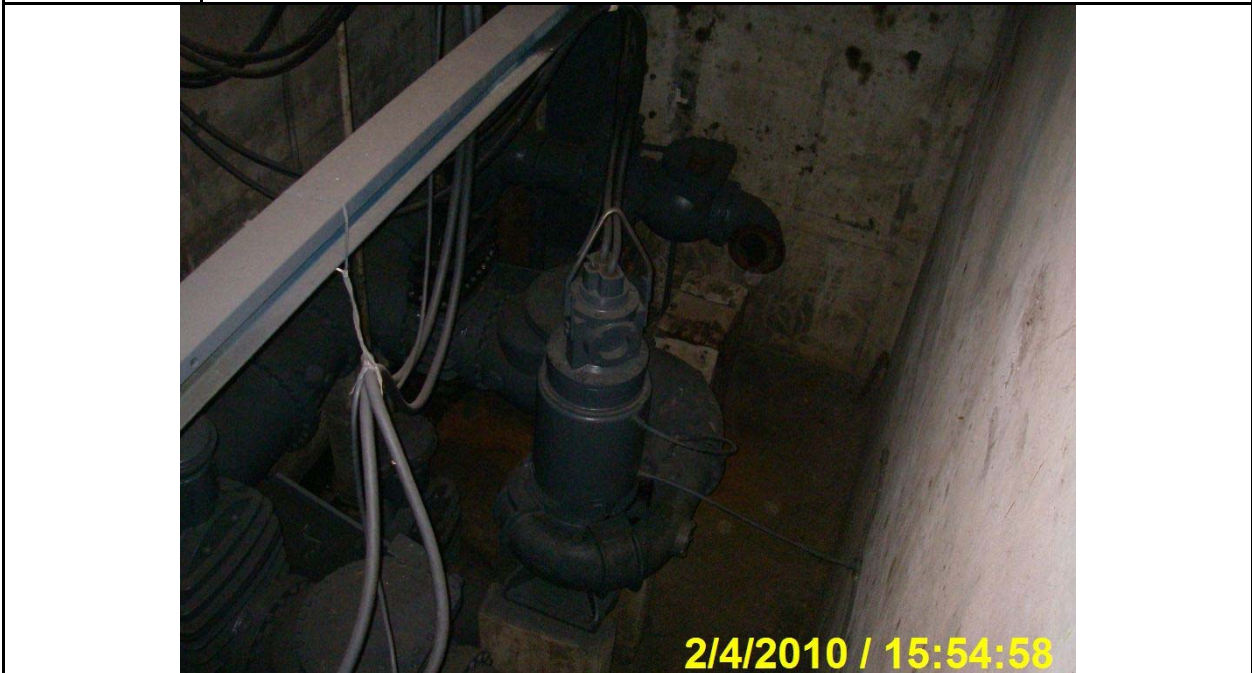
Description:	Lights inoperative in lower level.						
---------------------	------------------------------------	--	--	--	--	--	--

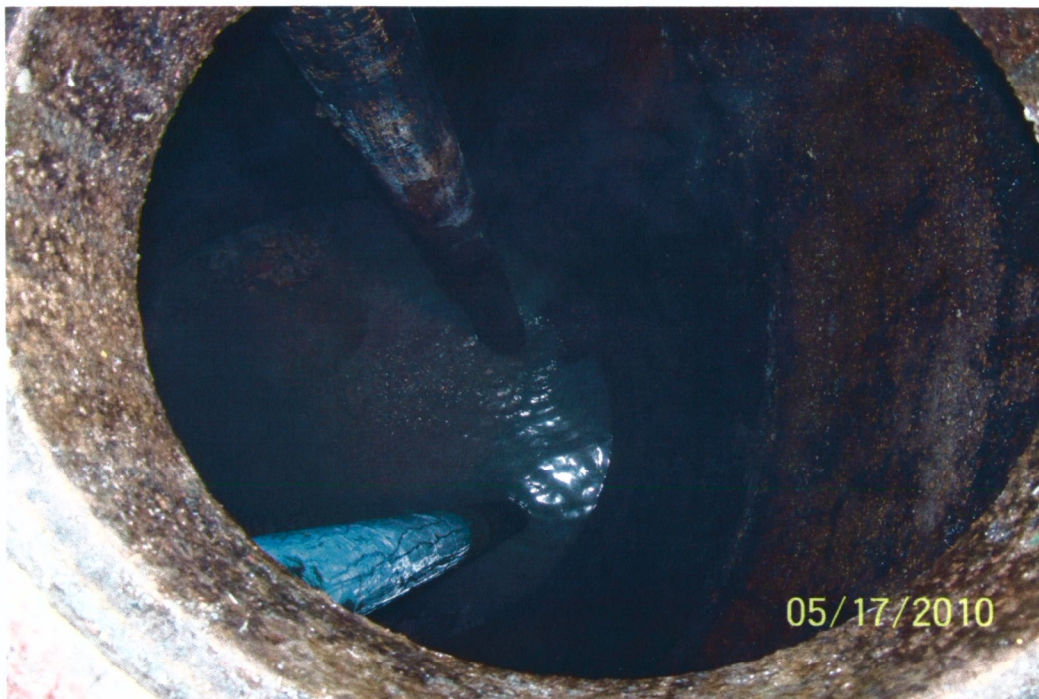
Location: Pump Station-25 (mound City Road)

Description: Wet Well

1. Pump Station-25 (Mound City Road)
 - a. The wet well was cleaned on April 26, 2010 by Jim's Tank Service. As of this date there is no sign of petroleum oil in the wet well. The cause was found to be a business located close to the pump station.
 - b. The electrical wiring and connections for the float switches has been covered up.
 - c. The safety guards for the drive belts between the motors and pumps have been put in place.
 - d. The suction line on one of the pumps was bad and it was replaced. Both pumps are operational at this time.

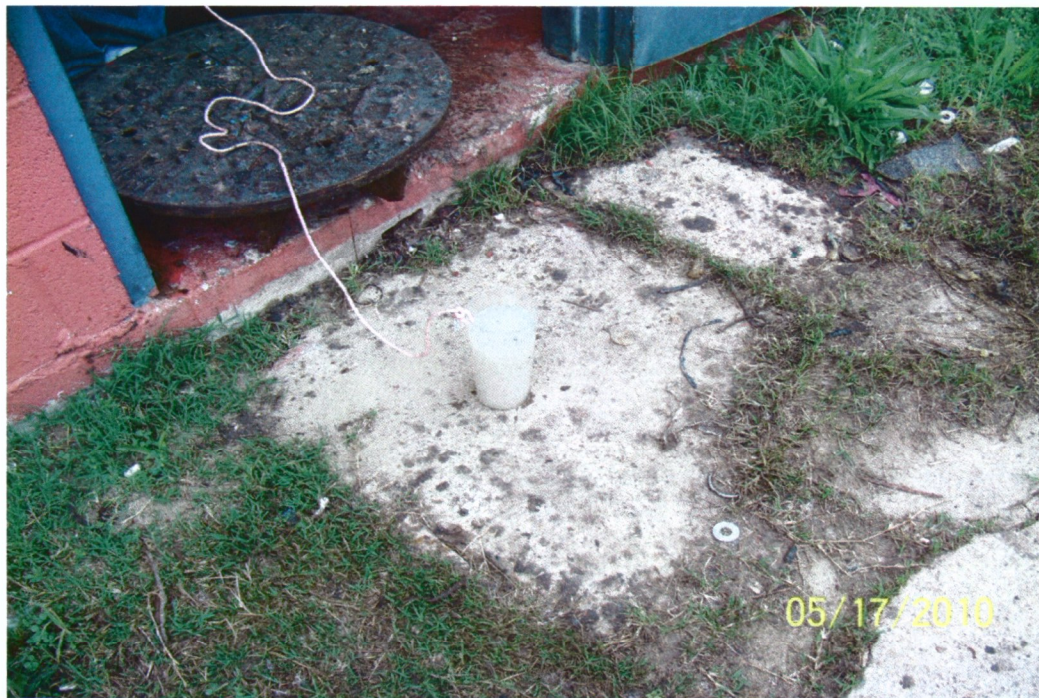
Description: Sample of contents of wet well

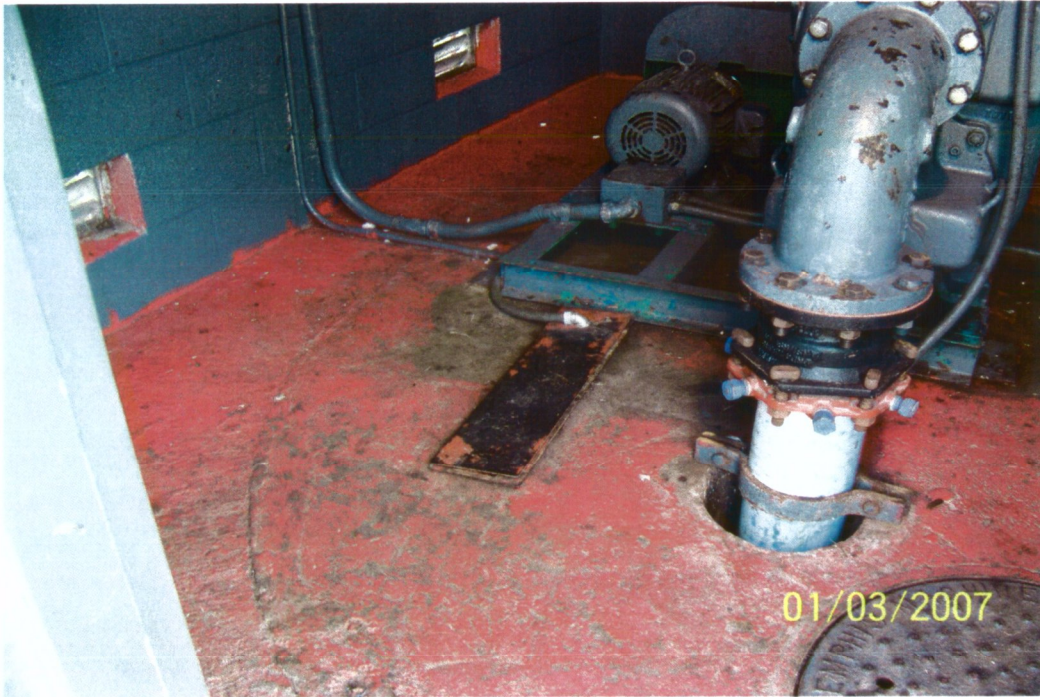
Location:	Pump Station-25 (Mound City Road)		
Photographer:	Denise Bosnick	Witness:	Marvin Jones
Photo #:	Of	Date:	5/17/2010
Description:	Exposed wiring (Covered)

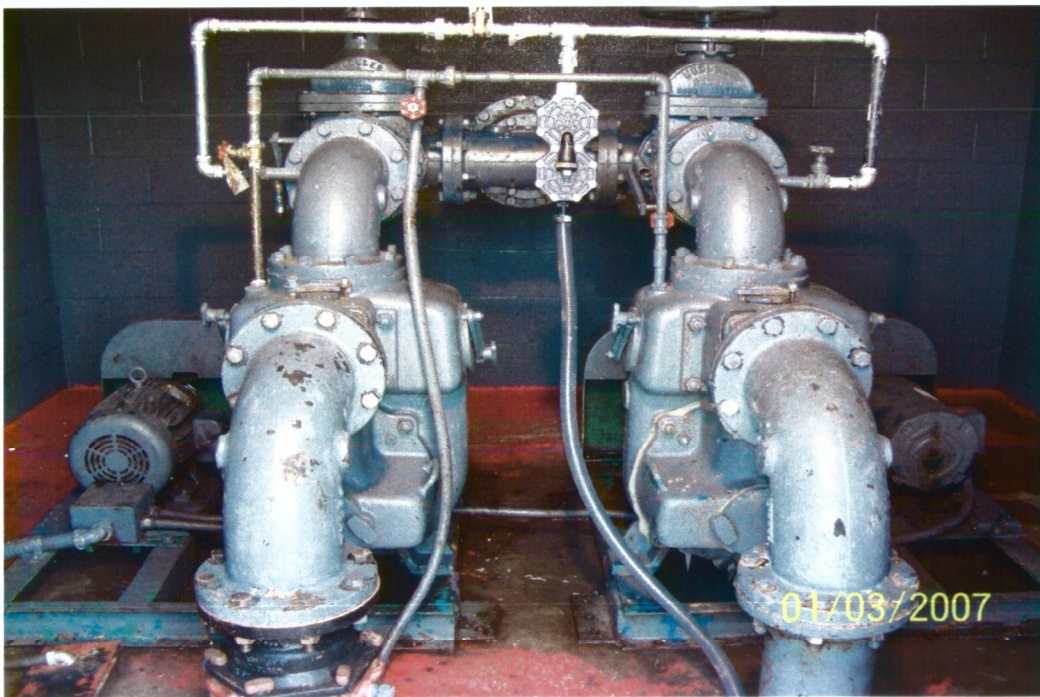
Location:	Pump Station-25 (Mound City Road)		
Photographer:	Denise Bosnick	Witness:	Marvin Jones
Photo #:	Of	Date:	5/17/2010
Description:	Guards replaced on belts.

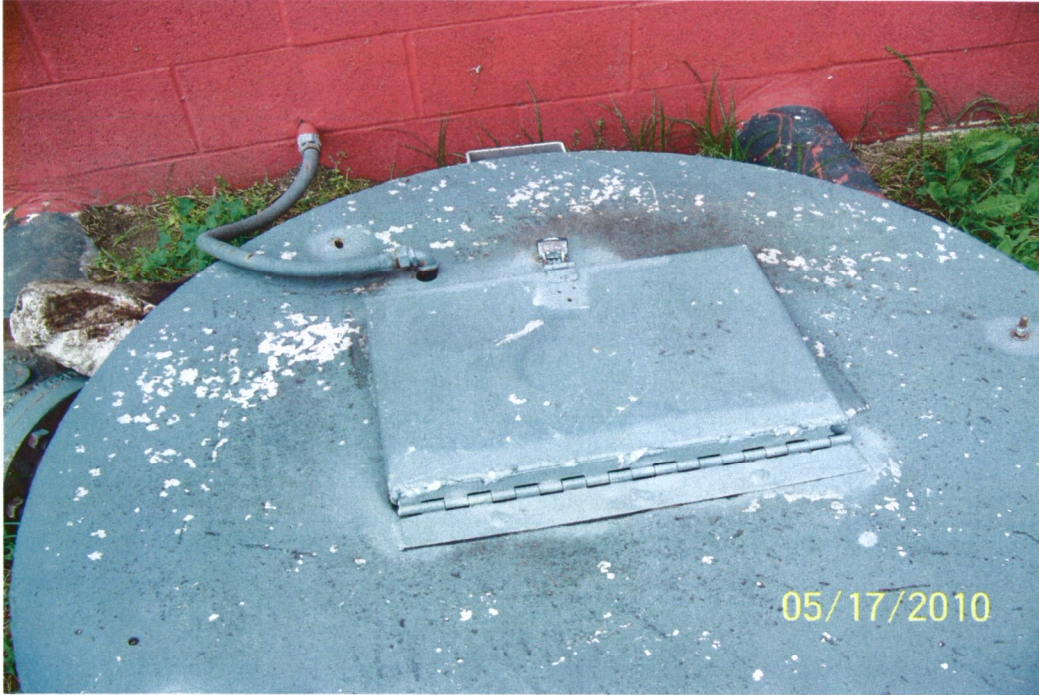
Description: Exposed wiring on outside of station. (Covered and locked)

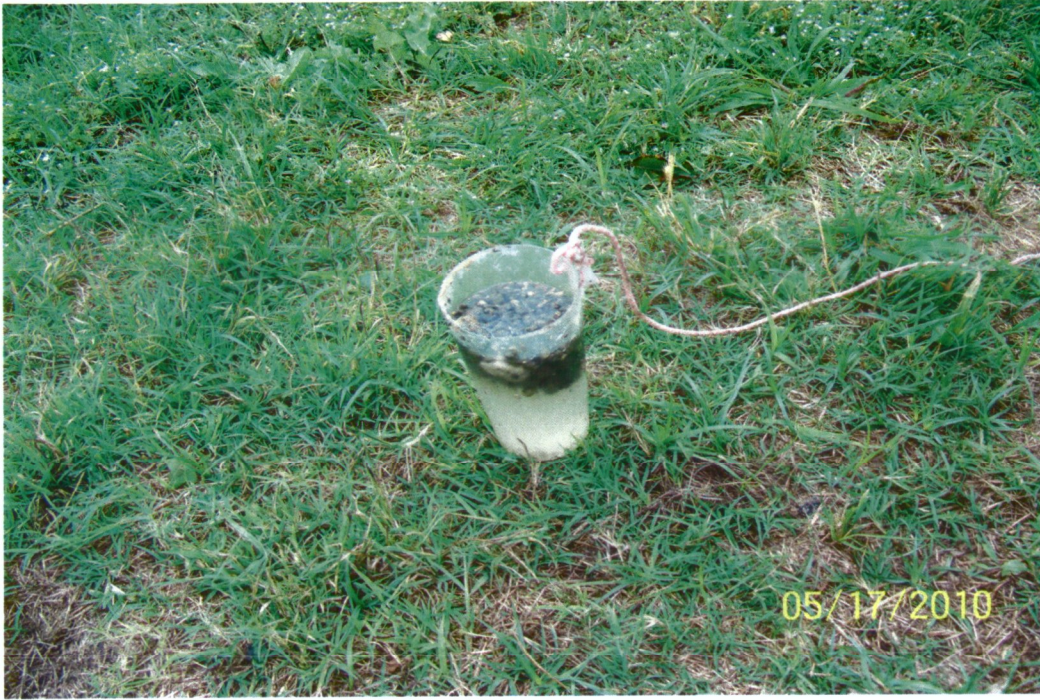
Location:	Pump Station-13 (Club Road)		
Photographer:	Denise Bosnick	Witness:	Marvin Jones
Photo #:	Of	Date:	5/17/2010
Description:	Sample from the wet well (Not Petroleum oil)

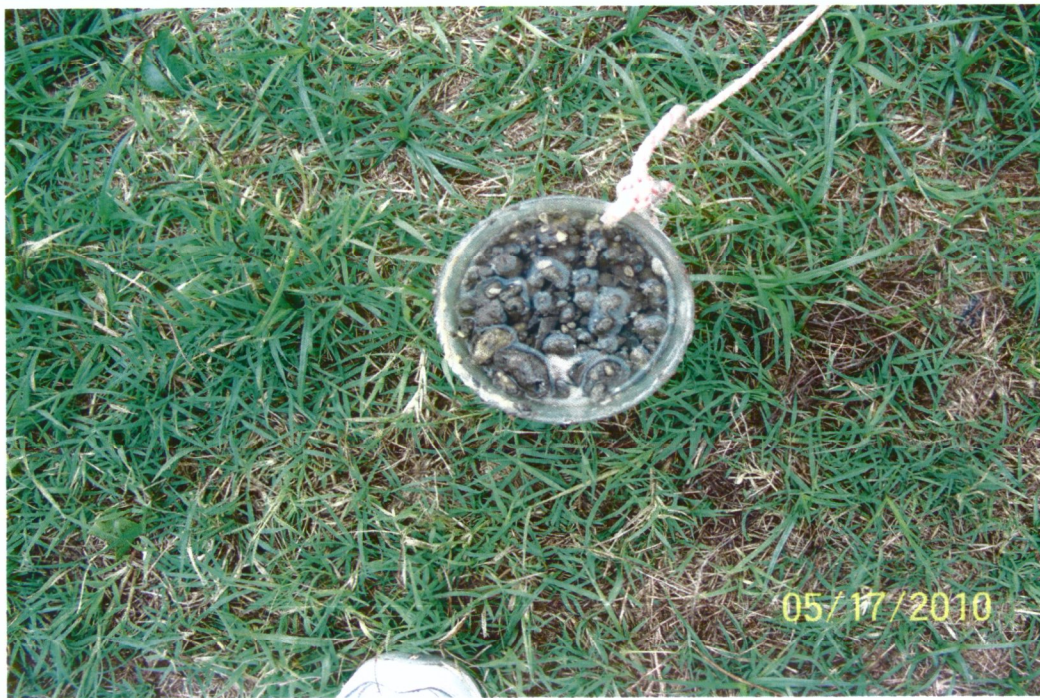
Location:	Pump Station-13 (Club Road)		
Photographer:	Denise Bosnick	Witness:	Marvin Jones
Photo #:	Of	Date:	5/17/2010
Description:	Sample from the wet well (Not Petroleum oil)

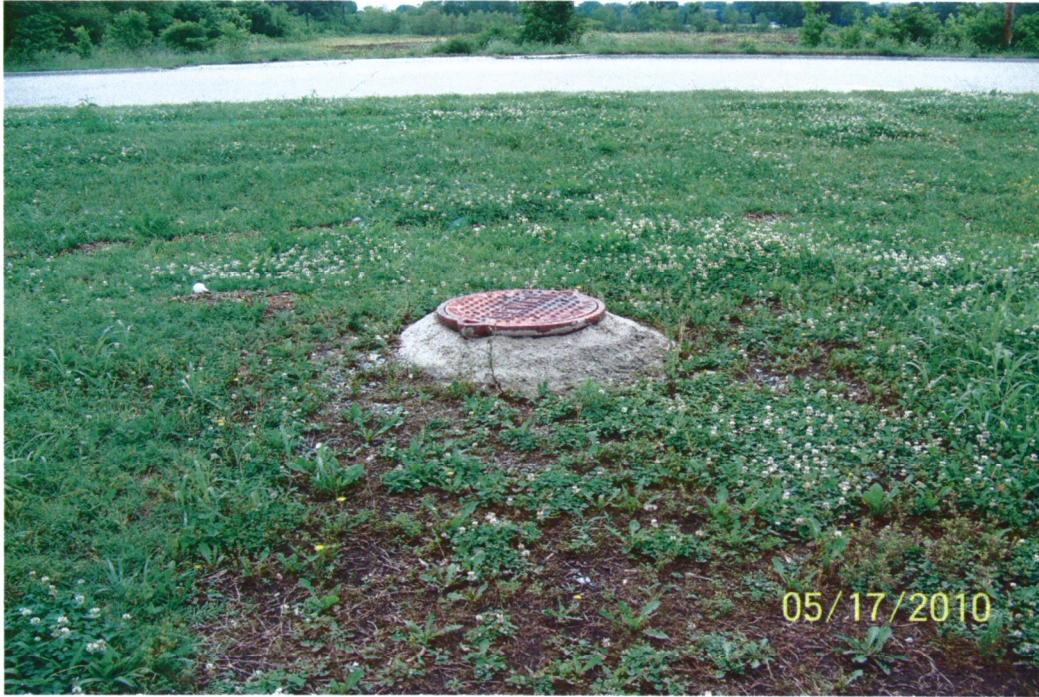
Location:	Pump Station-13 (Club Road)		
Photographer:	Denise Bosnick	Witness:	Marvin Jones
Photo #:	Of	Date:	5/17/2010
Description:	Adjacent manhole was repaired

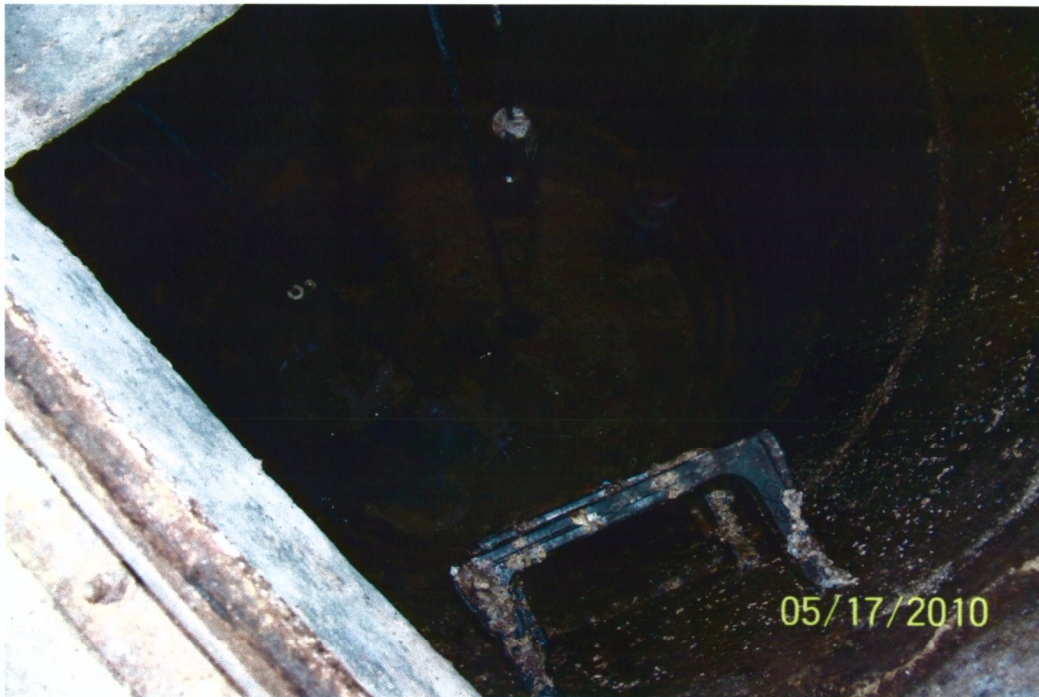
Location:	Pump Station-13A (Park Plaza)		
Photographer:	Denise Bosnick	Witness:	Marvin Jones
Photo #:	Of	Date:	5/17/2010
Description:	Wet Well

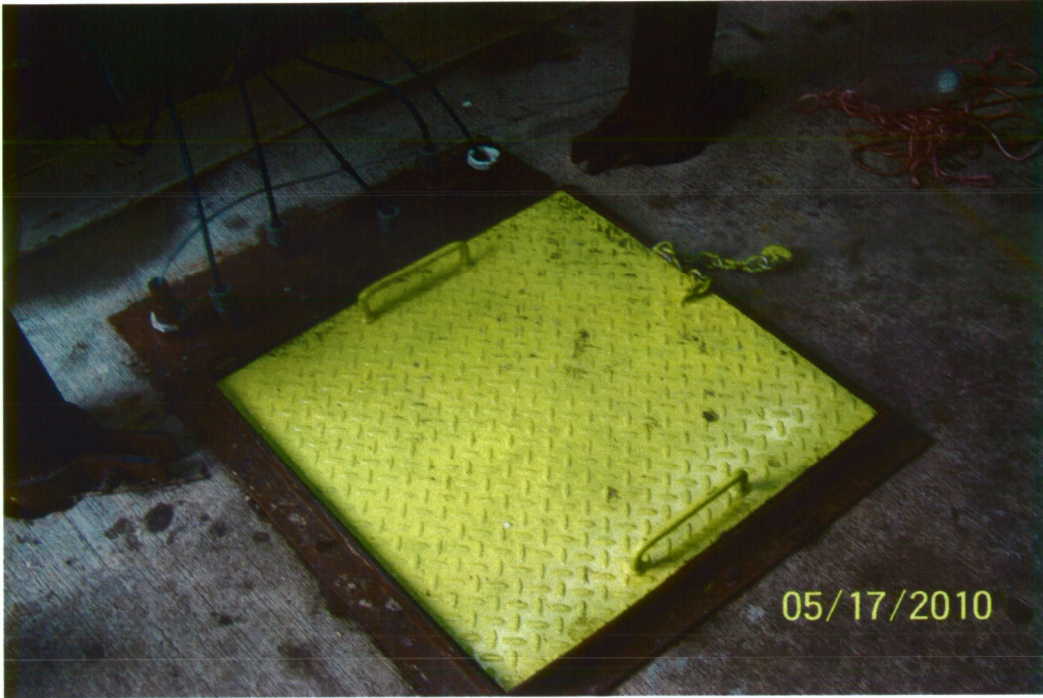
Description: Wet Well Covered

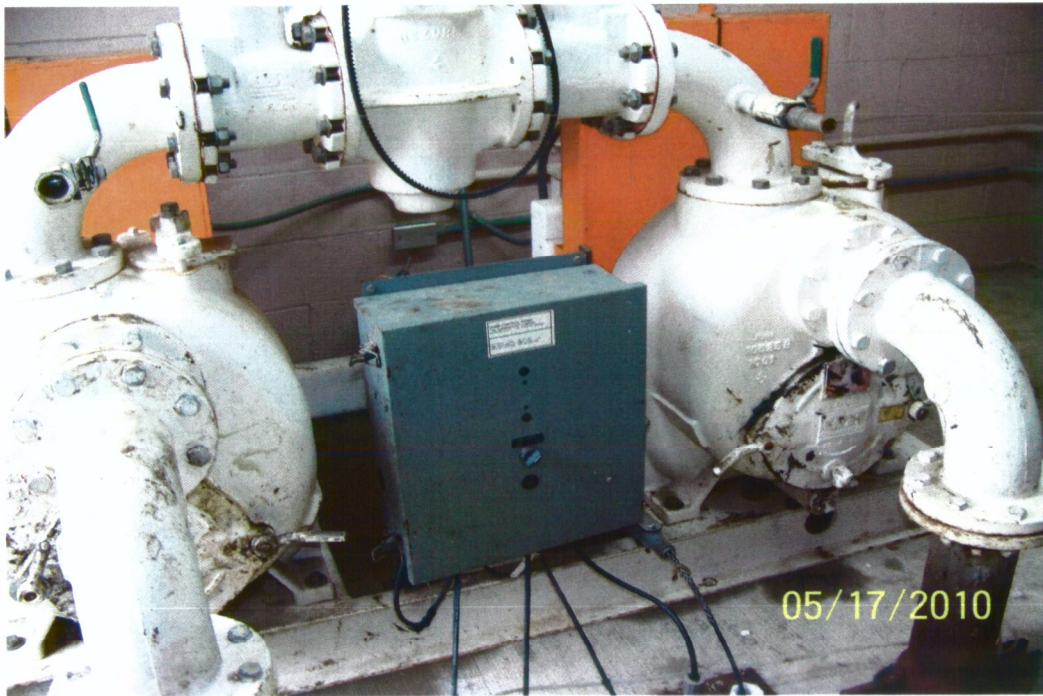
Description: Exposed wiring; control panel (Closed)

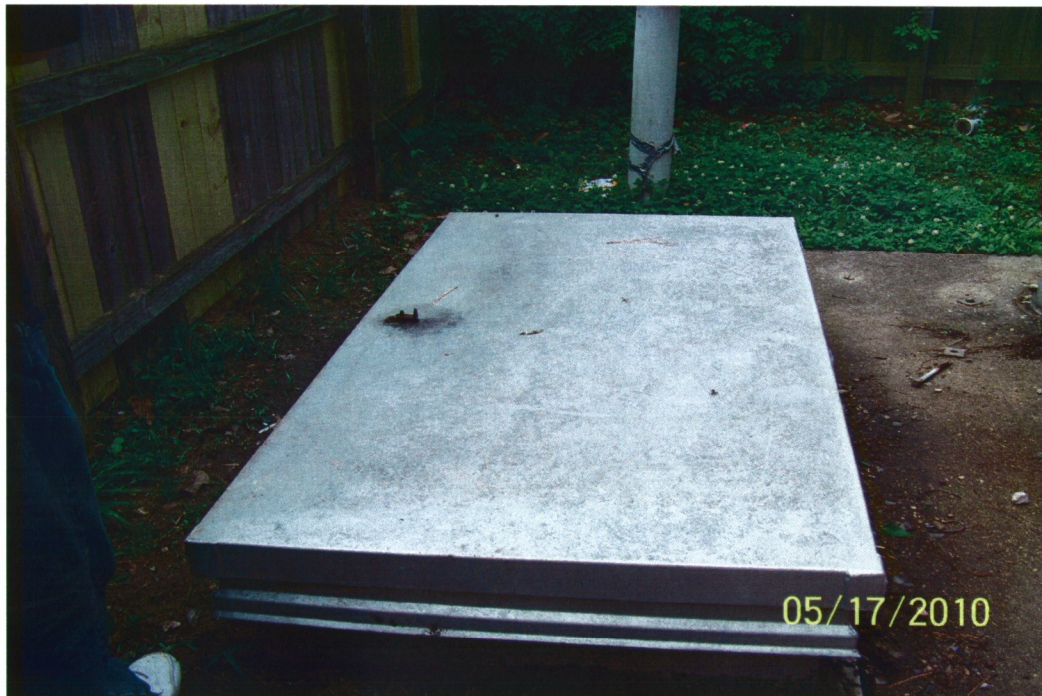
Location:	Pump Station-6 (401 South Avalon)		
Photographer:	Denise Bosnick	Witness:	Marvin Jones
Photo #:	Of	Date:	5/17/2010
Description:	Wet Well (Covered)

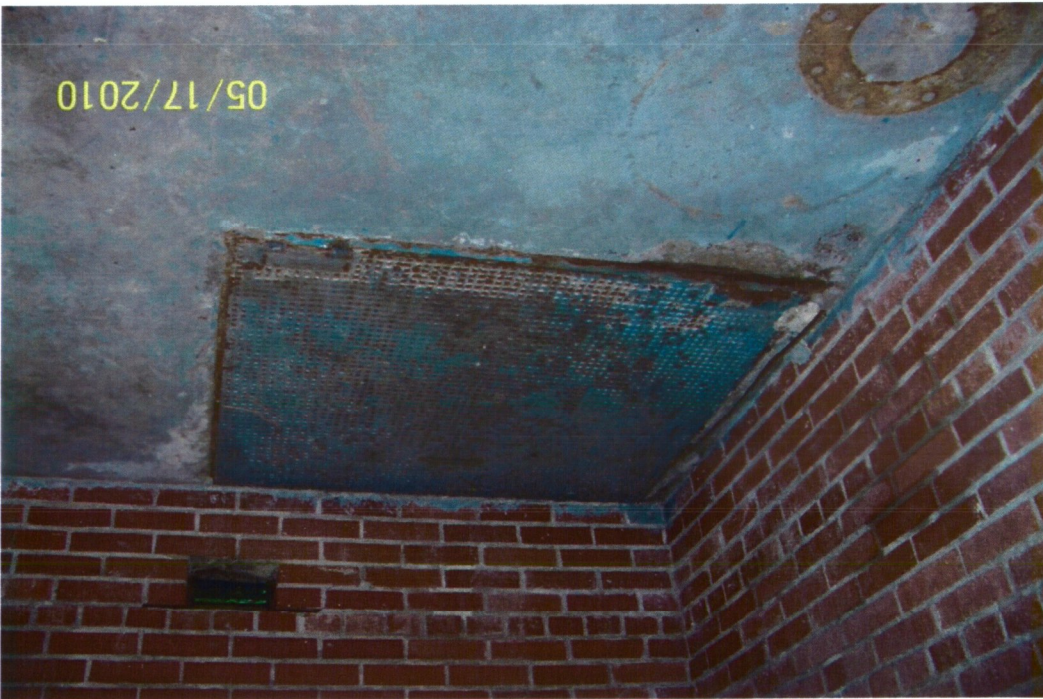
West Memphis Utility		Location: Pump Station-6 (401 South Avalon)	
Photographer: Denise Bosnick		Witness: Marvin Jones	
Photo #: Of		Date: 5/17/2010	
Description: Pump Shaft with Guards

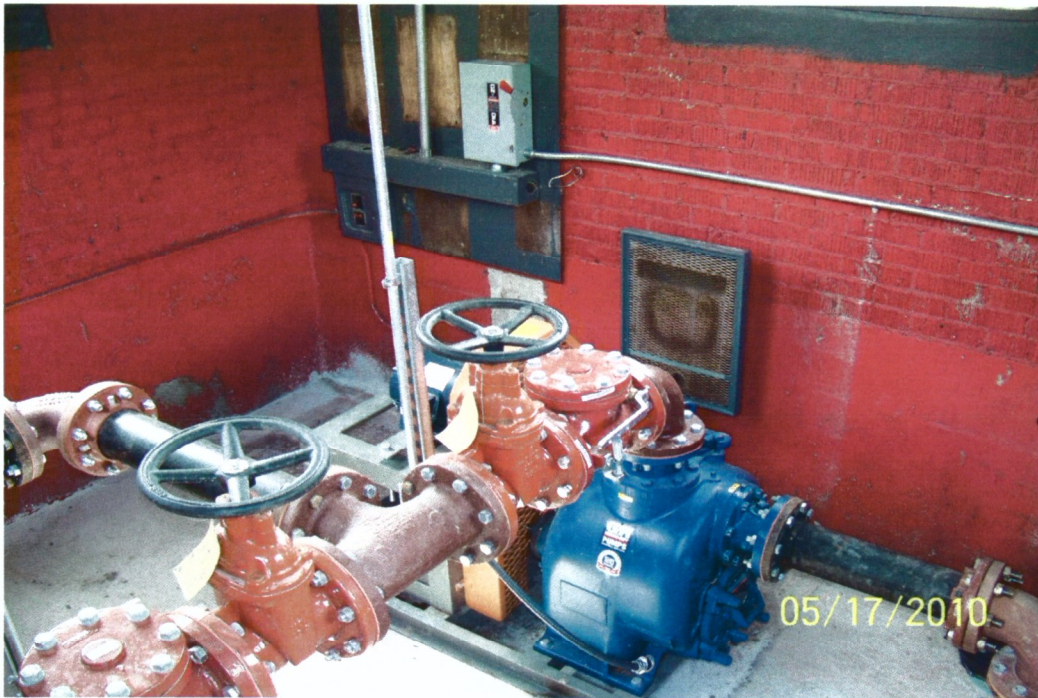
Description: Inside station

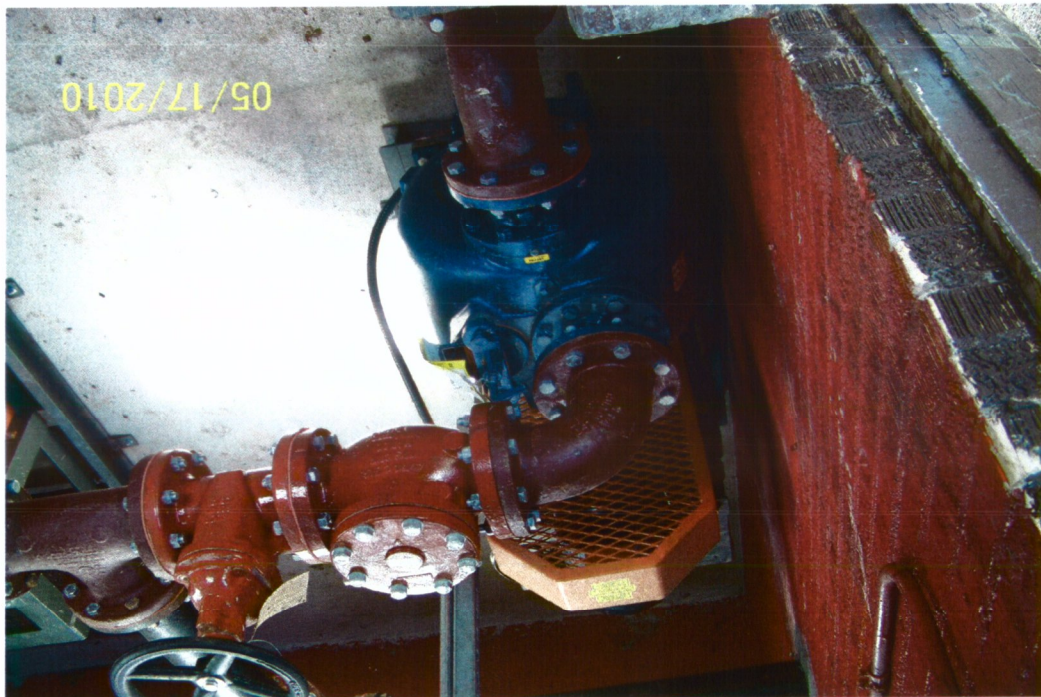
West Memphis Utility		Location: Pump Station-5 (334 West Oliver)	
Photographer: Denise Bosnick		Witness: Marvin Jones	
Photo #:	Of	Date:	5/17/2010
Description: Inside station

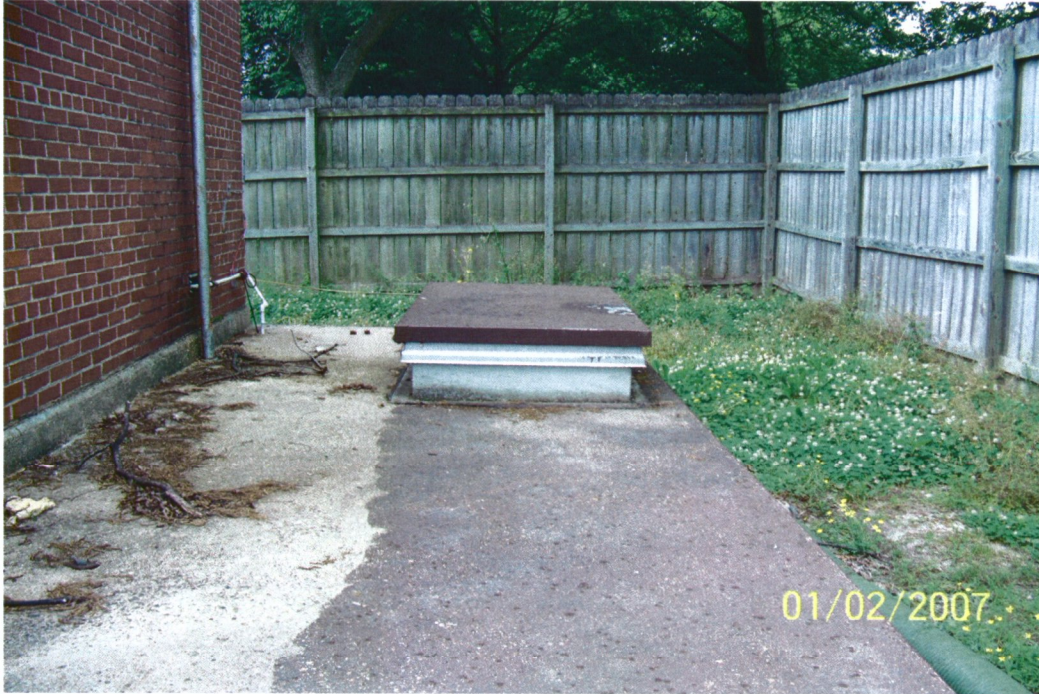
Description: Wet well (Covered)

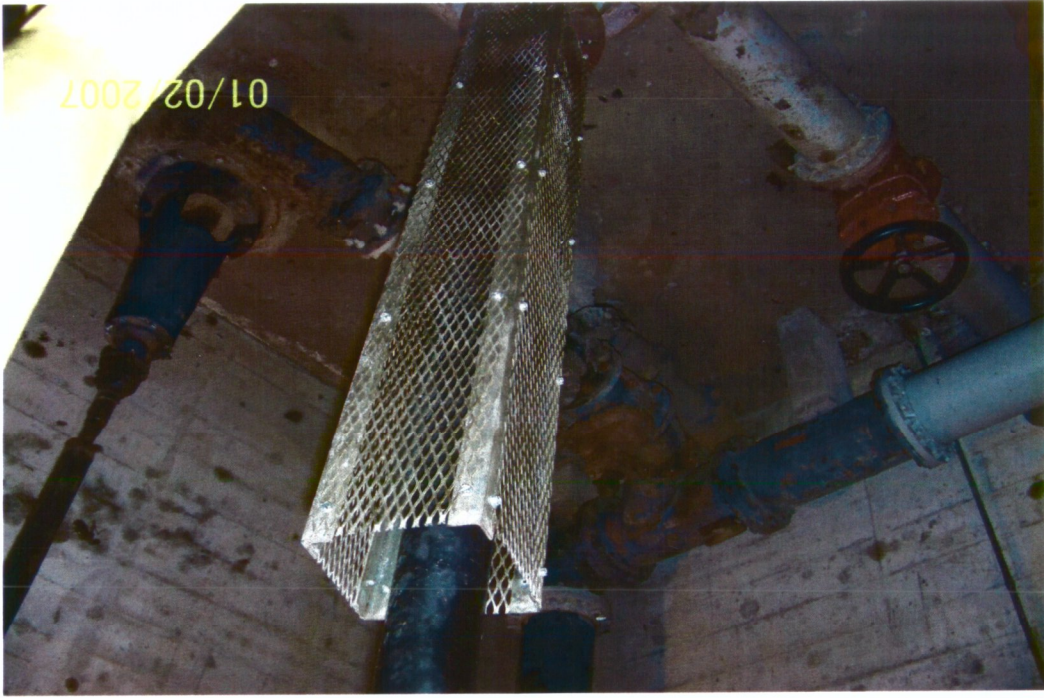
West Memphis Utility		Location: Pump Station-4 (900 Lehr)	
Photographer: Denise Bosnick		Witness: Marvin Jones	
Photo #:	Of	Date: 5/17/2010	
Description: Pump Shaft with guard in place

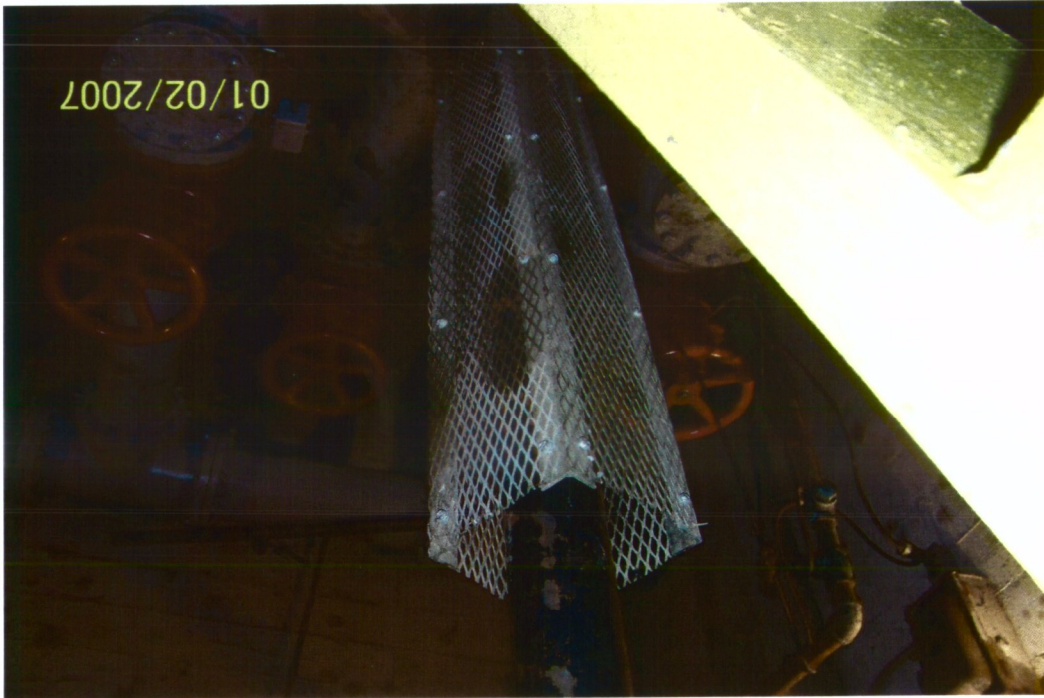
West Memphis Utility		Location: Pump Station-4 (900 Lehr)	
Photographer: Denise Bosnick		Witness: Marvin Jones	
Photo #:	Of	Date: 5/17/2010	
Description: Pump Shaft with guard in place

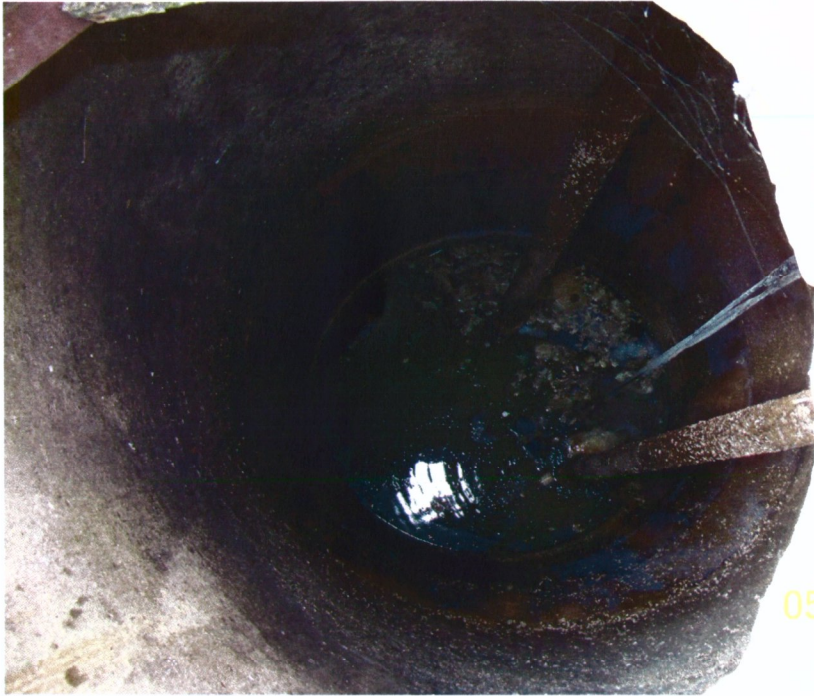
Description: Wet Well

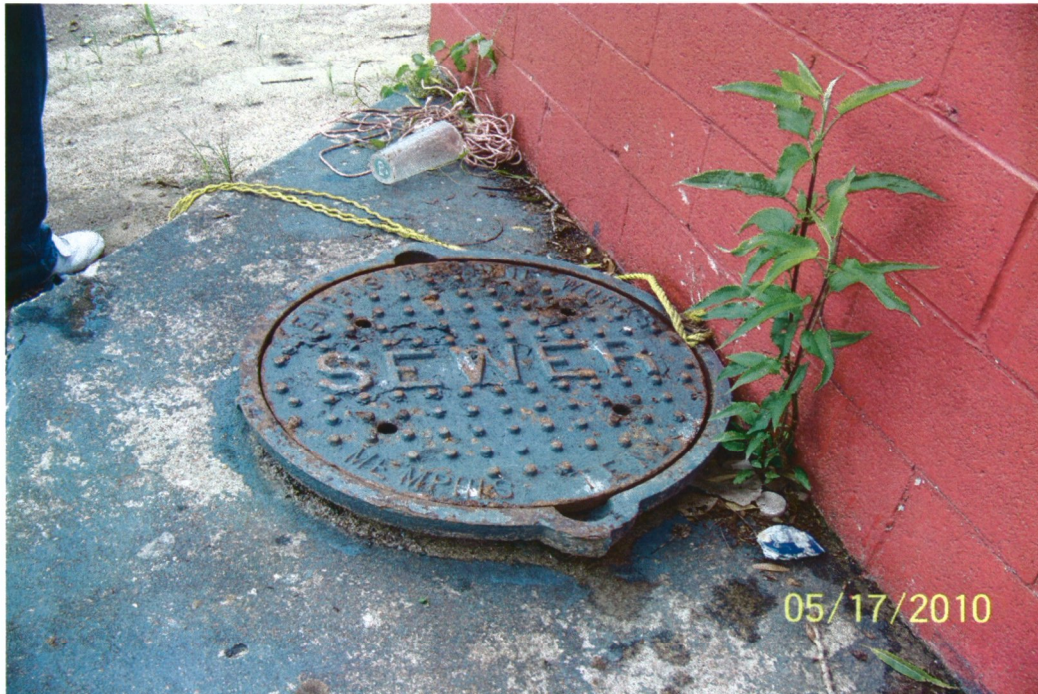
Description: Wet Well (Covered)

10. Pump Station-34 (Highway 77)
- a. This station will be put on a routine schedule to be cleaned.
 - b. The cover to the wet well is now in place.
 - c. The lights in the lower level of the station have been repaired and are operational.

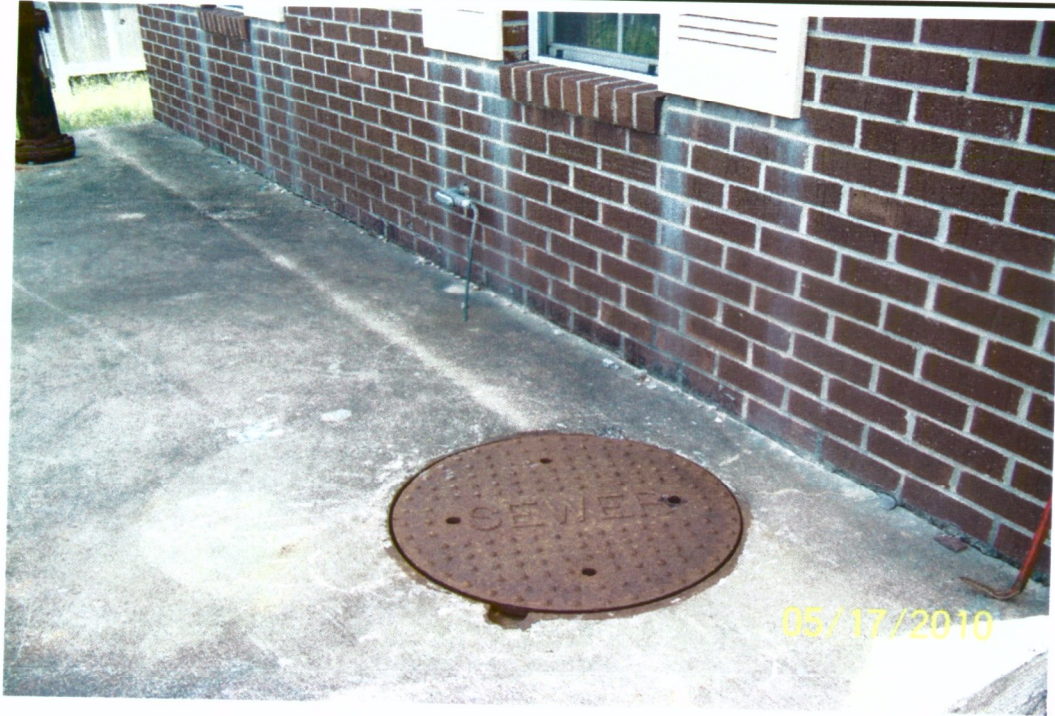
Description: Wet Well (Covered)

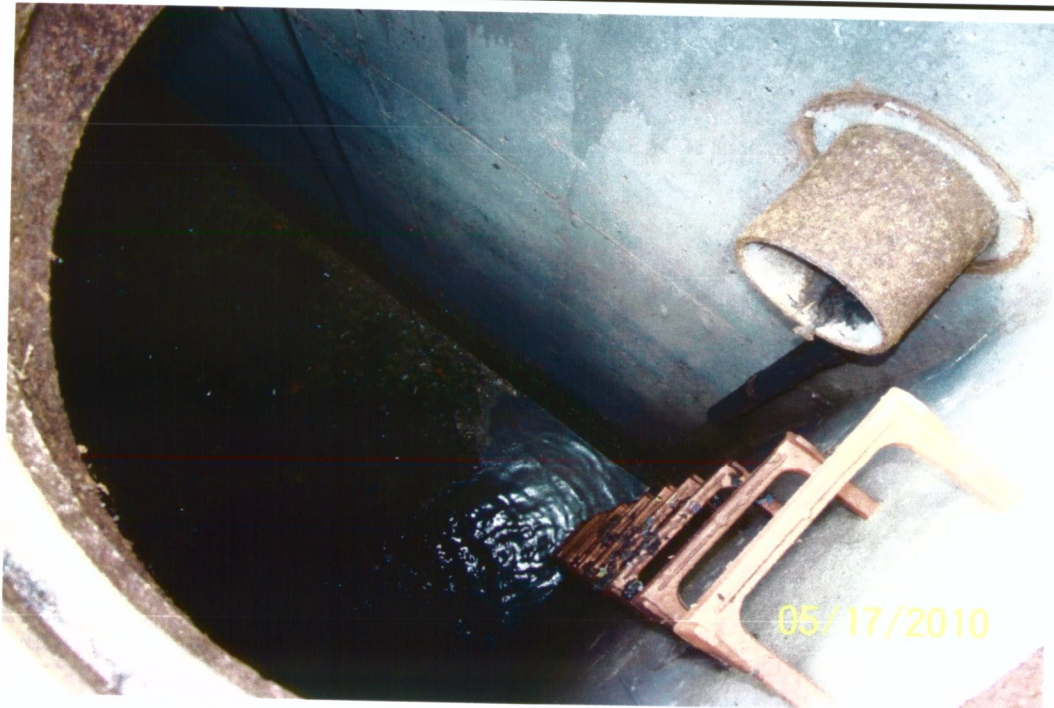
Description: Wet Well (Covered)

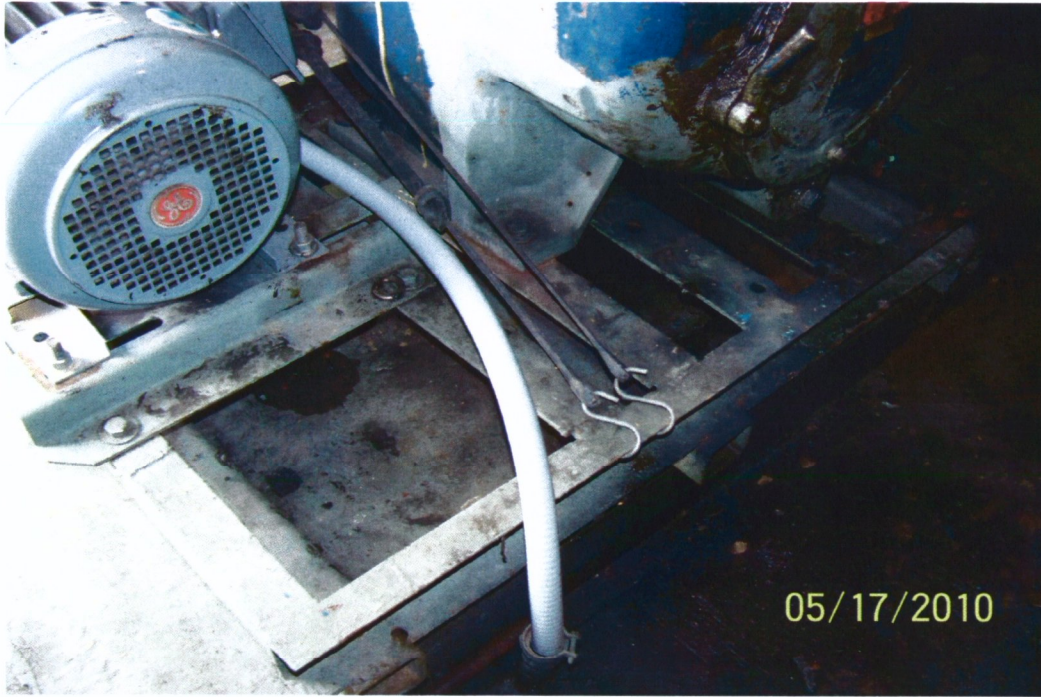
Description: Exposed wiring (Covered)

- d. The guards/covers for the drive shaft for the pumps are in place.
11. Pump Station-20 (603 North 7th)
- a. The conduit leading to the electric motors for the pumps has been replaced.

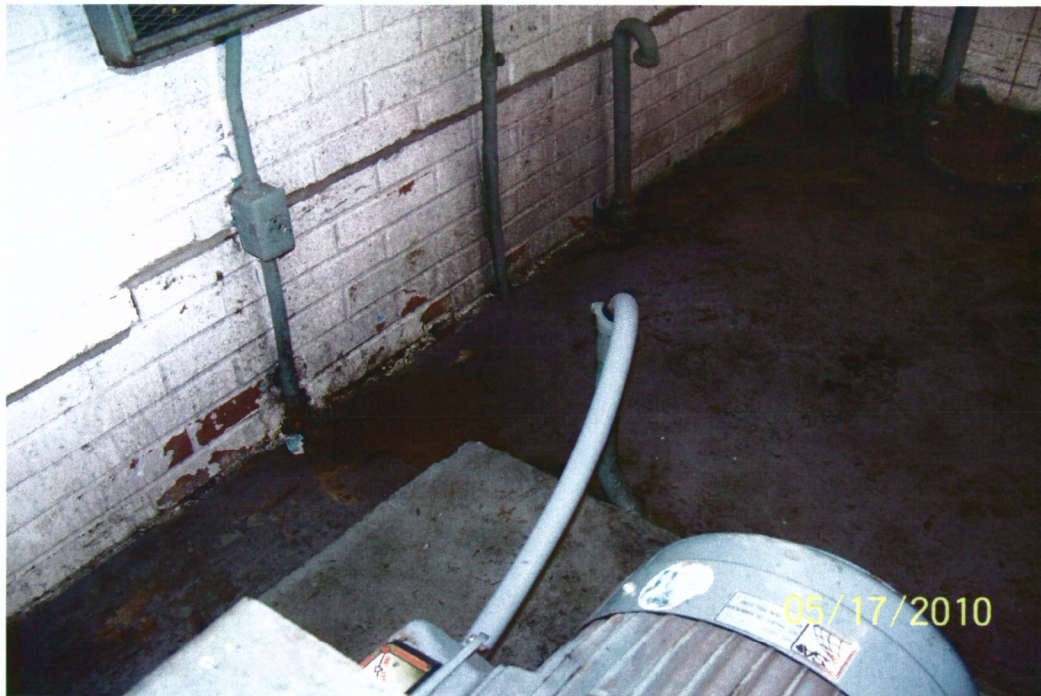
Description: Exposed wiring (Covered)

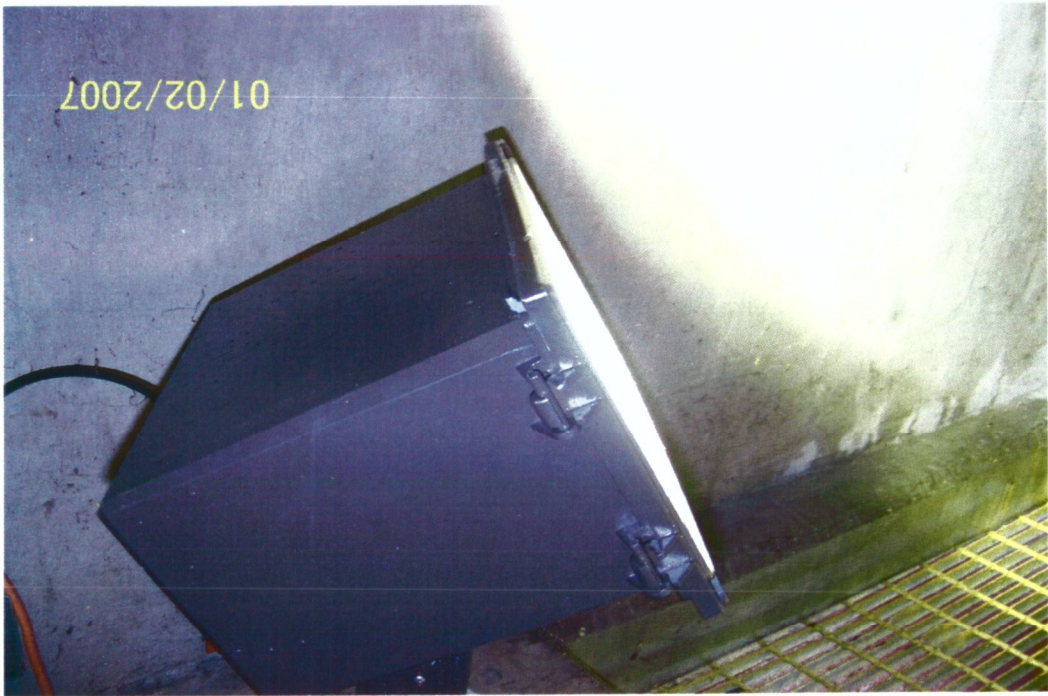
West Memphis Utility		Location: Pump Station-8 (610 East Jefferson)	
Photographer: Denise Bosnick		Witness: Marvin Jones	
Photo #:	Of	Date: 5/17/2010	
Description: Lights in lower level

- b. Windows are repaired
 - c. Lights in the lower level are now installed and operational.

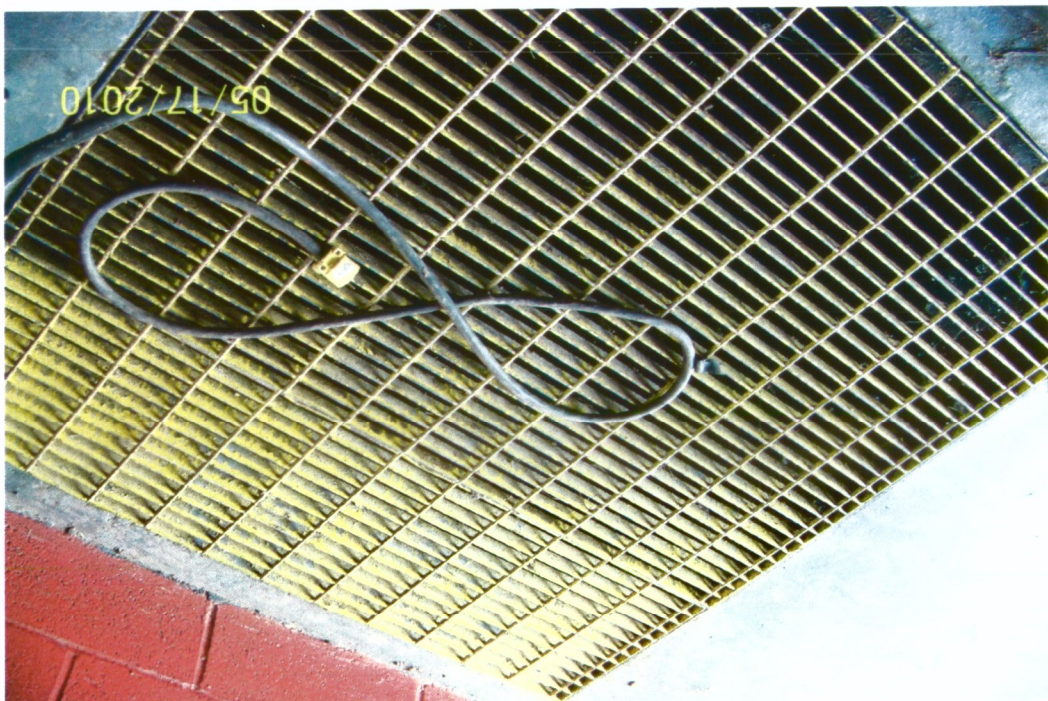
West Memphis Utility		Location: Pump Station-8 (610 East Jefferson)	
Photographer: Denise Bosnick		Witness: Marvin Jones	
Photo #:	Of	Date: 5/17/2010	
Description: Grate (Closed)
