RE: AFIN: 44-00018

NPDES Permit Tracking No.: AR0022004

## NPDES Compliance Inspection Report

Name and Location of Facility Inspected ( <i>For industrial users discharging to POTW, also include POTW name and NPDES permit number</i> ) <b>City of Huntsville</b> <b>30187 Madison Hwy 23</b> <b>Huntsville, AR</b>	Entry Time/Date <b>2:10 p.m./6-24-10</b> <b>1:45 p.m./6-30-10</b> <b>2:30 p.m./7-12-10</b>	Permit Effective Date <b>10-1-04</b>
	Exit Time/Date <b>2:50 p.m./6-24-10</b> <b>3:30 p.m./6-30-10</b> <b>2:55 p.m./7-12-10</b>	Permit Expiration Date <b>9-30-09</b>
Name(s) of On-Site Representative(s)/Title(s)/Phone and Fax Number(s) <b>Bill Eoff/Wastewater Plant Manager/479-738-2081/479-738-1285</b>		Other Facility Data <b>GPS @Outfall 001:</b> <b>N36-06-44.6</b> <b>W093-43-58.2</b>
Name, Address of Responsible Official/Title/Phone and Fax Number <b>Larry Garrett/Director/479-738-6929/479-738-1285</b> <b>Huntsville Water Utilities</b> <b>City of Huntsville</b> <b>P.O. Box 430</b> <b>Huntsville, AR 72740</b>

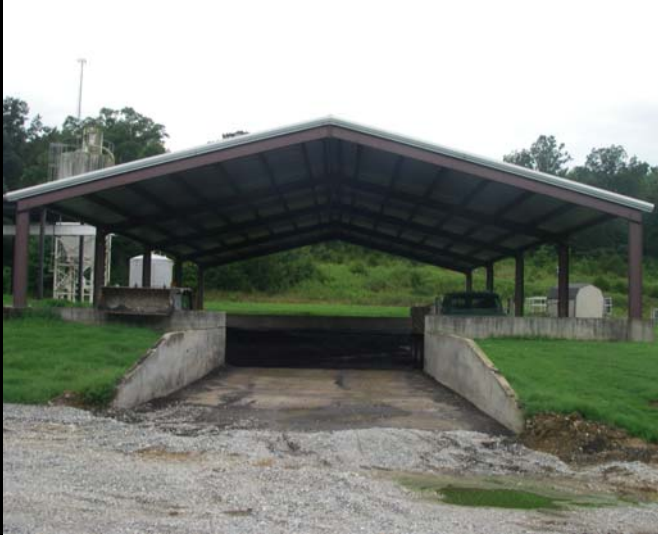
<b>Location:</b>	City of Huntsville Wastewater Facility							
<b>Photographer:</b>	John Fazio				<b>Witness:</b>	Alison West		
<b>Photo #</b>	1	<b>Of</b>	19		<b>Date:</b>	7-12-2010	<b>Time:</b>	2:45 p.m.
<b>Description:</b>	IMGP9407. Biosolids stored under cover.

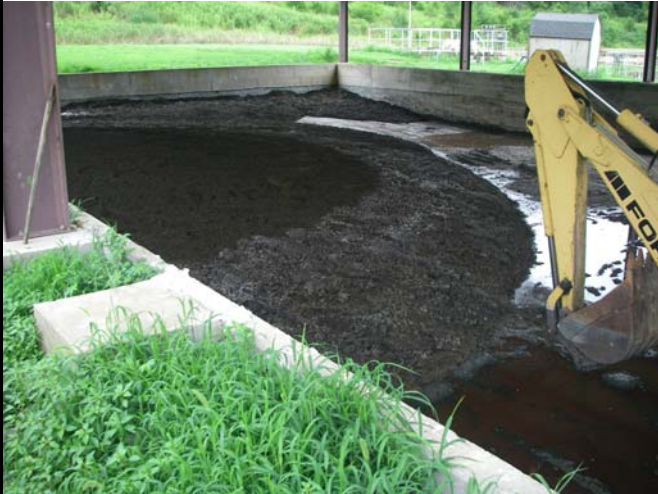
<b>Photographer:</b>	John Fazio				<b>Witness:</b>	Alison West		
<b>Photo #</b>	2	<b>Of</b>	19		<b>Date:</b>	7-12-2010	<b>Time:</b>	2:46 p.m.
<b>Description:</b>	IMGP9410. Biosolids.

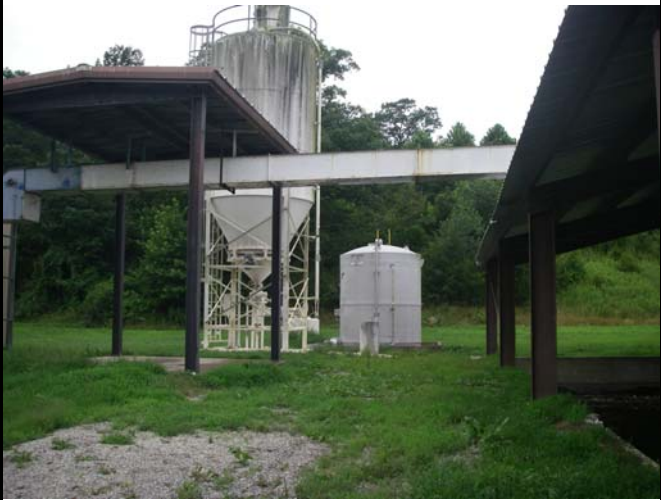
<b>Location:</b>	City of Huntsville Wastewater Facility								
<b>Photographer:</b>	John Fazio				<b>Witness:</b>	Alison West			
<b>Photo #</b>	3	<b>Of</b>	19		<b>Date:</b>	7-12-2010	<b>Time:</b>	2:46 p.m.	
<b>Description:</b>	IMGP9411. Lime storage.

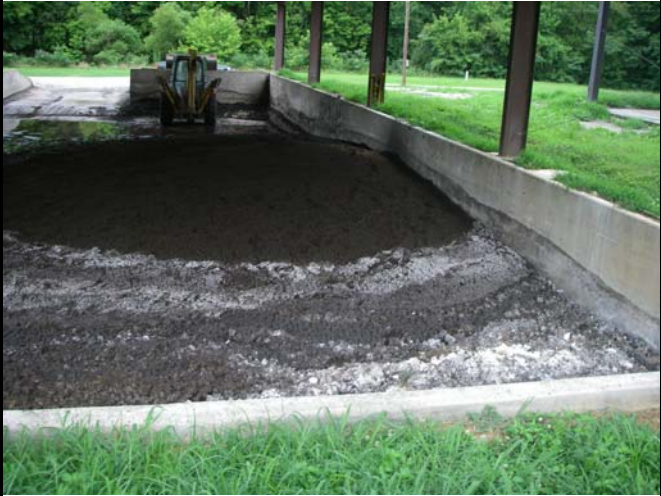
<b>Photographer:</b>	John Fazio				<b>Witness:</b>	Alison West			
<b>Photo #</b>	4	<b>Of</b>	19		<b>Date:</b>	7-12-2010	<b>Time:</b>	2:47 p.m.	
<b>Description:</b>	IMGP9413. An area where lime had been added to the biosolids.

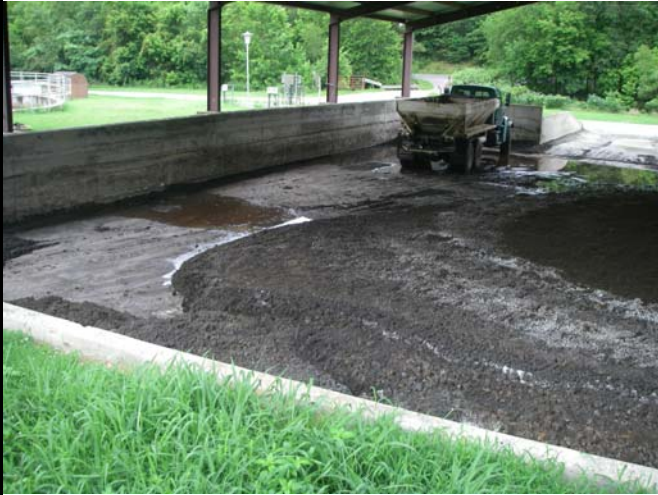
<b>Location:</b>	City of Huntsville Wastewater Facility						
<b>Photographer:</b>	John Fazio				<b>Witness:</b>	Alison West	
<b>Photo #</b>	5	<b>Of</b>	19		<b>Date:</b>	7-12-2010	<b>Time:</b> 2:47 p.m.
<b>Description:</b>	IMGP9414. Area where lime had been added to the biosolids.

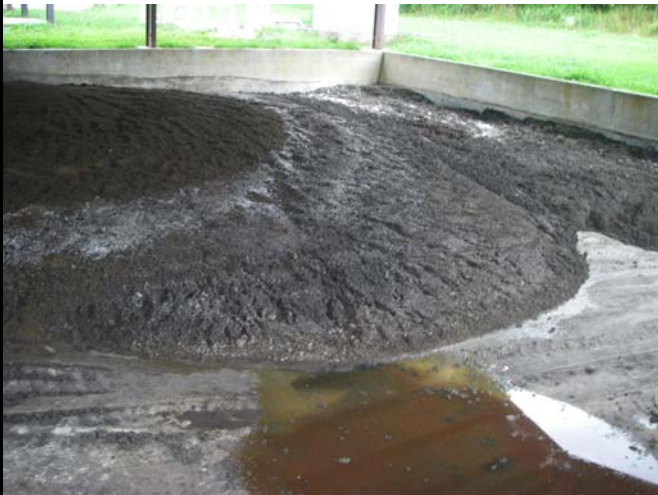
<b>Photographer:</b>	John Fazio				<b>Witness:</b>	Alison West	
<b>Photo #</b>	6	<b>Of</b>	19		<b>Date:</b>	7-12-2010	<b>Time:</b> 2:48 p.m.
<b>Description:</b>	IMGP9415. Leachate from biosolids is pumped into a manhole back to the plant.

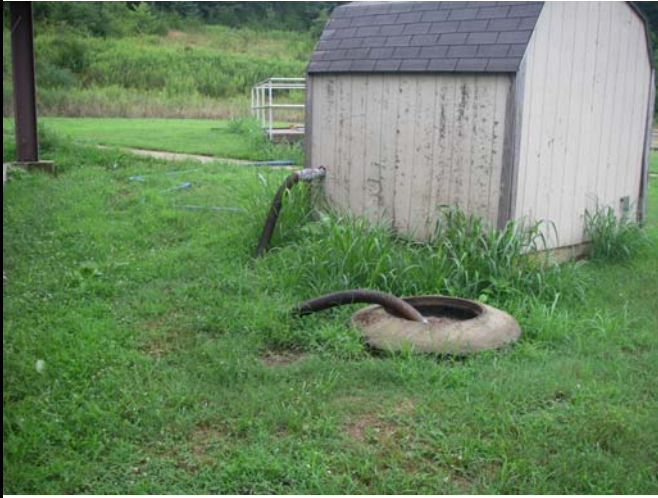
<b>Location:</b>	City of Huntsville Wastewater Facility						
<b>Photographer:</b>	John Fazio				<b>Witness:</b>	Alison West	
<b>Photo #</b>	7	<b>Of</b>	19		<b>Date:</b>	7-12-2010	<b>Time:</b> 2:48 p.m.
<b>Description:</b>	IMGP9417. Leachate pumped into a manhole near the biosolids storage building.

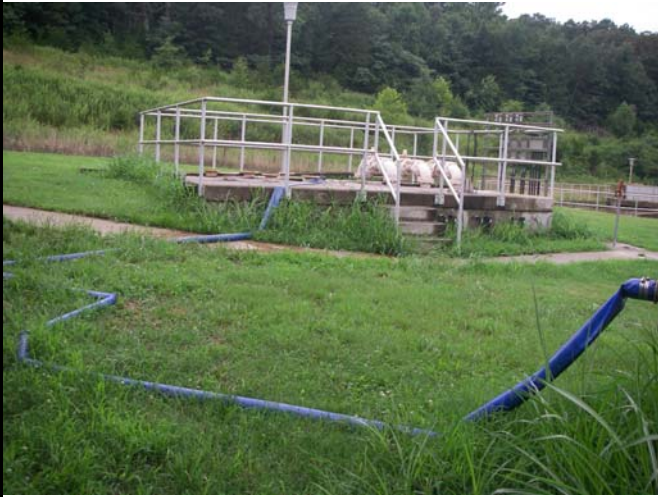
<b>Photographer:</b>	John Fazio				<b>Witness:</b>	Alison West	
<b>Photo #</b>	8	<b>Of</b>	19		<b>Date:</b>	7-12-2010	<b>Time:</b> 2:48 p.m.
<b>Description:</b>	IMGP9418. Leachate pumped back to the plant.

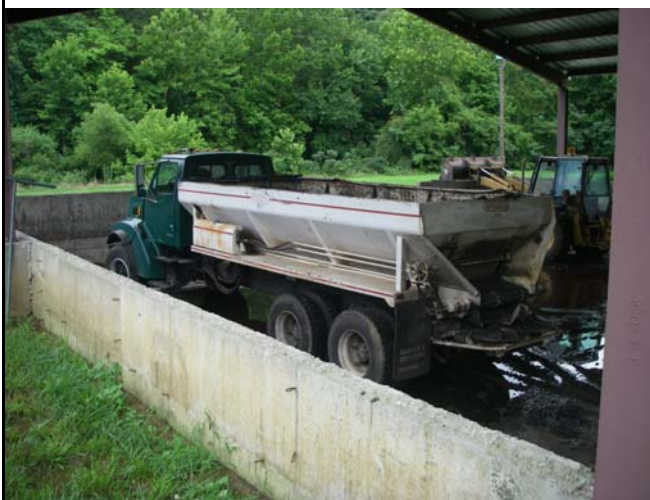
<b>Location:</b>	City of Huntsville Wastewater Facility						
<b>Photographer:</b>	John Fazio				<b>Witness:</b>	Alison West	
<b>Photo #</b>	9	<b>Of</b>	19		<b>Date:</b>	7-12-2010	<b>Time:</b> 2:48 p.m.
<b>Description:</b>	IMGP9421. The truck used for land application of biosolids.

In addition, necessary steps must be taken to prevent biosolids from leaking out of the truck onto the roads during transport.

1. As soon as this was brought to our attention by Alison we went immediately and spread the piles out.
2. The driver was transferred from the wastewater facility and another operator was transferred in from another department. He has been trained on sludge handling and the 100 foot setbacks he must meet from all lakes, ponds, springs, wetlands, sinkholes and streams.
3. He has also been instructed to clean tires and equipment before entering the roadway.

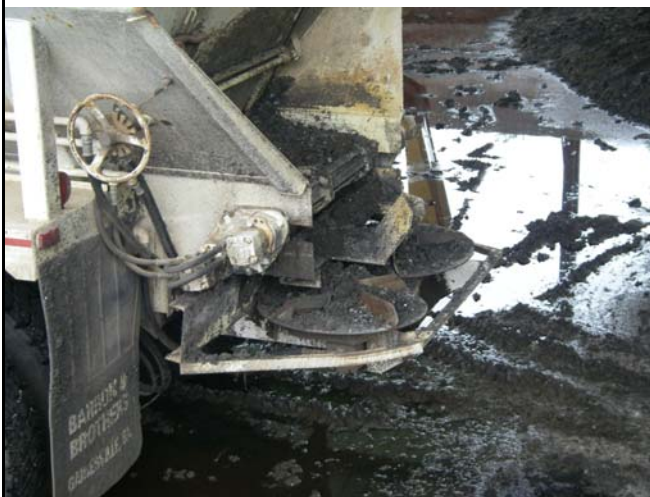
<b>Photographer:</b>	John Fazio				<b>Witness:</b>	Alison West	
<b>Photo #</b>	10	<b>Of</b>	19		<b>Date:</b>	7-12-2010	<b>Time:</b> 2:48 p.m.
<b>Description:</b>	IMGP9420. The truck used for land application of biosolids.

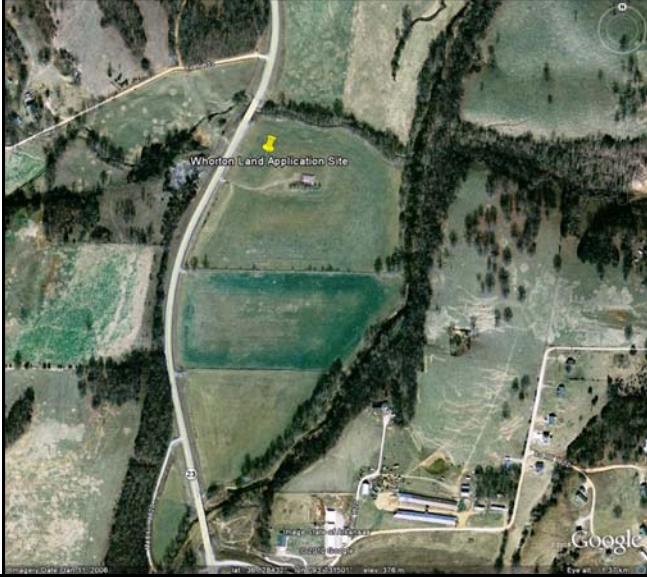
<b>Location:</b>	City of Huntsville Wastewater Facility							
<b>Photographer:</b>					<b>Witness:</b>			
<b>Photo #</b>	11	<b>Of</b>	19		<b>Date:</b>		<b>Time:</b>	
<b>Description:</b>	Google Earth Imagery of Whorton Field 1. Smryna Creek runs East to West. Holman Creek runs North.

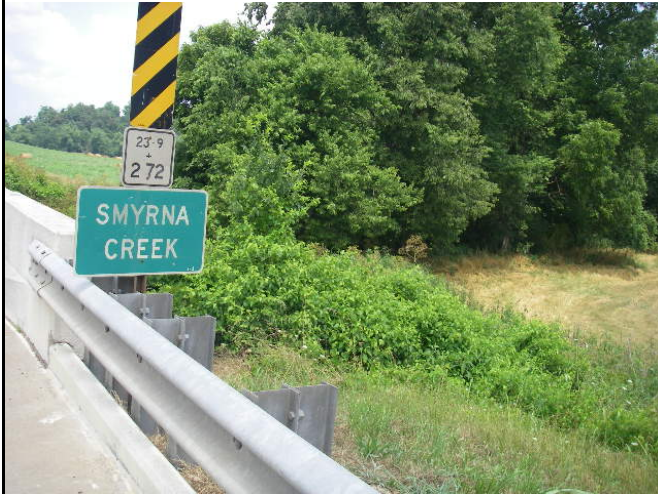
<b>Photographer:</b>	Alison West				<b>Witness:</b>	John Fazio		
<b>Photo #</b>	12	<b>Of</b>	19		<b>Date:</b>	6-24-2010	<b>Time:</b>	2:21 p.m.
<b>Description:</b>	IMGP4947. Bridge at Smyrna Creek on Hwy 23.

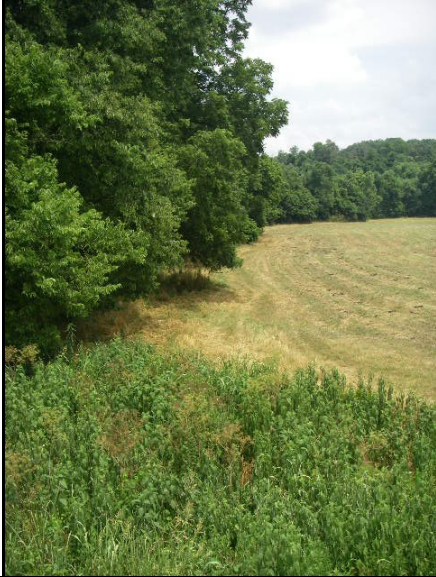
1. Placement of waste in such a manner that has the potential to cause the pollution of the waters of the State. This is in violation of the Arkansas Water and Air Pollution Control Act 8-4-217, (a)(1).
  - a. Biosolids had been land applied approximately 40-50 feet to Smyrna Creek and Holman Creek.
2. Biosolids were land applied approximately 40-50 feet to Smyrna Creek and Holman Creek. This is in violation of Part III, Condition 15 of your permit. When land applying biosolids, a 100 foot setback to all lakes, ponds, springs, streams, wetlands, and sinkholes must be met.
3. Biosolids were not evenly distributed in an area located in Whorton Field 1. This is in violation of Part III, Condition 11 of your permit. Biosolids must be spread evenly over the application area.

<b>Location:</b>	City of Huntsville Wastewater Facility						
<b>Photographer:</b>	Alison West				<b>Witness:</b>	John Fazio	
<b>Photo #</b>	13	<b>Of</b>	19		<b>Date:</b>	6-24-2010	<b>Time:</b> 2:21 p.m.
<b>Description:</b>	IMGP4946. Whorton land application site. Sludge had been land applied approximately 40 feet to Smyrna Creek.

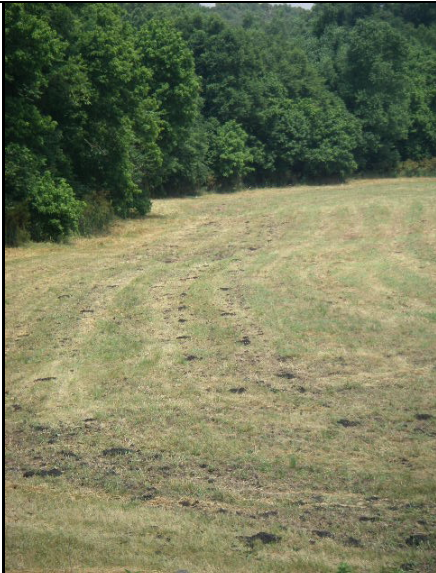
<b>Photographer:</b>	Alison West				<b>Witness:</b>	John Fazio	
<b>Photo #</b>	14	<b>Of</b>	19		<b>Date:</b>	6-24-2010	<b>Time:</b> 2:21 p.m.
<b>Description:</b>	IMGP4948. Sludge land applied on Whorton Field 1. Smyrna Creek is immediately left of the tree line.

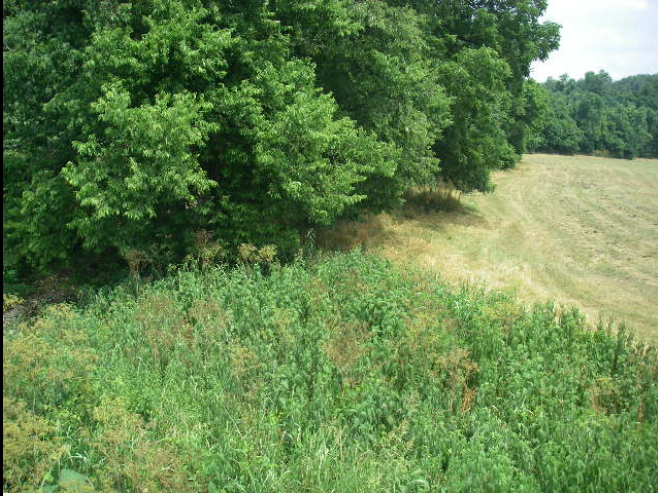
<b>Location:</b>	City of Huntsville Wastewater Facility						
<b>Photographer:</b>	Alison West				<b>Witness:</b>	John Fazio	
<b>Photo #</b>	15	<b>Of</b>	19		<b>Date:</b>	6-24-2010	<b>Time:</b> 2:21 p.m.
<b>Description:</b>	IMGP4945. Whorton Field 1. Smyrna Creek is to the left of the tree line.

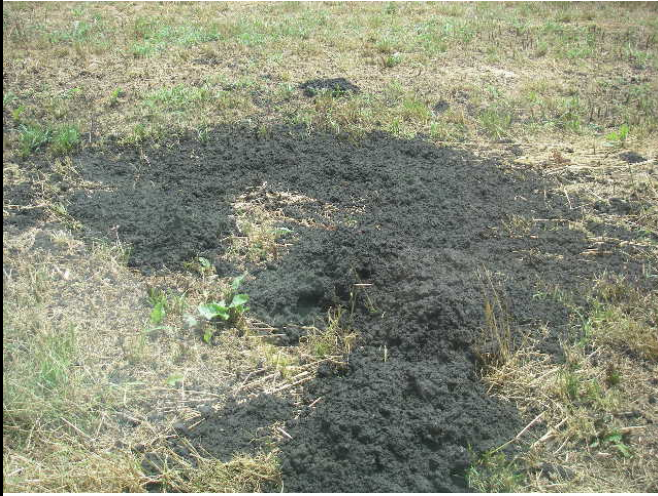
1. Placement of waste in such a manner that it has the potential to cause the pollution of the waters of the State.
2. Biosolids were land applied approximately 40 feet to Smyrna Creek and Holman Creek.
3. Biosolids were not evenly distributed in an area located in Whorton Field 1.

<b>Photographer:</b>	Alison West				<b>Witness:</b>	John Fazio	
<b>Photo #</b>	16	<b>Of</b>	19		<b>Date:</b>	6-24-2010	<b>Time:</b> 2:16 p.m.
<b>Description:</b>	IMGP4941. Biosolids that were not spread evenly in Whorton Field 1.

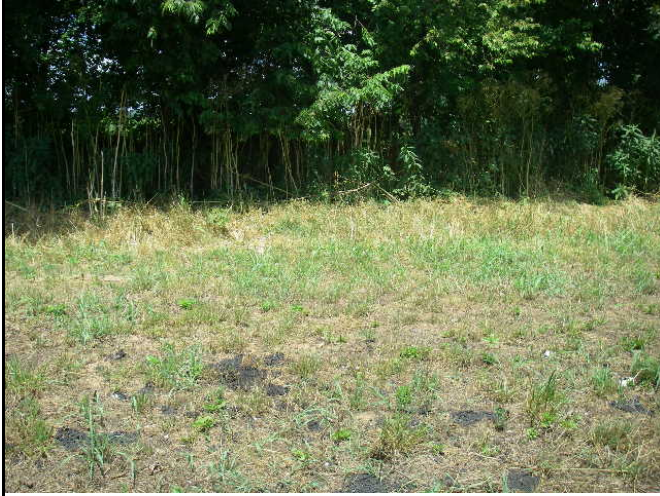
<b>Location:</b>	City of Huntsville Wastewater Facility						
<b>Photographer:</b>	Alison West				<b>Witness:</b>	NA	
<b>Photo #</b>	17	<b>Of</b>	19		<b>Date:</b>	6-30-2010	<b>Time:</b> 1:56 p.m.
<b>Description:</b>	IMGP4952. Biosolids were land applied approximately 40 feet to Smyrna Creek at Whorton Field 1.

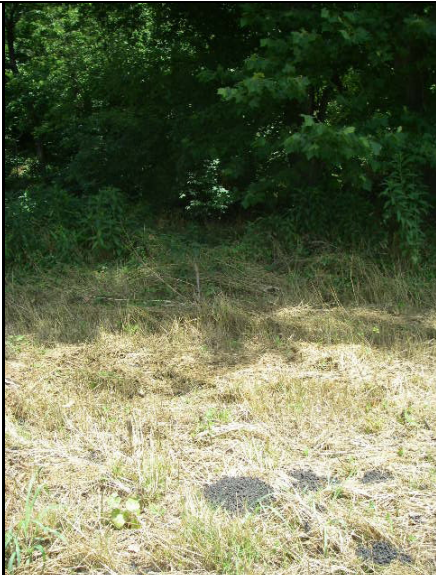
<b>Photographer:</b>	Alison West				<b>Witness:</b>	NA	
<b>Photo #</b>	18	<b>Of</b>	19		<b>Date:</b>	6-30-2010	<b>Time:</b> 1:59 p.m.
<b>Description:</b>	IMGP4953. Biosolids were land applied approximately 40-50 feet to Holman Creek at Whorton Field 1.
