ARKANSAS
Department of Environmental Quality

RE: Sanitary Sewer Overflow Complaint Investigation

NPDES Compliance Inspection Report

Location: Elkins Waste Collection System SSO Location –Manhole located near Lift Station #2

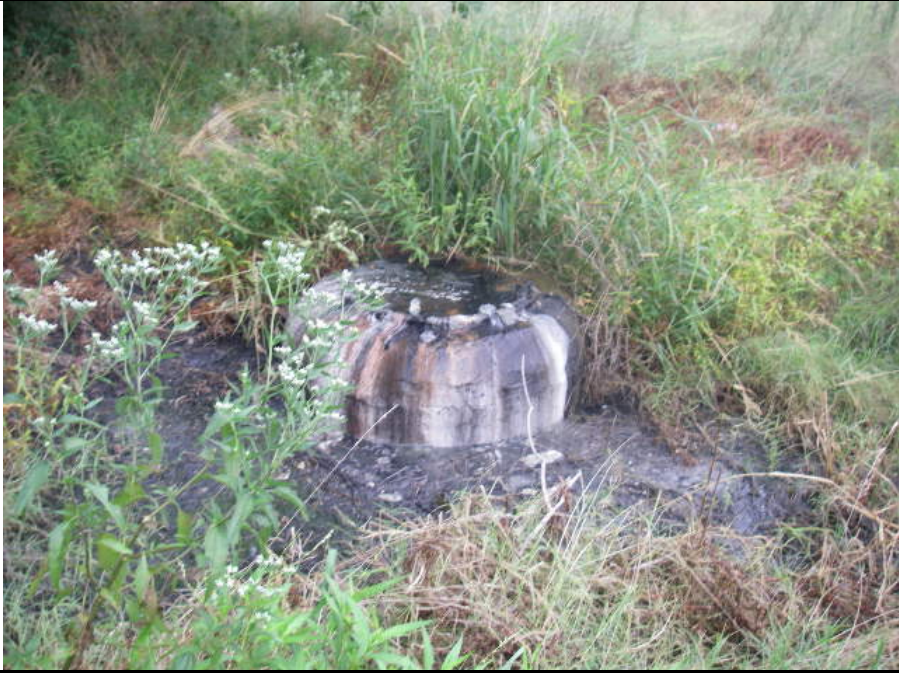
Photo # 1 **Of** 11 **Date:** 08/17/10 **Time:** 2:30 p.m.

Description: IMG5336. Sanitary sewer overflow located on the north side of the tributary to the White River near pump station #2.

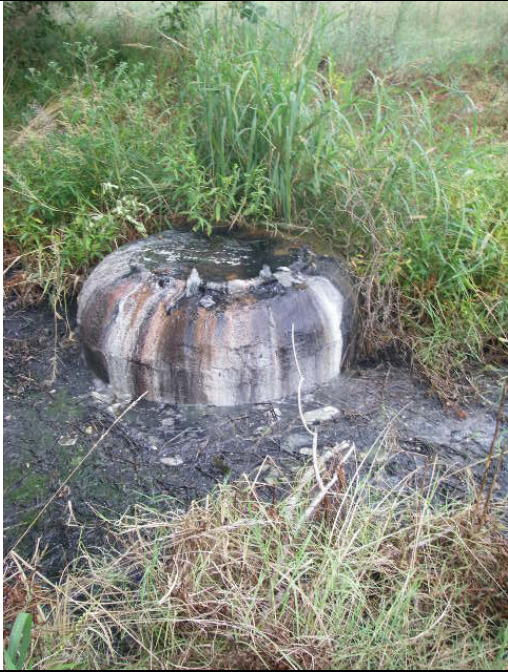
Photo # 2 **Of** 11 **Date:** 08/17/10 **Time:** 2:30 p.m.

Description: IMG5337. Sanitary sewer overflow located on the north side of the tributary to the White River near lift station #2.

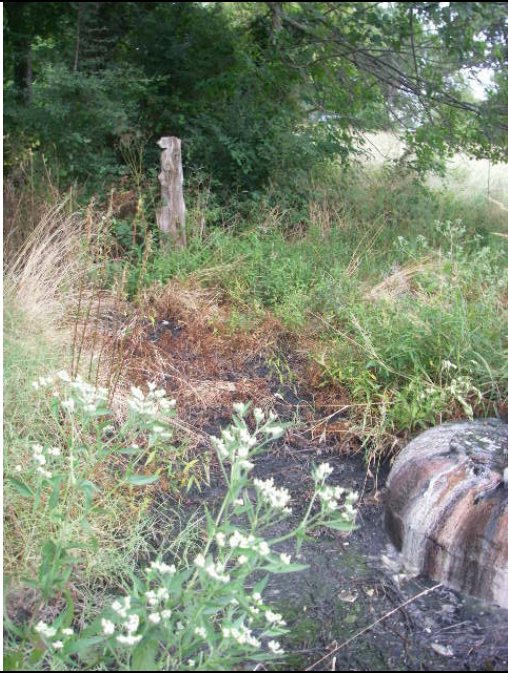
Location:	Elkins Waste Collection System SSO Location –Manhole located near Lift Station #2						
Photographer:	Alison West			Witness:	N/A		
Photo #	3	Of	11	Date:	08/17/10	Time:	2:30 p.m.
Description:	IMGP5338. Sanitary sewer overflow located on the north side of the tributary to the White River near pump station #2.

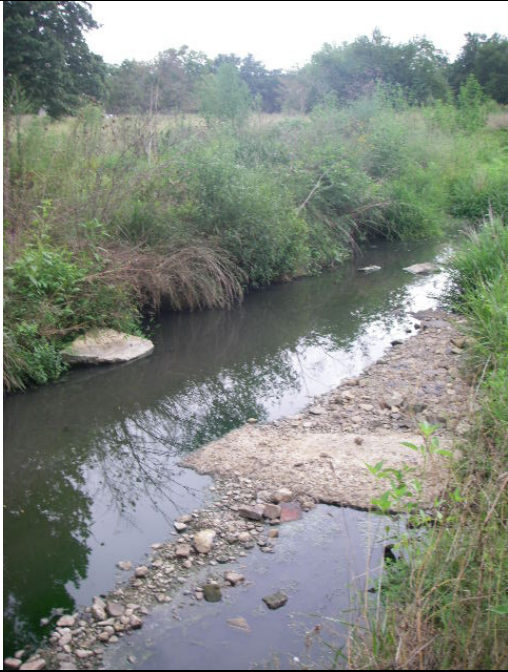
Photographer:	Alison West			Witness:	N/A		
Photo #	4	Of	11	Date:	08/17/10	Time:	2:09 p.m.
Description:	IMGP5331. Sewage observed in the tributary of the White River near lift station #2.

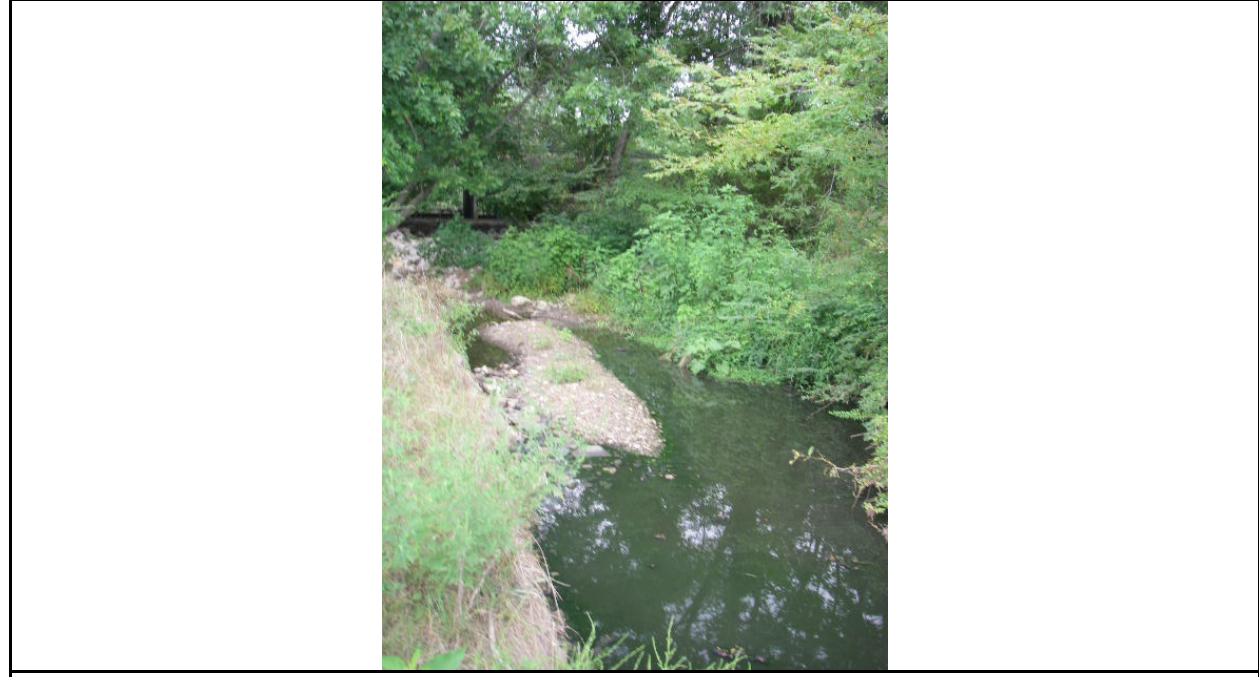
Photo # 5 **Of** 11 **Date:** 08/17/10 **Time:** 2:09 p.m.

Description: IMG5330. Sewage observed in the tributary of the White River near lift station #2.

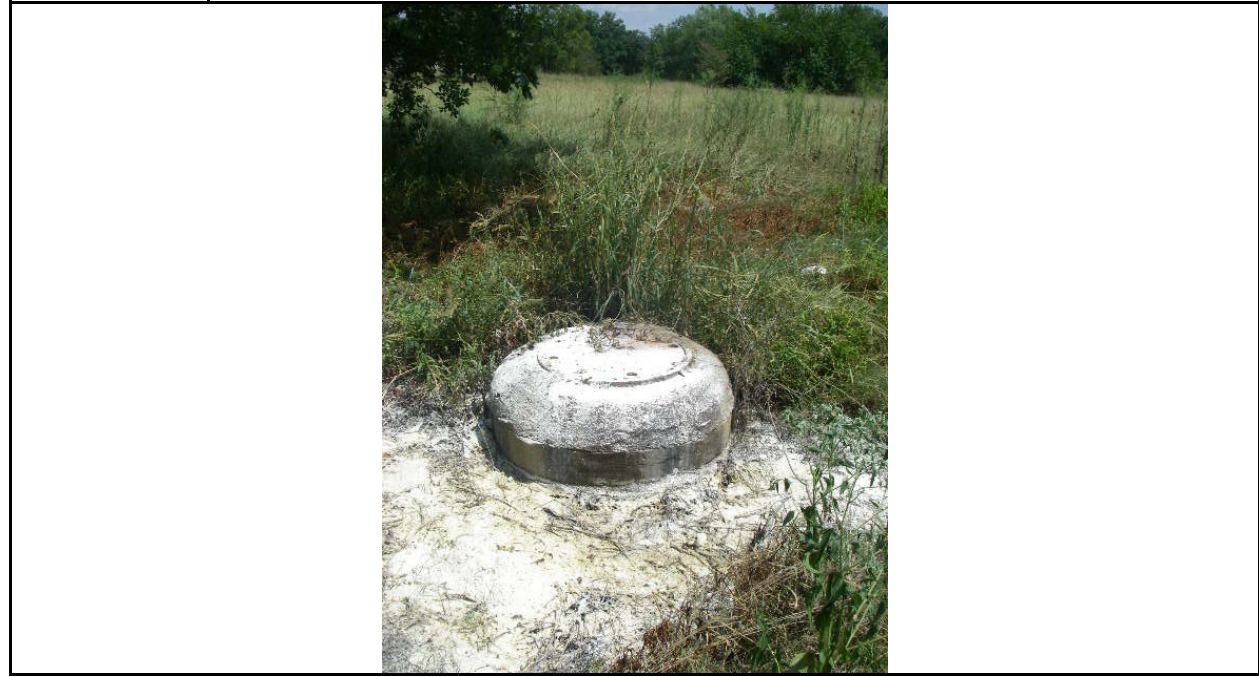
Photo # 6 **Of** 11 **Date:** 08/20/10 **Time:** 1:29 p.m.

Description: IMG5351. Area on and around the manhole was limed.

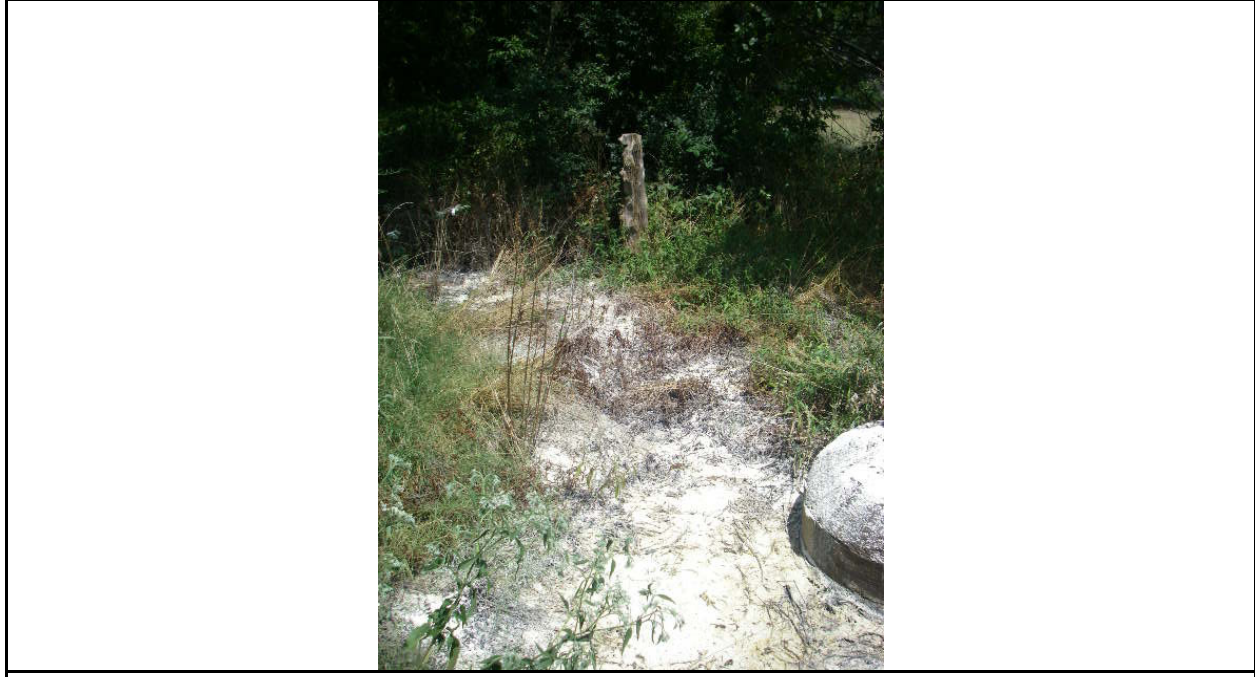
Photo # 7 **Of** 11 **Date:** 08/20/10 **Time:** 1:29 p.m.

Description: IMG5352. Area on and around the manhole was limed.

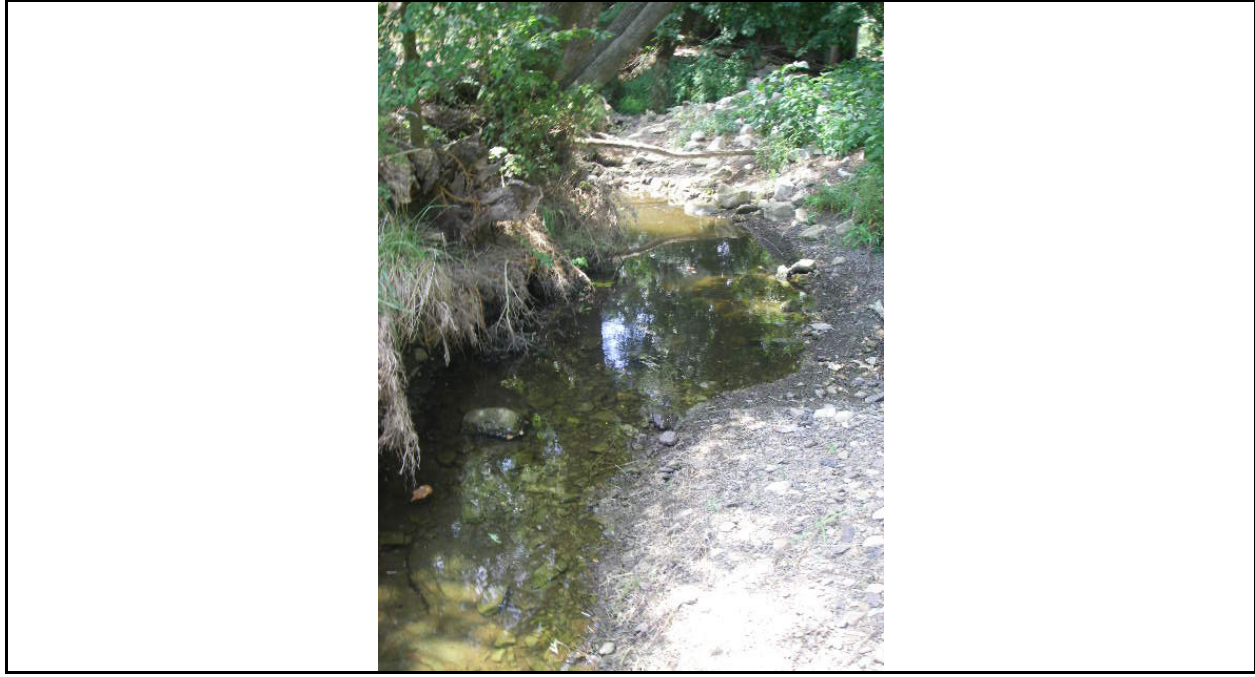
Photo # 8 **Of** 11 **Date:** 08/20/10 **Time:** 1:33 p.m.

Description: IMG5357. Tributary of the White River above impacted area from the sanitary sewer overflow.

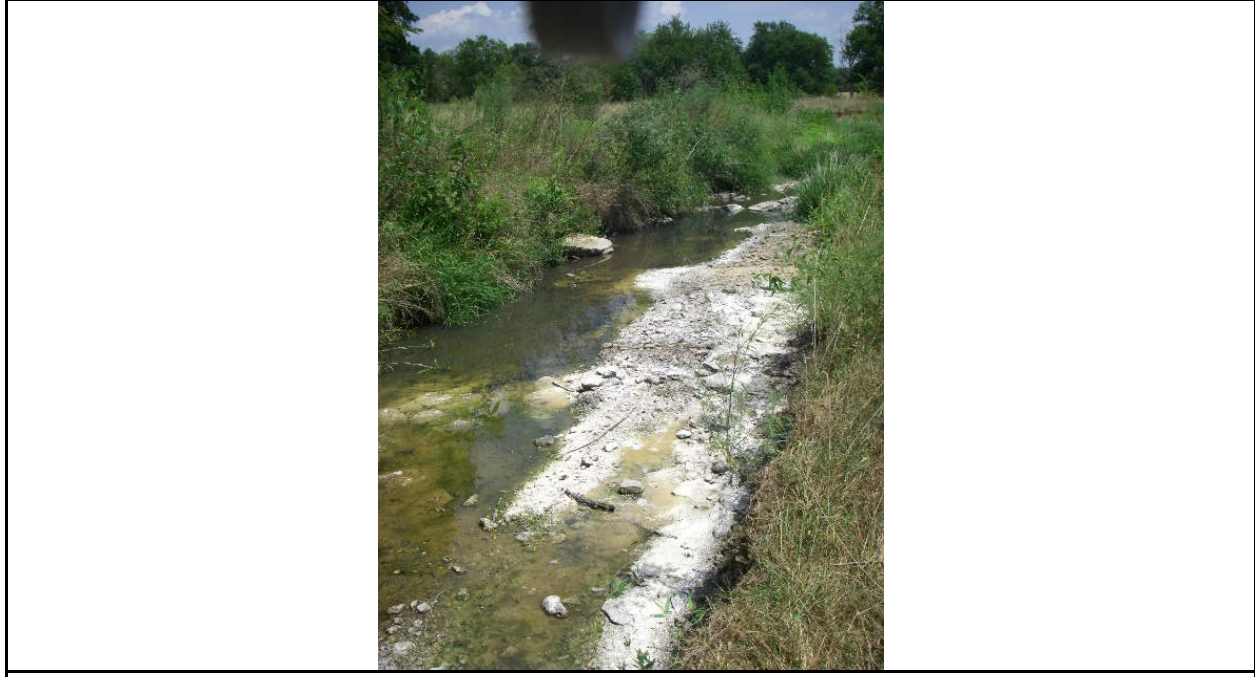
Photo #	9	Of	11	Date:	08/20/10	Time:	1:57 p.m.
----------------	---	-----------	----	--------------	----------	--------------	-----------

Description:	IMG5348. Sewage in the tributary of the White River. White material is lime.						
---------------------	------------------------------------------------------------------------------	--	--	--	--	--	--

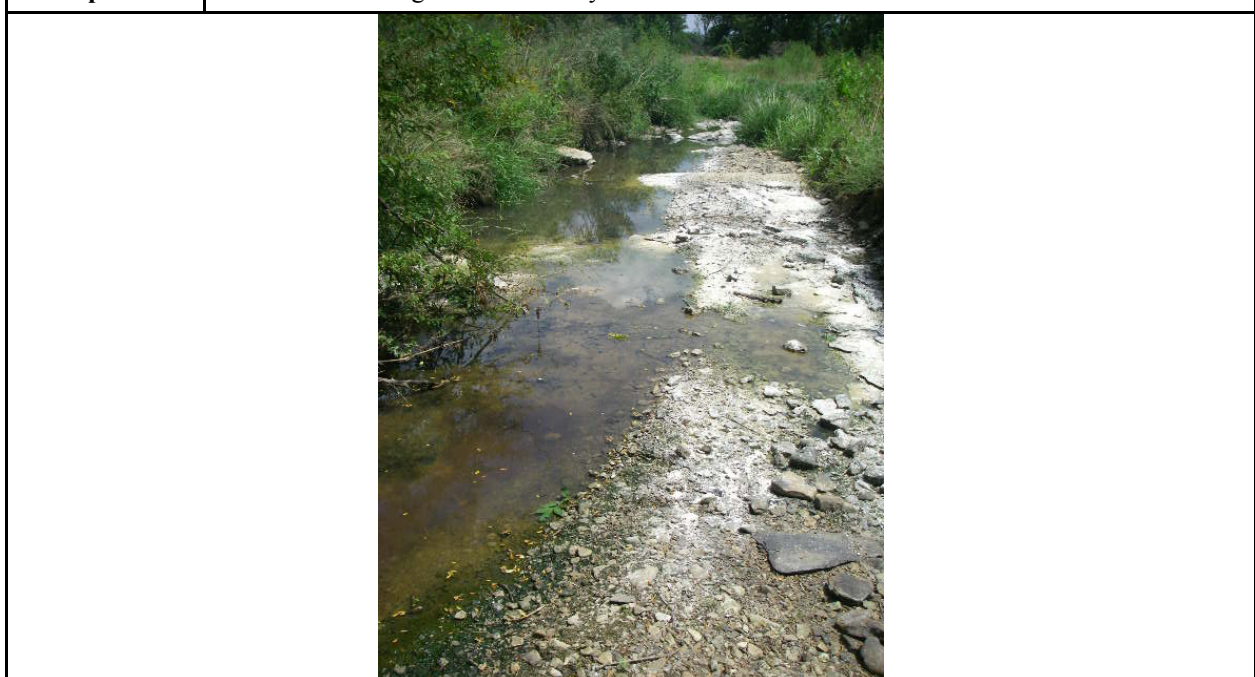
Photo #	10	Of	11	Date:	08/20/10	Time:	1:32 p.m.
----------------	----	-----------	----	--------------	----------	--------------	-----------

Description:	IMG5356. Sewage in the tributary of the White River. White material is lime.						
---------------------	------------------------------------------------------------------------------	--	--	--	--	--	--

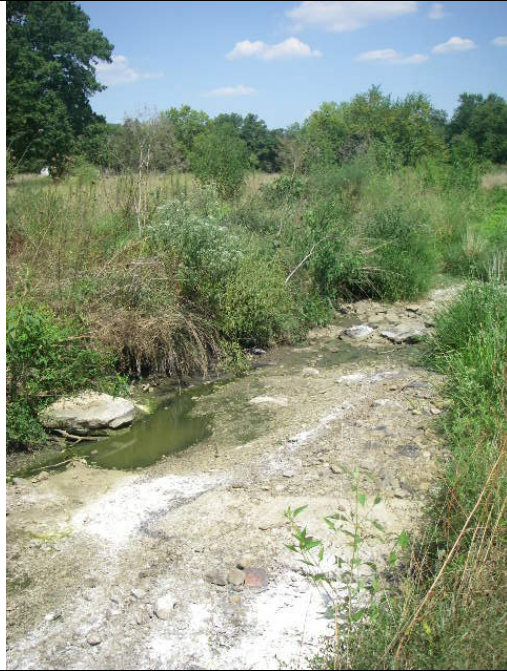
Photo # 11 **Of** 11 **Date:** 08/24/10 **Time:** 2:46 p.m.

Description: IMG5396. Majority of sewage was removed from the impacted area of the tributary of the White River.
