RE: Compliance Inspection and Complaint Investigation

AFIN: 61-00055 NPDES Permit No.: AR0034835

ADEQ Water NPDES Inspection	AFIN: 61-00055	Permit #: AR0034835

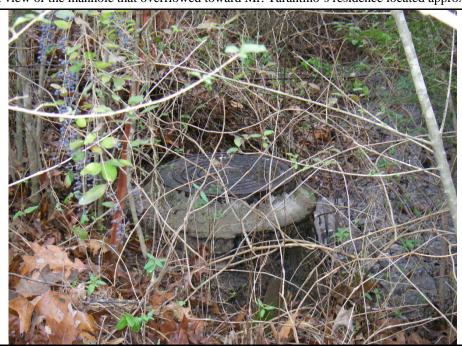
- 1. Raw sewage was observed on the ground from a manhole that overflowed previously. The sewage had flowed to within approximately 40-50 feet of a private residence located at 1512 Convent Street in Pocahontas, Arkansas. This is a violation of the Arkansas Water and Air Pollution Control Act (8-4-217) a, 2.
- 2. This overflow was not reported to the Enforcement Branch of the Department. This is a violation of Part II, Item 5, of the permit.

Water Division NPDES Photographic Evidence Sheet										
Location:	Location: At 1512 Convent Street in Pocahontas, Arkansas (Randolph Co.)										
Photographer	r <b>:</b>	Mike	Ken	nnedy		Witness:	None	None			
Photo #	1	(	f	6		Date:	1-18-11	Time:	1308		
Description:		A vie	w of	f the man	hole that overflowed toward I	Mr Tarantino	's residence locate	ed approx 60	-80 feet southwest

Crew was called to address because sewer running in yard. Crew ran line, though line was clear. Line was not clear had to go back farther upstream to next manhole found where power line, and trees were down over manhole. Had to wait until power line was fixed to cut trees to get to manhole. Fixed problem.

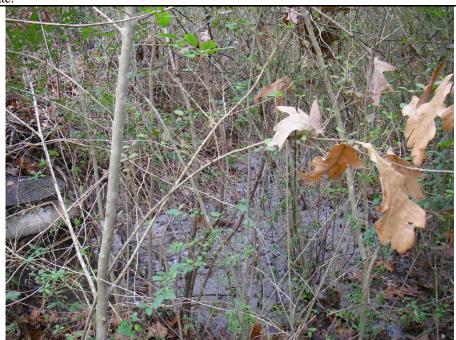
Photographer	r:	Mike Ke	ennedy	Witness:	None		
Photo #	2	Of	6	Date:	1-18-11	Time:	1309

**Description:** A view of the sewage that flowed approx. 60 feet from the manhole. The manhole was not flowing on this date.

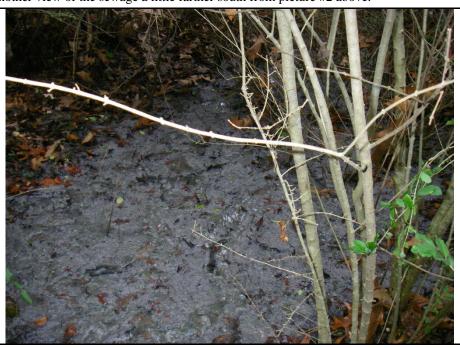
Water Division NPDES Photographic Evidence Sheet										
Location:	At 1512 Convent Street in Pocahontas, Arkansas (Randolph Co.)										
Photographer	oher: Mike Kennedy Witness: None										
Photo #	3	Of	6		Date:	1-18-11	Time:	1306			
Description:		Another	view of th	e sewage a little farther south	from picture	#2 above.

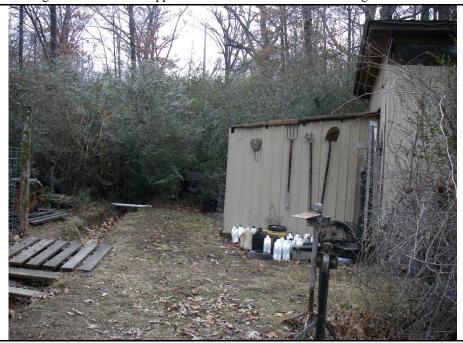
Photo #
 4
 Of
 6
 Date:
 1-18-11
 Time:
 1306

**Description:** The sewage flowed to within approx. 20 feet of Mr. Tarantino's storage shed shown.

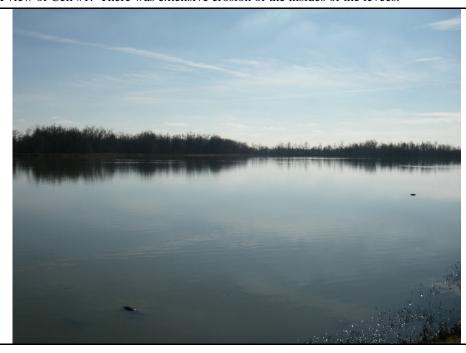
Section C, Item 2: Extensive erosion on insides of levees of Cell #1, Rock Filter partially clogged. This is a violation of Part III, Section B, 1, a, of the permit.

Water Division NPDES Photographic Evidence Sheet										
Location:	Cocation: On Swan Cove Road approx. 2 miles off Highway #67 near Pocahontas, Arkansas (Randolph Co.)										
Photographer: Mike Kennedy			ennedy		Witness:	William Daniel					
Photo #	5		Of	6		Date:	1-19-11	Time:	1131		
Description:	<b>Description:</b> A view of Cell #1. There was extensive erosion of the insides of the levees.

- Extensive erosion was observed on the inside of the levees of Cell #1, the Rock Filter was partially clogged
  - 1.a Plans are being made to redo the levees of Pond #1, also plans are for the filter to be redone with larger filter rock.
- 2. Daily flow reading were not being performed as required.2.a Daily flow are now being done the days the men work, on weekend and holiday a flow is taken from the charts.
- 3. 3-hour composite samples were being taken before 10:00 A.M.
  - 3.a sample are now being taken starting at 9:00-10-11
    A new auto sample will be used after ponds are redone.
- 4. Secondary Flow Meter exceeded the permit.
  - 4.a Flow Meter was calibrated by OSI

For your information, our City Council has just approved a 25% increase in our water and sewer rates. The sewer part of this increase will be used to finance a major overhaul and upgrade of our waste water treatment facility. This should correct the erosion and rock filter problems mentioned in your February 25, 2011, Inspection Report.

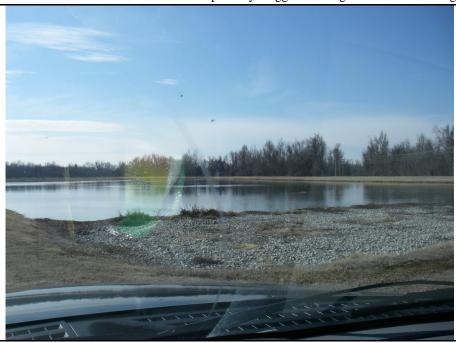
Photographer:		Mike Kennedy			Witness:	William Daniel		
Photo #	6	Of	6		Date:	1-19-11	Time:	1132

**Description:** A view of the Rock Filter. The filter was partially clogged and vegetation was covering part of the filter.
